## **51 Abbeyhill, Edinburgh Standing Building Survey Report No 2086**

Authors	Stuart Mitchell MA AIfA
Illustrator	Leeanne Whitelaw BSc MIfA
Editor	Bruce Glendinning BSc PgDip MIfA
Commissioned by	Dr Geoffrey Platt
Date issued	July 2012
Version	0
Planning Ref	12/01364/FUL
Oasis Ref	cfaarcha1-129181
Grid Ref	NT 26823 74124

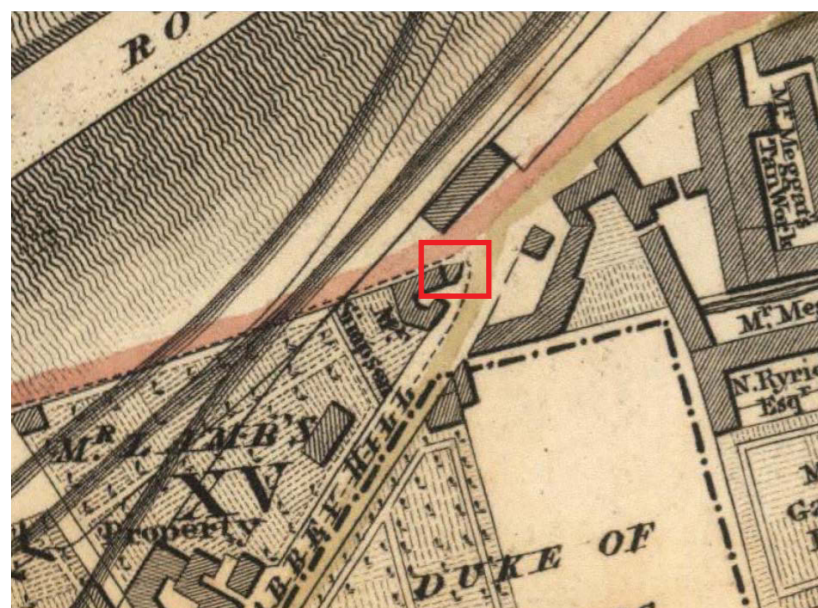
Fig 2a - Kirkwood's 'New plan of the City of Edinburgh' 1817

The earliest appearance of a structure with the same footprint as the surveyed building is shown on Kirkwood's map of 1817 (Fig 2a). This map depicts the building as being part of a larger complex of buildings under the ownership of a Mr Simpson. The 1852 edition Ordnance Survey town plan (Fig 2b) shows the building as an element of the larger Abbeyhill Foundry which occupied the site prior to the construction of the Police Station at No.55 Abbeyhill. The 1865 map by Hislop/Bartholomew (Fig 2c) shows increased development north towards the railway line. The 1877 First Edition map (Fig 2d) depicts only schematic block development at the site. The 1894 Second Edition map (Fig 2e) shows the building footprint with an angled gable fronting onto Abbeyhill.

The building appears to have been built during the early 19<sup>th</sup> century. Its original purpose is unclear although it is likely to be a remnant of the Abbeyhill Foundry which was established at the site by 1817 (Fig 2a).

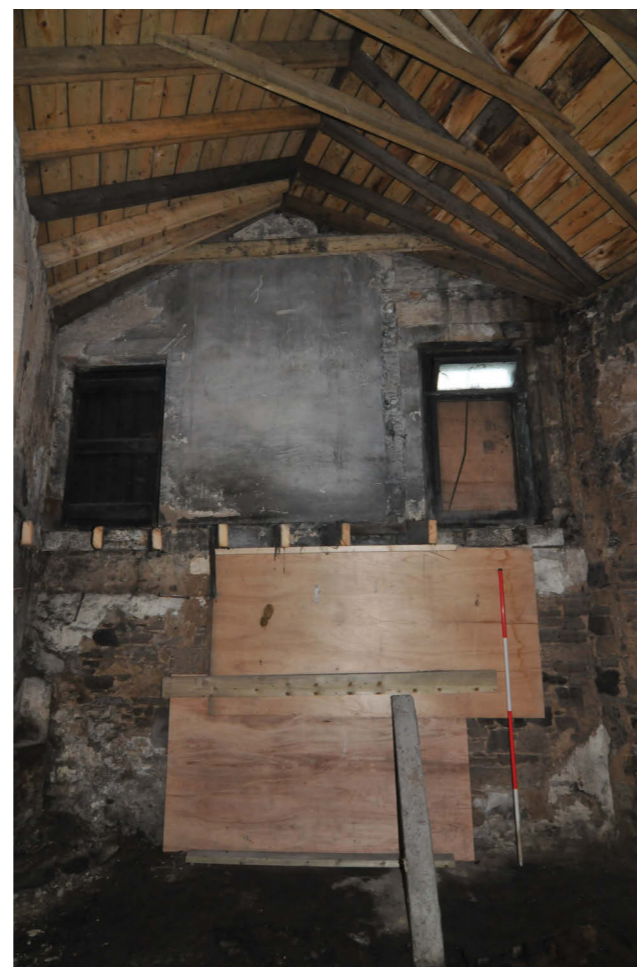
Plate 5 - Interior, west-facing elevation

The main build (4.6m x 4.1m) is random rubble and mortar bonded. Much of the ground floor level is obscured by timber panelling to secure the entrance. Most of the first floor/loft level wall is covered with a smooth cement render. The two vertical windows have slightly splayed surrounds and have timber window frames which have been boarded up.

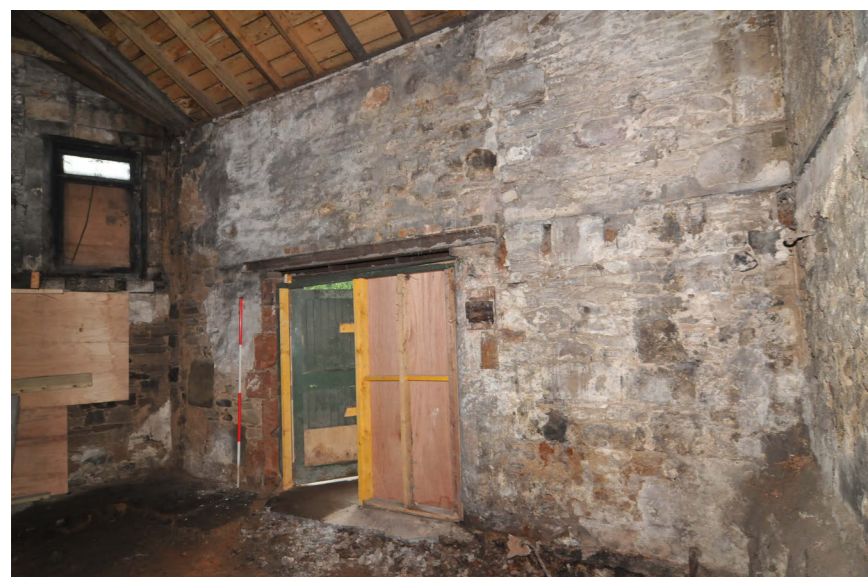
Plate 7 - Interior, north-facing elevation

The elevation (6.1m x 3.9m) is random coursed rubble which is mortar bonded and thinly rendered. The double doorway is framed by red sandstone quoins and a replacement iron 'I' beam girder lintel. A modern concrete ramp has been laid across the entrance. Vertical joist sockets are set into the wall at west end showing the height of the loft floor.

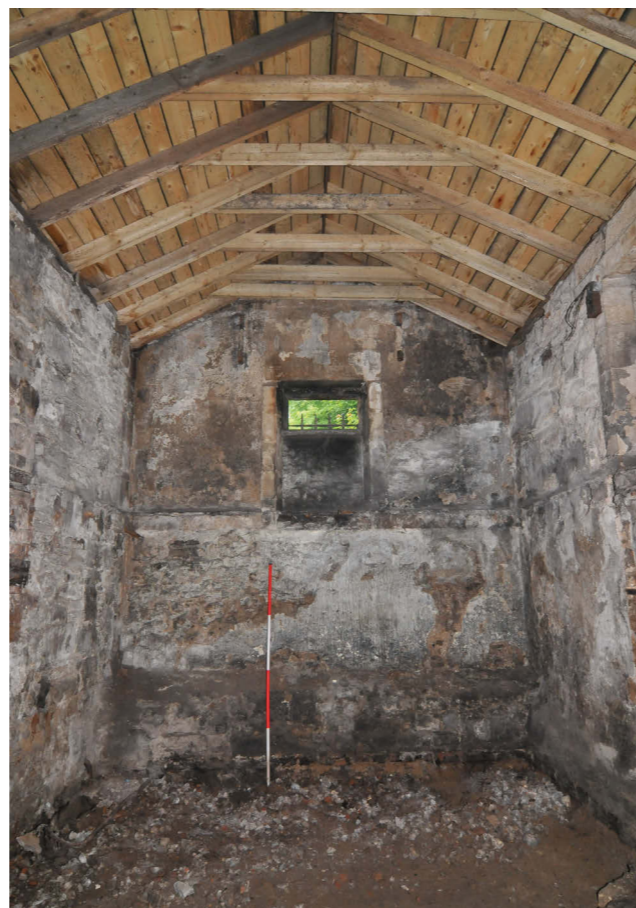
This elevation (3.9m x 3.9m) forms the inside of the rear gable. It is built of coursed rubble. The base of the wall is thicker than the wall head to form a retaining wall to the railway bank material on its exterior. The line of the former loft floor is marked by the remains of a plaster fillet. The lower wall has thin white render, while the loft level above has patches of render surviving. A vertical window is centrally placed and framed by red sandstone. The base of the window has been infilled by two courses of brick to bring it level with the loft floor. Two vertical features are visible either side of the window towards the top of the elevation, their purpose is not clear but they are likely to be blocked slit vents.

Plate 8 - Interior, east-facing elevation showing floor joists

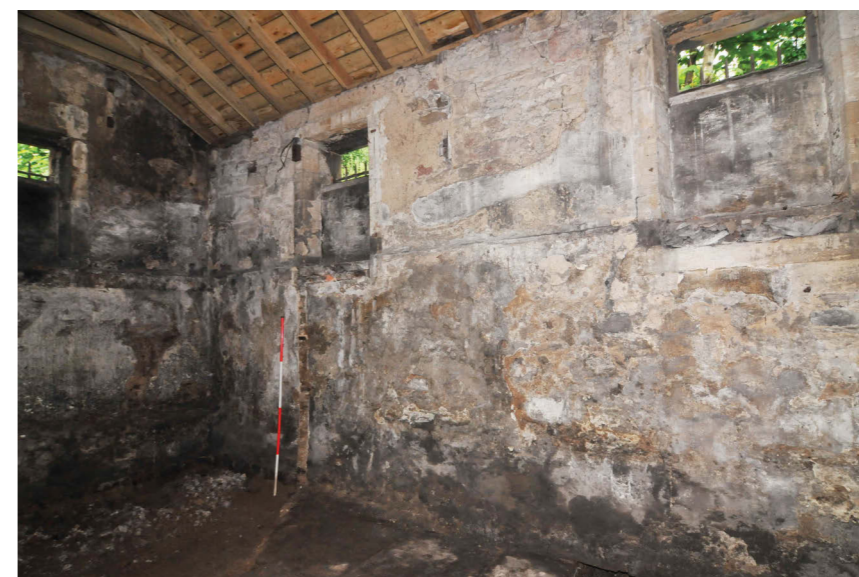
Plate 9 - Interior, south-facing elevation

The south-facing elevation (7.9m x 4.2m) is built of random coursed rubble and is whitewashed. It has a thick cement render at the base. The elevation has two vertical windows set within sandstone surrounds and each has been bricked up at the base to bring them level with the former loft floor. The loft floor level is indicated by a shallow concrete fillet running along the wall, and vertical joist sockets at the left hand side of the wall which match those on the north facing interior elevation. The stub of a brick partition wall (Plate 10) is visible towards the left hand side of the wall. A square dook socket and an *in situ* dook were situated between the windows at the loft level. An iron rod with a square section has been fitted into the wall, its purpose is unclear.

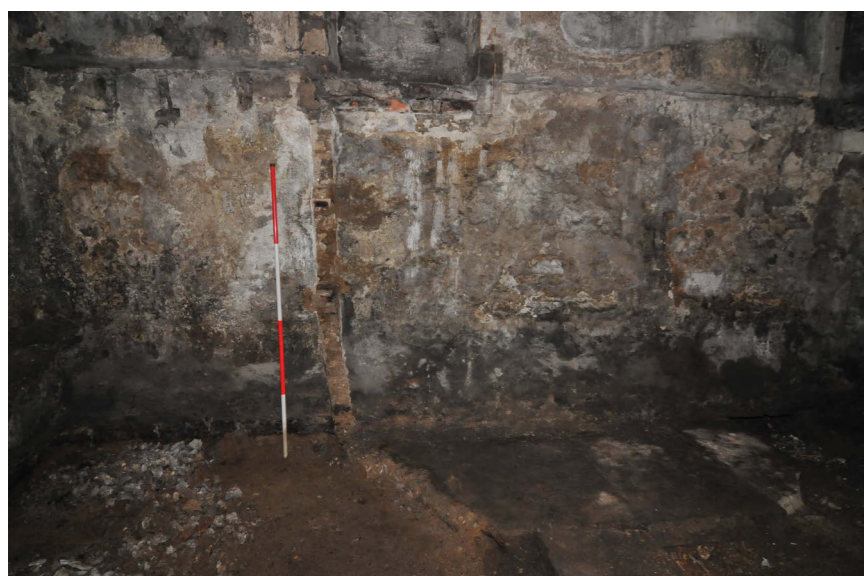
Plate 10 - Interior, south-facing elevation, detail of partial wall stub

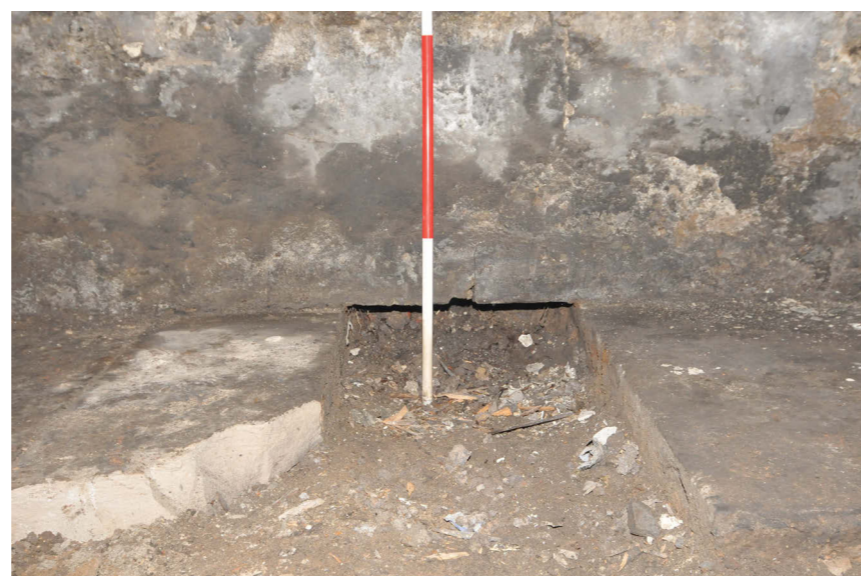
The floor plan is sub-rectangular with an angled east end. Thick sandstone flagstones survived around the east perimeter of the building but had been robbed from the rest of the floor, leaving a foundation solum of rubble, beaten earth and natural clay. The stub of the brick partition wall runs obliquely across the building defining what was likely to have been a trapezoidal shaped main unit accessible through either of the exterior doors. A 0.64m wide sub-floor gap in the flagstones showed that the flags continue underneath the inner skin of the wall to a depth of 0.25m. It is unclear whether the flagstones were an integral part of the construction and tied into the walls thus forming a very stable structure, or if this gap was a vent now blocked with rubble. Given that the north facing exterior wall of the building forms a retaining wall for part of the railway bridge embankment it would seem unlikely that a vent would be placed here. A stone built feature (Plate 12) occupied the corner between the interior south and north-east facing elevations and is most likely a plinth for a small stove.

Plate 11 Interior, floor and vent

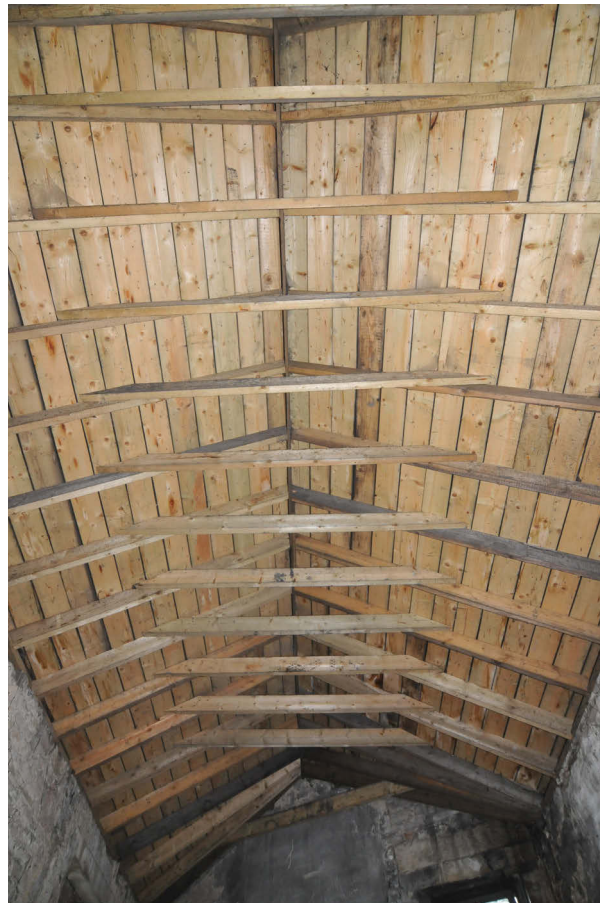
The A-frame roof trusses comprised machine cut timber (pine) that rest directly on the wall head. A partial fantail has been formed in the sarking at the east end to accommodate the angled gable.

Plate 14 - Interior roof trusses and sarking boards
