18-22 Potterrow, Edinburgh: Festival Theatre Extension

Archaeological Recording

Report No. 2082

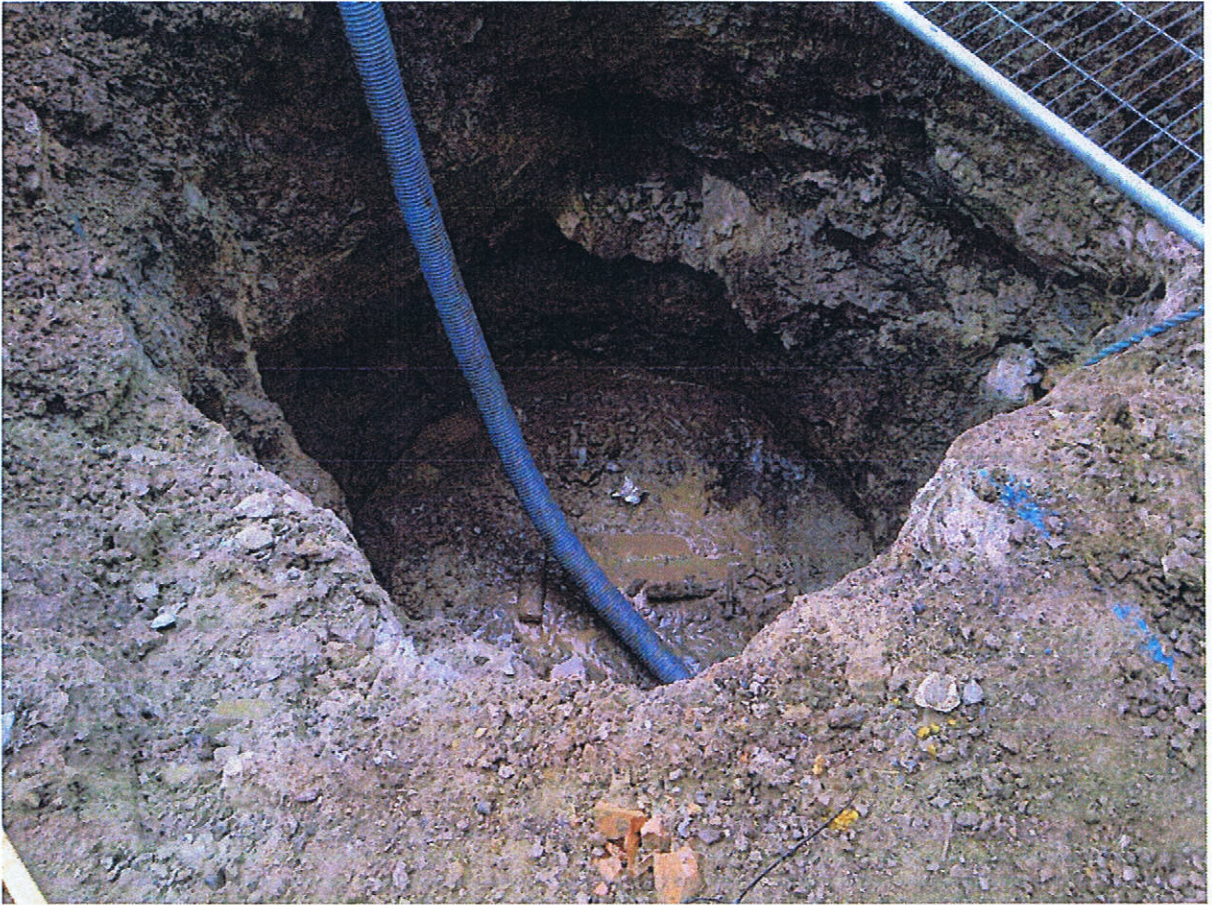
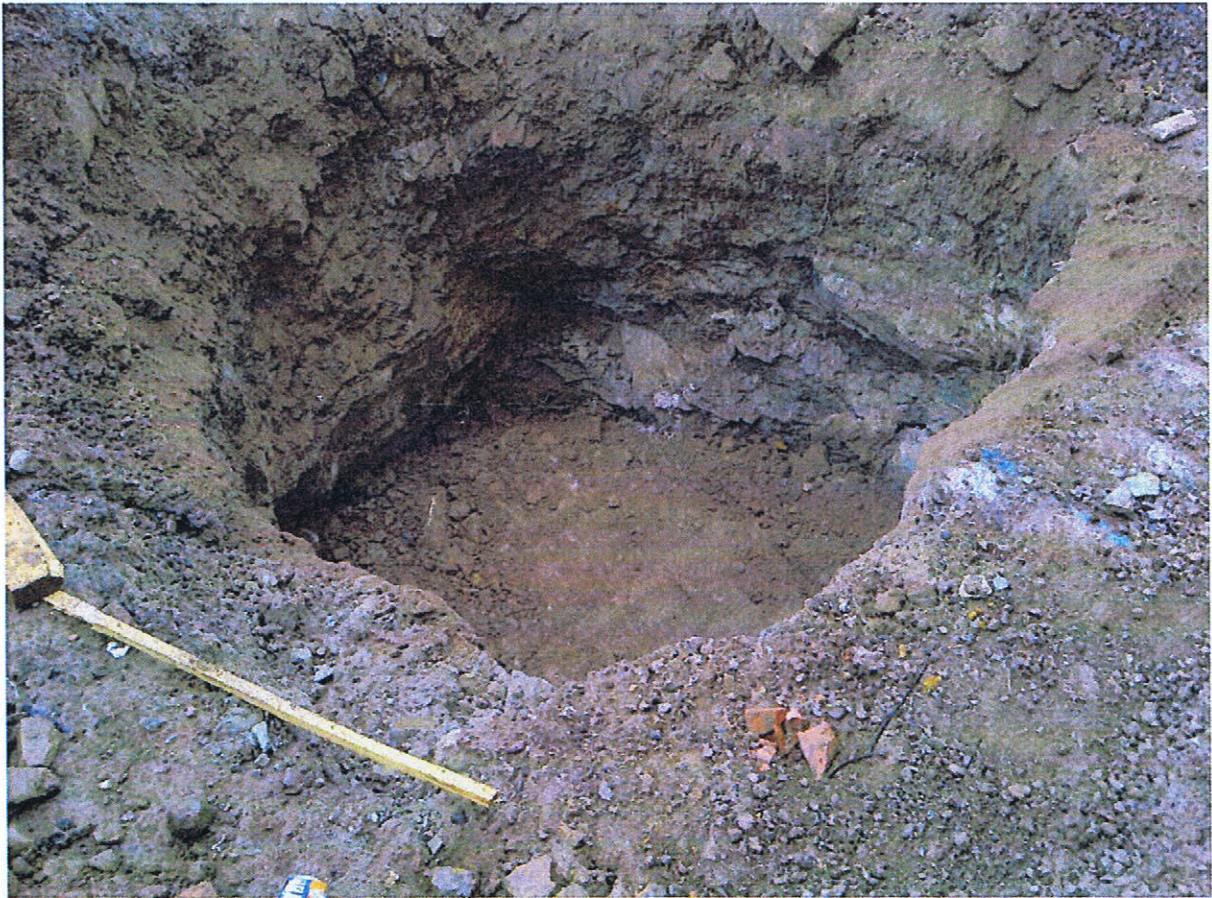
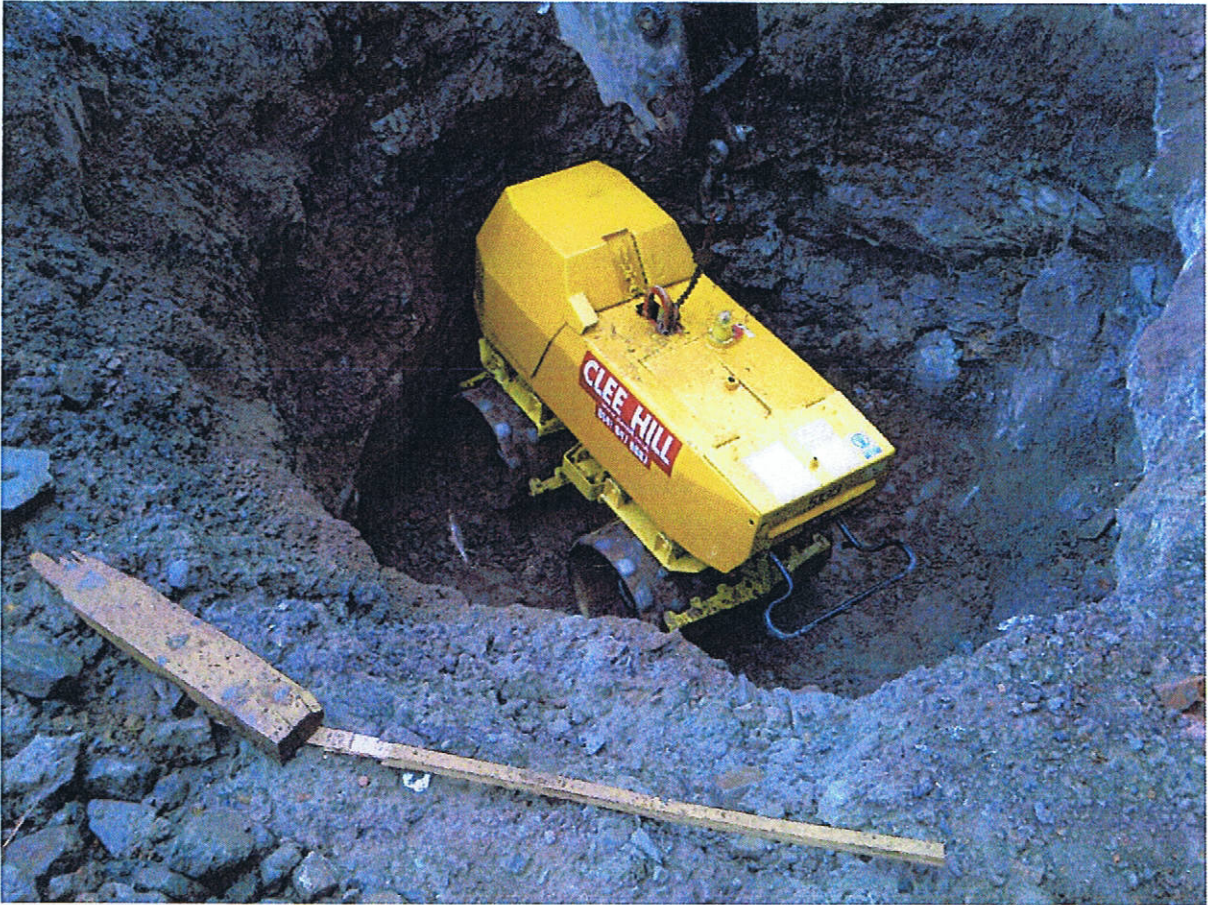
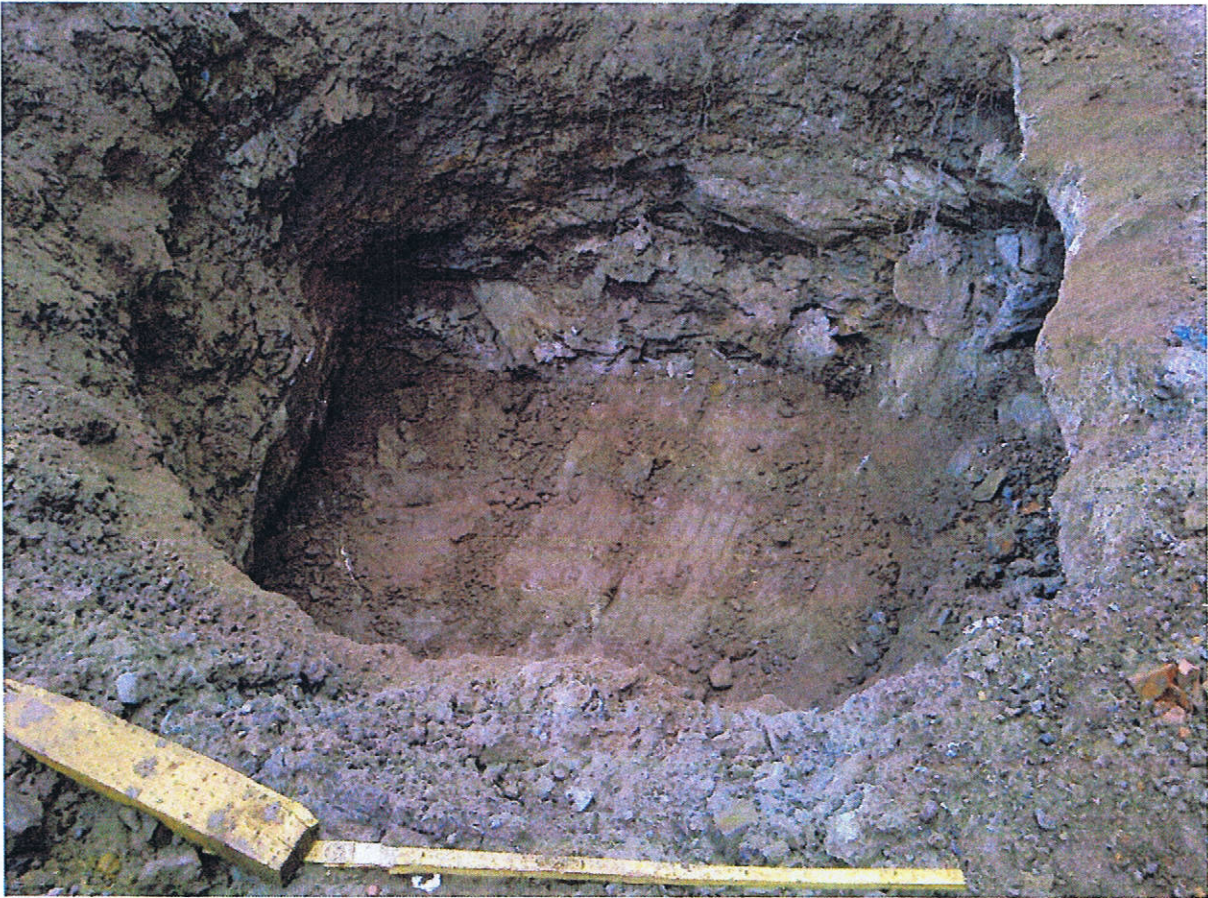
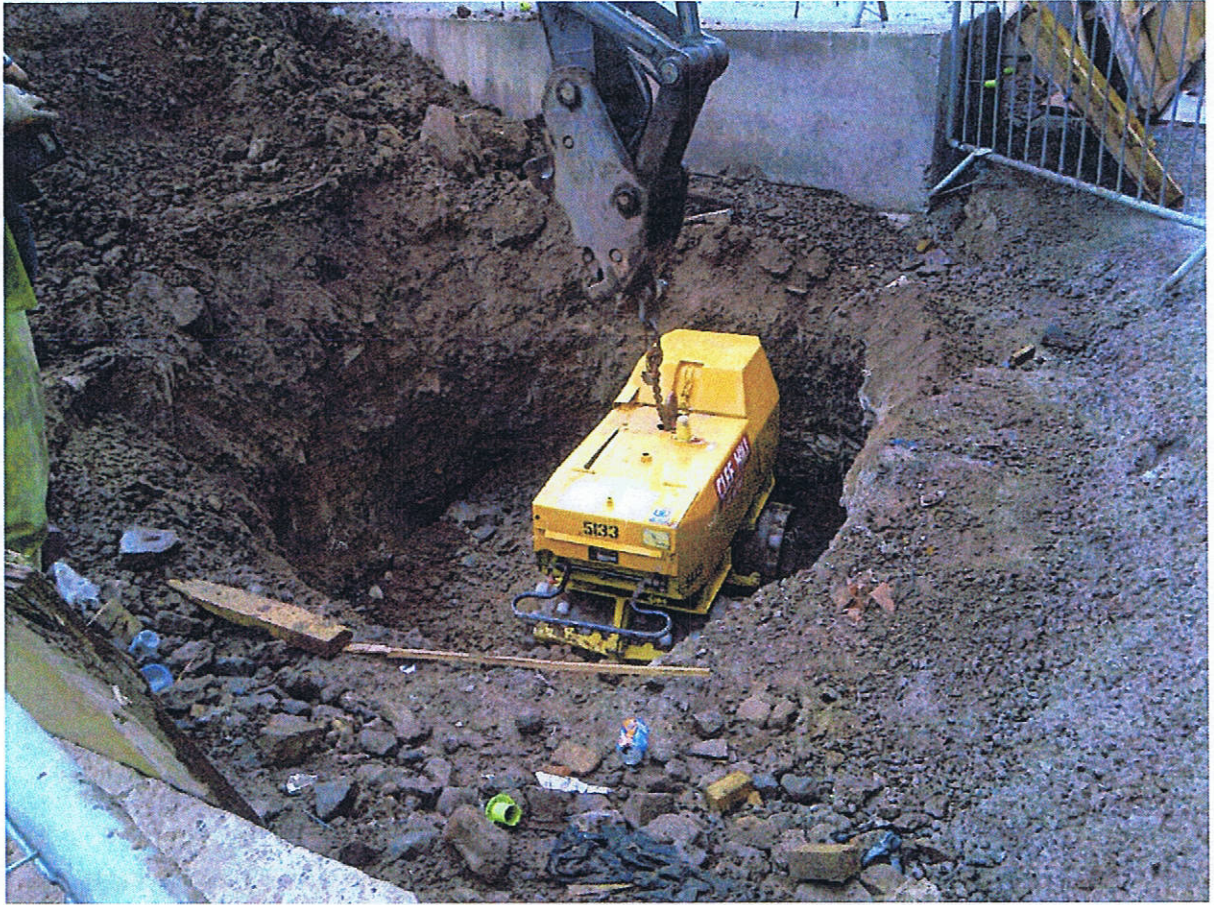
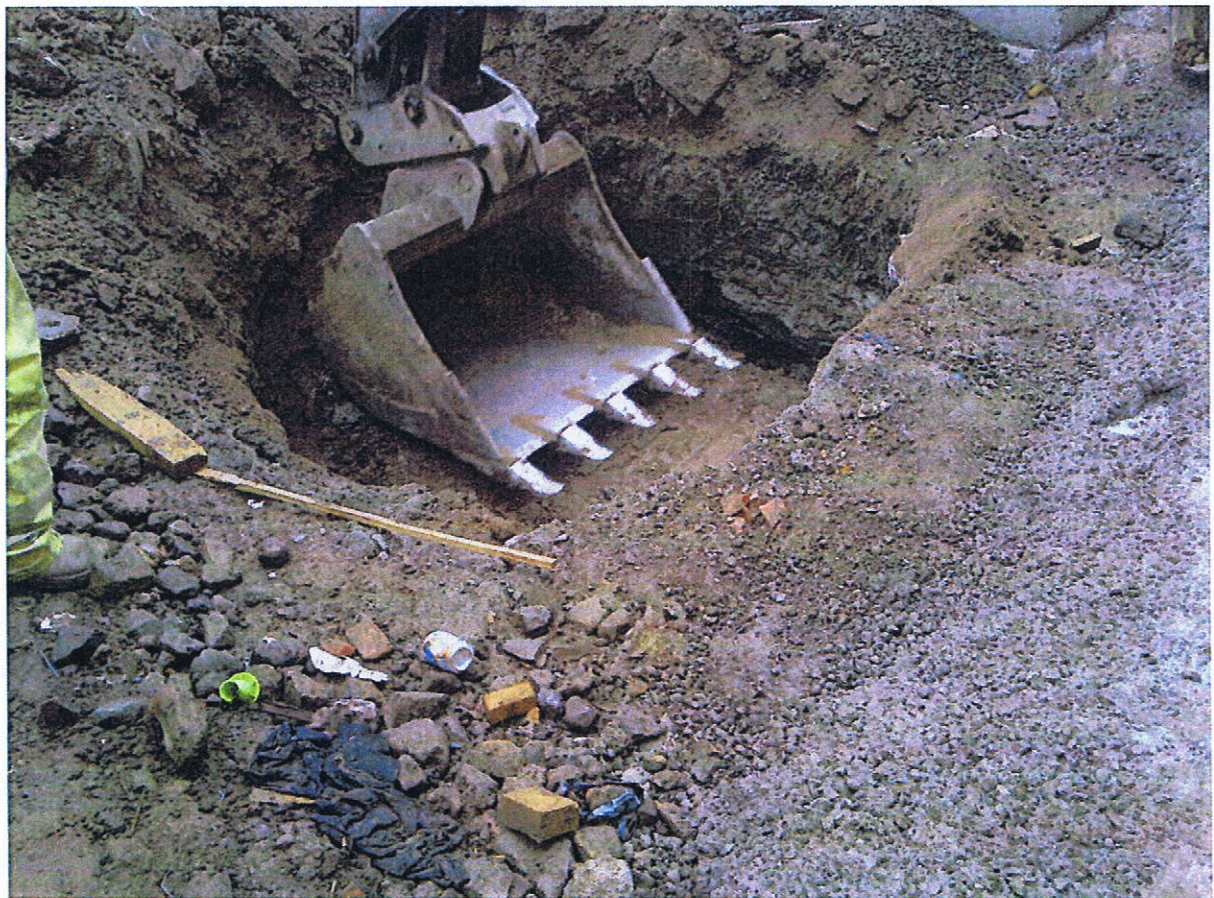
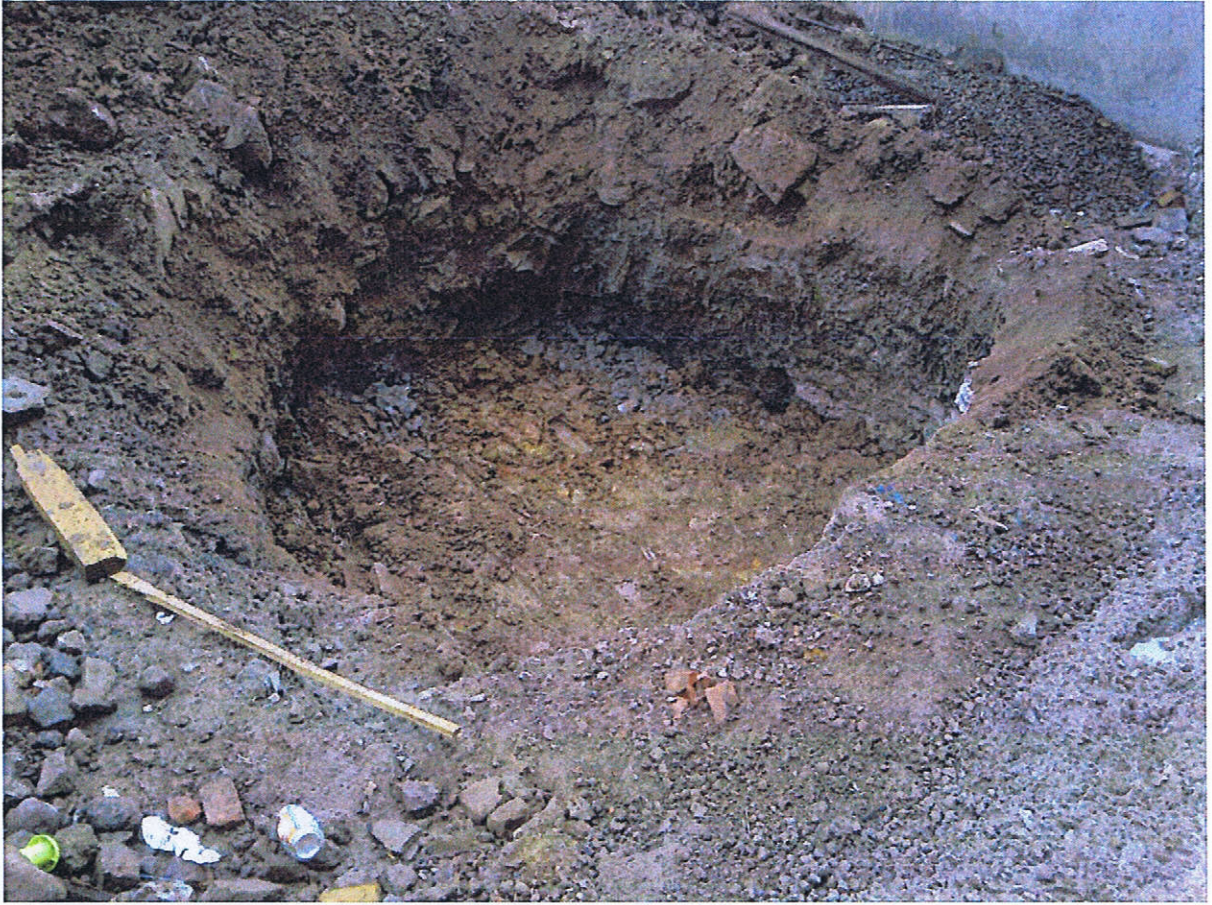
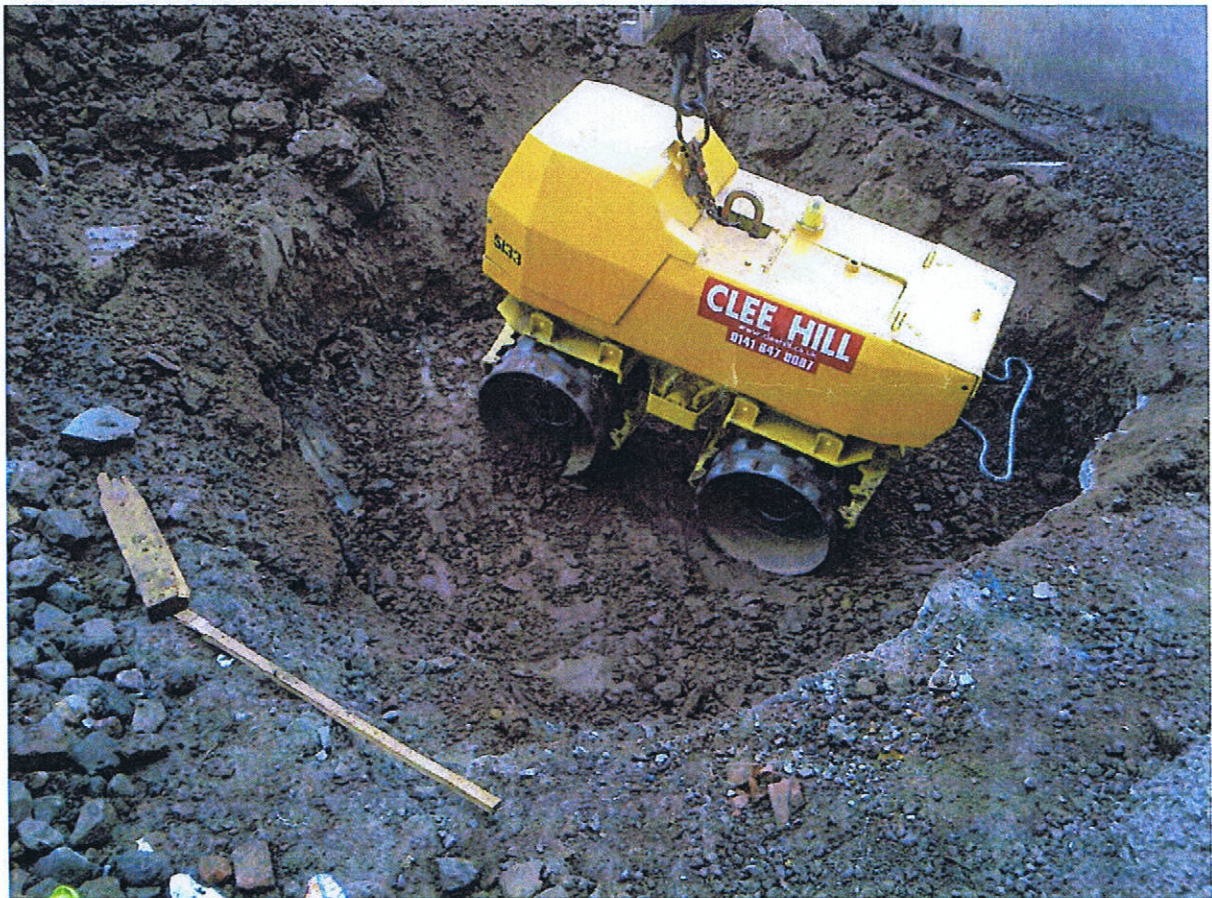
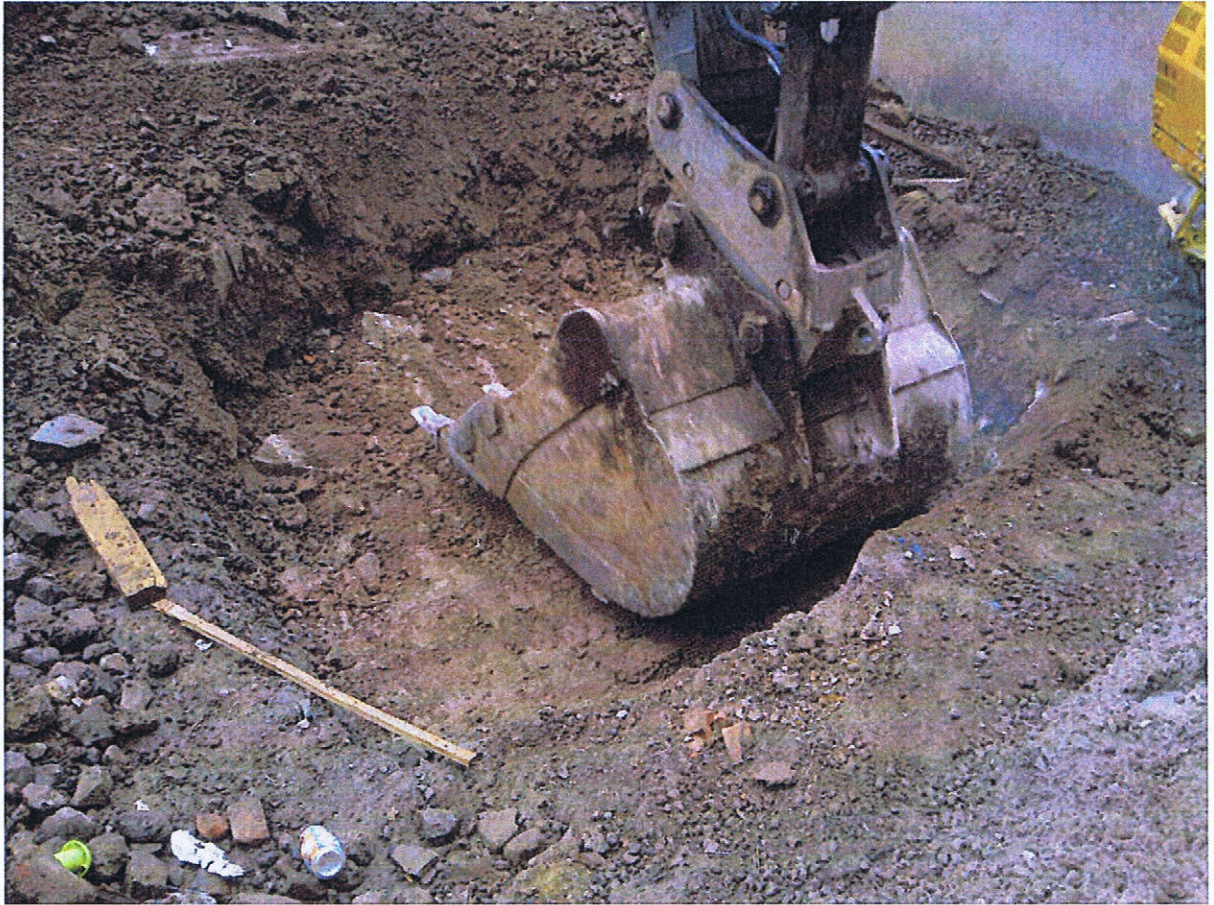
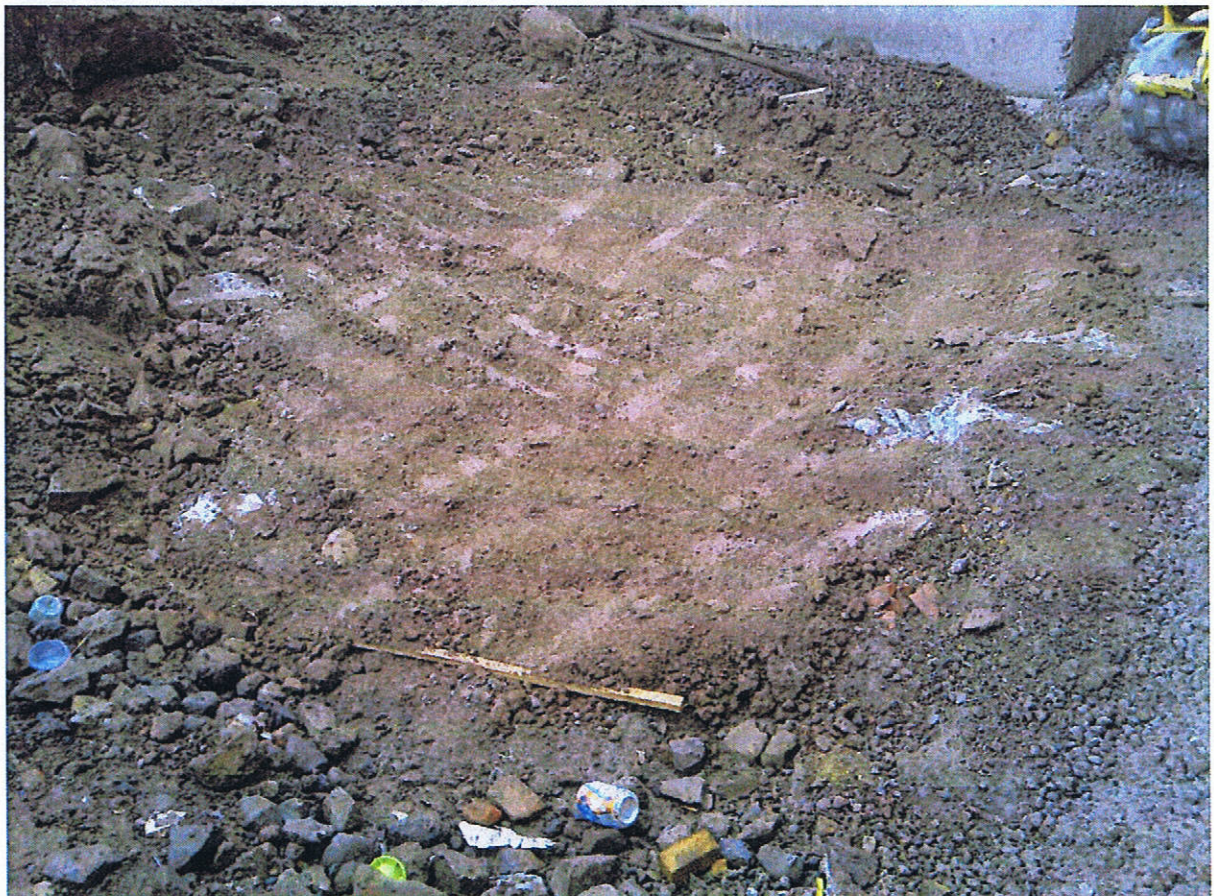
Appendix 2
Photographs

The backfilling operations were undertaken on 6th June 2012. The 'well' was once again pumped free of surface water prior to any filling and glacial till was excavated from within the site to be used as the backfill material. The glacial till was placed within the 'well' in layers approximately 200 mm thick with each layer compacted. Photos of the backfilling process are included in Appendix 2.

It is understood that a 200mm thick concrete slab will be placed over the backfilled 'well' and that this will be situated beneath the proposed building. This will minimise any future infiltration of surface water into the feature presenting a low risk to any deeper lying groundwater.

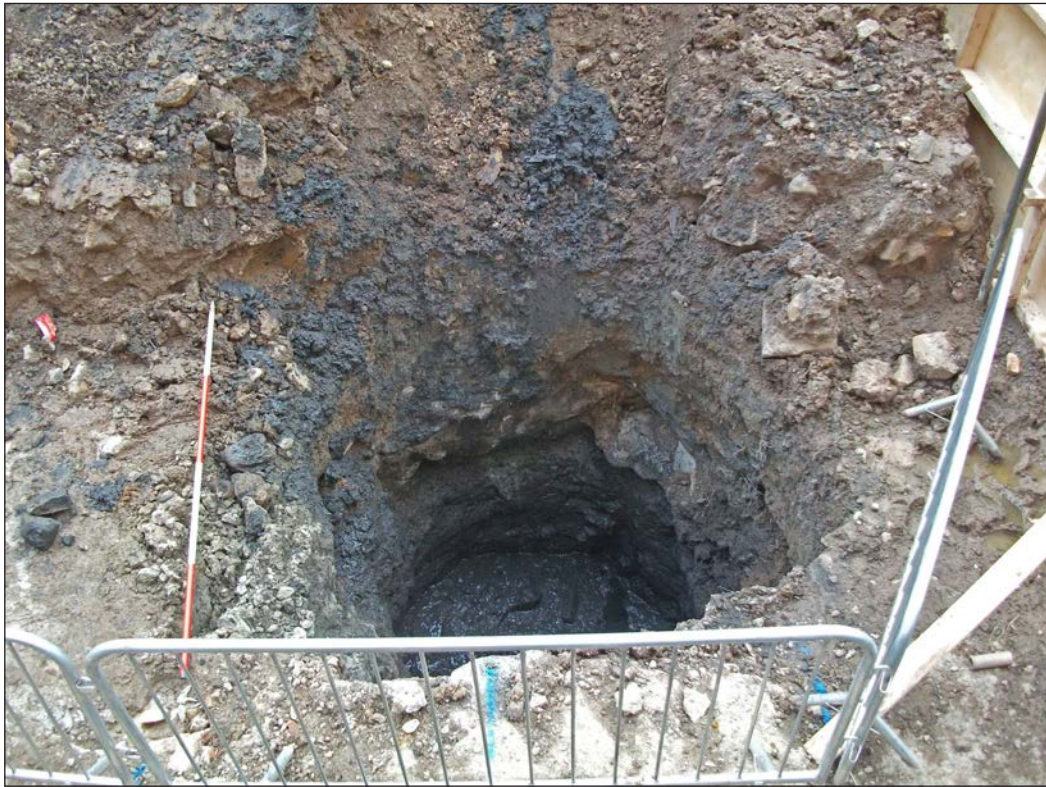
Fig. 2 - View of the well from the east

The well survived as a rock-cut shaft filled with water and black silt. There was no lining or capping visible, and the aperture of the well at existing ground level was 3m by 2.3m due to the collapse of the surrounding bedrock. The circular shaft of the well measured 1.8m across and was excavated to a depth of 3.5m (Fig. 1). The bottom of the well was not reached and the silt deposits were left in situ below this depth, with any remaining water pumped out by the contractors.

The existing ground level at the well aperture was bedrock, suggesting that the upper part of the well had been lost. The east side of the well was abutted by a concrete slab relating to the construction of the existing Festival Theatre but there was no covering present over the well when it was discovered, and no surviving superstructure or associated pipework was noted (Fig. 2-3).

The well's position on site meant that the foundations for the theatre extension needed to be redesigned and the well had to be filled in. This was all carried out with the agreement of John Lawson (CECAS).

A well was uncovered by the main works contractors during ground works for the theatre extension. This was recorded and subsequently filled with sterile clay and capped, and thus survives in situ.
