## **Blackadder West Cottages, Near Allanton, Scottish Borders**

### **Standing Building Survey & Archaeological Watching Brief**

**Report No. 2085**

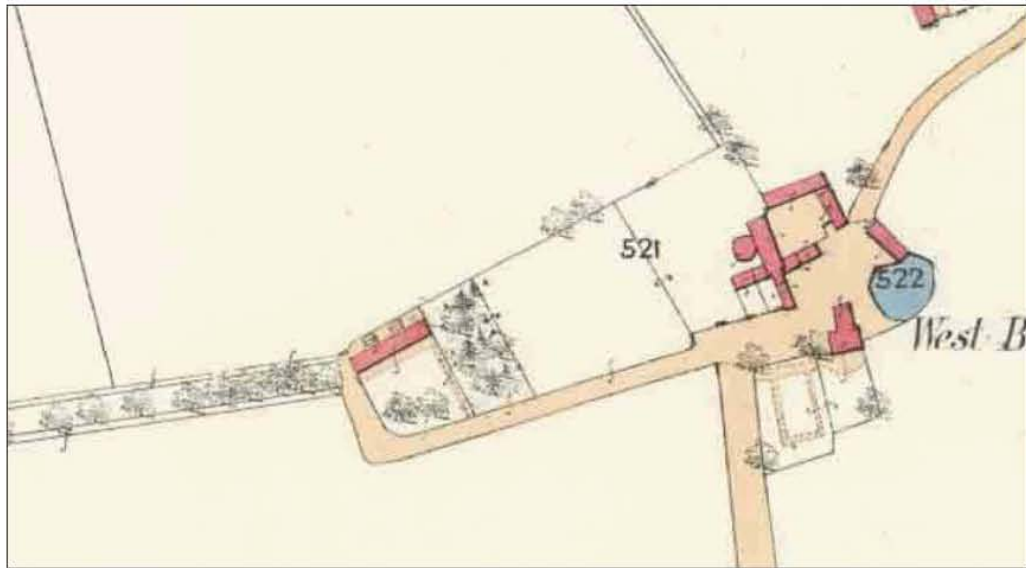
Fig. 2a - 1856 Ordnance Survey First Edition

Blackadder West Cottages are first depicted on the 1856 First Edition Ordnance Survey map (Fig. 2a). The cottages are depicted in block layout with the main access provided by a track from West Blackadder farm. An area of hardstanding or track is shown along both the northern and southern sides of the buildings and what may be two small livestock pens are attached to the northern side of the cottages. Another access is provided by a path which crosses the field to the south of the cottages and links the main access track to the cottages. A shelter belt of trees is located to the east of the cottages.

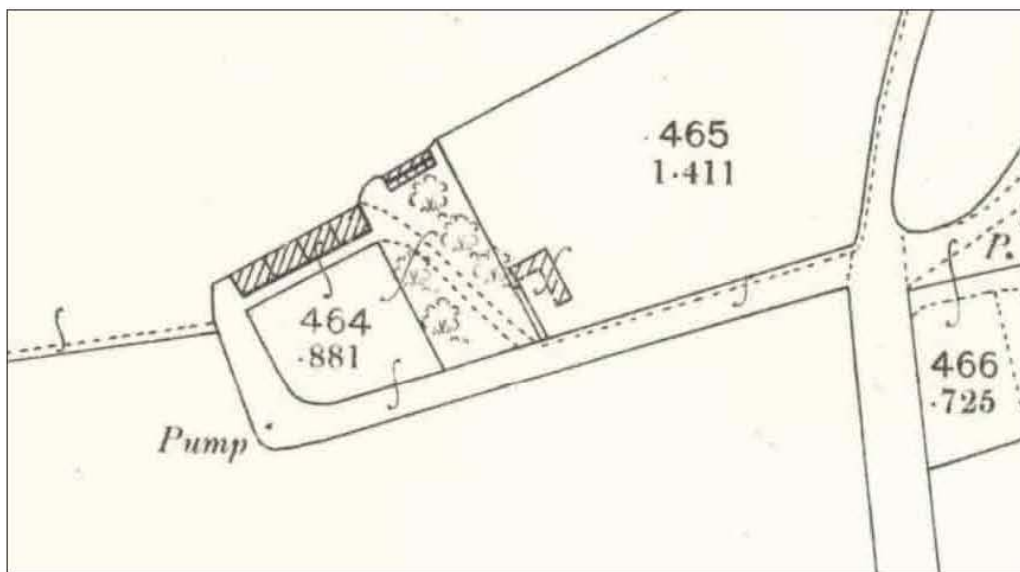
Fig. 2b - 1898 Ordnance Survey Second Edition

The 1898 Second Edition Ordnance Survey map (Fig. 2b) shows the cottages with four compartments. The track to the south of the cottages has moved to the east and now crosses the shelter belt. The hard standing and possible livestock pens on the northern side of the cottages are now gone and this area has been taken in to the adjacent agricultural field. A water pump is depicted on the main access track to the south of the cottages. A possible livestock pens is shown at the north end of the shelter belt.

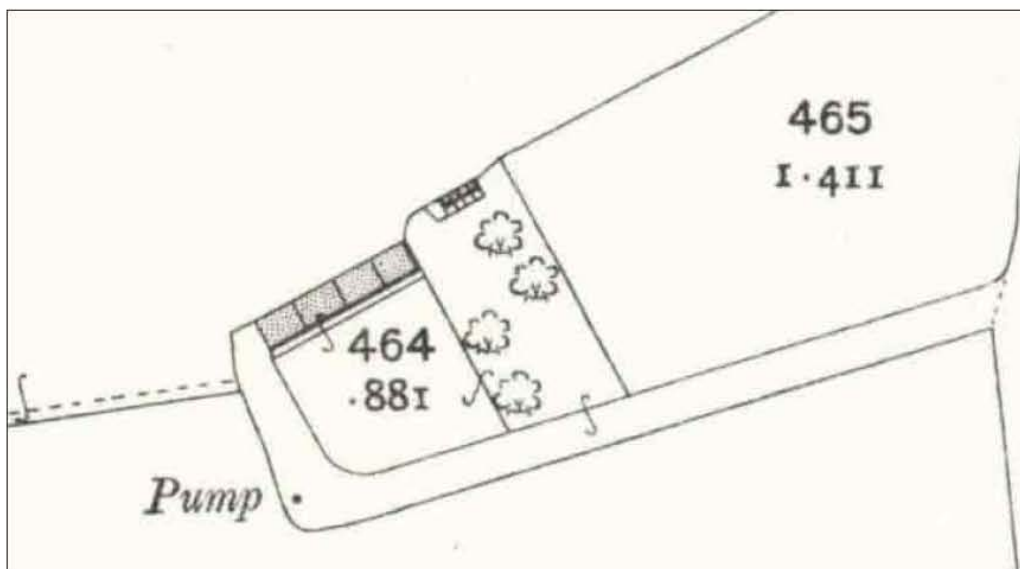
Fig. 2c - 1908 Ordnance Survey Third Edition

The 1908 Third Edition Ordnance Survey map (Fig. 2c) shows the same detail for the cottages as the 1898 map although the track running through the plantation is no longer present.

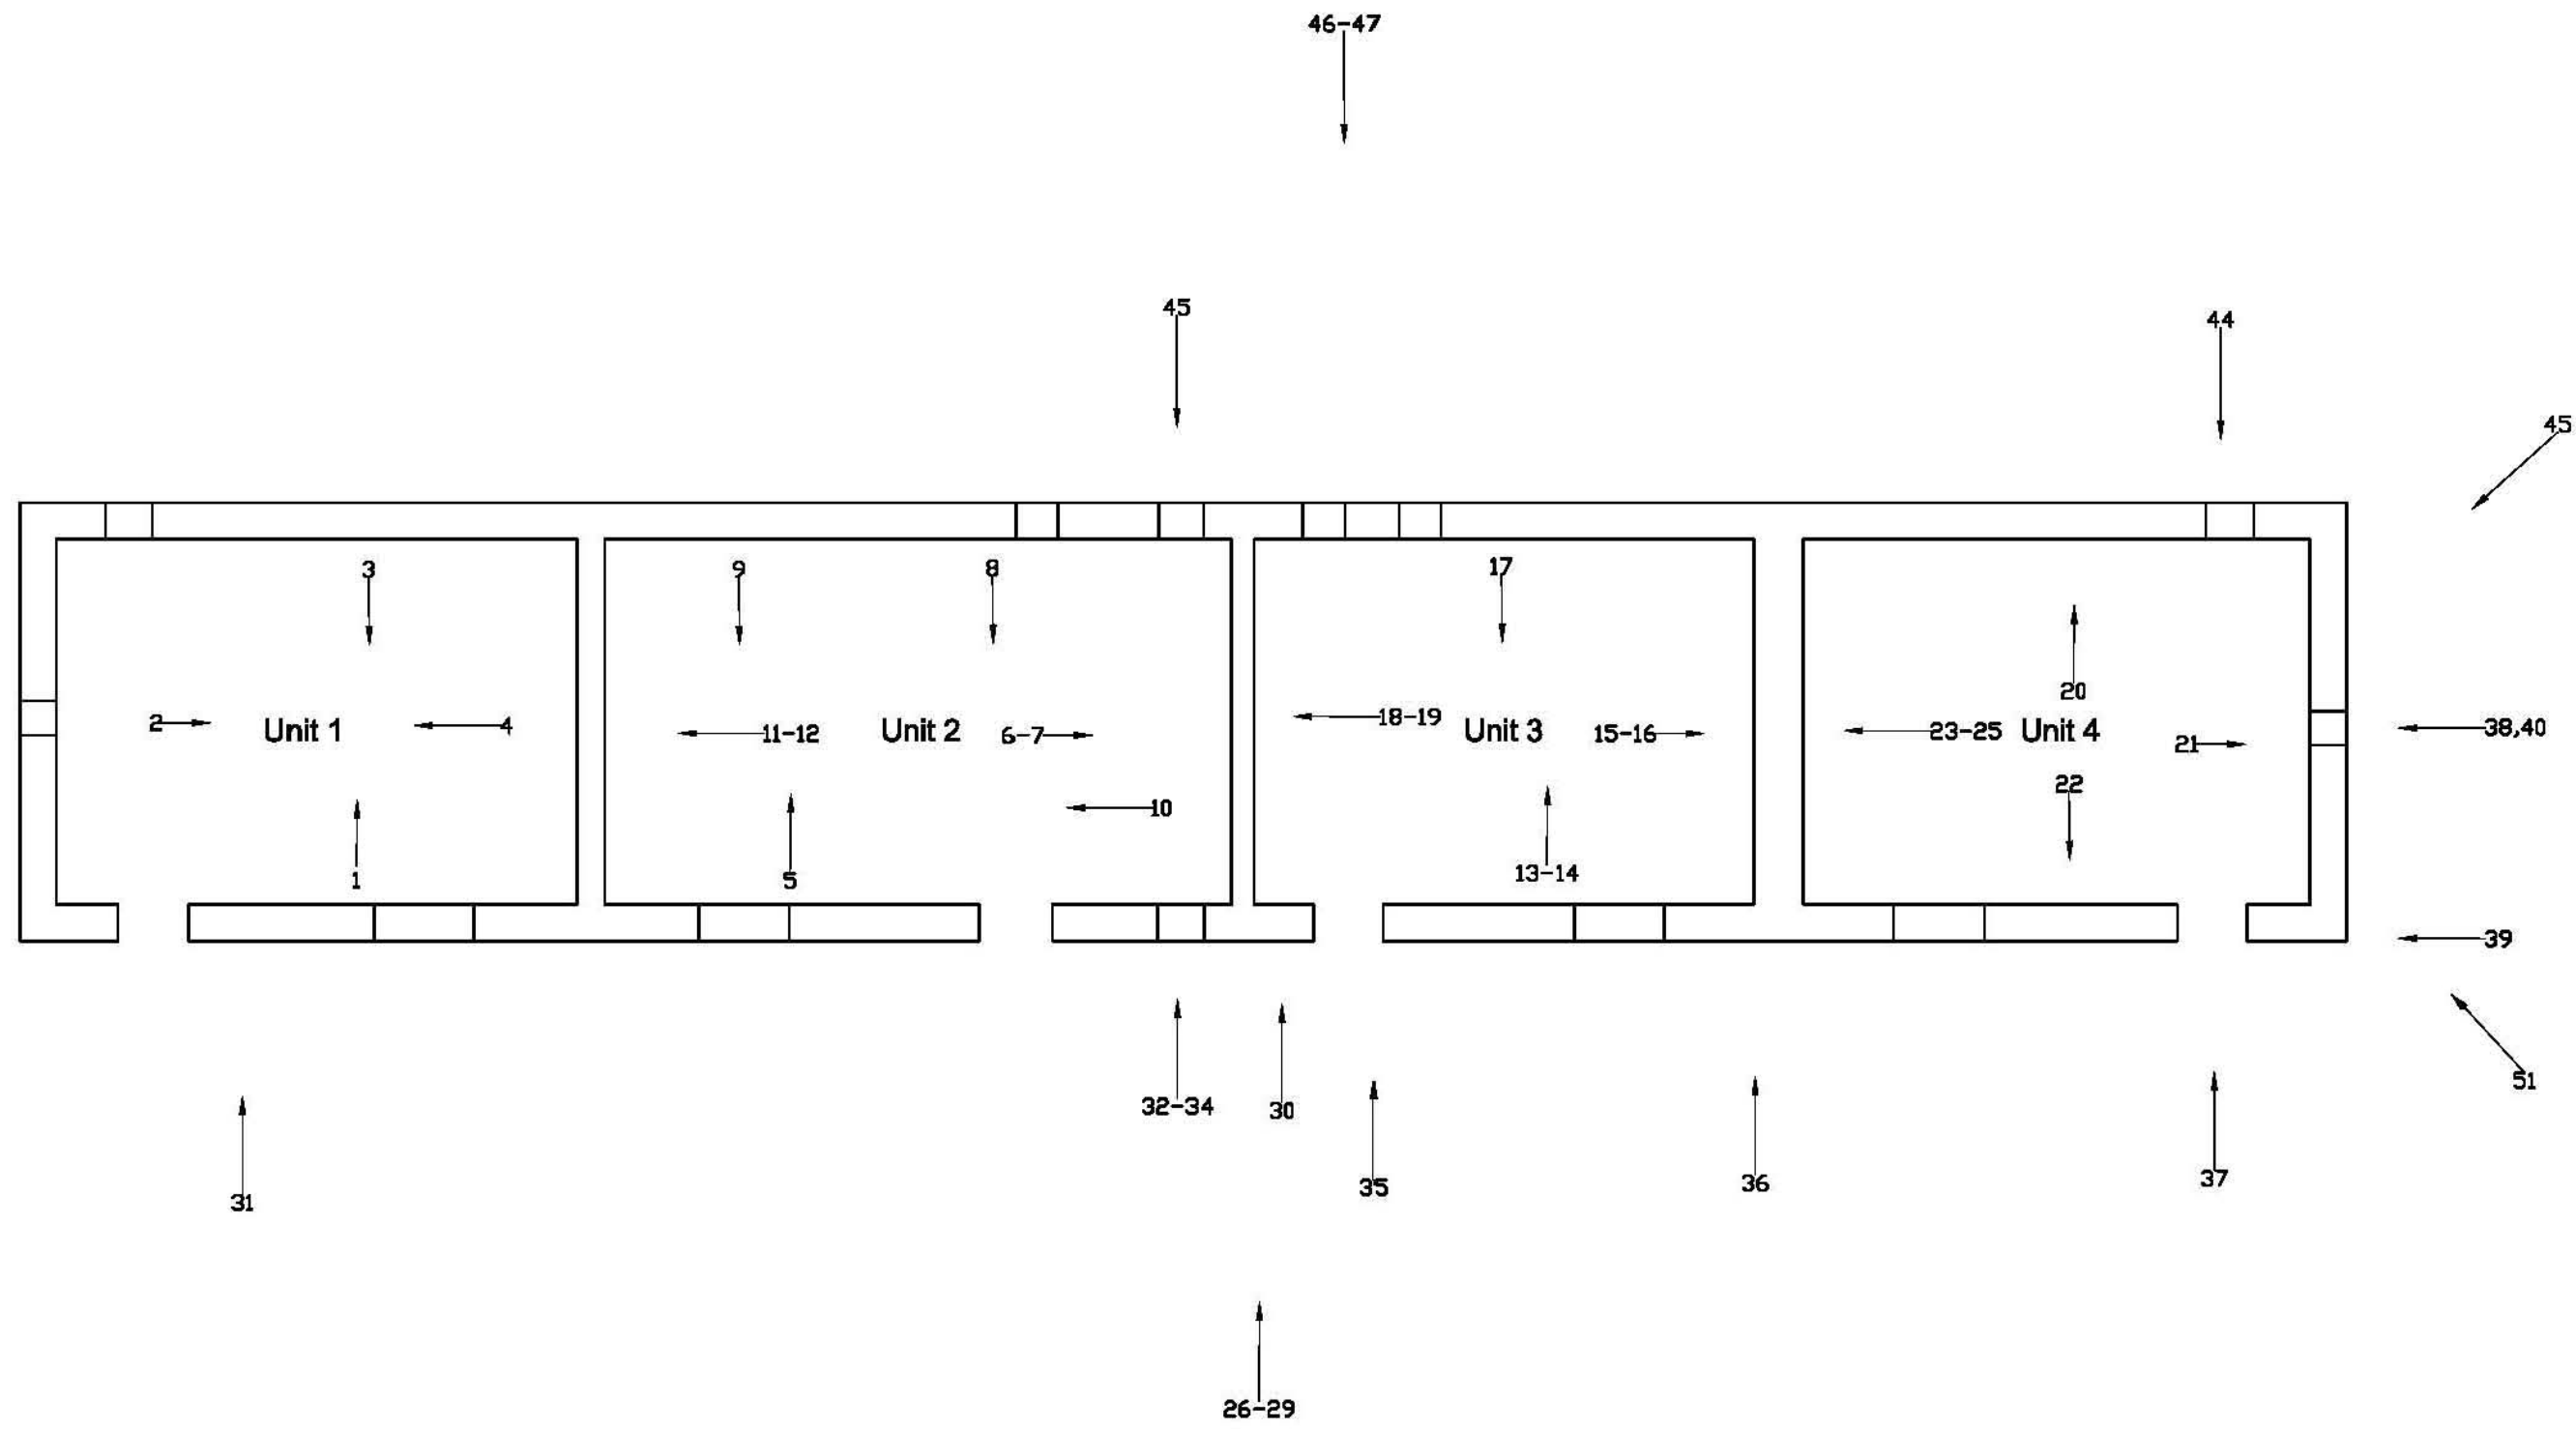
Fig. No: <b>3</b>	Revision: <b>A</b>	Checked: <b>LW</b>	Report No: <b>2085</b>	Drawn by: <b>LW</b>	Scale at A3: <b>1:100</b>	Key:

The cottages had a combined measurement of 21.4m long by 5.3m wide and were divided into four individual units (Units 1-4, Fig 3). The walls were on average 0.5m thick and their linings had been removed as part of the on-going renovation. The existing floor plan shows that each cottage had its own entrance situated on the south-facing elevation which provided access to a narrow vestibule with a doorway to a simple box staircase leading to the attic floor.

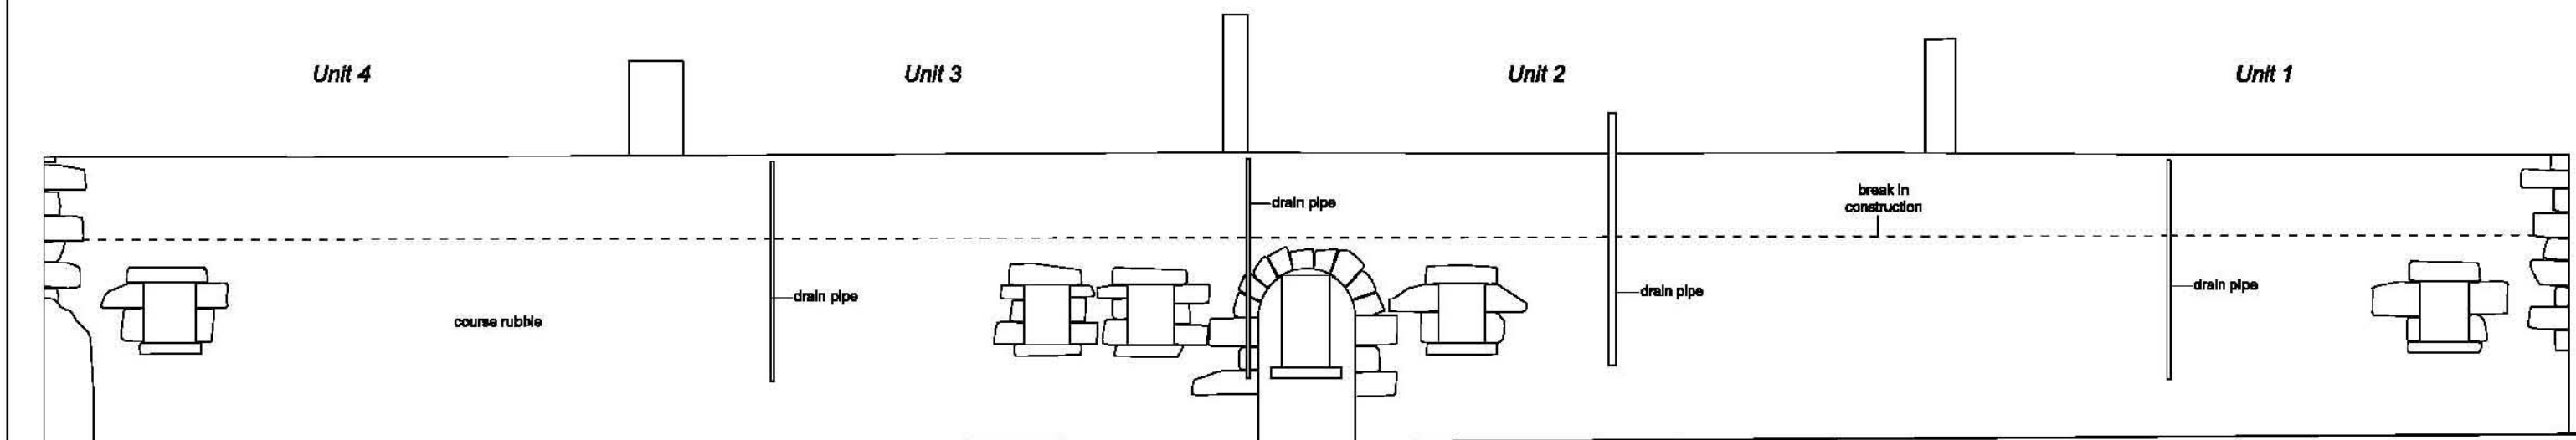
Fig. 4b - North-facing elevation

The north-facing elevation was constructed of coursed rounded boulders and had six bays. Two small windows lit Units 1 and 4 with two windows each lighting Units 2 and 3 respectively. The windows had droved sandstone dressings. At the centre of the elevation, one of the windows lay below a round-arched recess. A distinct line marking the position of the original wall height was visible where approximately seven to eight courses of coursed rubble had been used to raise the wall head by about 1m to accommodate the later roof.

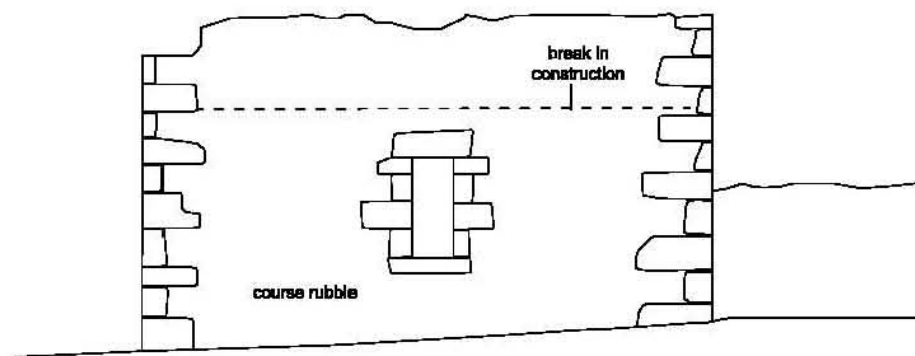
Fig. 4c - East-facing elevation

The east-facing gable wall was largely featureless with coursed and snecked whinstone and sandstone both used in its construction. Large droved ashlar sandstone quoins framed the elevation. A central window had droved sandstone surrounds. As with the rest of the building, evidence of wall heightening was visible above the window lintel where a distinct horizontal line marks the change in height.

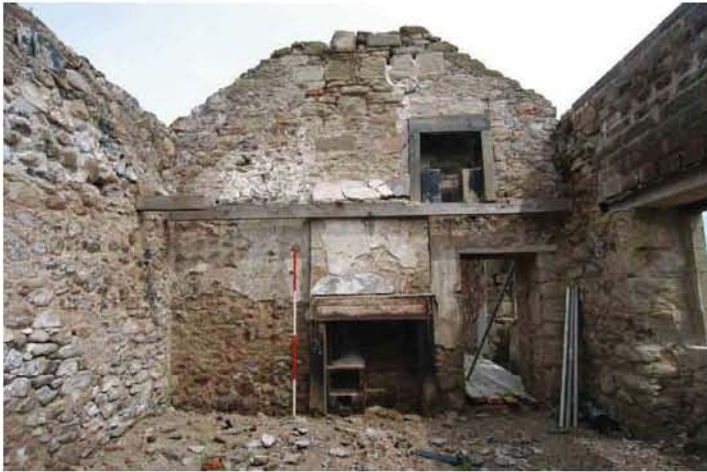
Unit 1 measured 6.7m long by 4.8m wide with walls surviving to a height of 3.5m high. The walls were constructed of sub-rounded boulders with a distinct break in their construction towards the wall head. The walls were originally covered with lath and plaster. The south-facing wall had a small window measuring 0.86m by 0.80m situated towards the west end of the wall. The east-facing wall was a pitched partition wall with an advanced chimneybreast and a former cupboard on the south side of the wall). The fireplace contained a cast-iron range measuring 1.4m by 1.4m. The range had a small oven with a missing door and a sway for hanging pots over the fire. At first floor level a second fireplace was situated on the south side of the partition wall. This fireplace had stone surrounds with a small grate and brick-lined fire back. There was a noticeable break in construction where the partition wall had been heightened by about 0.5m.

Fig. 5 - Unit 1, interior west-facing elevation showing two fireplaces

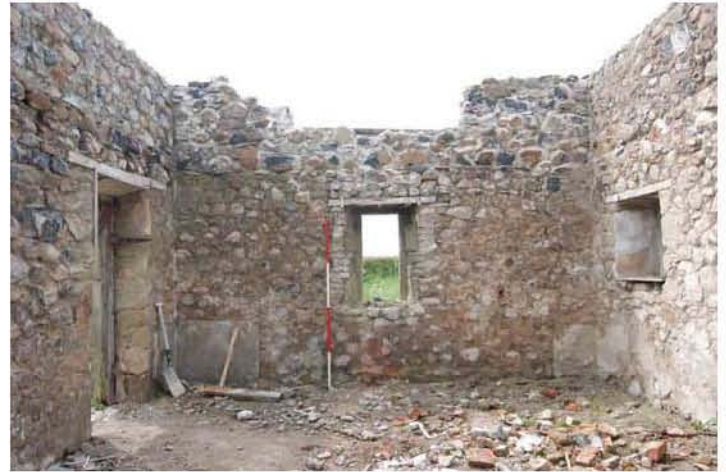
Fig. 6 - Unit 1, interior east-facing elevation showing the gable wall

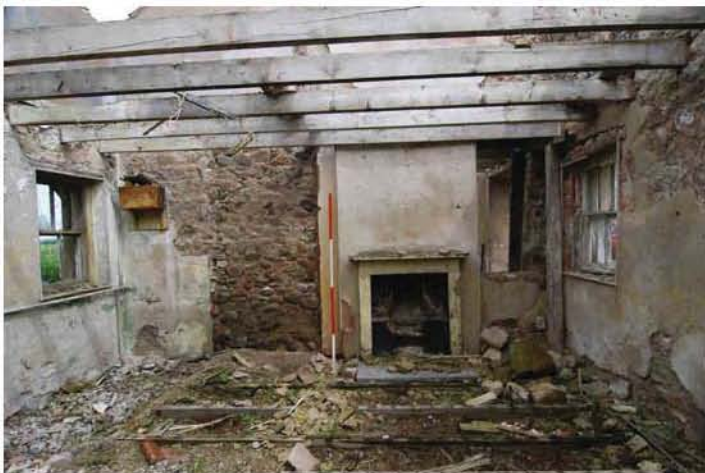
The east-facing partition wall had an advanced plastered chimneybreast with a small fireplace with sandstone surrounds and wooden mantelpiece. The fireplace was stone and brick-lined with cast-iron cheeks surrounding a small grate. A small cupboard flanked the fireplace. The cupboard had been partly removed when the interior of the building was stripped. At the opposite end of the elevation, pipework and a water cistern for a flushing toilet were present.

Fig. 7 - Unit 2, interior west-facing elevation showing the fireplace

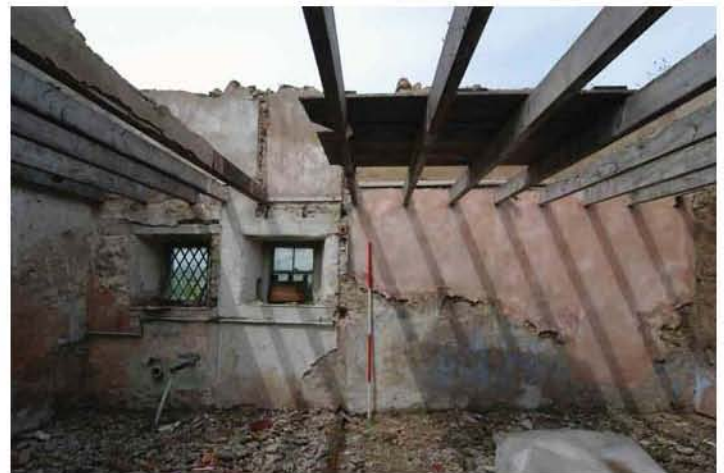
Unit 2 measured 8.4m long by 4.8m wide with walls surviving to a height of 3.5m. The rubble-built south-facing wall had two windows situated at its east end. The largest measured 1m high by 0.8m wide and contained a 2-over-2 sash and case window and formerly lit a small water closet. The second smaller window measured 0.9m by 0.8m and lit the main living room. Remnants of original wall plaster survived at the east end and within the former attic space.

Fig. 8 - Unit 2, interior south-facing elevation showing windows

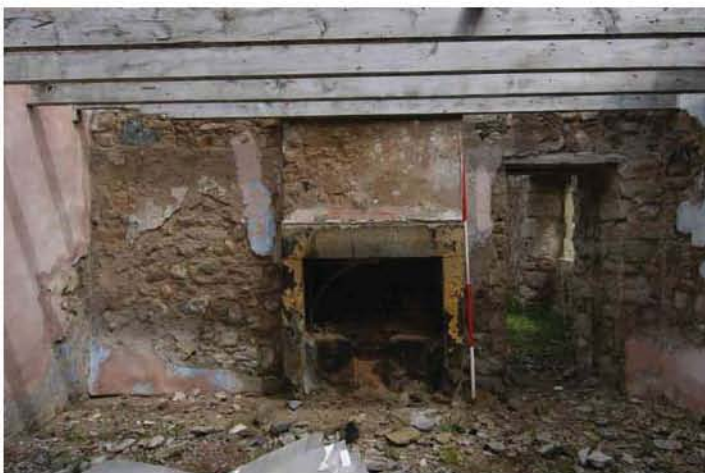
The east-facing elevation contained a central fireplace flanked by a former cupboard on its south side. The fireplace measured 1.5m by 1.5m and had stone surrounds. Internal features included the stone-built cheeks for a cast-iron range only the wrought-iron sway that held cooking pots above the grate survived.

Fig. 9 - Unit 3, interior west-facing elevation showing the fireplace

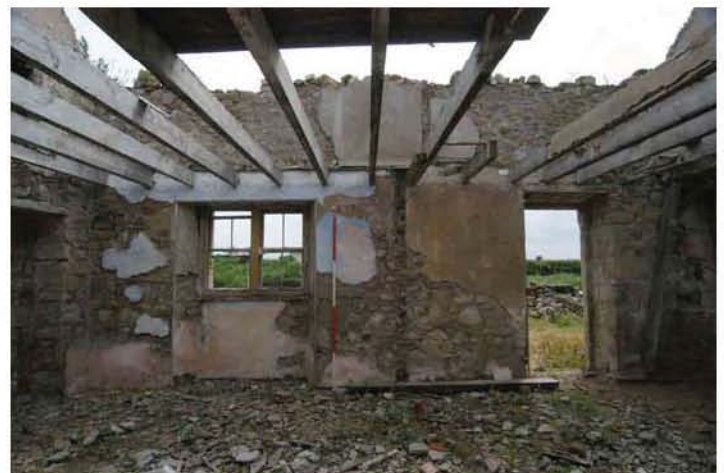
The north-facing elevation incorporated a doorway at the west end and a bi-partite window at the east end with 2-over-2 sash and case windows. The west wall was featureless. The attic floor was approximately 2.7m above the present floor and would have been lit by a single dormer window.

Fig. 10 - Unit 3, interior north-facing elevation showing doorway and window

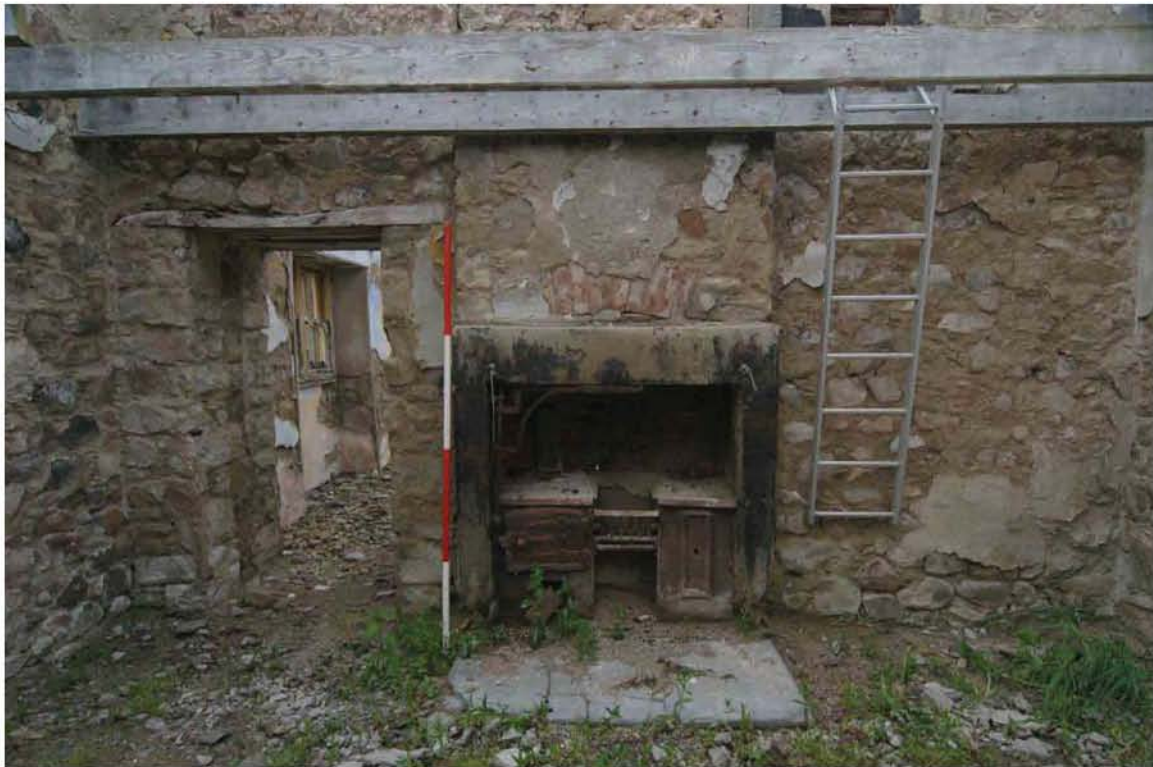
The west-facing partition wall contained a ground floor and attic fireplace. The ground floor fireplace consisted of a cast-iron range with oven and boiler with a small grate in between. The hearth stone was a single piece of grey slate. Above the mantle stone was a small brick-built relieving arch. Above the grate was a small iron sway. The attic fireplace was on the north side of the partition wall and had stone surrounds with a small grate inserted within its interior. The attic floor was approximately 2.7m above the floor and was lit by a single former dormer window situated on the south wall.

Fig. 11 - Unit 4, interior east-facing elevation showing the fireplace

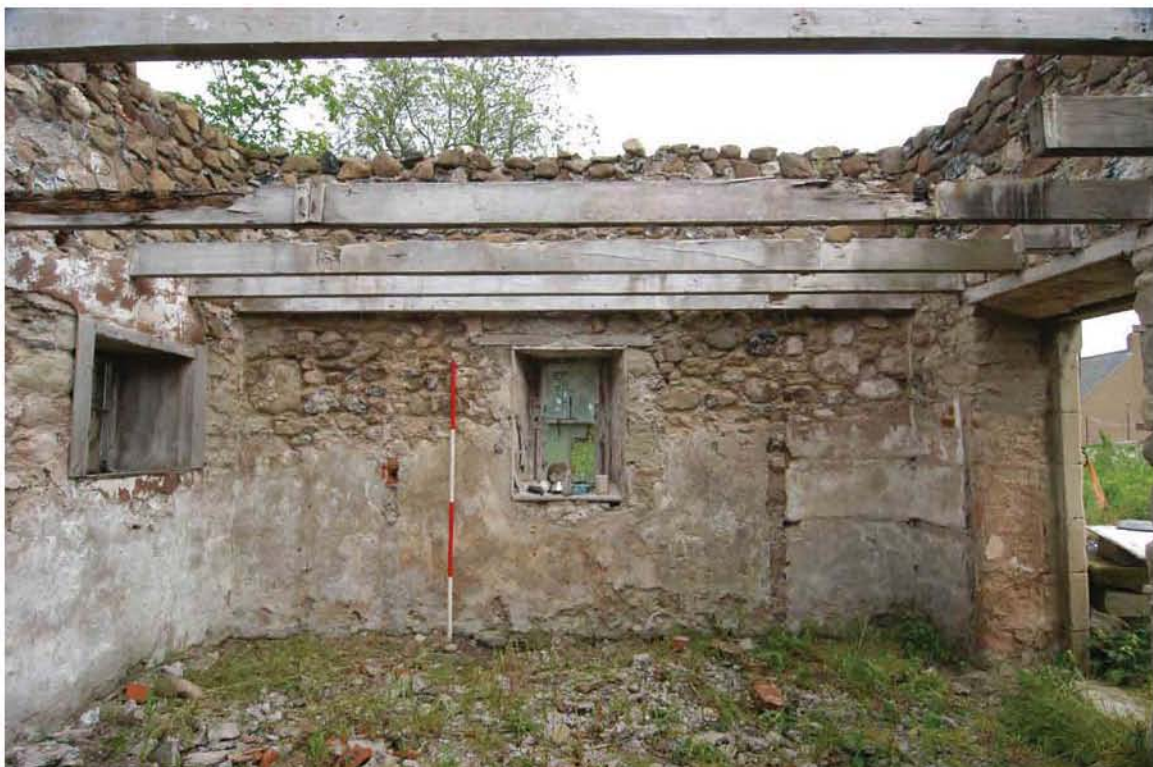
Fig. 12 - Unit 4, interior west-facing elevation showing the gable wall

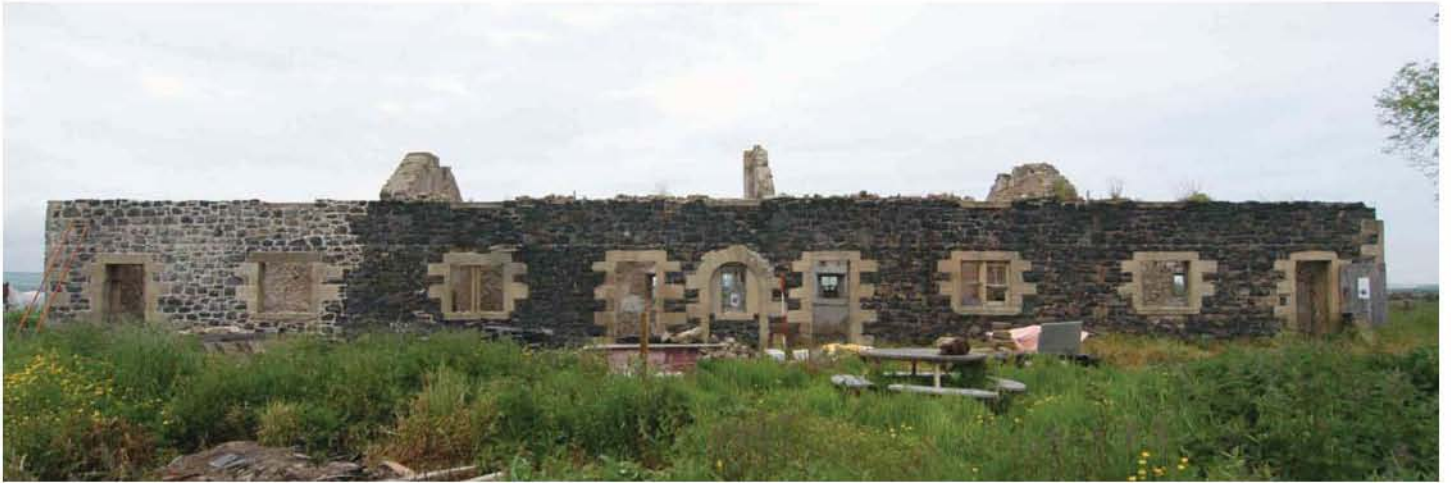
The south-facing elevation was constructed of harl-pointed squared and snecked whinstone (basalt) with droved ashlar quoins at each end. Nine symmetrical bays were present including a doorway at each end accessing Units 1 and 4 and two central doors accessing Units 2 and 3. Four windows, one for each unit were present. At the centre of the elevation, a round-arch niche with a deep set window had a date of 1836 carved on the arch key stone. The cream-coloured dressings surrounding the fenestration contrasted sharply with the black whinstone on the main elevation. The position of the former dormer windows was marked by the position of their respective sandstone sills. Unit 2 being the larger cottage of the four had two dormer windows lighting its attic. A distinct line marking the position of the original wall height was visible where four courses of whinstone had been added to heighten the elevation, by about 1m when a new roof with dormers was added.

Fig. 13 - General view of the exterior south-facing elevation

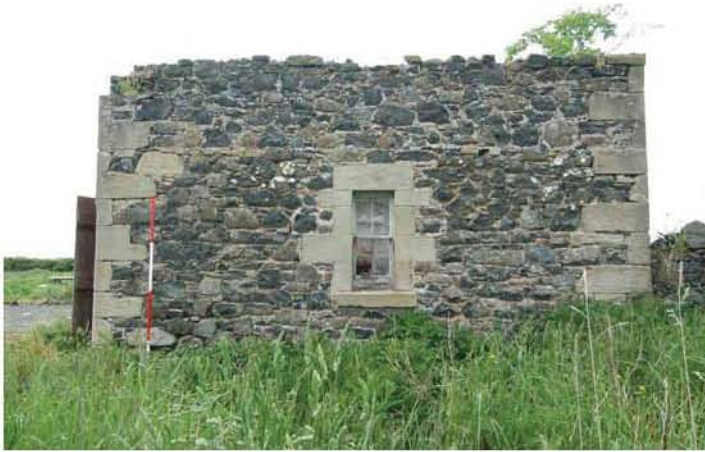
Fig. 14 - General view of the exterior east-facing gable

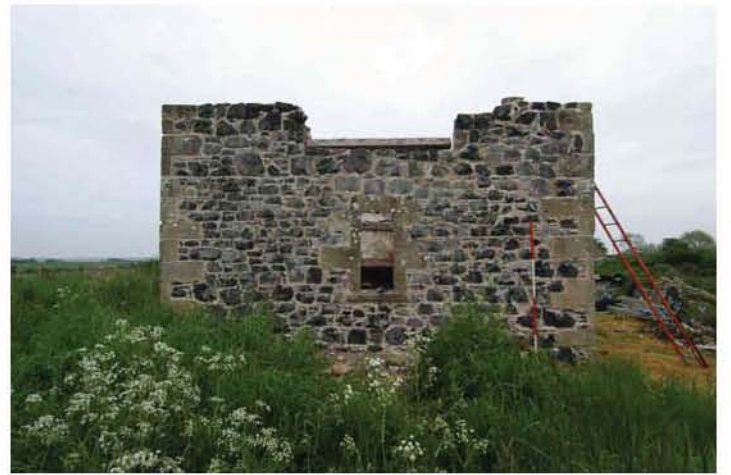
Fig. 15 - General view of the exterior west-facing gable

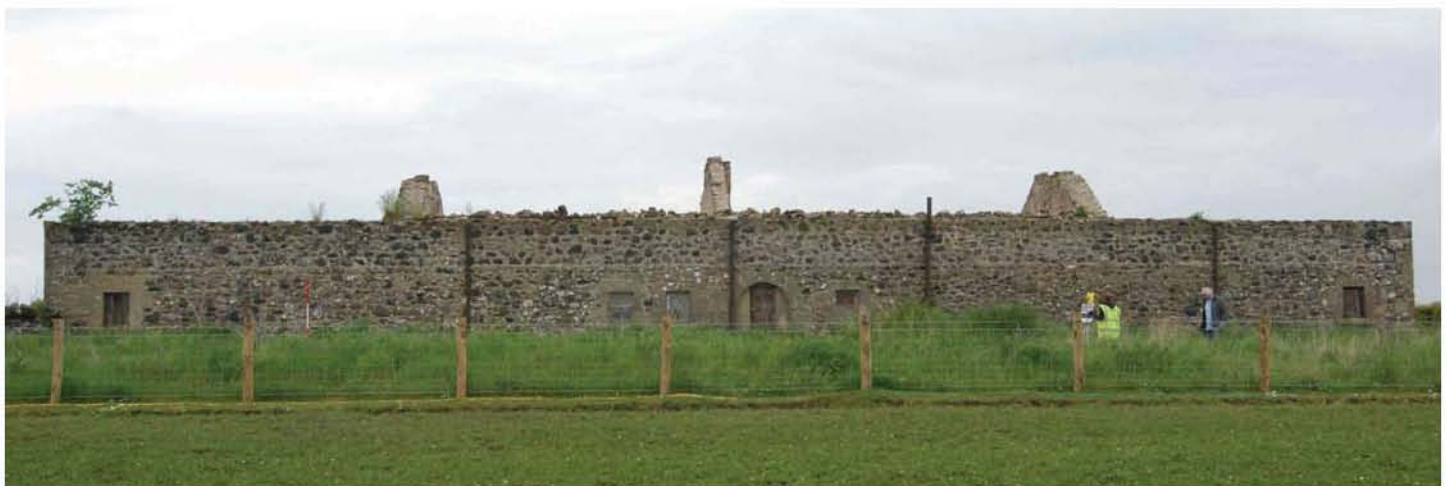
Fig. 16 - General view of the exterior north-facing elevation

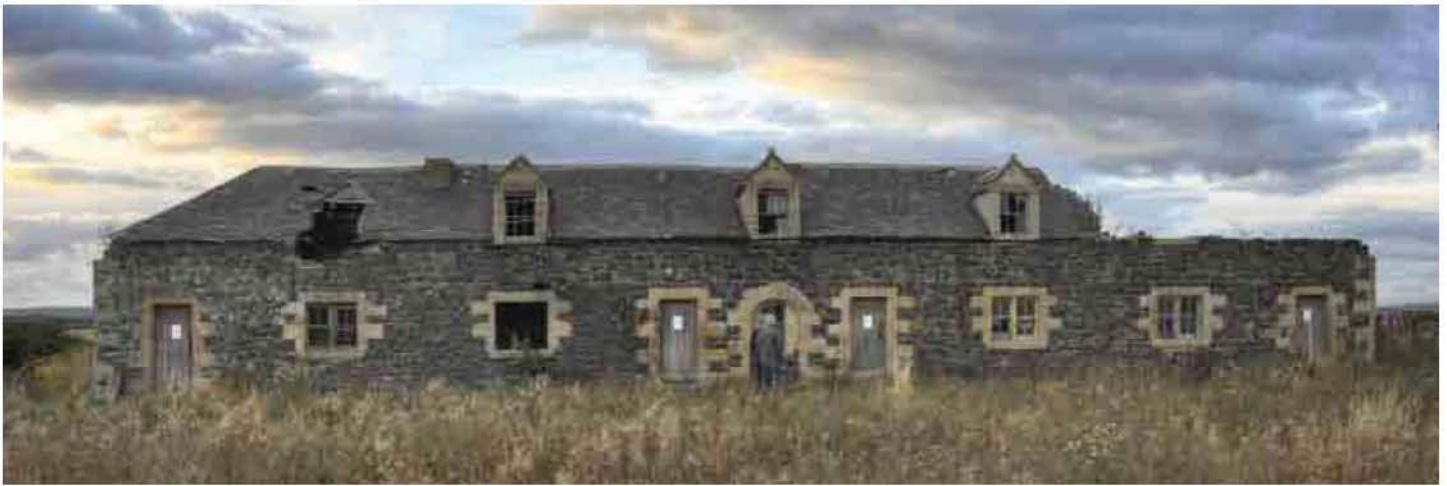
The slate roof (Fig 17) had been removed to allow the refurbishment to be carried out safely. Fragments of roof timbers had been set aside by the owner and these were found to comprise A-frame scarfe-jointed timbers. The attics were formerly lit by dormers situated on the south-facing elevation. The dormers (Fig 18) were constructed using cream-coloured brick with moulded sandstone lintels and pediments capped with sandstone copings. The dormers contained 3-over-3 sash and case windows.

Fig. 17 - General view of the exterior south-facing elevation prior to roof removal

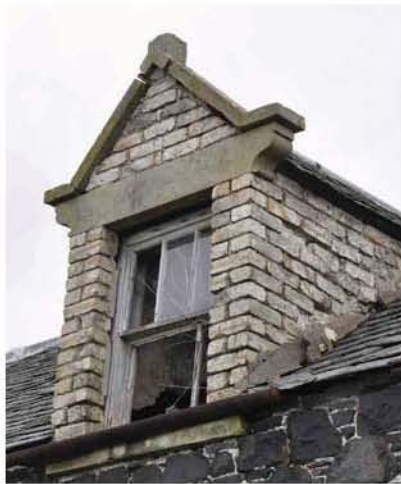
Fig. 18 - General view of one of the dormer windows prior to its removal

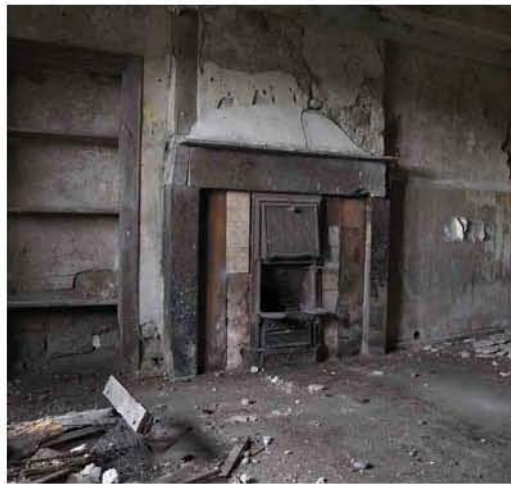
Fig. 19 - Unit 2 fireplace prior to stripping out the building

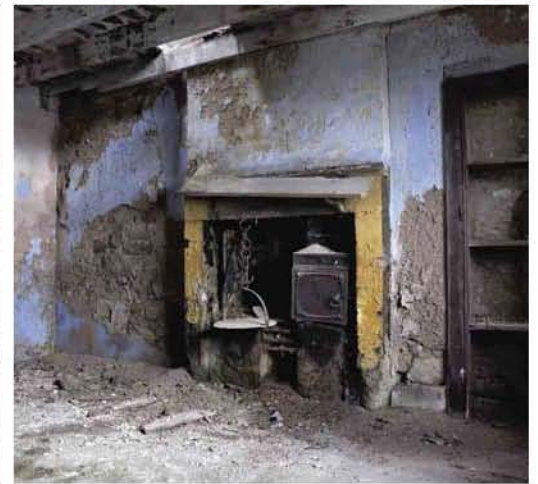
Fig. 20 - Unit 3 fireplace prior to stripping out the building

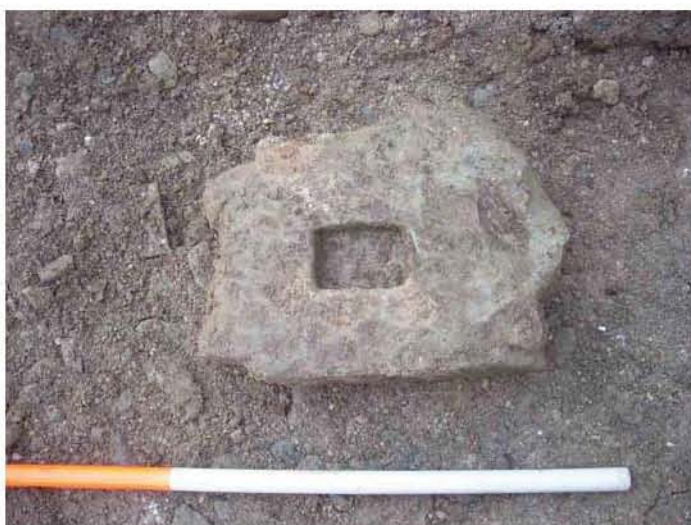
Natural (003) was recorded as a pink-red silty clay located at a depth of 0.4m. The natural was overlain by a dirty pink-red silty clay (102) with coal flecks. Both layers were cut by a foundation trench (103) which was filled by large un-bonded boulders (104). The mortared main build of the wall (105) was built on top of this. Both the foundations (104) and layer 102 were overlain by c.0.3m of made ground (101) consisting of dark-brown clay-silt with large cobbles in the north-west and cleaner sand and gravel to the south-east. A poorly preserved lime-mortar floor (100) was present over 101 around the base of the wall (105). Roughly-squared sandstone blocks with rectangular cut-outs c. 9cm by 7cm and 2.5cm deep in their upper surfaces (pad-stones, 106, Fig 21) were recorded set into 101 and these were used to support the timber uprights of the internal partition walls and staircase. The internal wall elevations were photographed as further structural details were exposed following the soft stripping of the interior fixtures and fittings.

Fig. 21 - Typical padstone recorded in Unit 1 during the watching brief

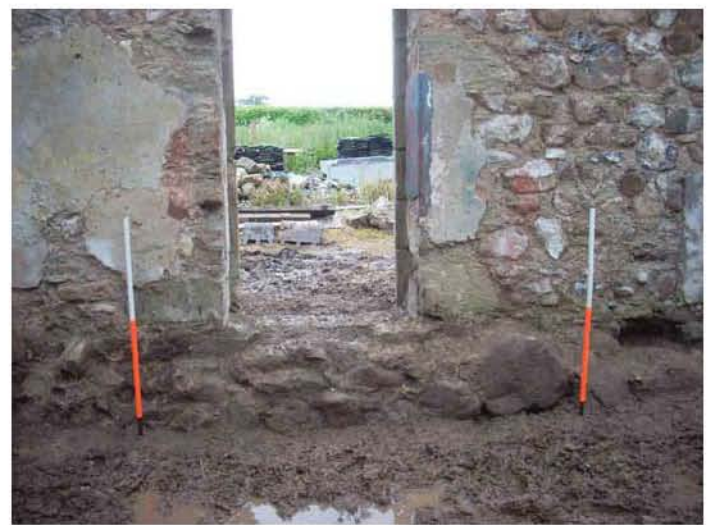
The nature and depth of natural (003) and overlying deposits (201, 202) were the same as in Unit 1. The foundations (204) were more massive (Fig 22) especially on the south-east side of the floor towards the arched recess (which included the date-stone) in the middle of the unit. The main walls (205) were also similar to those in Unit 1 but here, they included the protruding stubs of what may have been a cross-wall (207). These were located opposite each other towards the north-east end of the unit. A lime-mortar floor (200) survived around the base of the walls. Similar pad-stones (206) with rectangular sockets measuring 9cm by 7cm and 2.5cm were recorded.

Fig. 22 - Exposed foundations in Unit 2 during the watching brief
