## **Rothes Windfarm Extension Moray**

### **Archaeological Walkover and Instrument Survey**

**Report No. 1955**

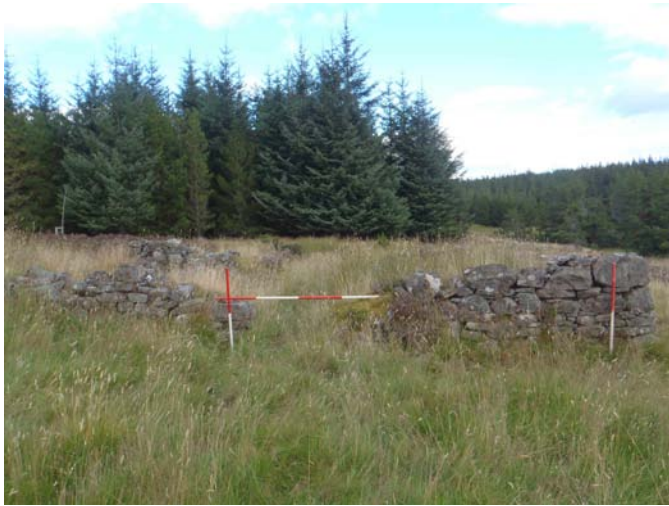
Fig.3 - Shot of west-facing elevation of room 1 (Site 1a)

Site 1a comprised the remains of a building divided into six compartments. The remains were orientated north to south. Room 1 (Fig. 3-5) was c 4.7m wide and survived to a maximum height of 0.94m. This part of the building comprised the south-west corner and south-east corners of the building which showed no evidence of quoining. The relationship with enclosure 1b could not be determined due to overlying vegetation. Room 1 had two opposing entrances c. 0.8m in width to the east and west. The western entrance provided access into enclosure 1b (Fig. 3). The walls were c 0.6m in width and of drystone construction. The exterior was roughly faced and roughly brought to course. There was a partition wall into Room 2 which comprised largely of tumble, 0.35m in height by c. 0.7m in width. The interior of Room 1 was covered by thick vegetation and a high proportion of stone tumble which prohibited the identification of any internal features (Fig. 5).

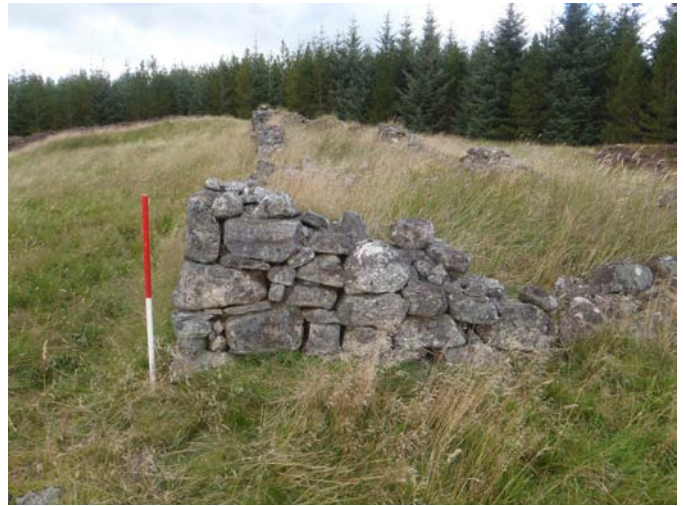
Fig.4 - Shot of south-west corner of Room 1 (Site 1a)

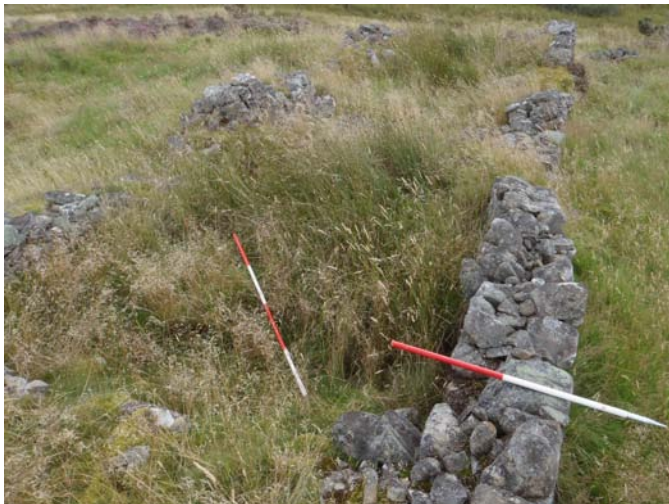
Fig.5 - Shot of Room 1 & 2 interior and partition wall (Site 1a)

Room 2 (Fig. 5) had an east-facing entrance 0.8m in width. The stonework survived to a maximum height of 0.9m, but was generally in the region of 0.7m. The entire internal area was covered by vegetation with a high degree of stone tumble obscuring any possible identification of further features. A dividing wall between Rooms 2 and 3 comprising a rubble spread c 0.7m in width showed no signs of any entrance.

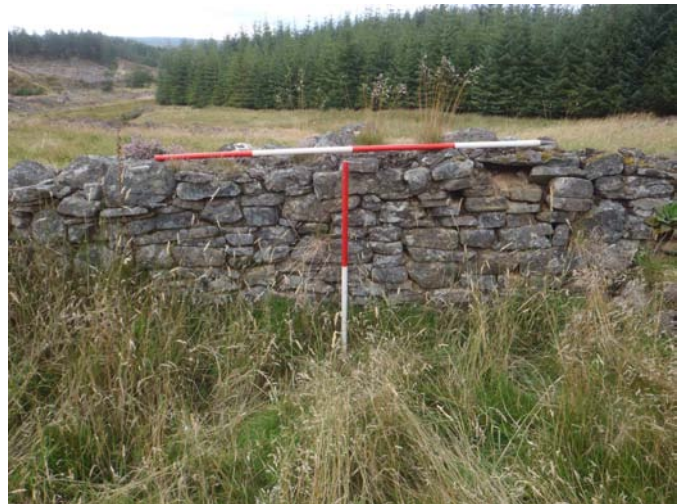
Fig.6 - Shot of internal east facing elevation of wall in Room 3 (Site 1a)

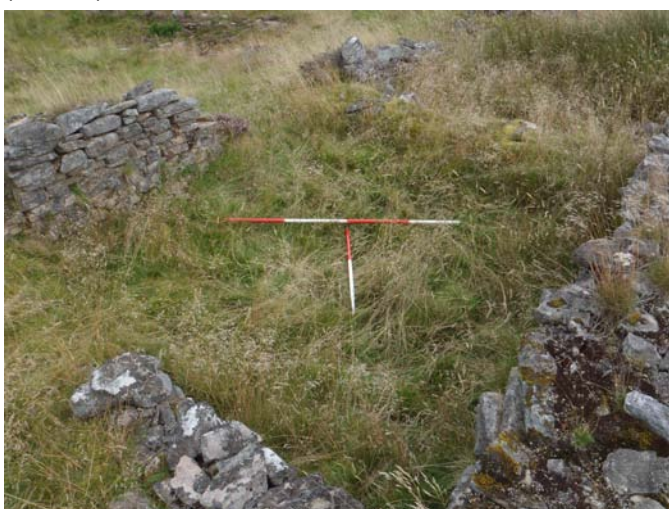
Fig.7 - Shot of Room 3 interior (Site 1a)

Room 3 had no internal features that could be identified due to the high proportion of stone tumble (Fig. 8). The walls survived to a maximum height of c. 1.15m to the west (Fig. 7) and c 1.0m to the east. A badly denuded entrance c. 0.6m in width in the east-facing elevation could be identified. The abutment of the partition wall between Rooms 3 and 4 was clearly visible and therefore it was determined that the west-

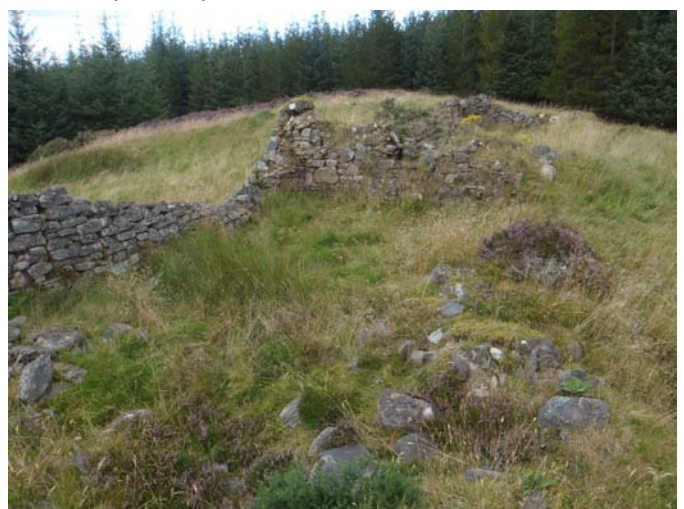
Fig.8 - Shot of Site 1a from the east wall of Room 4 (Site 1a)

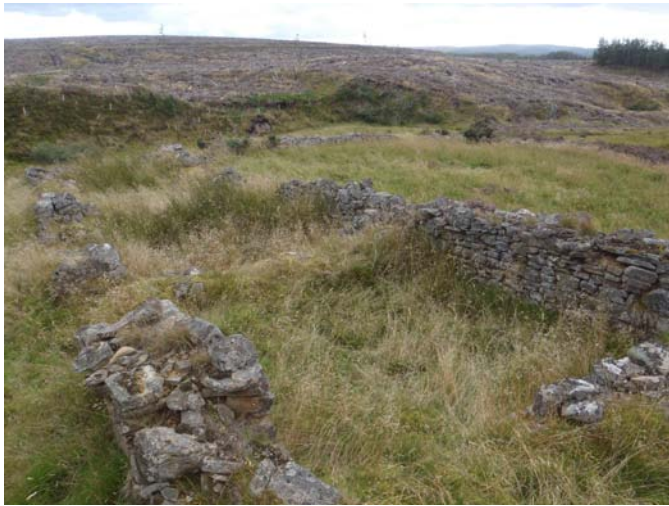
Fig.9 - Oblique shot of Rooms 1 to 3 from Room 4 (Site 1a)

facing elevation from Room 3 to 4 was continuous. The relationship means that Rooms 1 to 4 were also probably contemporary (Fig. 9-10).

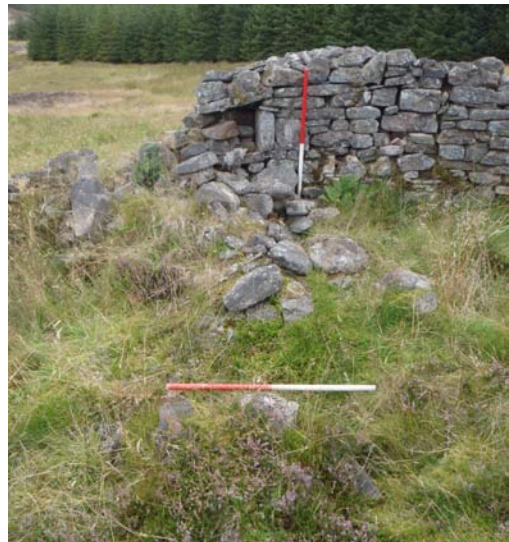
Fig.10 - Shot of east facing internal elevation of Room 4 & 5 including Aumbrey and partition wall (Site 1a)

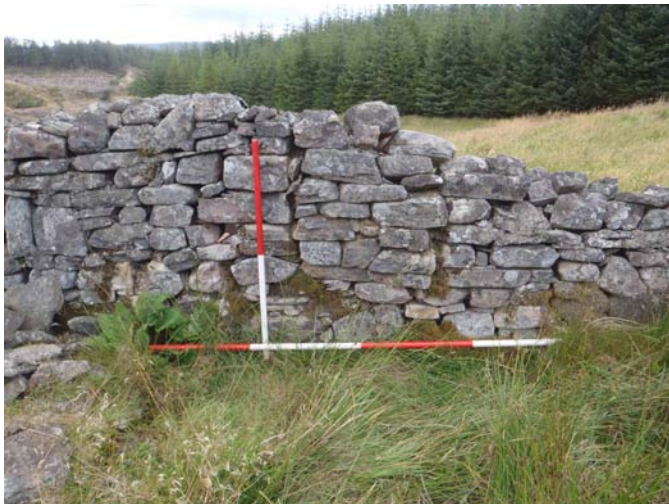
Fig.11 - Detailed shot of blocked opening & probable window Room 5 (Site 1a)

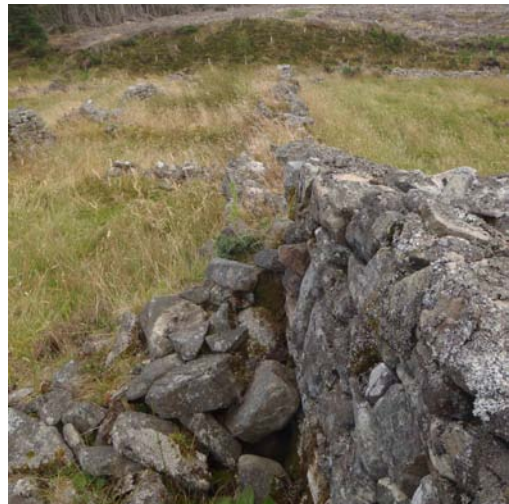
Fig.12 - General shot of offset wall alignment of Room 1-4 with Room 5 in foreground (Site 1a)

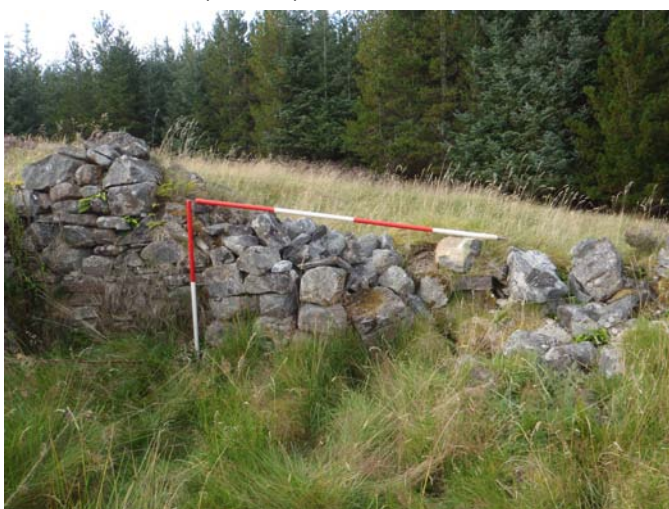
Fig.13 - Shot of blocked feature in south-facing elevation of former north gable of Room 6 (Site 1a)

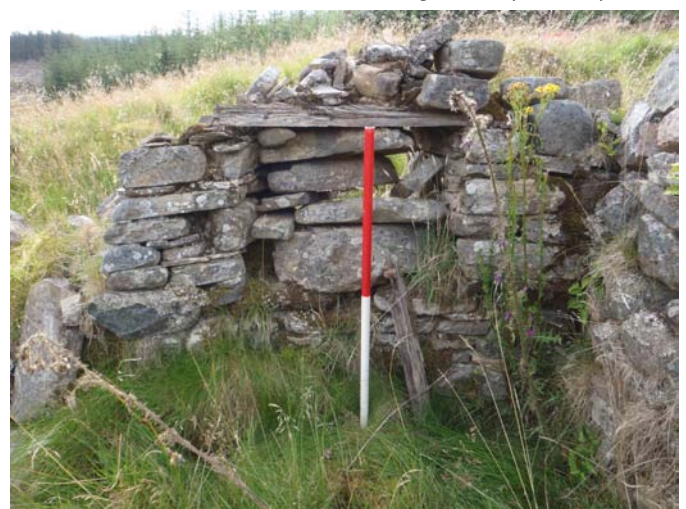
Fig.14 - Blocked feature, probably a window, with wood lintel; west wall Room 6 (Site 1a)

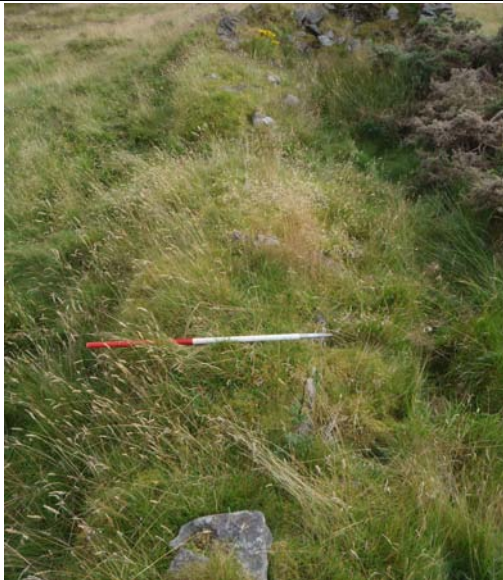
Fig.15 - Shot of turf covered east wall of Room 6 (Site 1a)

Room 6 is probably the main dwelling at Whiterashes. The east wall was heavily denuded and survived as a 1.4m wide spread of rubble, c. 0.6m in height and covered by vegetation (Fig. 16). A roughly central 1m wide doorway was visible along wall. The wall itself was estimated to have been in the region of c. 0.7m wide. The north wall of the dwelling is c. 5.3m in length and is c. 0.8m in width. The extra width of the masonry is indicative of a load bearing gable end. The south-facing elevation of this wall has two running joints between which a deposit of stonework had blocked an opening (Fig. 14 & 17). It remains unclear as to the precise function of the opening, but possible interpretations include a disused fireplace. In the west wall (Fig. 18) of Room 6, a blocked opening, which was splayed inward, was recorded (Fig. 15 & 19). The feature, which was probably a window, had a wooden lintel and measured 0.72m in width by 0.55m in height. It was elevated c. 0.43m from the base of the wall. Room 6 had a c. 0.4m wide stub of wall which measured 1.45m in length creating an east to west partition or screen. The partition divided Room 6 into two unequal parts, with

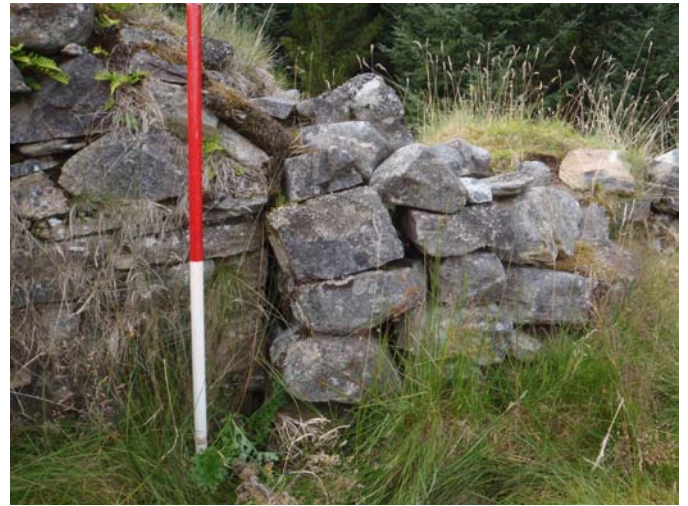
Fig.16 - Shot of running joint and blocked feature in south-facing elevation of north gable (Site 1a)

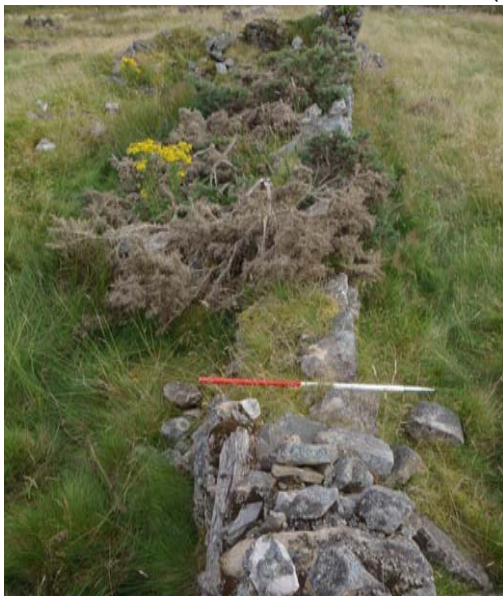
Fig.17 - Shot of west wall of Room 6 in plan (Site 1a)

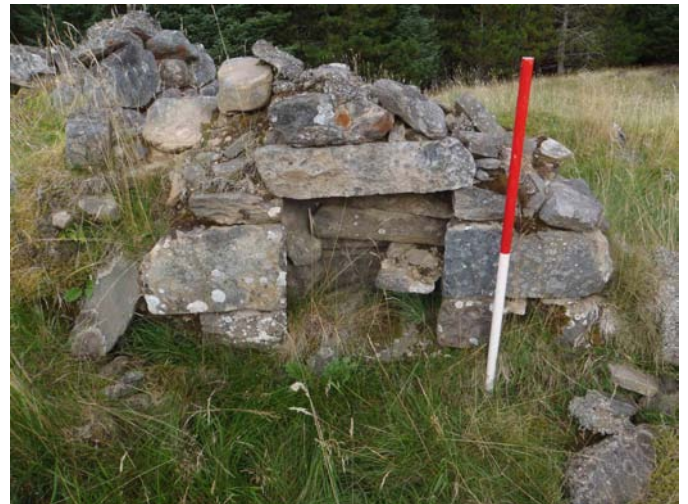
Fig.18 - Shot of blocked feature/ probable window in external west-facing elevation of Room 6 (Site 1a)

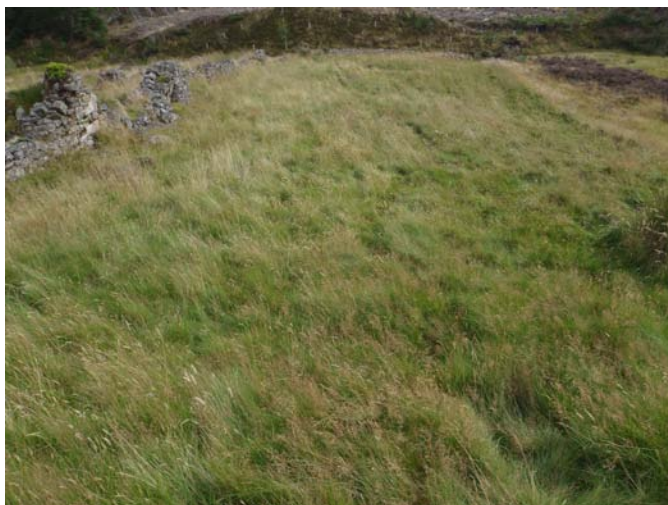
Fig.19 - General shot of Site 1b

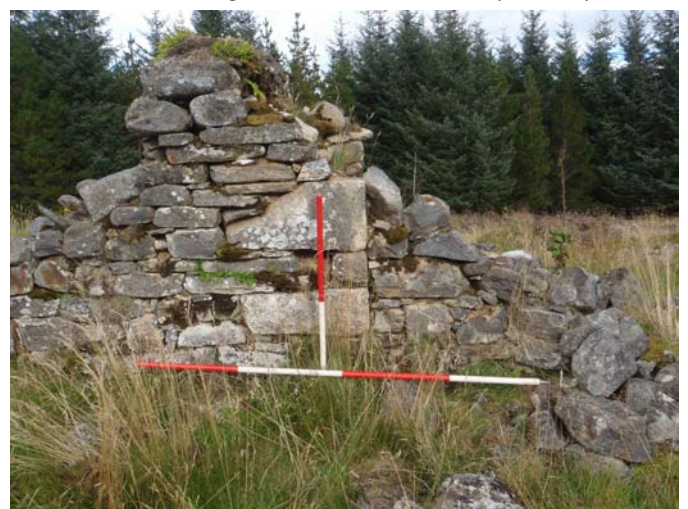
Fig. 20 - Shot of quoining where Room 6 abuts Room 5 (Site 1a)

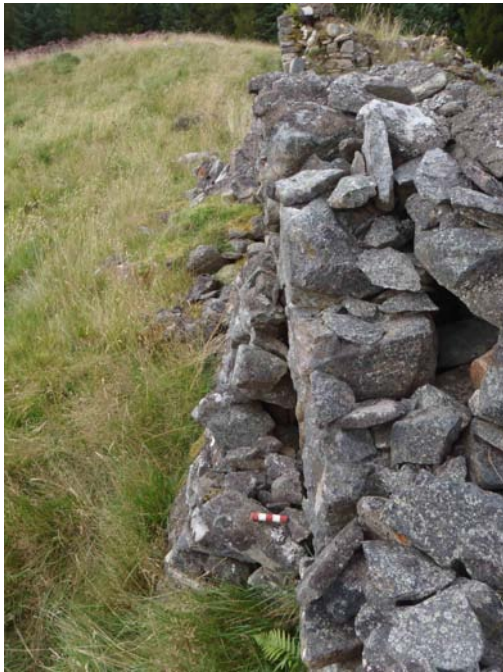
Fig.21 - Detailed shot of drystone buttressing against west wall of Room 5 (Site 1a)

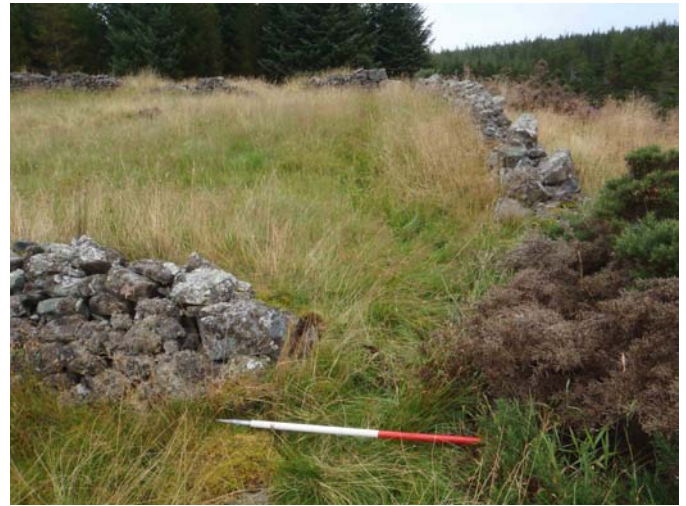
Fig.22 - Shot of probable entrance in south-west corner of Site 1b

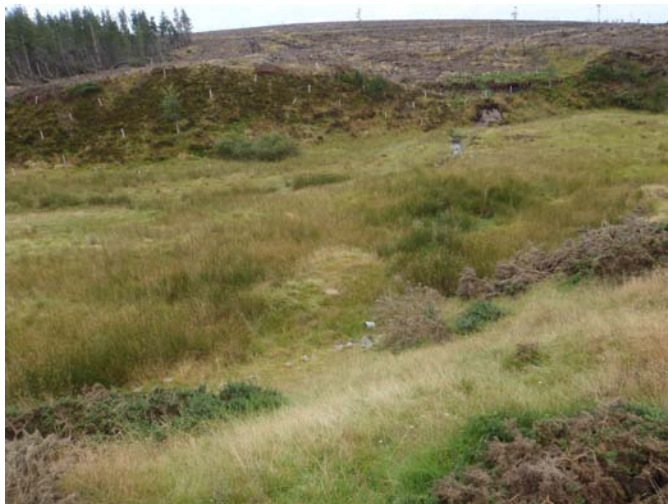
Fig.23 - Location of probable well (Site 1g) viewed through trackway (Site 1k)

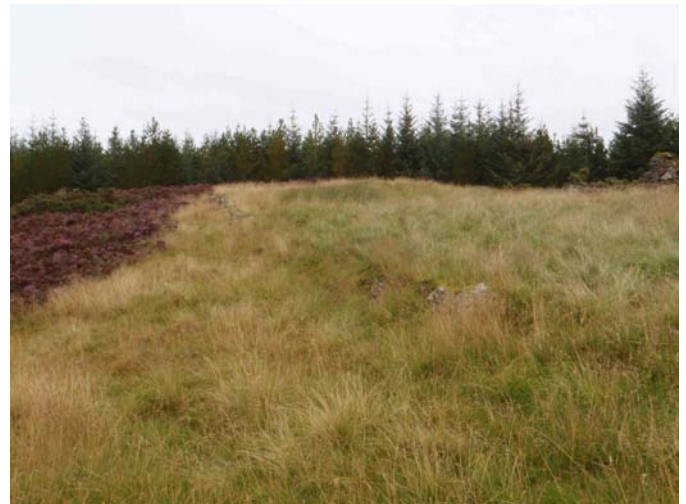
Site 1b (Fig. 2, 20) was located adjacent to Site 1a and is an enclosed area of land, the western boundary of which has been terraced into the naturally sloping terrain at Whiterashes. The enclosure walls survive as either rubble spreads or wall stubs with a rubble core. Entrance to the enclosure was probably in the south-west (Fig. 23) and north-west corners, where gaps in the stone perimeter are visible. There is also an entrance into the enclosure through the west wall of Room 6 (Fig. 3). The terrace is c. 0.6m high above the surrounding ground level, with the top of the wall truncated to the interior ground level (Fig. 25). The south wall is the best preserved example with an elevation that survived to a height of c. 0.75m. The base of the wall was c. 1m wide and tapered to its current truncated width of 0.6m. The precise purpose of the enclosure is unknown; however, possible interpretations include a stock enclosure or kaleyard.

Fig.24 - General shot of terraced Site 1b & west-facing enclosure wall

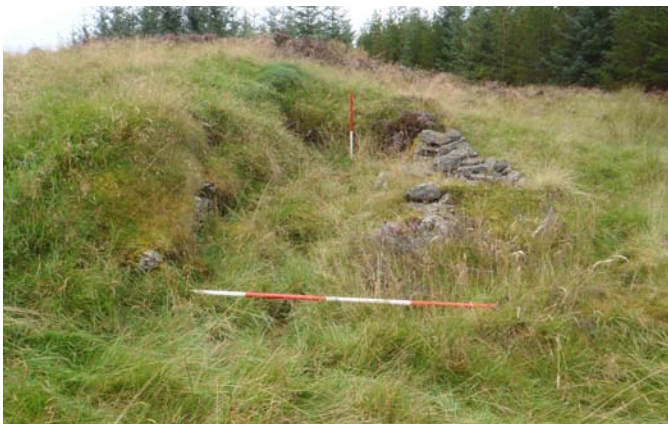
Field survey recorded the remains of a structure (Fig. 2, 26) which had been cut into a slope to the north of Site 1a. The structure is better preserved to the west where it survived to a maximum height of c. 1.1m. The other elevations were much denuded and largely overgrown. The entrance to the feature would probably have been in the south-east corner, and is estimated to be c. 0.9m in width. The interior is c. 2m in width by 3.4m in length (east-west) and obscured by stone tumble and vegetation. The wall thickness is estimated to have been c. 0.6m. The purpose of the structure, which is annotated on the 1<sup>st</sup> Edition Ordnance Survey map, is unknown.

Fig.25 - General shot of Site 1d

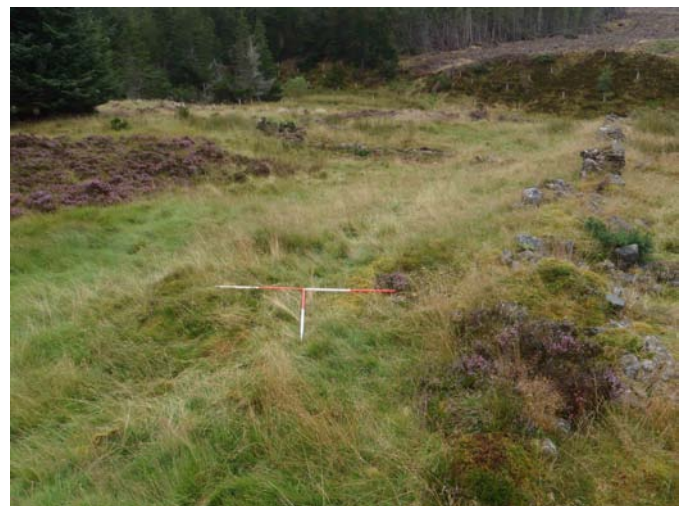
Field survey could find no upstanding remains of Site 1h which was interpreted from rectified aerial photographs as an upstanding conjoined structure adjacent to Site 1a. However, a concentrated stone spread roughly in this location may be the denuded remains of Site 1h which is now covered by vegetation (Fig. 2, 27). The approximate area was surveyed by Total Station. The area was visible as a raised 'mound' c. 0.5m in height and c. 4.5m east-west by 6.0m north-south. The only possible feature was a slight sub-rectangular depression to the west of the spread. However, this was in close proximity to the heavily denuded east wall of Site 1a (Room 5) and the possibility remains that the surveyed area is tumble from this part of the former building.

Fig.26 - Oblique shot of possible location of Site 1h

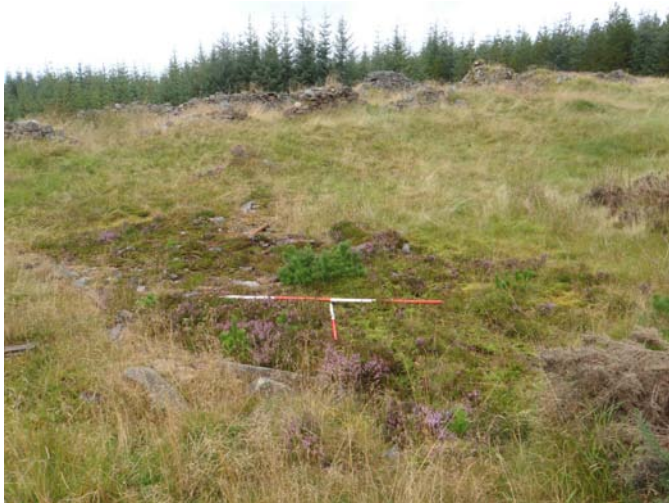
Field survey recorded the remains of a building footprint were located on level ground to the east of Site 1a (Fig. 2, 28). The footprint is probably the remains of hard standing associated with Site 1i and measured c. 3.9m by 6.7m east-west. Probing around the area suggested further deposits of stone hidden under low-lying vegetation. Debris including cast iron guttering, pipe-work, glass fragments and wood fragments were scattered in the immediate area.

Fig.27 - Oblique shot of building footprint (Site 1i)

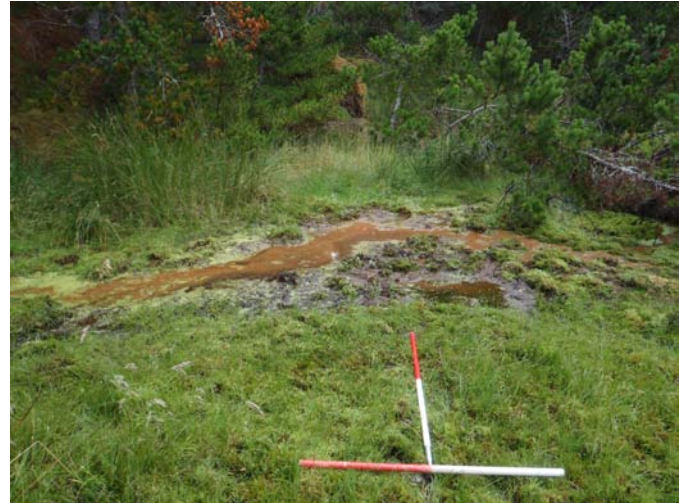
Field survey recorded the location of a natural spring in a small clearing adjacent to commercial forestry (Fig. 29). The feature, a small irregular-shaped shallow body of water in marshy ground, was rich in iron deposits, which had stained the surrounding

area. The feature, which is c. 6m by 4m, is annotated on the 1<sup>st</sup> Edition Ordnance Survey map as a 'Chalybeate' well.

Fig.28 - Shot of Chalybeate well (Site 2)

Sites 2 and 6 are situated within afforested areas which are earmarked for felling as part of the construction process (Turbine Core Area). An appropriate programme of mitigation will be agreed with ACAS prior to felling.

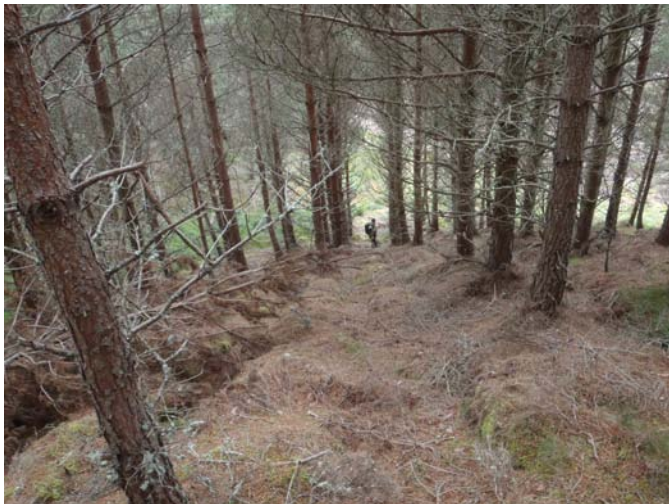
The desk-based assessment contained a record for a camp or possible Dun in the location of the Fairy Knowe. Field survey ascended the Fairy Knowe which is a pronounced natural knoll in the surrounding landscape and could find no evidence of any features (Fig. 30). The Fairy Knowe is within the commercial forestry plantation. Deep ploughing ruts were noted throughout the area.

Fig.29 - Shot from top of 'Fairy Knowe' (Site 3)

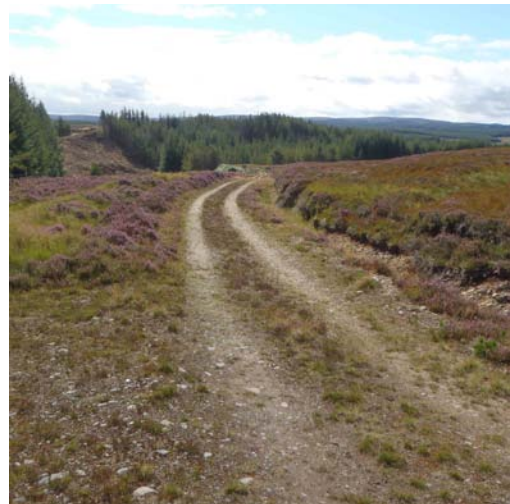
Field survey followed the line of Scots' Road (Fig. 31). The track is c. 3.25m in width and has a c. 3m wide by c. 1.8m high bank to one side which suggested the track has been improved at some point after the depiction on the 1<sup>st</sup> Edition Ordnance Survey map, possibly as a result of forestry activity. The field survey also noted modern underground service accesses at the road's edge. The route of Scots road is therefore the trackway depicted on current mapping.

Fig.30 - Shot of Scots Road (Site 4)

Site 4 has been previously upgraded for use as a forestry access track, which will be further upgraded as part of the extension works. The proposed upgrading would represent a minimal change of character to the baseline condition and no further mitigation measures are proposed,

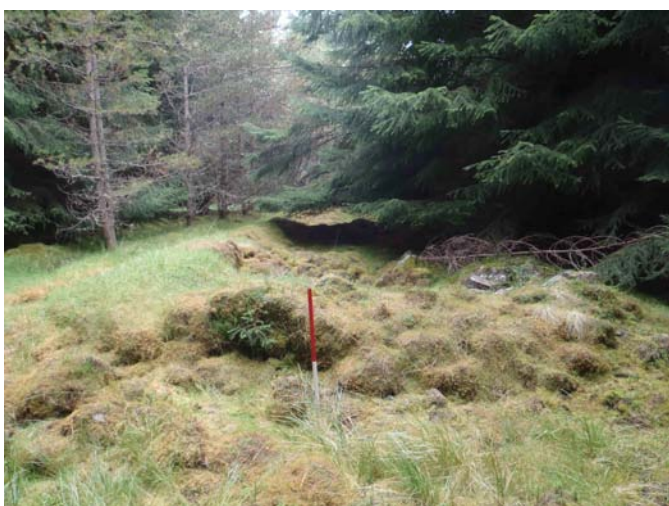
Field survey recorded the remains of a farmstead depicted on the 1<sup>st</sup> Edition Ordnance Survey map in a clearing near to the location of Corr Hatnich (Fig. 32). The remains comprised a rectangular structure, measuring c. 12m north-south by 6m east-west. The range was divided by a roughly central internal wall. The surviving walls were much denuded and survived to a maximum height of c. 0.75m. The width of the walls at their base was c. 1.5m, which included a high proportion of stone tumble. Stone debris and vegetation obscured any internal features. The remains became more truncated and vestigial to the north. The survey could only locate a c. 3m length of the large enclosure shown on the 1<sup>st</sup> Edition depiction, which projected from the north-west corner of the building.

Fig.31 - Shot of south wall of Corr Hatnich farmstead (Site 6)

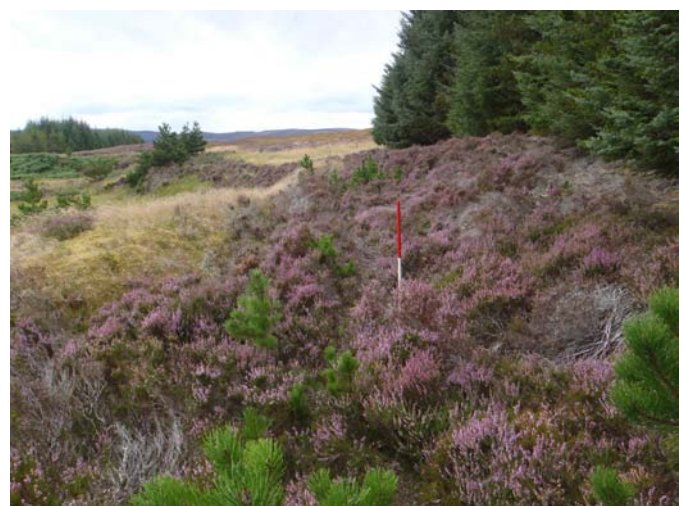
The remains of an east to west orientated track (Site 1m) was recorded on a ridge above the Cold Burn (Fig. 33). The track was seen as a level terrace in a cutting running along the northern edge of the ridge. The feature runs east to west possibly connecting Scots Road (Site 4) to Whiterashes farmstead (Site 1). A small berm of grass-covered compacted material ran along the edge of the track to the south. The track was cut (c. 0.3m) into what now heather moorland on the edge of forestry plantation. The track opened out onto a level area close to Scots Road

Fig.32 - Shot of cutting for trackway/path (Site 1m)

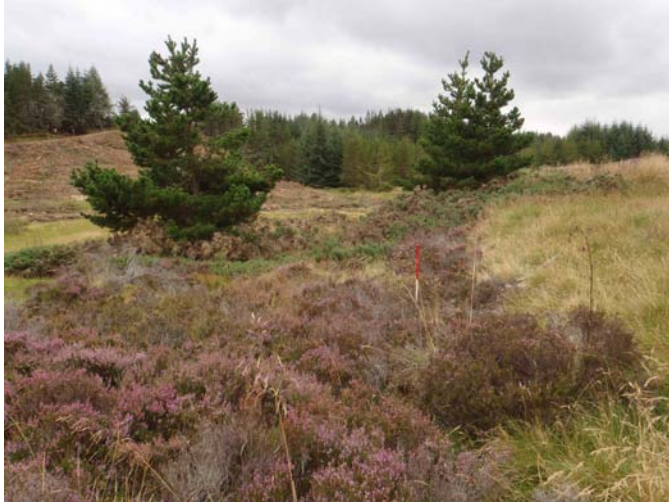
A probable track or pathway (Fig. 34) headed toward the Cold Burn from the vicinity of Scots Road (Site 4) and Site 1m. The feature ran north-east to south-west in a distinct cutting (c. 1.35m max.) up a slope to level ground to the north and was c. 3.5m to 4m at its widest point. At lower datum near the vicinity of the Cold Burn, the track petered out and could no longer be traced. The 1<sup>st</sup> Edition Ordnance Survey map appears to show a narrow hachured feature, which is probably Site 1n, in this location

Fig.33 - Shot of probable trackway (Site 1n)

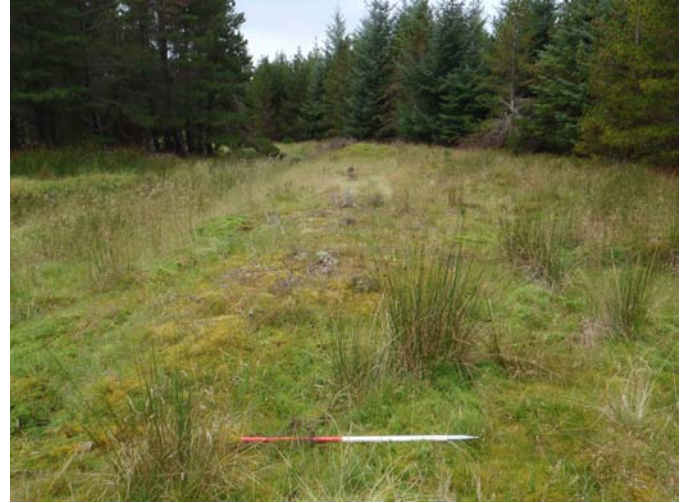
The remains of a probable trackway (Fig. 35) near to the Cold Burn which is probably a segment of trackway depicted on the 1<sup>st</sup> Edition Ordnance Survey map heading east from Whiterashes farmstead (Site 1a). The remains, which were orientated north-east to south-west, ran for c. 28m and were c. 3.5-4m in width. The feature disappeared in both directions into commercial forestry and could no longer be traced.

Fig.34 - Shot of probable trackway (Site 1j)

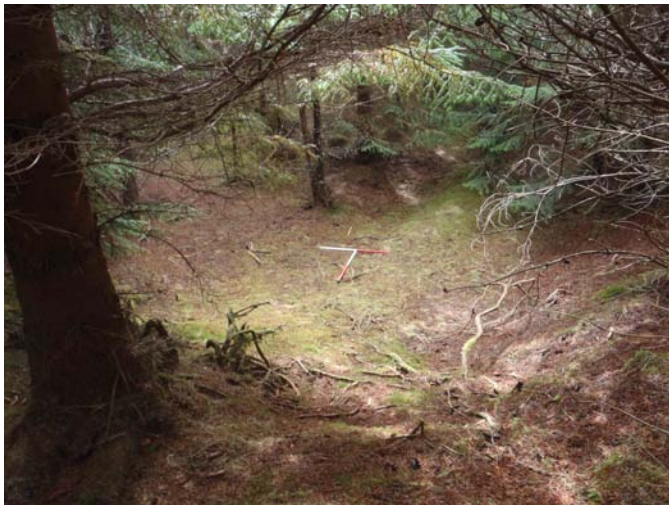
Field survey located the remains of a disused quarry scoop within commercial forestry to the north of Site 1a. The quarry, which is annotated on the 1<sup>st</sup> Edition Ordnance Survey map, has mature conifers within its interior. The sub-circular scoop is c. 20m x 14m (north-east to south-west), with the interior c. 3m deep on the north side of the quarry. Cartographic sources show that access to the quarry appears to have been via a track to the south and this was confirmed by field survey, which noted the sides of the quarry to the south-east were very shallow. There was no trace of the trackway.

Fig.35 - Shot of quarry scoop (Site 1f)

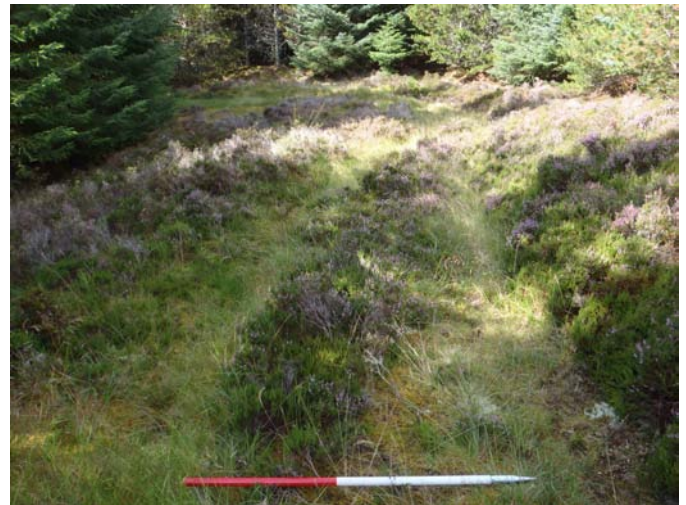
The 1<sup>st</sup> Edition Ordnance Survey map depicts a number of trackways associated with the farmstead of Whiterashes. Field survey was able to record part of the farm access track, which was c. 2.5m in width (Fig. 2, 37). The track is located within a forest ride and headed towards Scots Road (Site 4). Its projected route disappeared into commercial forestry plantation where no trace of the feature could be seen. A modern access road bisects the projected route of Site 1l as it heads towards Scots Road. Field survey failed to locate any remains of this feature beyond what was recorded. It is likely that part of the route of the track is now a later track which is depicted on current mapping. This secondary route is now gated and leads onto Scots Road to the west. There are deep (c. 0.35m) ruts in the trackway which are probably modern in origin and probably related to forestry activity.

Fig.36 - Shot of trackway (Site 1l) near Whiterashes farmstead (Site 1a)
