**Cairnpark 2 Residential Development,  
Redhall House, Craiglockhart Drive,  
Edinburgh**

**Archaeological Evaluation  
Report No. 2111**

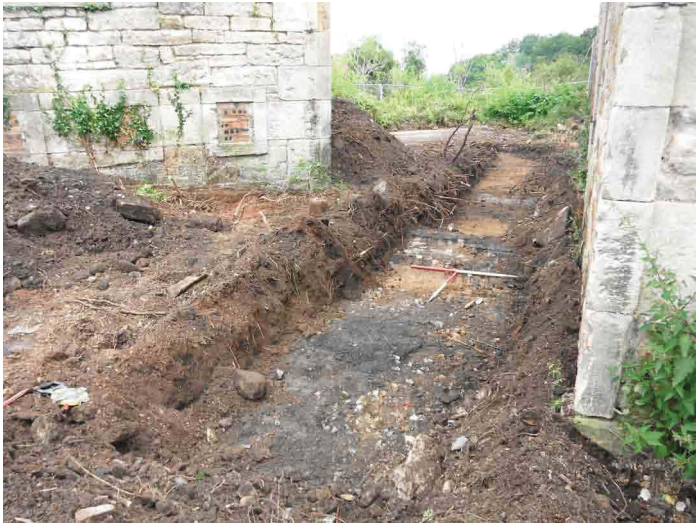
Fig. 3 - Trench 1 looking northwest

Trench 1 was aligned NW-SE and measured 15m long, 1.5m wide and 0.6m deep (Fig. 2-3). The stratigraphy consisted of a maximum of 0.5m of dark brown sandy silt topsoil (**001**) which overlay the natural geology of orange sand and gravels (**002**).

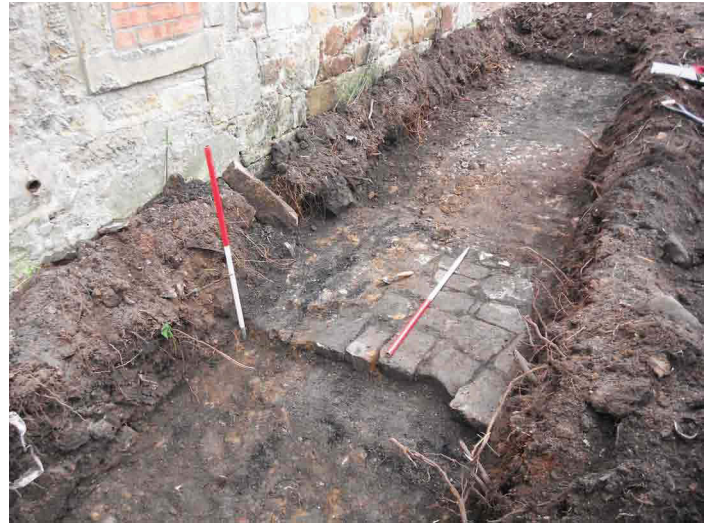
Fig. 4 - Flagstone floor 007 and Cobbled surface 008 in Trench 1, looking southeast

A flagstone surface (**007**) was located 4m from the SE trench terminus (Fig. 2, 4). The floor extended beyond the SW edge of the trench and on its NE side it was truncated by a modern drain (**005**). The surface covered an area of 1.17m<sup>2</sup> and consisted of 15 shaped rectangular sandstone blocks. The blocks measured 0.2m long by 0.1m wide and 0.1m thick and were fitted without the use of mortar. The surface overlay the natural geology.

A metallised surface (**008**) was located at the SE end of the trench and extended beyond the southern and eastern side of the trench (Fig. 2-4). The surface was constructed straight on to the natural geology and comprised small sub-angular stones approximately 5cm<sup>2</sup> and these were compacted together to form a metallised surface. The surface was on the same level as the flagstone surface (**007**), with which it was probably contemporary.

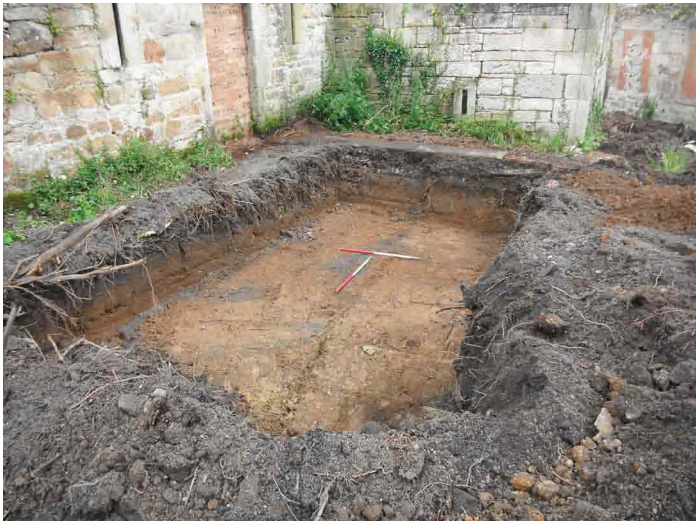
Fig. 5 - Trench 2 looking northwest

Trench 2 was aligned NE-SW and measured 6.5m long, 3.3m wide and 0.92m deep (Fig. 5). The stratigraphy comprised 0.2m of topsoil (**001**), overlying 0.6m of subsoil (**002**) which lay above the natural geology (**002**). No archaeological features or deposits were found in this trench.

A 'garden wall' (**004**) was located along the NE edge of Trench 2 and was aligned NE-SW. The wall consisted of 6 large sandstone stones and these measured between 0.25m long, 0.45m wide and 0.1m thick to 1.9m long, 0.43m wide and 0.1m thick. All the stones were either square or rectangular except one which was shaped as one side of a cylinder. This stone appears to have been re-used.

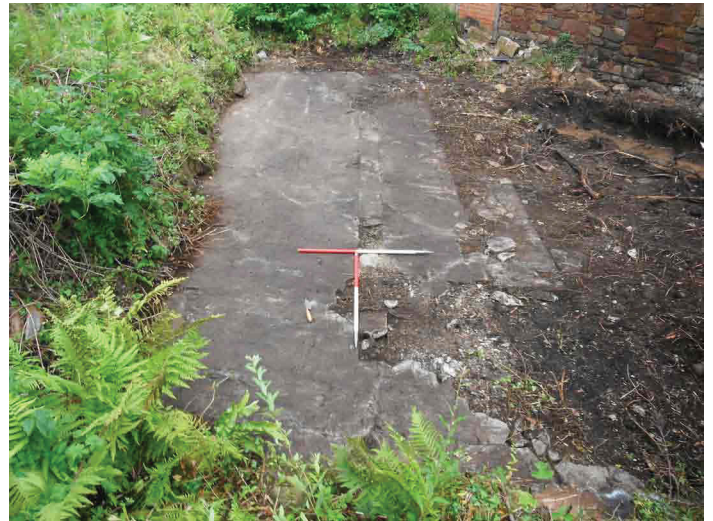
Fig. 6 - Concrete floor 003 looking north

The concrete floor (003) was located in the northern area of the site and it measured 7.85m long, 3.35m wide and 0.10m thick (Fig. 6). This overlay a layer of made ground (010) which consisted of large shaped sandstone blocks which were deposited to form a foundation for the concrete floor. The bocks used for this foundation were probably demolition rubble from the partial demolition of the surrounding structures.

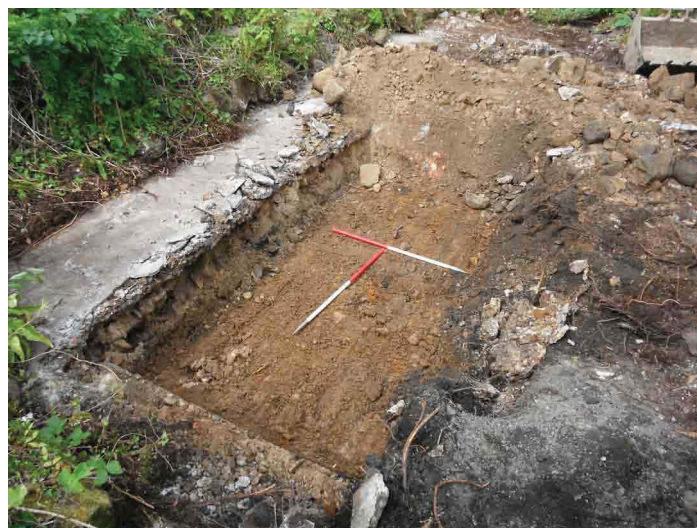
Fig. 7 - Trench 3 looking northwest

Trench 3 was aligned NE-SW and measured 3m long and 1.5m wide (Fig. 7). The stratigraphy comprised of a concrete floor (**003**) 0.1m thick overlying, 0.4m of made ground (**010**) below which was the natural geology (**002**).

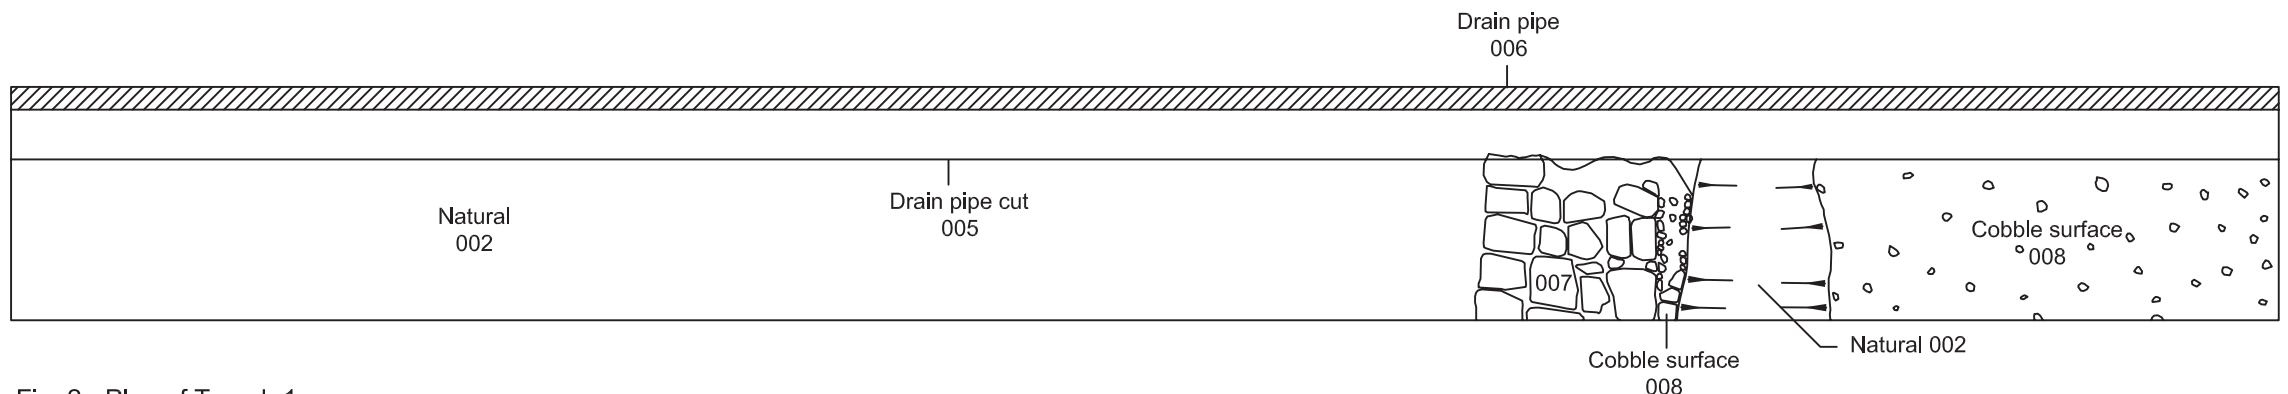
Fig. 2 - Plan of Trench 1

Layer **009** was found in the SW area of the trench, underlying the topsoil and covering a flagstone surface (**007**) and a cobbled floor (**008**). It comprised black cinders and sand with no inclusions. The layer was truncated by a modern drain (**005**) on the NE side of the trench.
