**Towerbank Primary School,
Figgate Bank, Edinburgh**

Archaeological Watching Brief

Report No. 2092

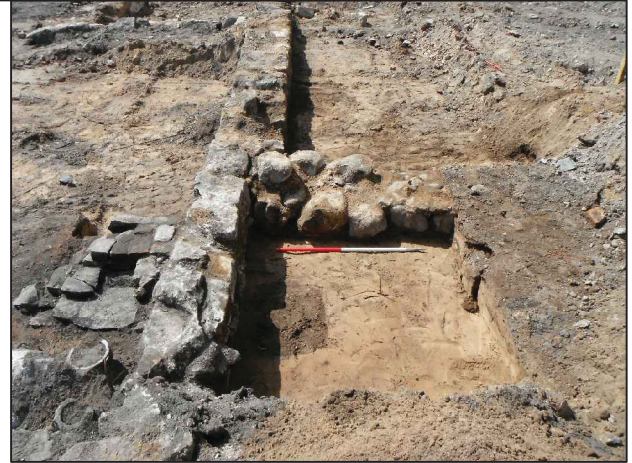
Fig. 6 - Walls 010 and 011 with brick abutment 012

Wall **010** was uncovered for a length of c.17.5m; its width varied between 0.4-0.69m with the widest section lying between Walls **011** and **013**. It survived to a height of between 0.5-0.7m and was constructed of irregular, shaped, sandstone blocks and these survived to three to four courses high. The blocks were bonded together with yellow-brown sandy mortar.

Wall **011** measured at least 1.6m long, 0.77m wide and survived to a height of 0.35m. It was constructed with irregular shaped sandstone blocks which survived to a single course high. The blocks were bonded with yellow sandy mortar.

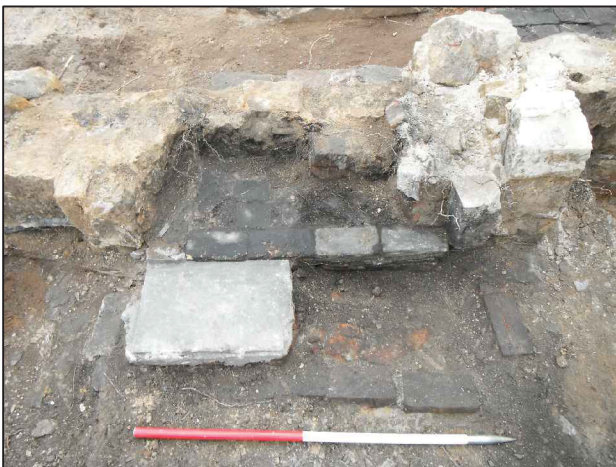
Fig. 7 - Fireplace 053, room 1

Approximately 3m from the NW end and on the NE side of wall **033**, in Room 1, was an in-built fireplace (Fig. 7). The base of the fireplace (**053**) was constructed of red brick and its edge was demarcated by two courses of brick lying side by side. Between this point and the back wall (**033**) the base of the fireplace was constructed using pieces of bricks and cobbles placed in a random order. At least at one point during its use the size of the fireplace was reduced (**054**, see below) as part of a repair or intentional narrowing/cladding of the hearth walls.

Subsequently, the fireplace was either modified or repaired. At the NW end of the fireplace, abutting wall **053**, a small red brick construction (**054**) was installed. The bricks were machine-made and bonded with yellow lime mortar. The small construction measured 0.4m long, 0.38m wide and survived to a height of 0.3m.

In front of the fireplace was a large slate flagstone which measured 0.5m long by 0.36m wide, probably one of two originally in place. Surrounding these flagstones was a boundary of red brick (**055**) of which five were visible and continued under the surviving floor (**056**, see below).

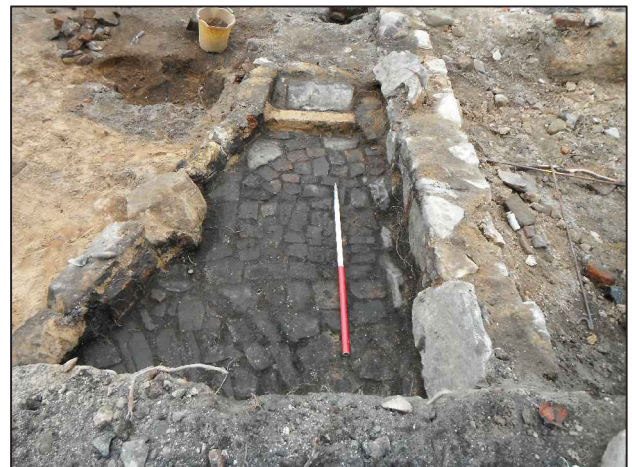
Fig. 8 - The coalbunker: Floor 015 with walls 009 and 022

A coal bunker (Fig. 8) was located in the corner formed by Walls **010** and **009**, within a probable unroofed courtyard area. Overall, it was trapezoidal in shape, measuring 4m long.

Wall **022** was L-shaped, forming the external wall of the bunker, running N-S from wall **010** and then turning NE-SW where it abutted wall **009**. The wall was constructed of large, unfaced, irregular sandstone blocks and red bricks. The wall was bonded with lime mortar and was constructed within foundation cut **037** which cut natural sand (**000**).

The floor of the bunker was red brick and cobble (**015**). The bricks were irregularly laid with no bonding present. They were laid upon a thin 0.02m thick foundation layer (**028**) of soft brown sand, within which was found a 19th-century clay pipe bowl.

Located at the SE end of the floor was a small ramp and at the base of the ramp was a small wall (**021**). This wall measured 0.24m long, 0.12m wide and 0.07m thick. It was constructed of a single course of red brick laid head to head and bonded with lime sand mortar. Set at the base of the small ramp, it may have functioned as a sort of door-stop for barrows being tipped and emptied into the bunker.

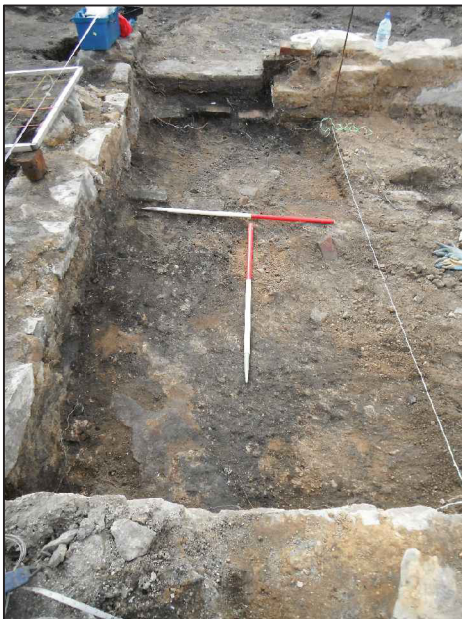
Fig. 9 - Room 1, floor 035

Floors **035** and **056** were part of the same feature and comprise the remains of a floor within Room 1 (Fig. 9). The floor survived in patches the largest of which was 0.9m long, 0.7m wide and 0.02m thick. The floor was constructed of small stones and a plaster rendering contiguous with the plaster facing of Wall **010**. It abutted walls **009**, **010**, **014** and **033** and part of the fireplace **055**. Underneath the floor was brown grey sand (**036**), 0.05m thick. This sand was probably a foundation deposit laid down to level the floor and it was deposited straight over the natural sand (**000**).

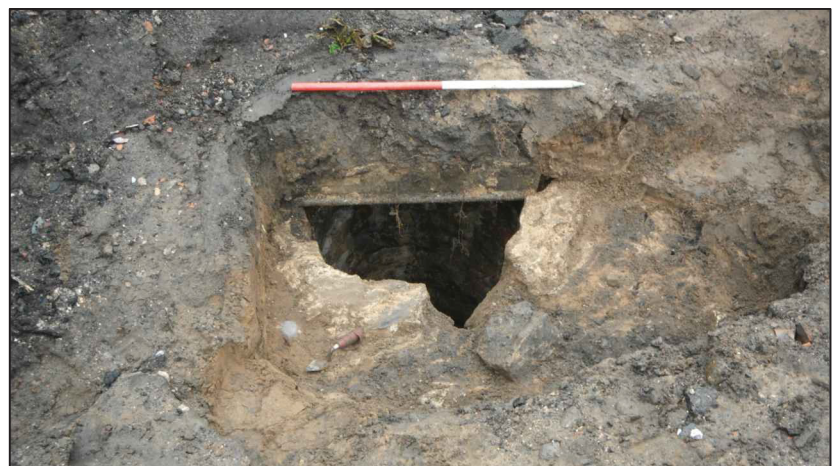
Fig. 10 - Well 003

Well **003** was located in the south-eastern area of the site (Fig. 1). Cutting through **004** but located below **002** was a stone-lined circular well (**003**). The well was empty to a depth of 2.7m, below which were silts. It was constructed of random un-coursed sandstone, 0.2m thick, and measured 0.85m in diameter. No cut for the well was observed.

The well had been covered by a single piece of almost rectangular sandstone (Fig. 11) and capped by an iron girder which extended beyond the limit of excavation. A ceramic drain pipe exited into the top of the well.
