**Water of Leith Flood Prevention Scheme,  
Warriston Road, Edinburgh**

**Archaeological Watching Brief**

**Report No. 1729**

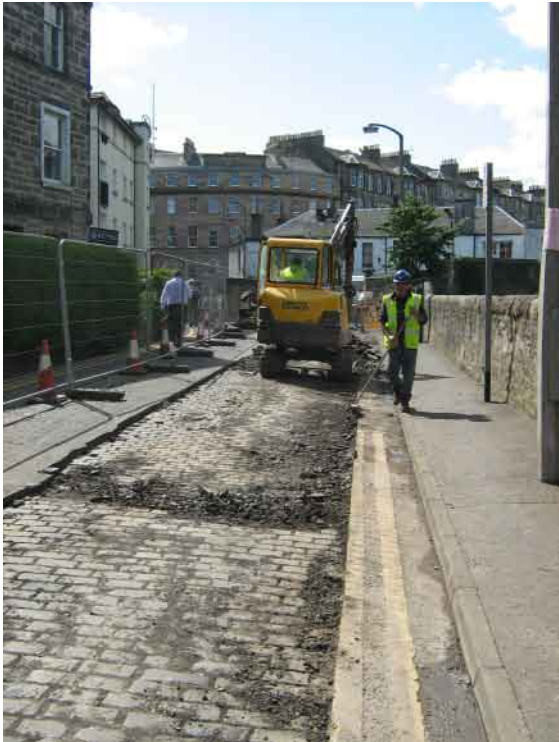
Fig. 2 Working shot of excavation at Warriston Road

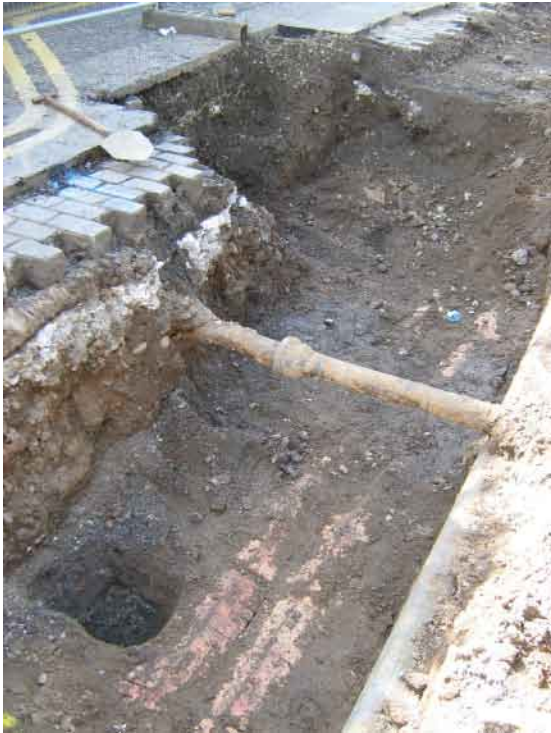
- 3.2 The uppermost deposits along Warriston Road consisted of 0.05m of tarmac surface (**001**) which overlay a uniform cobbled surface (**002**). The cobbled surface (**002**) was deposited on a bedding layer of coarse grained sand (**003**) which covered an indurated deposit of concrete (**004**) that varied in depth from 0.2 to 0.25m in depth.

Fig. 3 General shot of excavation at Warriston Road

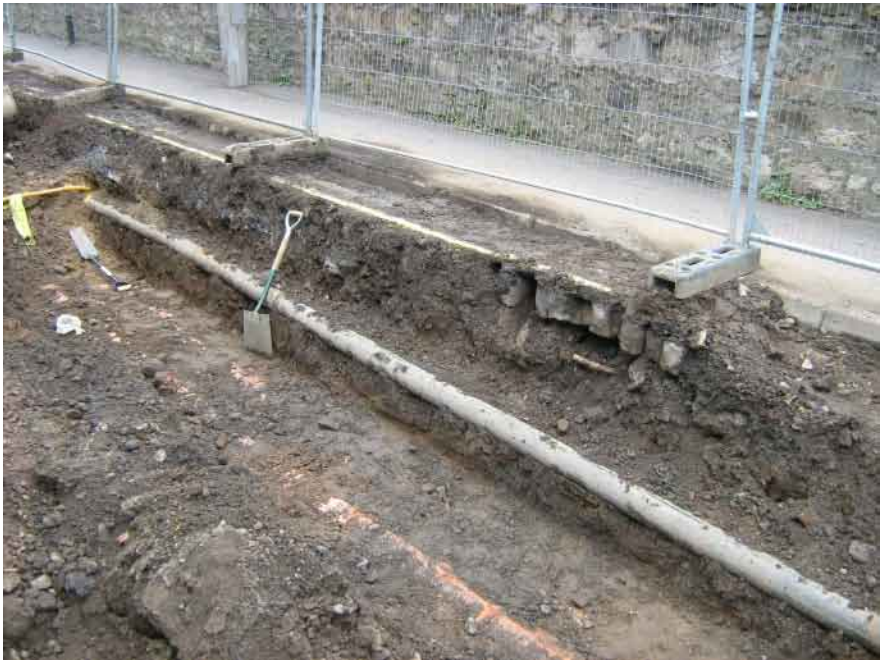
- 3.4 A number of buried services were encountered, which included gas and water pipes as well as electric cabling. The services were located between c. 0.6m and 1.2m below the road surface.

- 3.5 A mixed deposit of ash, coal and clinker (**006**), that varied in compaction and colour and contained inclusions of tile and brick, was typically found at depths of >0.8m and probably constitutes further made ground or service trench backfill.

- 3.6 Deposit **006** overlay a >0.2m deep, dark-brown silty-sand (**007**) which continued beyond the limit of excavation. Deposit **007** contained small, commonly occurring round to sub-rounded cobbles. The deposit was not interpreted as a natural substrate although the cobble element may indicate this material contained re-deposited natural within the matrix.

Fig. 4 Shot of buried services and underlying deposits
