**10-12 Inglis Green Road  
Longstone  
City of Edinburgh**

**Archaeological Evaluation  
(Phase 2 and Phase 3)**

**Report No. 2104**

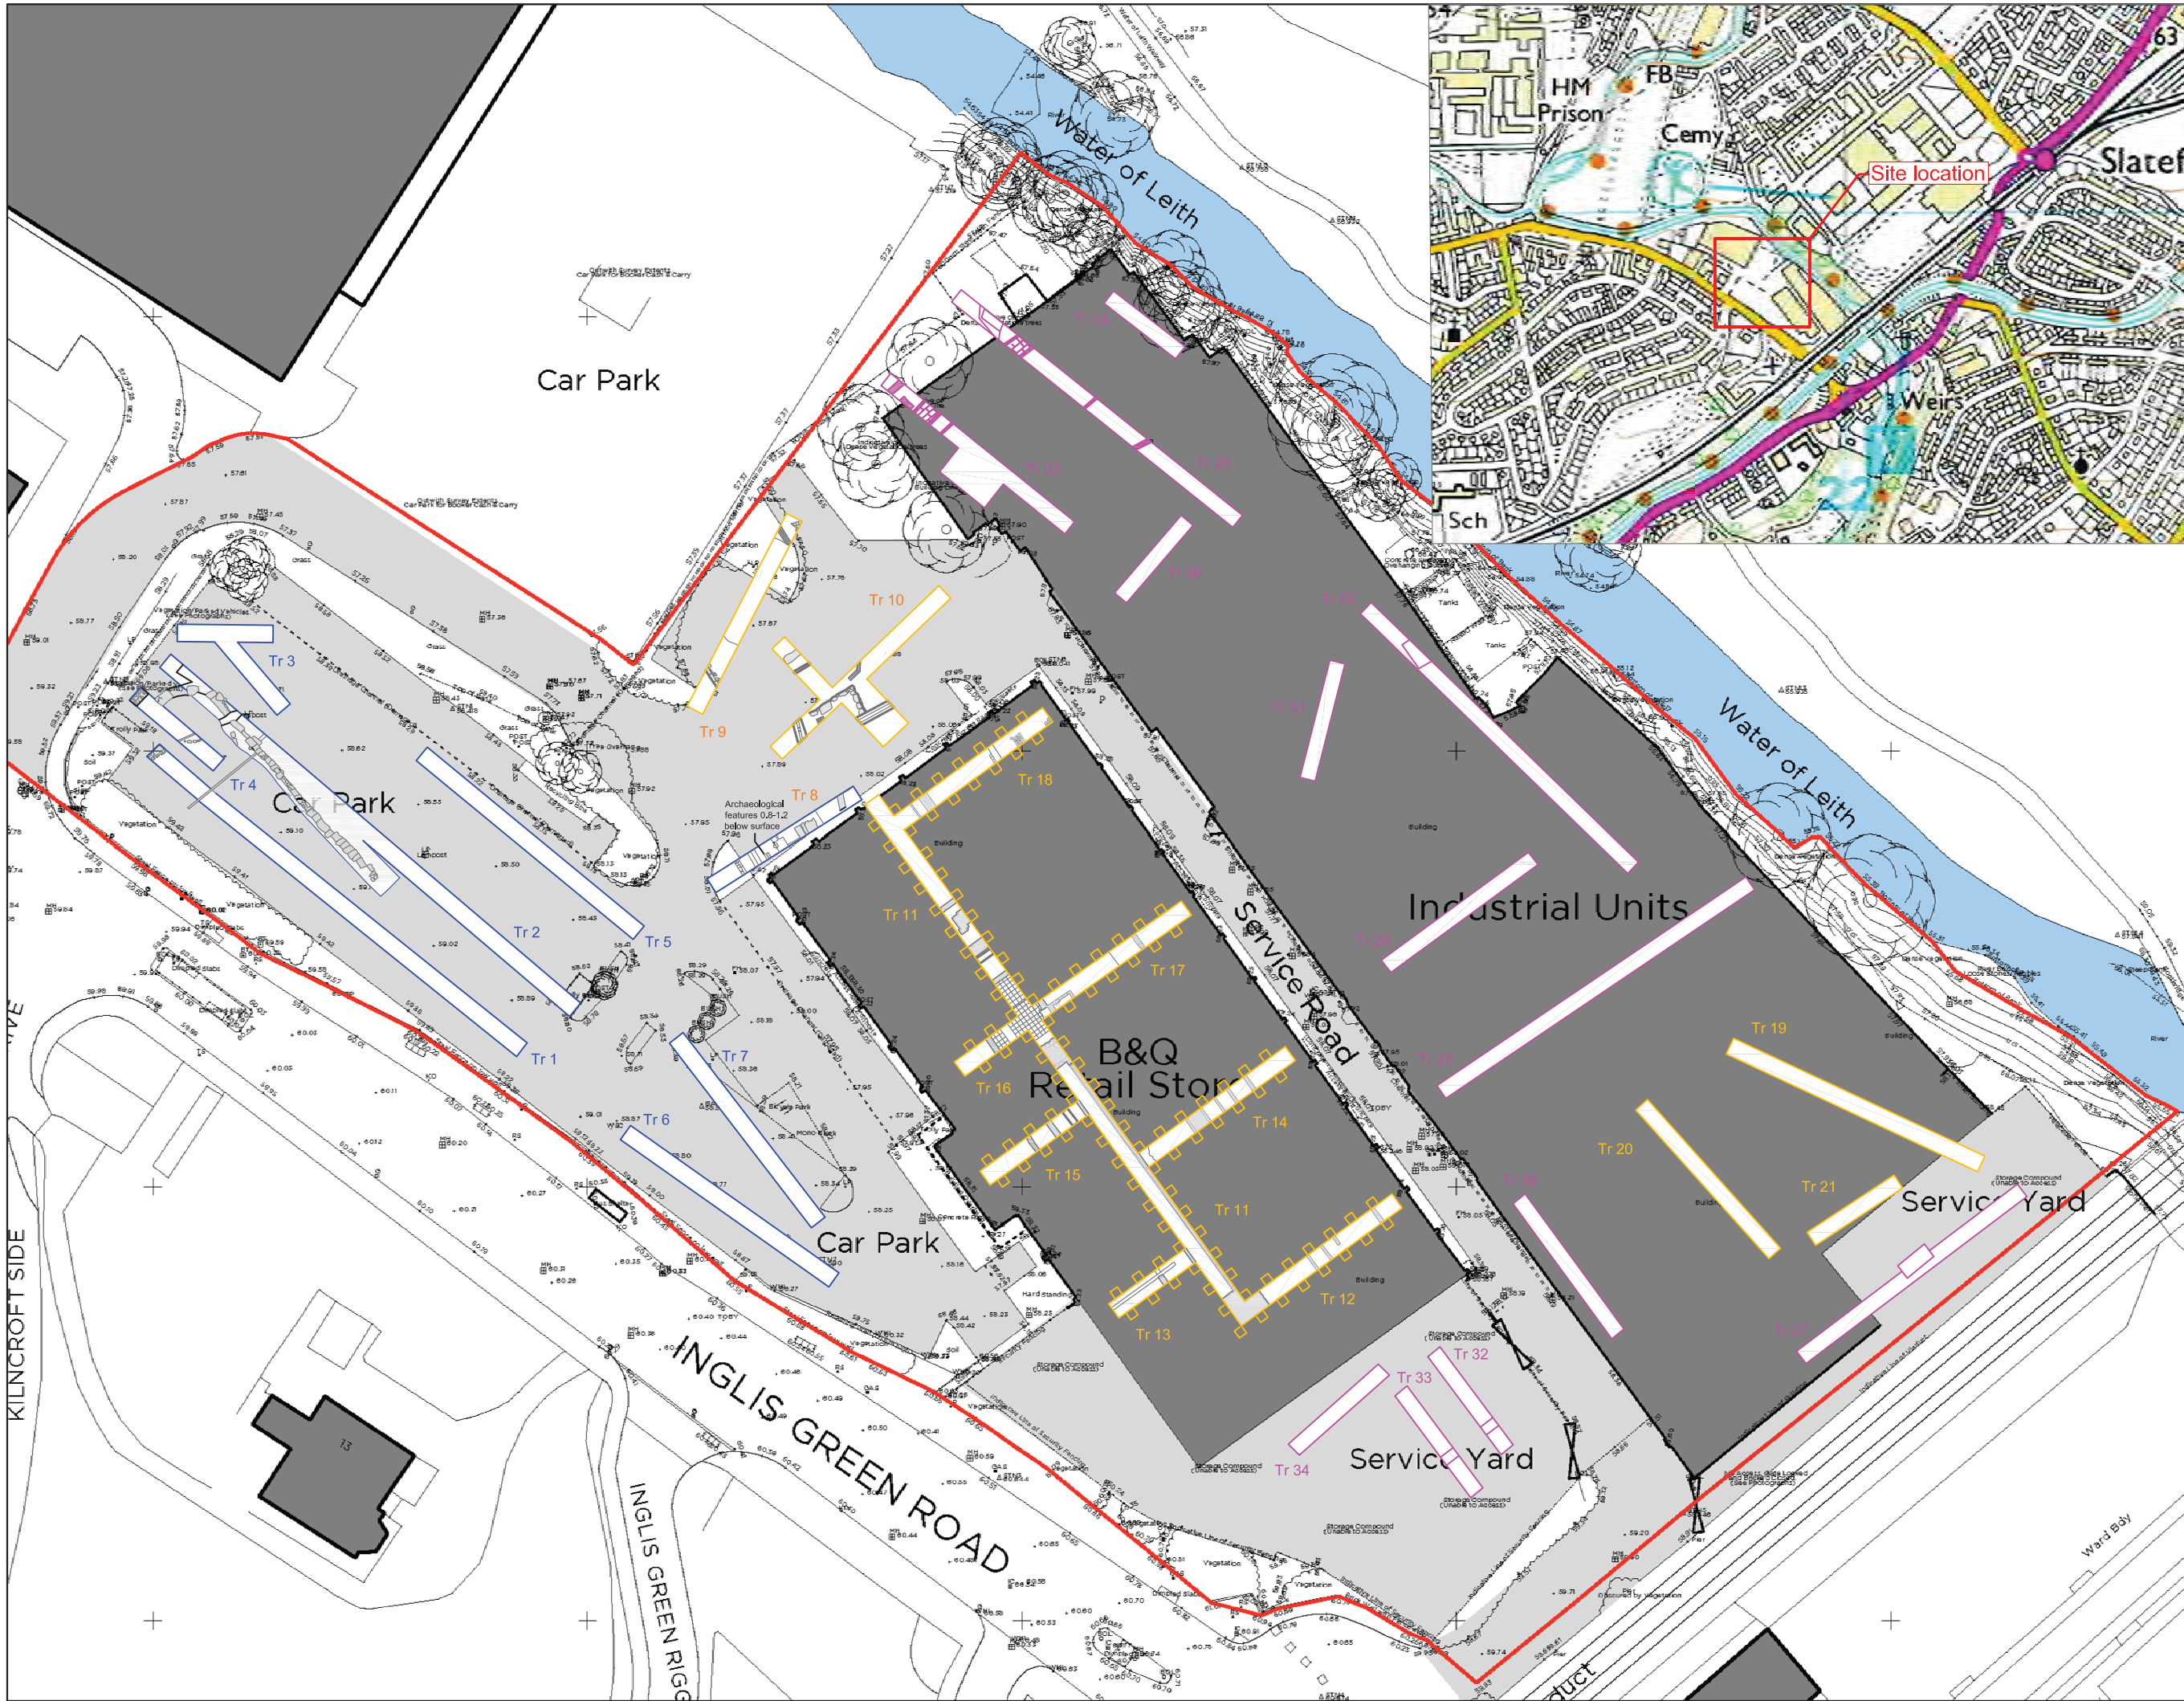
Fig. No: 1 Revision: A

A total of thirteen trenches (Fig. 1) were excavated. This consisted of 478m<sup>2</sup> (10.4%) within the remaining Phase 2 area and 98m<sup>2</sup> (5.4%) within the Phase 3 area. Circa 50% of the Phase 3 area was unavailable for trial trenching due to on-site constraints such as live services.

Title:  
 Location map and trench plan

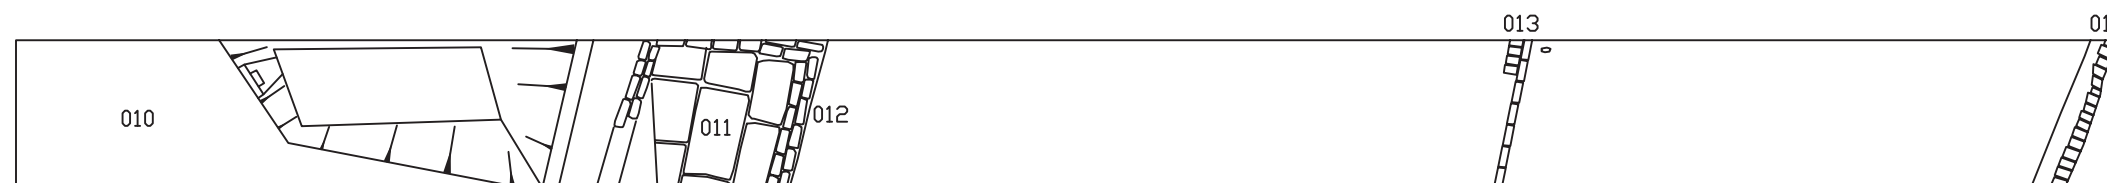
Fig. No: 2	Revision: A
------------	-------------

The deposits at the north-western end of this trench consisted of up to 1.45m of modern hardcore (**001**) and demolition debris overlying a series of walls/flagstone surfaces (**003 – 009**), while the deposits at the south-eastern end consisted of 0.45m of modern hardcore and demolition debris (**001**) overlying 0.3m of orange-brown silty-sand subsoil (**015**) which lay over orange brown sandy-gravel natural (**002**).

A brick wall **003** was situated at the north-western end of Trench 22 c.0.85m below the current ground surface. It was aligned south-west to north-east, continuing into the section on both sides of the trench. This wall was constructed directly on top of subsoil **015** and measured 0.47m wide (two length set bricks) by 0.16m high (two courses). The bricks were frogged colliery bricks with stamps including Prestongrange and Bankpath. Other stamped bricks were illegible, but were clearly from different manufacturers from the two aforementioned.

The deposits towards the north-western end of this trench consisted of up to 1.1m of modern hardcore (**001**) and demolition debris overlying a series of walls and a flagstone surface (**011** and **012**). The deposits at the south-eastern end consisted of 0.3m of modern hardcore and demolition debris (**001**) overlying 0.45m of orange-brown silty-sand subsoil (**015**) which overlay orange brown sandy-gravel natural (**002**).

At the extreme north-western end of the trench there was a modern concrete tank (**010**) with a water channel and a sluice gate situated immediately below the current ground surface. Immediately to the south-east of this there was a flagstone surface (**011**) (Fig.4) located 1.1m below the current ground surface. These flagstones were bordered on three sides by a brick wall (**012**) the top of which was situated 1.05m below the current ground surface. This feature was very similar in nature to the flagstone surface (**007**) and walls (**005**, **006** and **008**) identified within Trench 22 and is considered to be a continuation of the same feature. Here, the survival of the bordering walls was poorer with them only standing to a single course.

Title:  
Plan of Trench 22 and 23

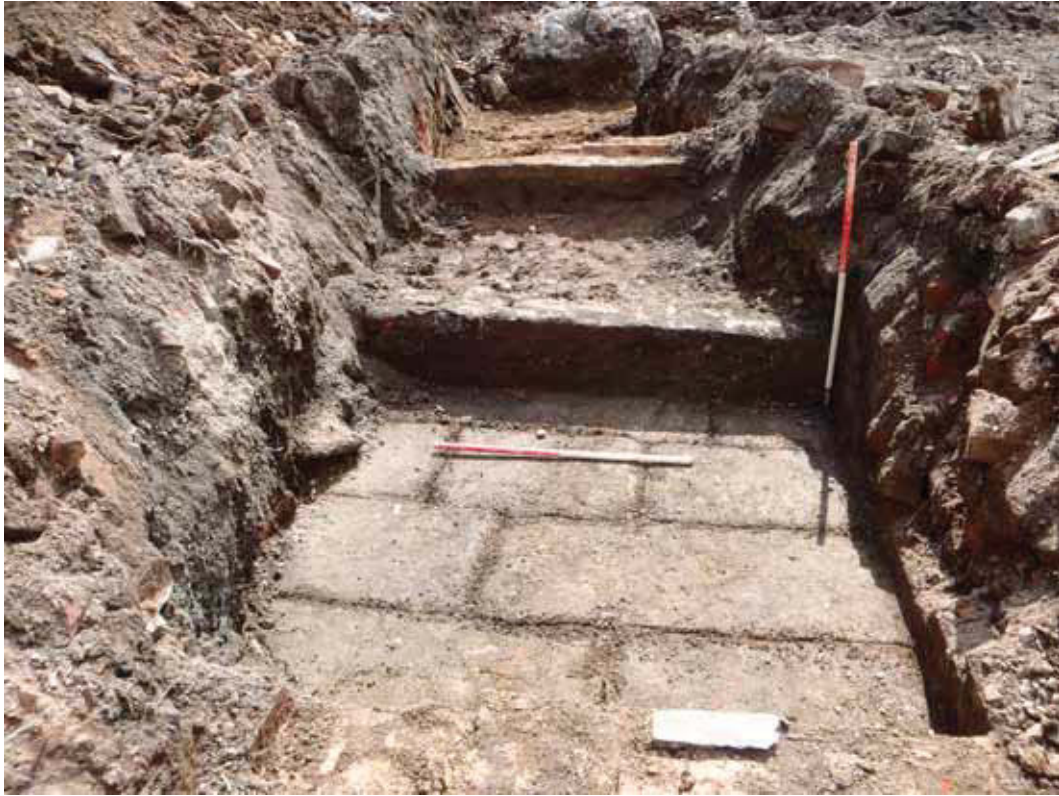
Immediately to the south-east of flagstone **004** was a flagstone surface (**007**) (Fig.3) situated 1.45m below the current ground surface. The flagstone surface measured 2m north-west to south-east by c.2m north-east to south-west and was constructed from flat slabs measuring up to 1.2m by 0.5m by 0.1m thick which sat directly on top of the natural subsoil (**002**). Bordering the surface to the north-west, south-east and south-west were walls **005**, **006** and **008**, which all represent the same phase of development (wall **006** is not represented in the plans as it was observed in the trench section). The walls were situated 1.15m below the current ground surface and were brick built. They measured 0.23m wide (two brick widths) and 0.34m in height (4 courses).

Fig. 3 - Flagstone surface 007 from southeast

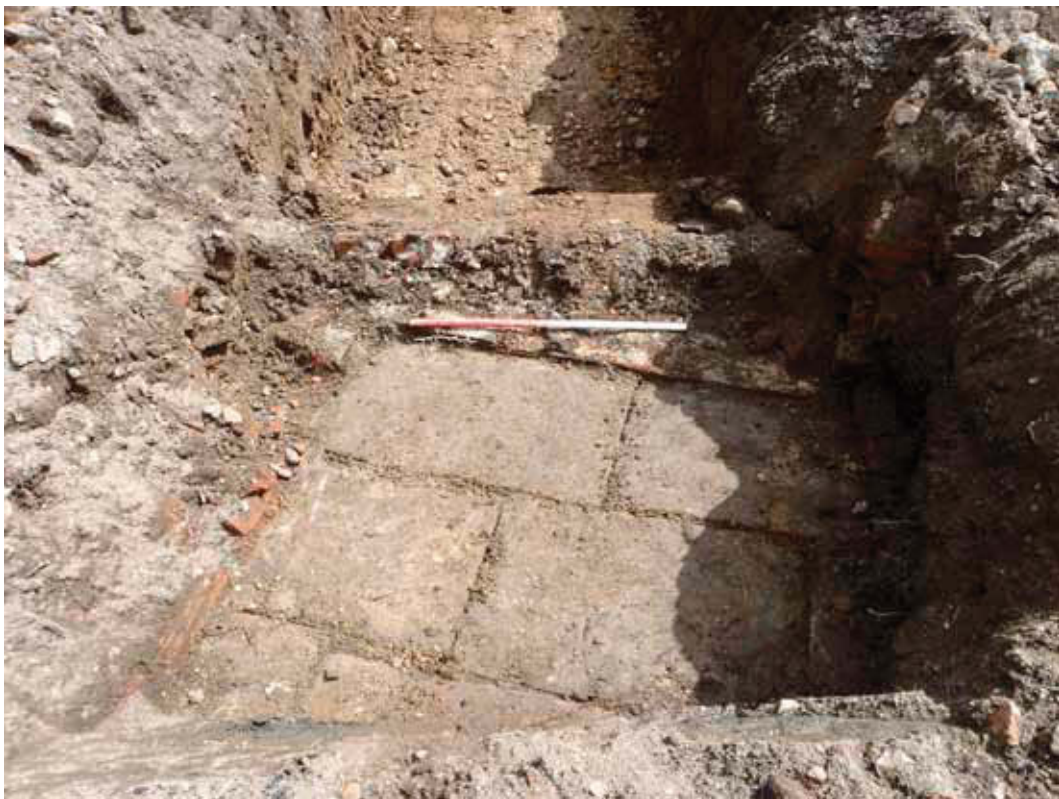
Fig. 4 - Flagstone surface 011 from northwest

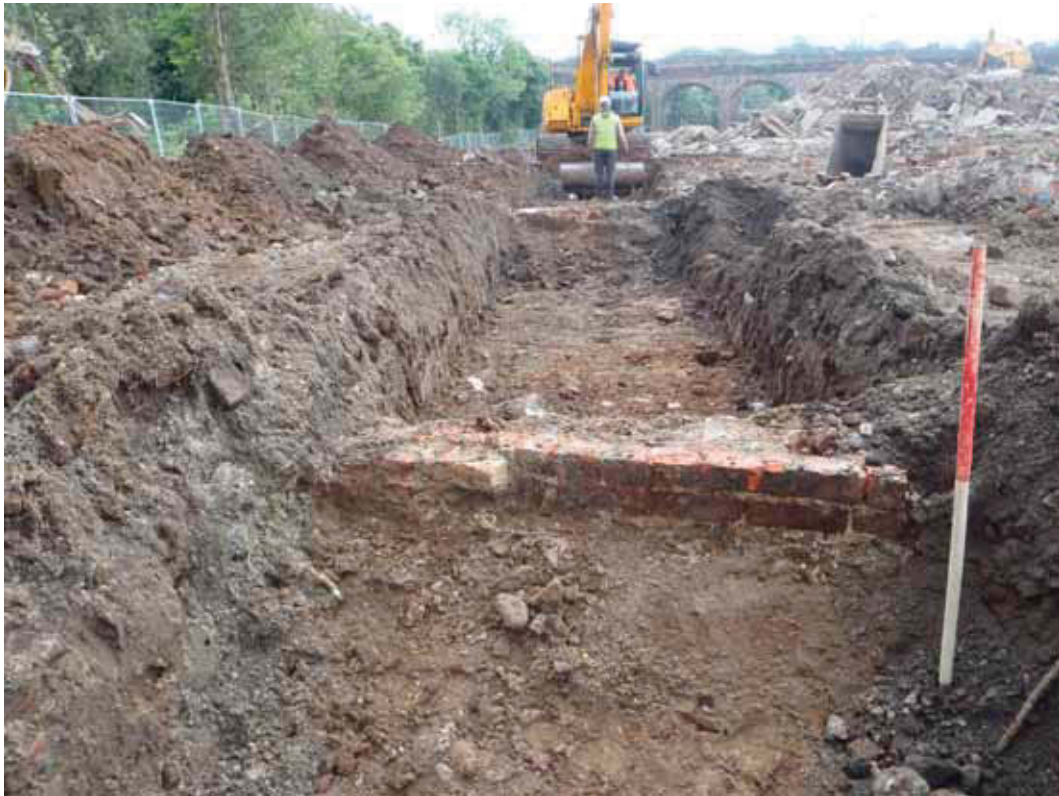
Circa 9m to the south-east of **011/012** was the footings of a brick wall (**013**) (Fig.5) situated 0.3m below the current ground surface. The wall was north-east to south-west aligned, measured 0.25m (two width set bricks), stood to a height of 0.18m (two courses) and continued into the section on either side of the trench. It sat directly on top of subsoil **015**.

Fig. 5 - Wall 013 from northwest

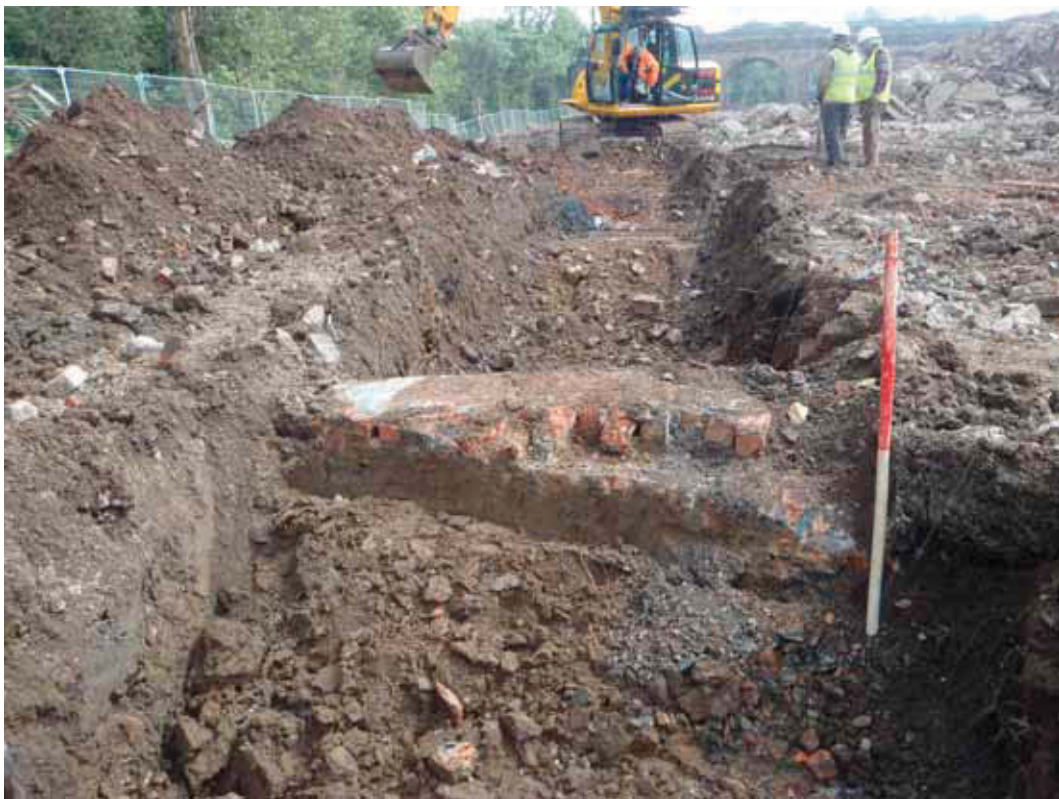
Circa 7m to the south-east of wall **013** a linear feature constructed of bricks and concrete (**014**) (Fig.6) was located c. 0.1m below the current ground surface. It was aligned north-east by south-west, measured 0.5m in width, stood to a height of 0.2m

and continued into the section on either side of the trench. Its construction and form suggested it was not a wall but possibly a foundation for something. This feature sat directly on top of subsoil **015**.

Fig. 6 - Brick and concrete feature 014 from northwest

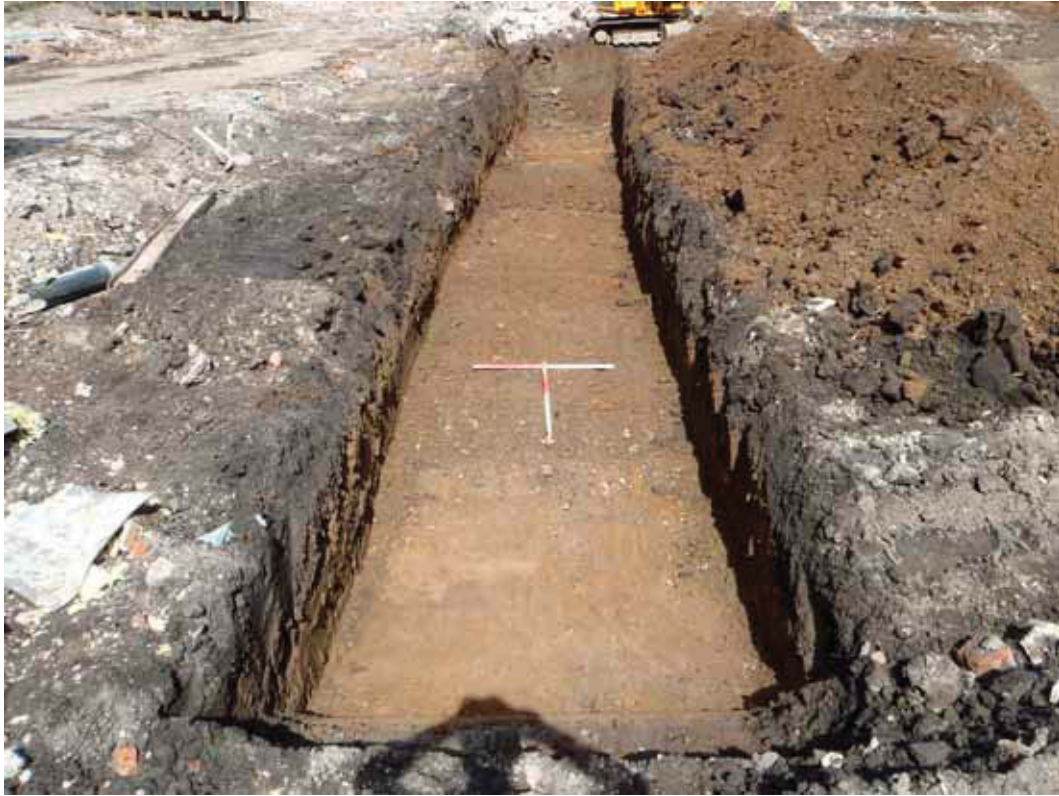
Fig. 7 - Trench 26 from southeast

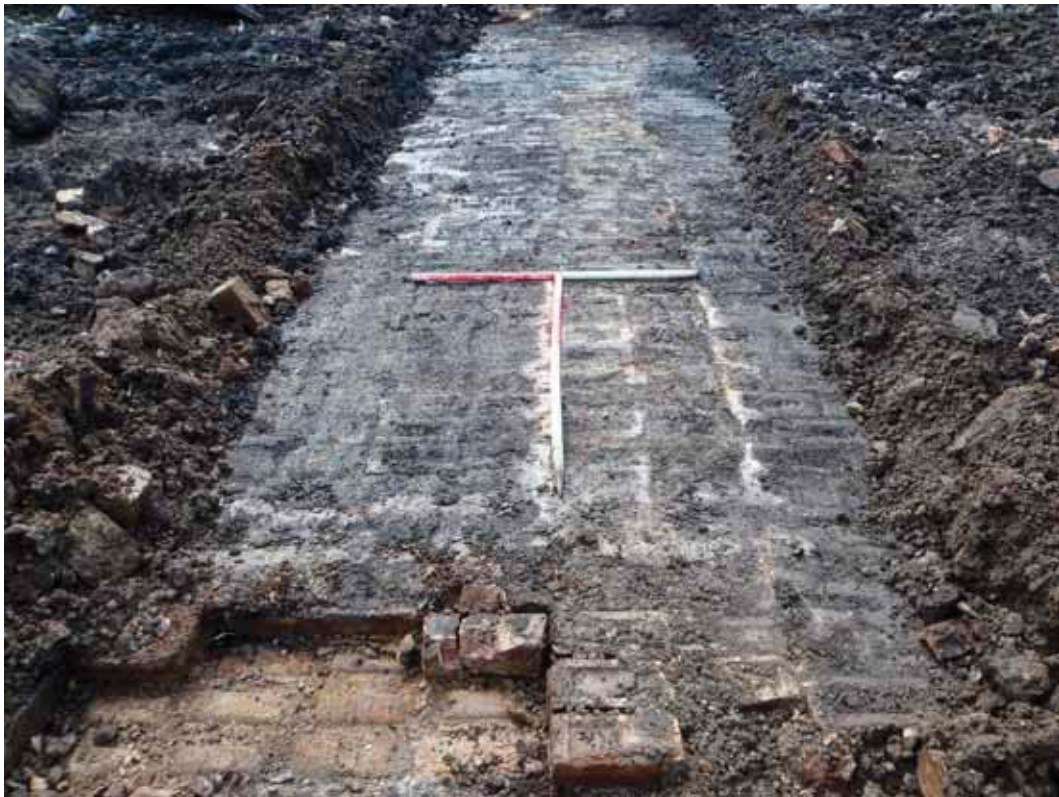
Fig. 8 - Brick surface within Trench 28

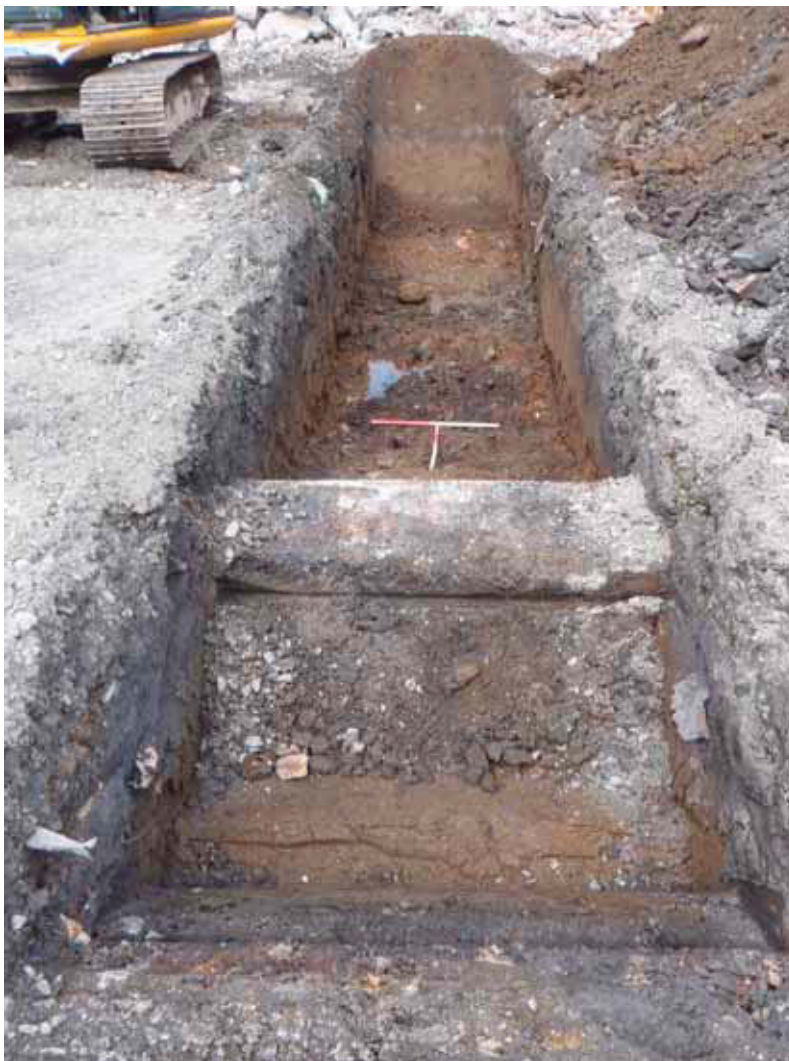
Fig. 9 - Trench 32 from southeast
