**Turbine Bases & Cable Trenches
Parkhouse Farm,
Quothquan, near Biggar,
South Lanarkshire**

**Archaeological Watching Brief
Report No. 2139**

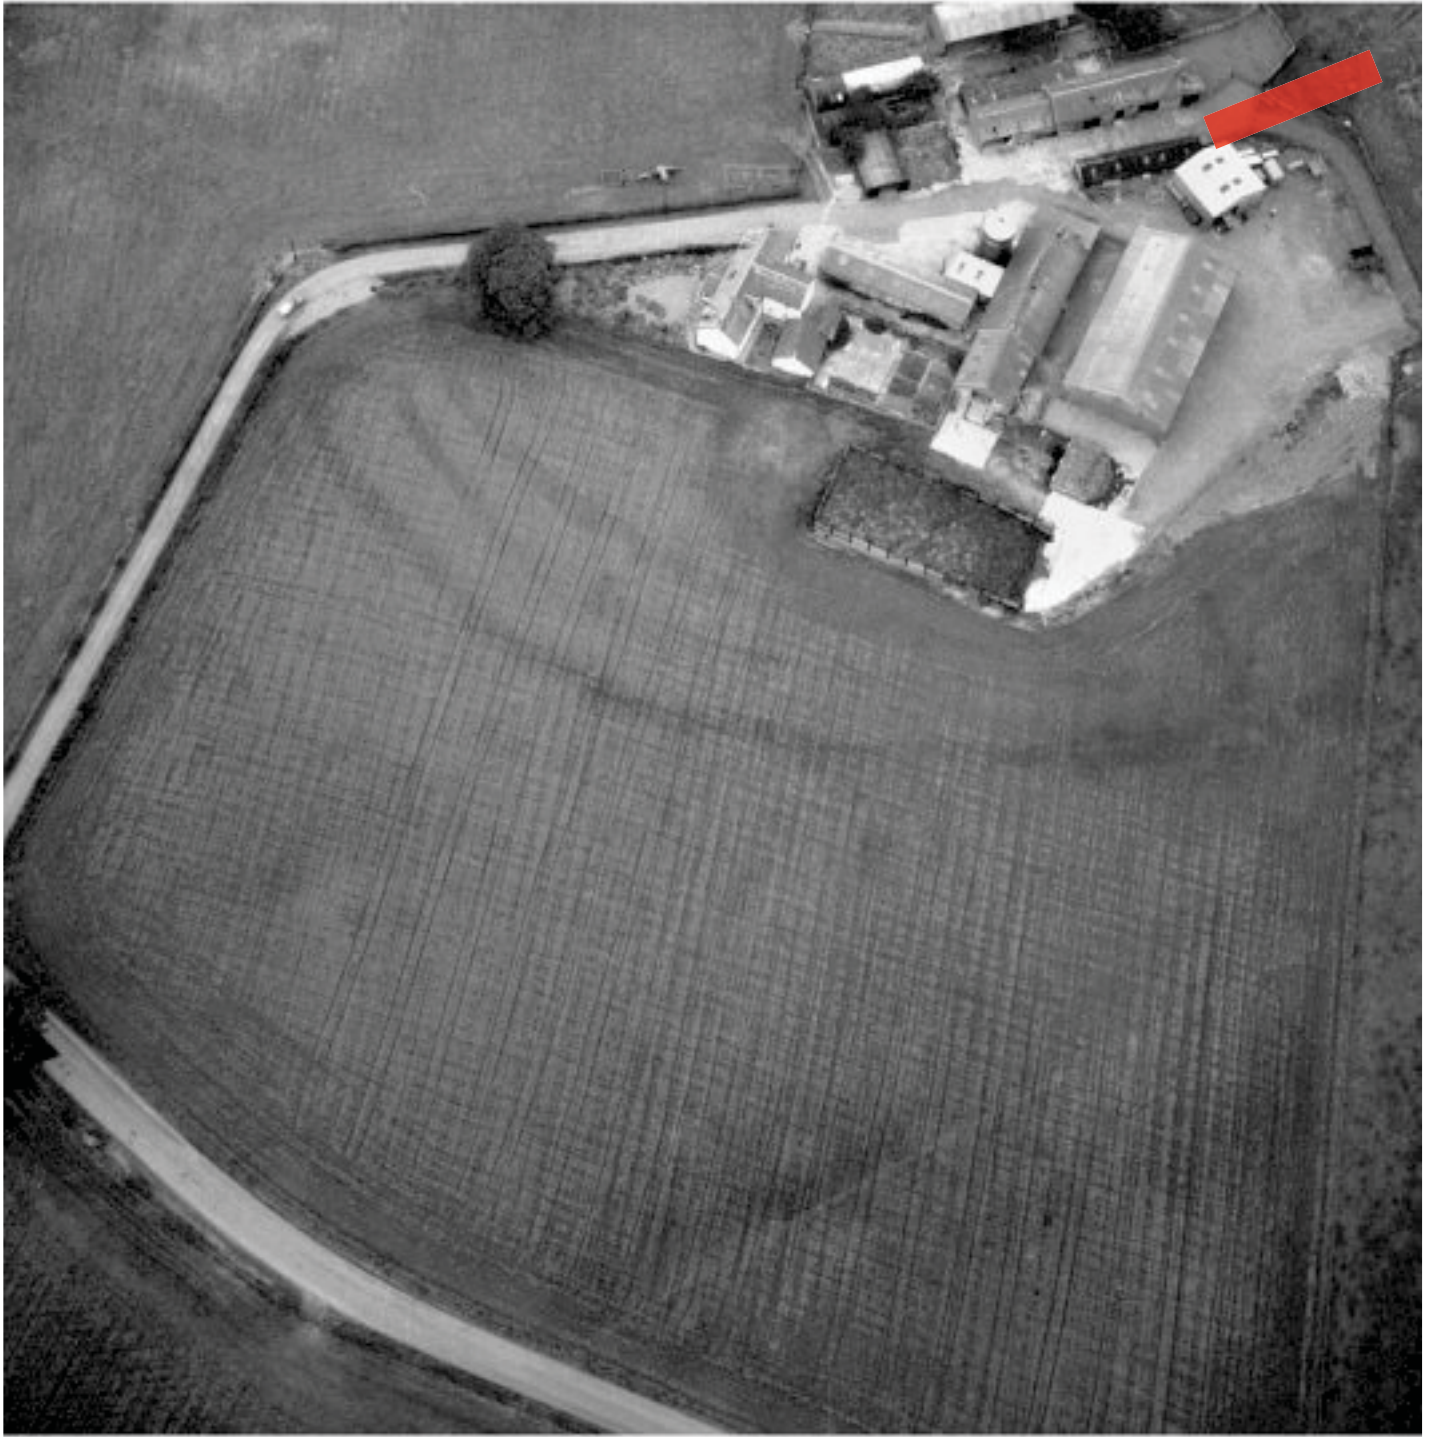
Fig. 2 - Aerial photograph of the Parkhouse Fort ditches

Location of ditches found in watching brief

A prehistoric fort is located on Quothquan Law, some 700m to the south of the turbines; this site is a Scheduled Monument. Parkhouse Farm is situated on top of a prehistoric settlement (RCAHMS Site No. NS93NE 33; Fig. 2). The cable trenches were expected to run across the buried defences of this settlement although the ditches in this area are not visible on the aerial photograph. Collections of prehistoric stone tools (eg. NS93NE 20) are also well known from the vicinity of the farm.

The watching brief at Parkhouse Farm was successful in locating the multi-vallate ditches of the fort that appear on the aerial photograph (RCAHMS Site No. NS93NE 33; Fig. 2). That photograph does not show the ditches in the area of the watching brief and so the project has therefore added to the available evidence for this site.

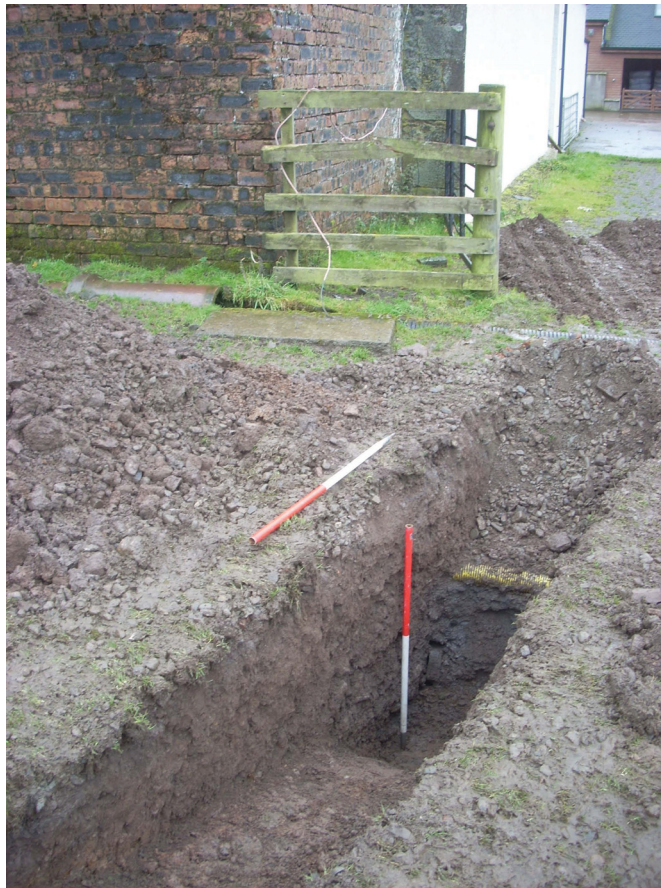
Fig. 4 - Inner ditch 001, oblique view from North

The inner ditch (**001**, Fig. 4) was recorded in a yard adjacent to one of the farm buildings. Full excavation was not possible due to a surface ceramic drain running alongside the shed (top left Fig. 4) and a buried plastic drain pipe (Fig. 4, 7). Cut into boulder clay, the ditch measured over 3.6m in width and was 1.3m deep. Three fills were recorded and the deposits were contaminated with diesel fuel. A basal fill (**008**) was 0.6m deep and consisted of a compact orange-brown clay-silt with frequent stones. Overlying this and with a depth of 0.5m was a light brown firm silty sand with occasional small stones (**009**). The upper fill (**010**) was 0.2m deep and was a mid brown firm silty sand with occasional small stones. The ditch was sealed by the gravel (**004**) forming the yard. There was no visible environmental content and no finds were recovered.

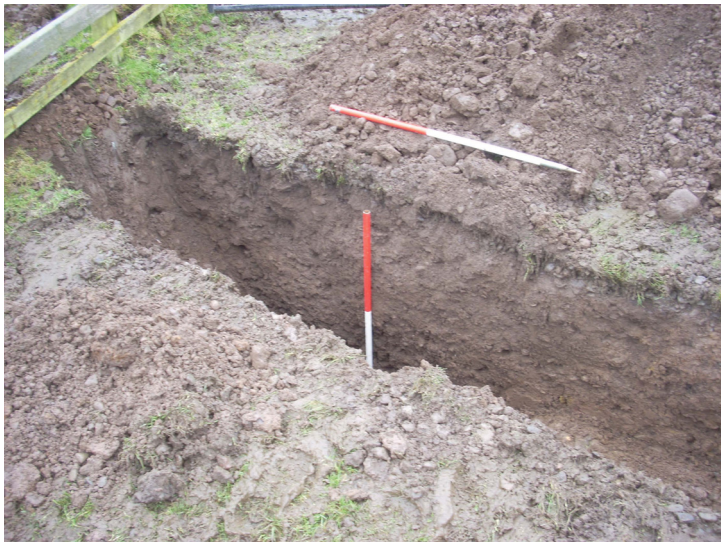
Fig. 5 - Middle ditch 002 from West

The middle ditch (**002**, Fig. 5, 7) was recorded under a wooden fence separating the yard from the pasture field to the north. Full excavation was not possible due to this fence (top left Fig. 5). Cut into boulder clay, the ditch measured 4.2m in width and was 1.1m deep. Three fills were recorded. A basal fill (**011**) was 0.5m deep and consisted of a compact grey-brown clay-silt with frequent stones. Overlying this and with a depth of 0.2m was a light brown firm silty sand with occasional small stones (**012**). The upper fill (**013**) was 0.4m deep and was a mid brown firm silty sand with occasional small stones. The ditch was sealed by gravel (**004**) within the yard and by topsoil (**016**) within the field. There was no visible environmental content and no finds were recovered.

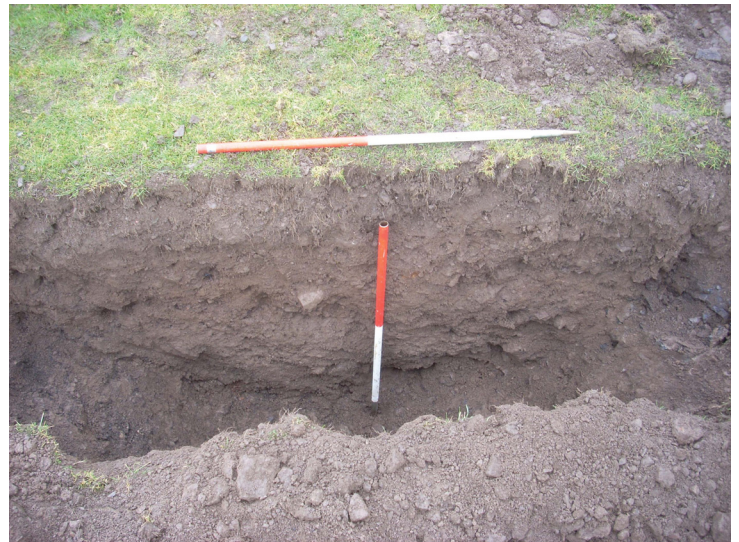
Fig. 6 - Outer ditch 003 from North-West

The outer ditch (**003**, Fig. 6, 7) was recorded 8m to the north of the wooden fence in the pasture field. Cut into shattered basalt bedrock, the ditch measured 3.2m in width and was 1m deep. Three fills were recorded. A basal fill (**005**) was 0.4m deep and consisted of a firm, chemically-stained grey coarse sandy silt with angular pieces of

basalt. Overlying this and with a depth of 0.4m was a light brown firm silty sand with occasional small stones (006). The upper fill (007) was 0.2m deep and was a mid brown firm silty sand with occasional small stones. The ditch was sealed by topsoil (016) with a depth of 0.2m. There was no visible environmental content and no finds were recovered.
