**A164 Humber Bridge to Beverley** Road Improvement Scheme, **East Riding of Yorkshire Archaeological Strip and Record**

> Report No. Y064/12

**Archaeological Strip and Record**

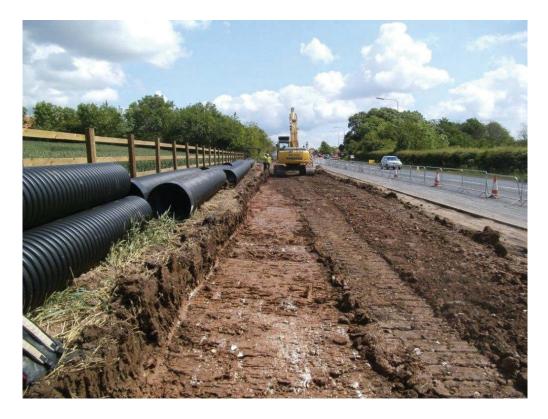
Plate 1: Area 1 during topsoil removal

The overburden strip revealed light greyish-brown clayey-silt topsoil (001) 0.2-0.3m deep, which overlay a firmer medium greyish-brown subsoil deposit (002) 0.2m thick. The natural substrate was firm orange-brown clay with occasional chalk pebbles and patches of coarse red-brown sand. The box-cut for the construction of the original road and its services (004) extended four to five metres from the current road, with that area being truncated and backfilled with a made-ground gravel deposit (003), leaving only a thin margin of undisturbed ground (Plate 1).

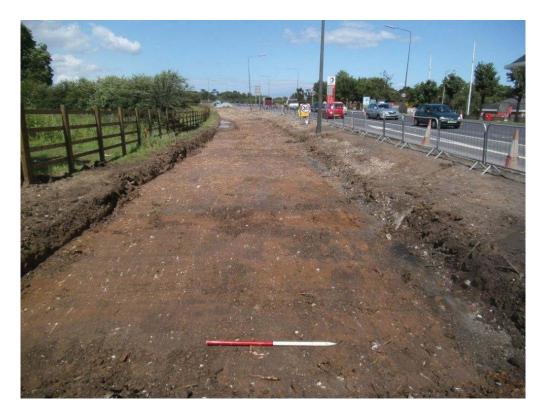
Plate 3: Area 5 following topsoil removal

Areas 4, 5 and 6 were to the north-west of the A164 road (Figs 5, 6 and 7). The construction cut of the original road (004) extended out between four and five metres from the current road-surface (Plate 3), which was backfilled with a deposit of firmly compacted clay and gravel (003).

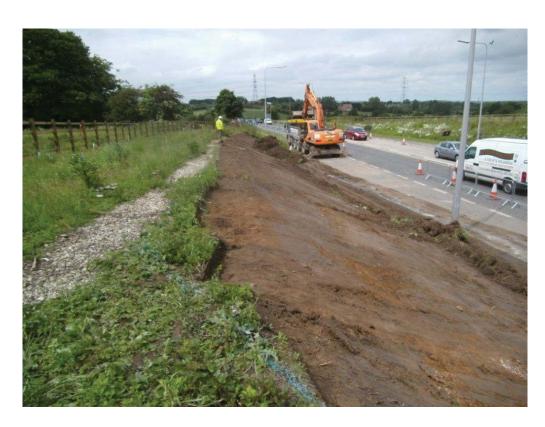
Plate 4: Area 9 following topsoil removal

Areas 8 and 9 were located at either side of the A164 to the immediate north of Skidby Roundabout (Fig. 2). Both areas were on present road embankments between adjacent fields and the footpaths alongside the road (Plate 4). The embankments were stripped of topsoil and then cut into to allow the placement of a revetting wall, and no new land was affected by the road widening. During the topsoil strip of Area 9 an unstratified flint was identified.
