**Ailsa Lodge, Erskine Ferry Road
Bishopton, Renfrewshire**

Archaeological Watching Brief

Report No. 2156

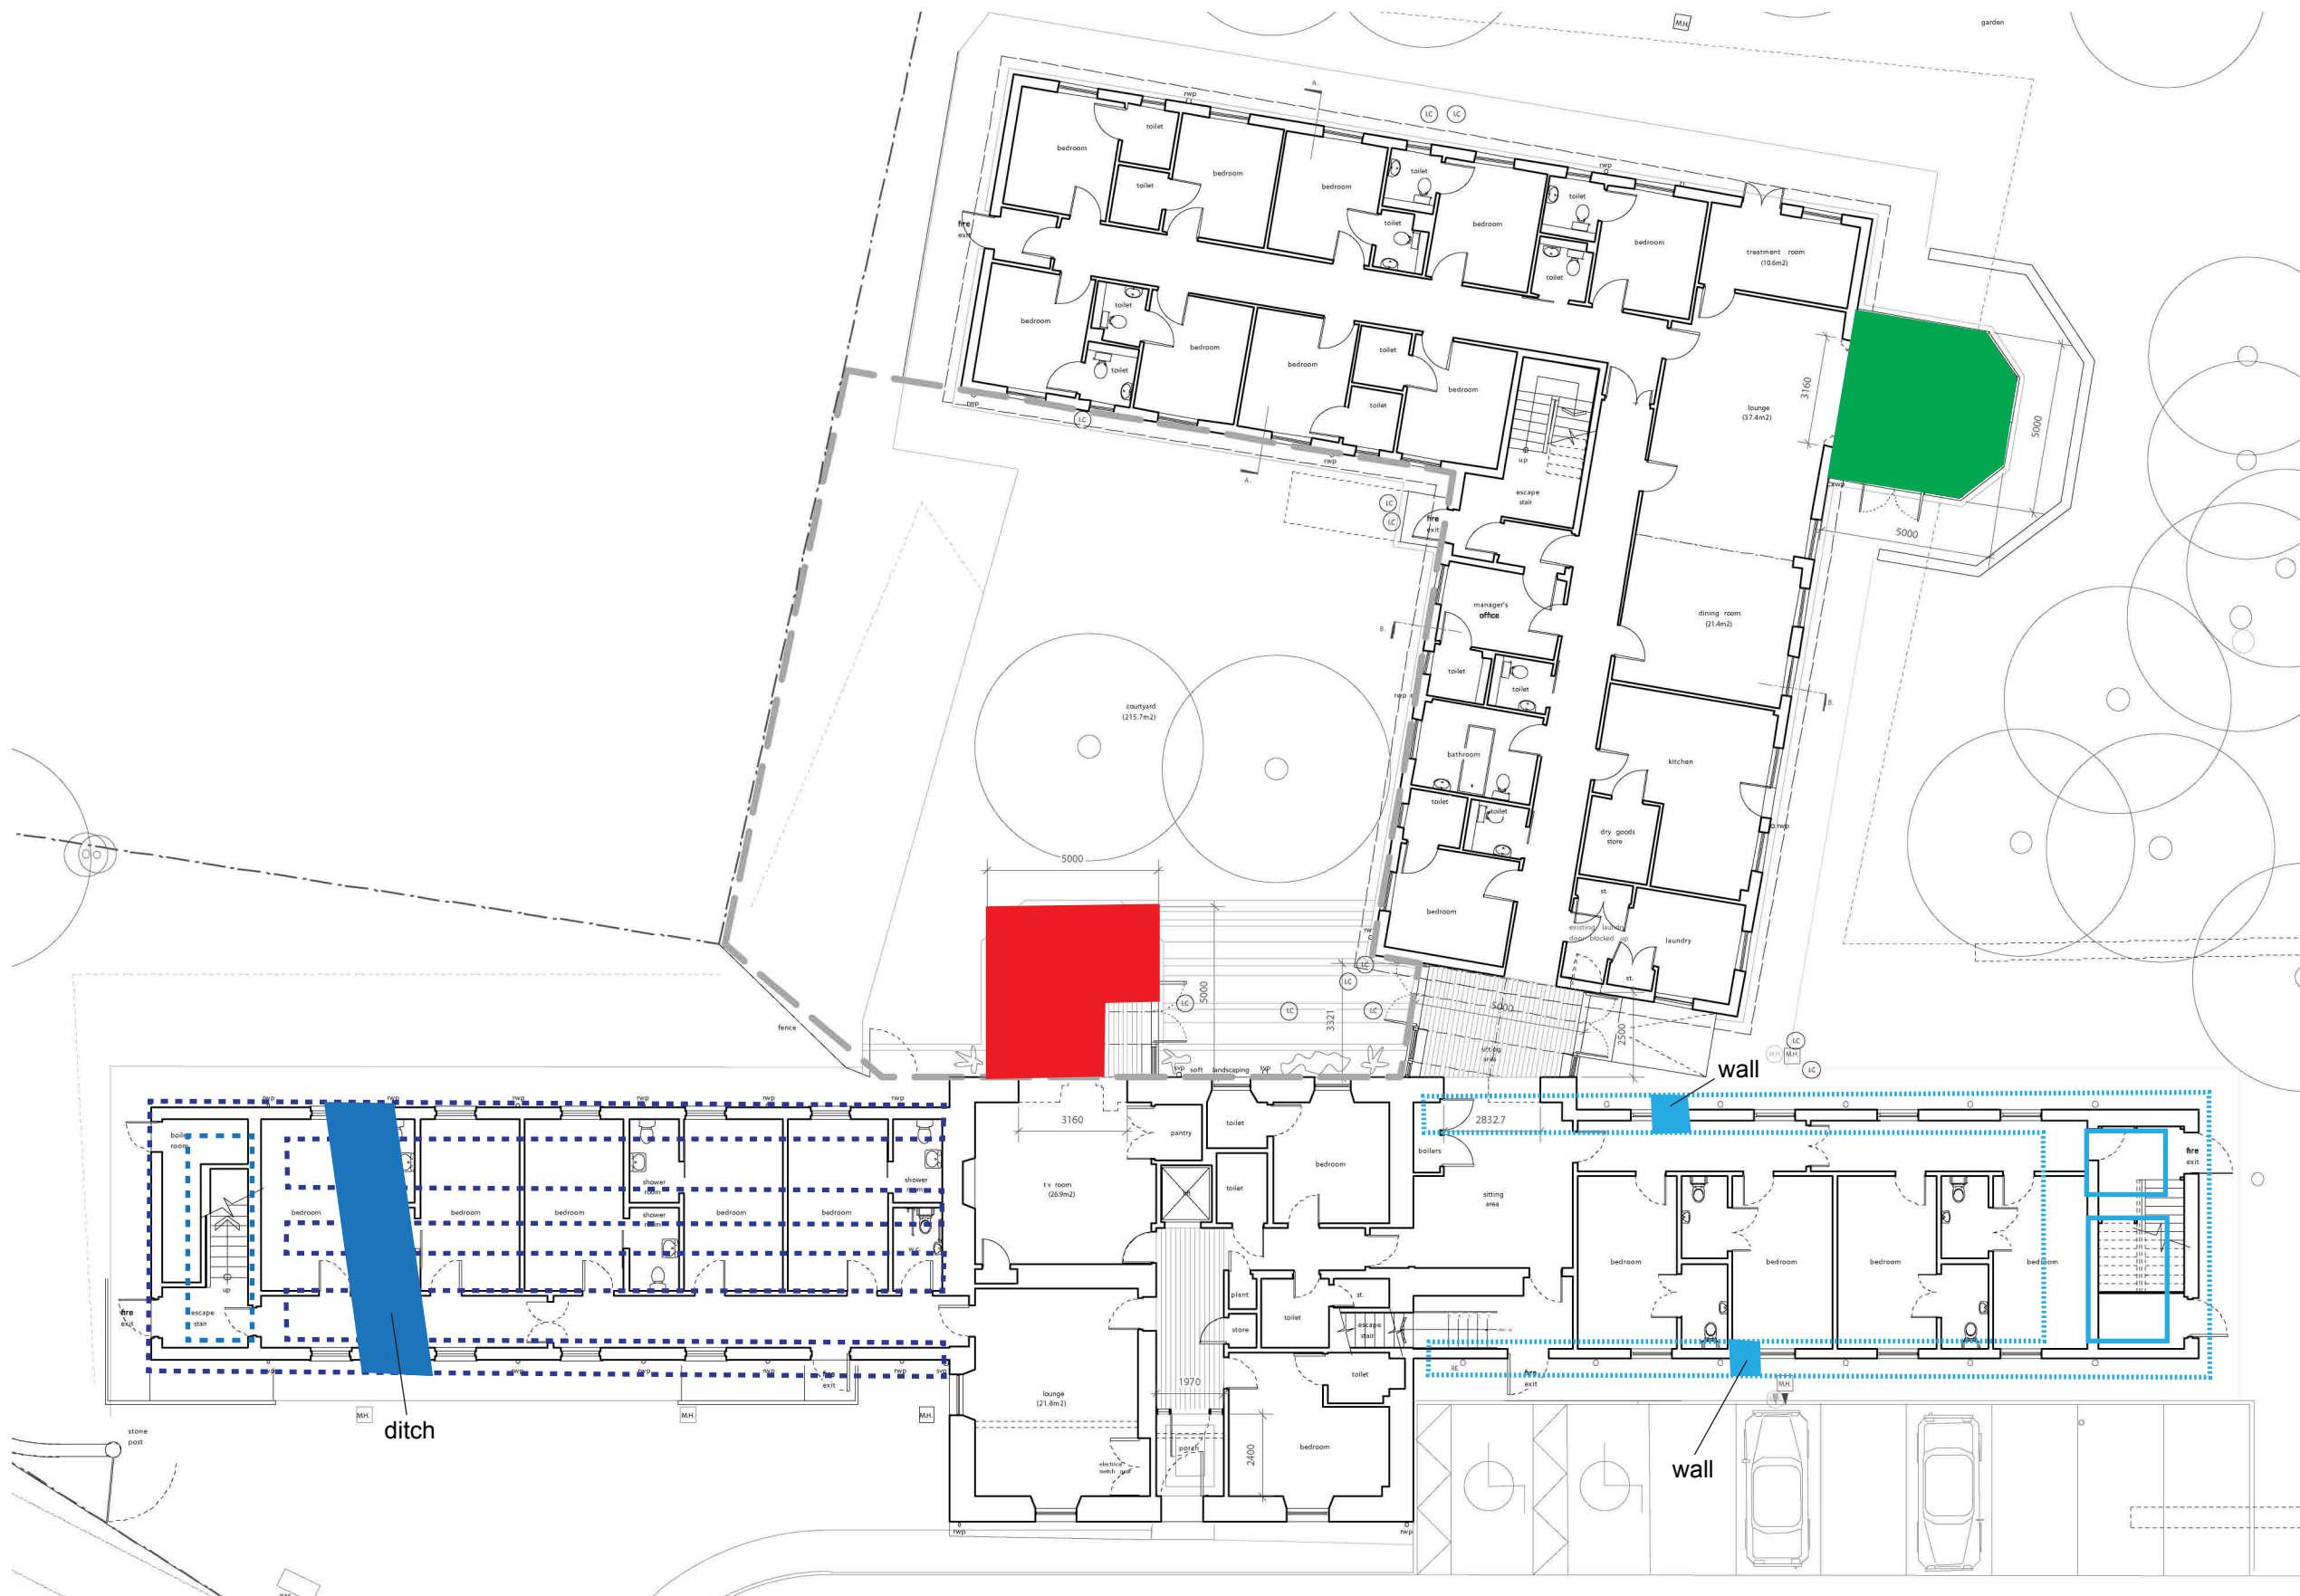
Title:
Location of watching brief area
and location of previous work

Planning permission (Ref No. 05/0394/PP and 05/0462/LB) was granted by Renfrewshire Council for the construction of two conservatories and a sitting area at Ailsa Lodge, Bishopton. At present, only one of the two proposed conservatories is being constructed, which is the subject of this report (Fig. 2).

Previous watching briefs have been conducted at Ailsa Lodge during earlier extensions in 2006 and 2009 (Kirby 2006, Moore 2009). In 2006, within foundation trenches for an extension on the west, findings included a north to south orientated ditch with a width of c.1.8m and a maximum depth of 0.9m (Fig. 2).

In 2009, within foundation trenches for an extension on the east, findings included: a north-south orientated garden wall; the fragmented sandstone remains for the foundations of the recently demolished eastern annexe; and the remains of a sandstone foundation footing, within which was found a fragment of re-used cornice incorporated into its fabric (Fig. 2).

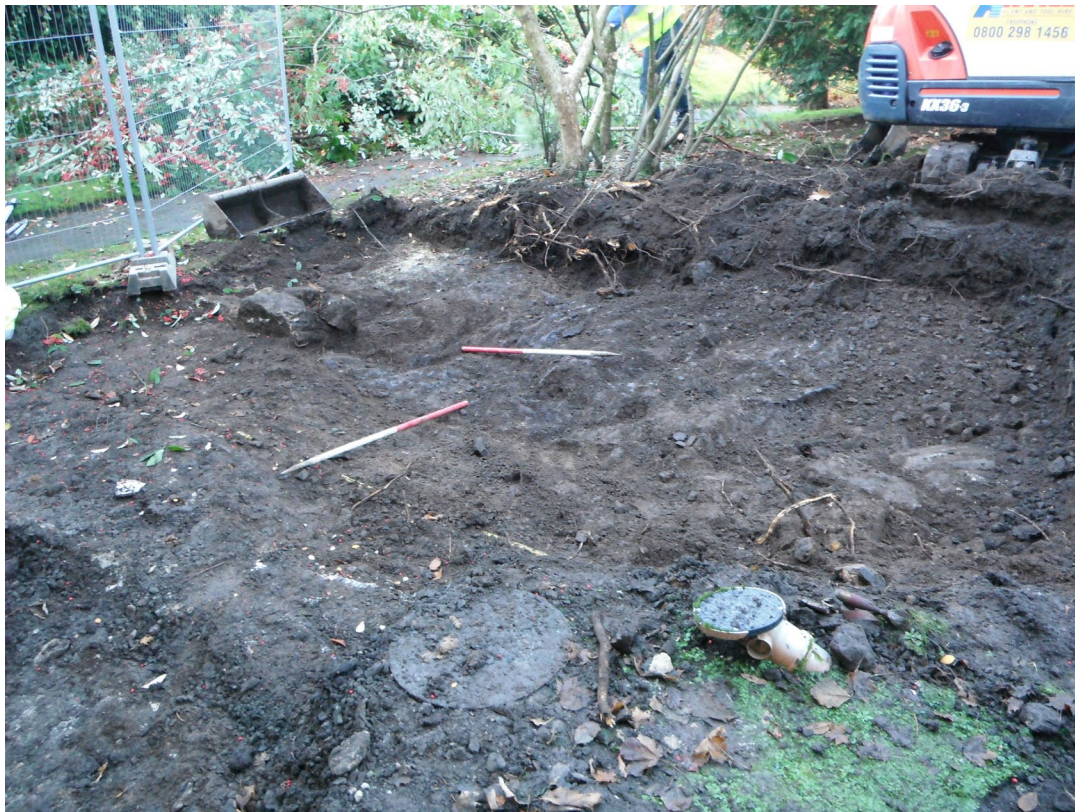
Fig.4 : General view of site

The numbers in bold and parentheses refer to contexts, a list of which is contained in Appendix 1. The watching brief monitored the excavation for the foundation of the conservatory (Figs. 2 & 4), the details of which are discussed below.

The foundation extended 5m from the northern side of the lodge and measured approximately 20m². The stratigraphy comprised of between 0.2-0.3m of topsoil (**000**), which overlay 0.2m of subsoil (**001**) and beneath this was the natural bedrock (**004**) (Fig. 4).

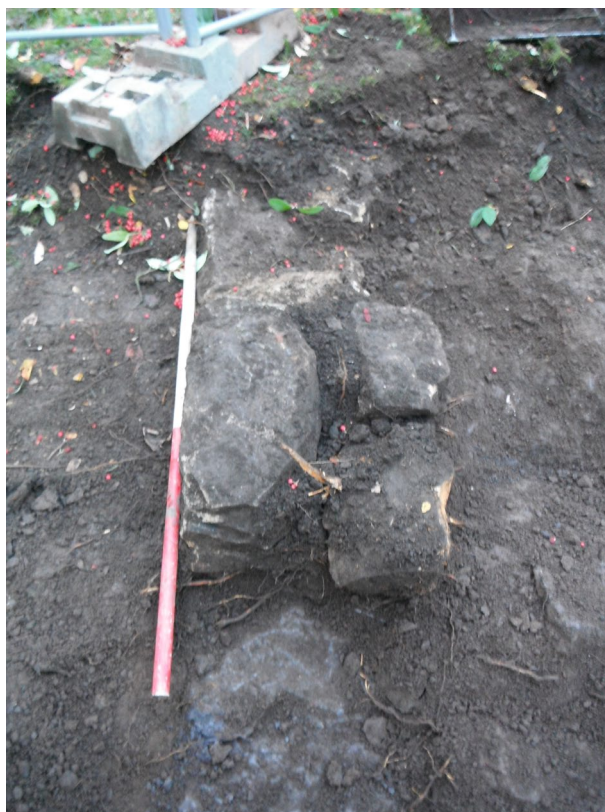
Fig.5 : Detailed view of wall 003

Located at the west side of the exposed area, and extending beyond the western excavation boundary, the remains of a wall (**003**) were found (Fig. 3). The wall was aligned east-west and measured 1m long, 0.45m wide and 0.25m high (Fig. 5). It consisted of two courses of large sandstone blocks bonded with yellow sand mortar and directly sat upon the bedrock (**004**). The wall was covered by topsoil (**000**).

Two vestigial walls were found during the investigation; Wall **003** is probably the remains of the garden wall depicted on the 1st and 2nd edition 25" Ordnance Survey maps, just to the north of the manse and parallel with it, and therefore dates to at least the mid-19th century. Wall **002** is not depicted on any of the OS maps, which might suggest that it is older than **003** or represents an insubstantial garden wall which was not worth depicting.
