**Meikle Carewe Windfarm,
Near Stonehaven,
Aberdeenshire**

Archaeological Watching Brief

Report No. 2163

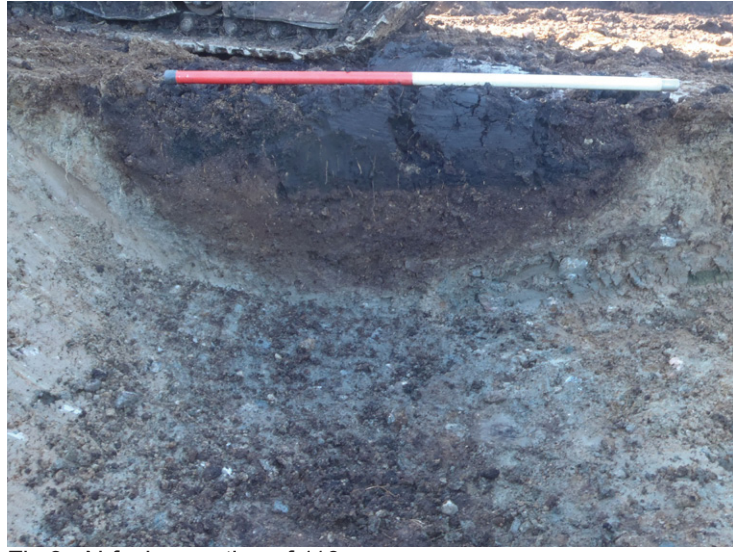
Fig 3 - N-facing section of 110

Ditch **110** was aligned north-south (on the access road between the substation and T6, between NGR NO 83 and NO 83) and measured 15.5m long, 1.2m wide and 0.42m deep. It contained two fills: the lower was brown sandy gravel with rounded pebbles and degraded stone inclusions (**111**); above this was dark brown silty peat (**112**). No finds were found within this feature.

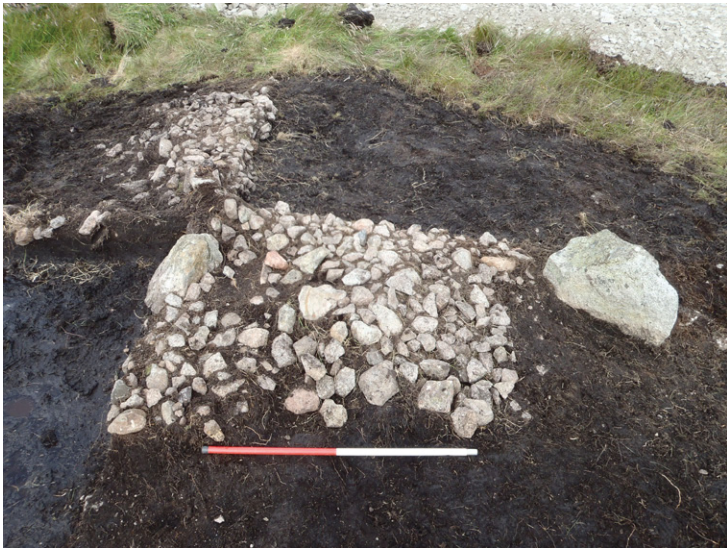
Fig 4 - South quadrant of cairn

A cairn was located within the wind farm access track at NGR NO 85592 81056 . It was turf-covered, sub-circular in plan and measured 5.6m long (NW-SE), 3.6m wide (NE-SW) and 0.4m high.

The stratigraphy consisted of a 0.08m thick layer of turf (**101**) and below this was the main cairn structure which consisted of angular and sub-angular stones (**102**). The stones were set within brown-grey silty gravel (**103**). Below this was 0.2m of peat (**104**) and natural orange/yellow clay-sand was recorded below the peat. A lens of brown-orange sandy gravel (**105**), measuring 0.6m across and 0.02m deep, was recorded between **103** and **104**; this may be re-deposited natural or degraded stone. No artefacts were found during the investigation of the cairn.

Although the cairn lay within Cultural Heritage Site 6, the Hill of Allochie Cairnfield (NMRS no. NO89SE 27), due to the cairn's being located upon peat it is thought to be a clearance cairn of modern date. This was likely to have been deposited during the construction of a haul road for a previous pipeline installation. The possible trackway (**109**) was also probably of post-medieval or recent date and likely relates to a trackway leading to a small farmstead.
