Stage 1 Interim Report Keir Wood Fort Kincardine, Fife

Archaeological Evaluation

Report No. 2159

Author	Magnus Kirby MA FSA Scot AIfA
Illustrator	Leeanne Whitelaw BSc MifA
Editor	Melanie Johnson MA PhD FSA Scot MifA
Commissioned by	Forestry Commission Scotland
Date issued	December 2012
Version	0
OASIS Reference	cfaarcha1-139888
Planning Application No	N/A
Grid Ref	NS 9464 8822

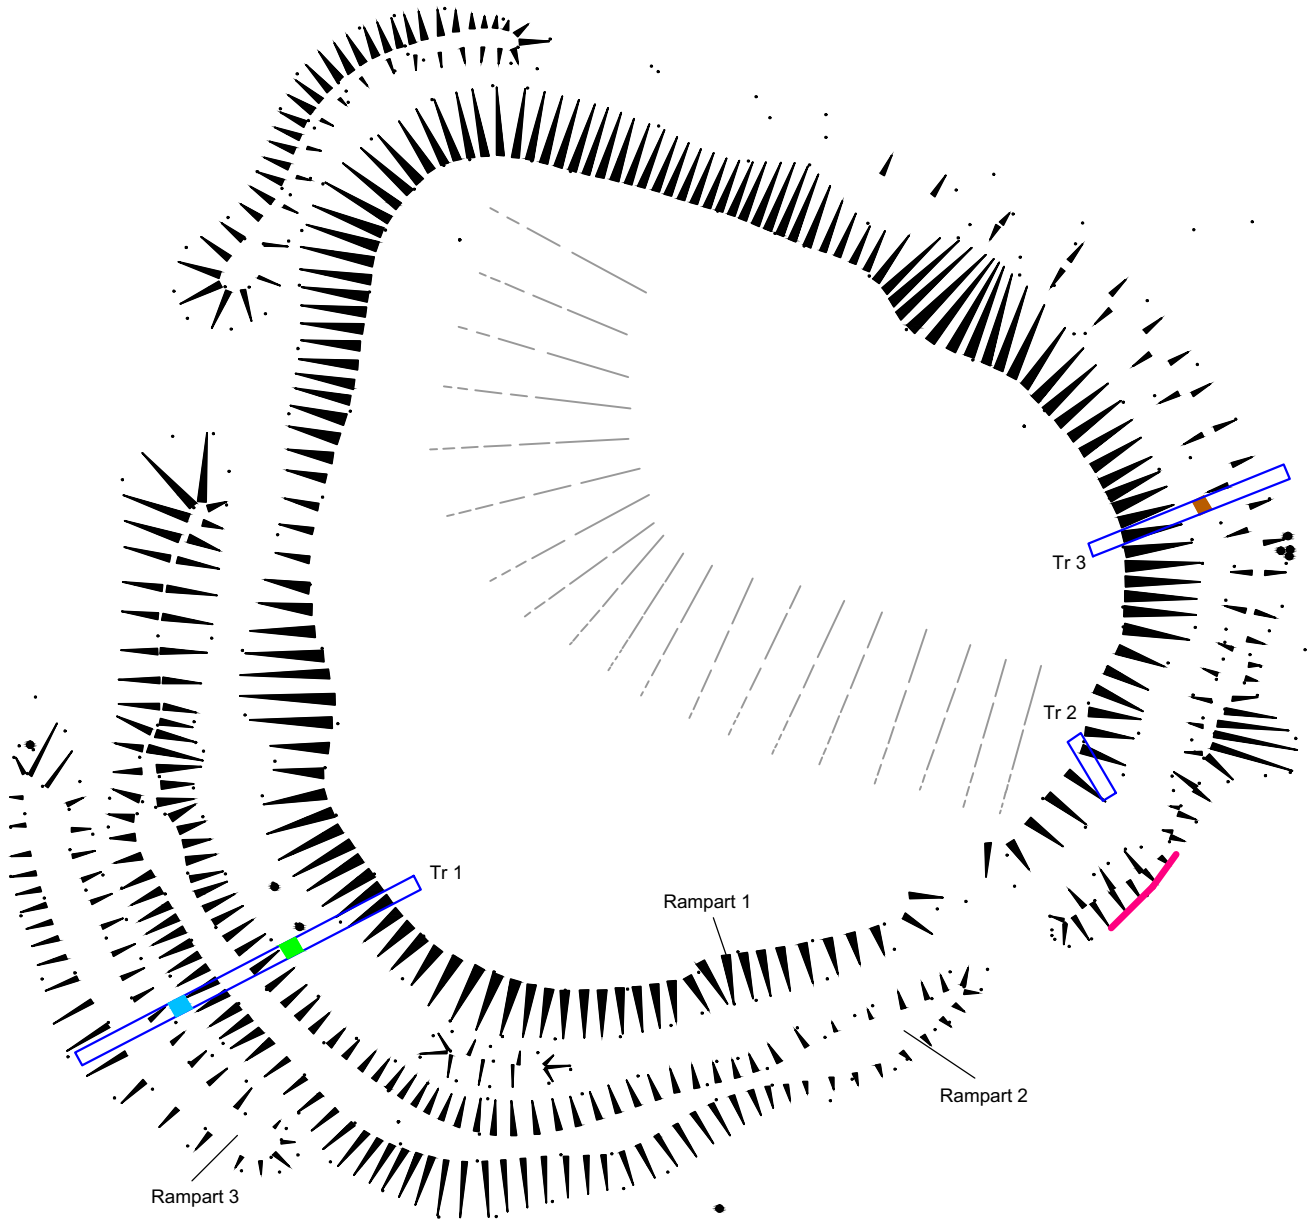
Fig No: 2	Revision: 0	Client: Forestry Commission Scotland
Title: Survey and excavation plan. (Hachure plan courtesy of Dr Ben Edwards - 2011)		
Project: Keir Wood Fort

In accordance with the terms of the PD, three trenches (Trench 1 – Trench 3) (Fig. 2) were hand excavated. These trenches were intended to explore both the effects of the wind-blow and to answer questions about the nature, function and date of the fort. The locations and intents of the individual trenches are described below.

Trench 2 measured 5.75m by 1m and was located to target a possible entranceway as defined by a break in the outer rampart (Fig. 2). The location of the entranceway as identified by CFA in the field lay slightly to the north-east of that depicted on the topographic survey, suggesting a degree of inaccuracy within the original survey (the surveyed position of the break in the rampart as identified by CFA is shown on Fig. 2).

The survey of the trench locations carried out by CFA as part of this programme of works identified an anomaly in the location of the possible entranceway, placing it c.10m to the north-east of the location indicated on the original topographic survey (Shaw and Edwards 2011). This anomaly is likely to relate to the usage of GPS technology within heavily wooded areas and potentially points towards problems with the original survey, which was undertaken prior to the storm damage when tree cover was denser. Consequently CFA recommend that the fort be re-surveyed following the removal of the trees when considerably more accurate results can be expected.

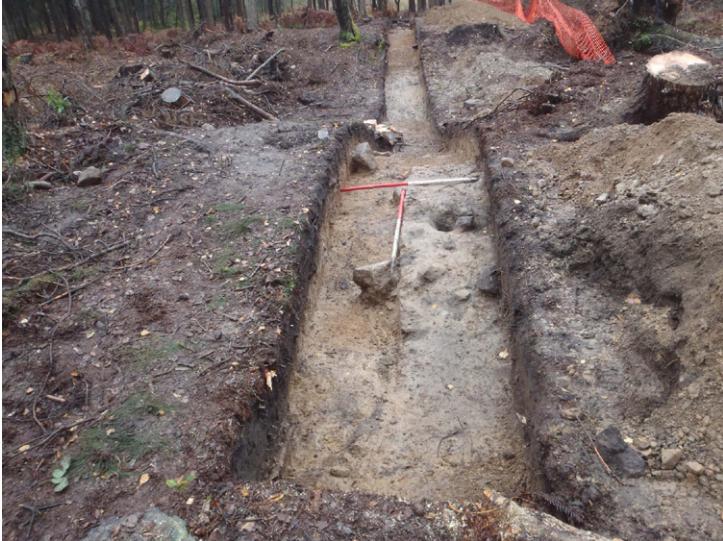
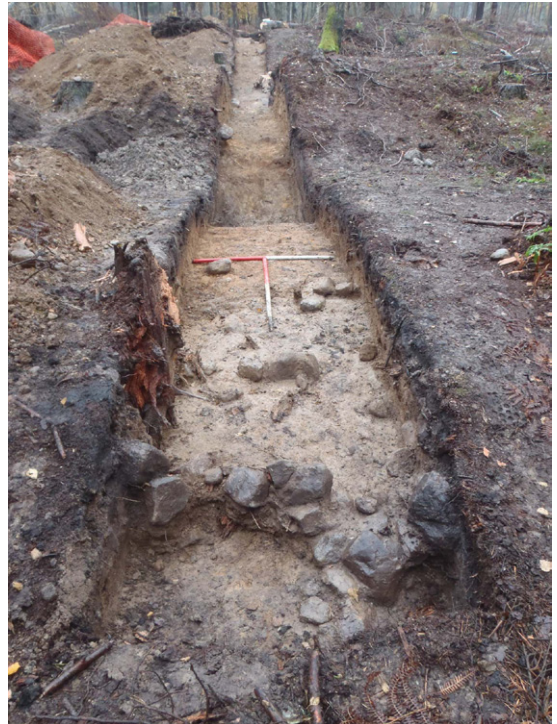
Trench 1 measured 25.4m by 1m (Fig. 6 and 7). Within this location, the fort defences from the interior to the exterior consisted of an inner rampart (Rampart 1), an inner ditch (Ditch 1), an intermediate rampart (Rampart 2), an outer ditch (Ditch 2), and an outer rampart (Rampart 3) (Fig. 3). Rampart 1 appears to have run around the full circumference of the fort, whereas Rampart 2 had a number of breaks and appears to have been absent from the northern side of the fort, and Rampart 3 appears to have been only present on the south-western side of the fort extending for a distance of c.35m. The ramparts had been constructed from re-deposited natural. Details of these principal defensive features are contained below.

Fig. 6 - Trench 1, general shot from NE

Fig. 7 - Trench 1, general shot from SW

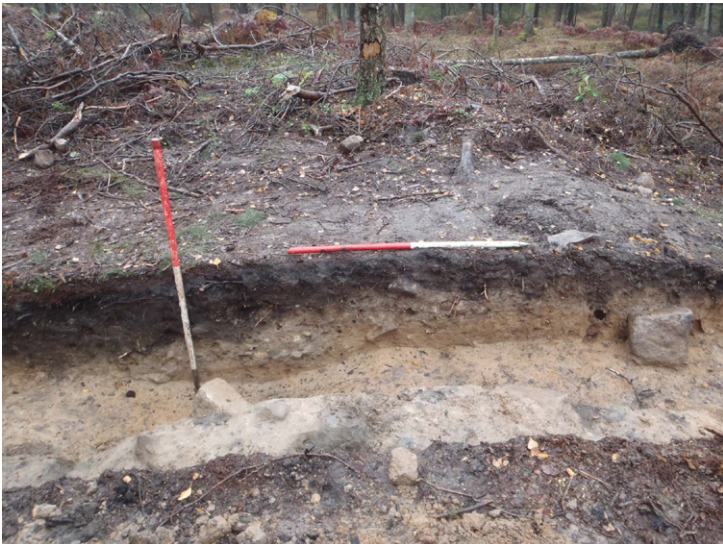
Fig. 8 - Trench 1, Rampart 1 (003/004), from NW

Rampart 1 (**003/004**) (Fig. 8) was situated on the outer edge of the interior of the fort. It measured 4.25m wide and was upstanding to a height of 0.3m above the level of the natural substrate (**002**). The rampart had been constructed from orange-brown clayey sand (**004**) and light grey-brown sandy clay (**003**). This rampart material was abutted by subsoil (**005**) and overlain by topsoil (**001**).

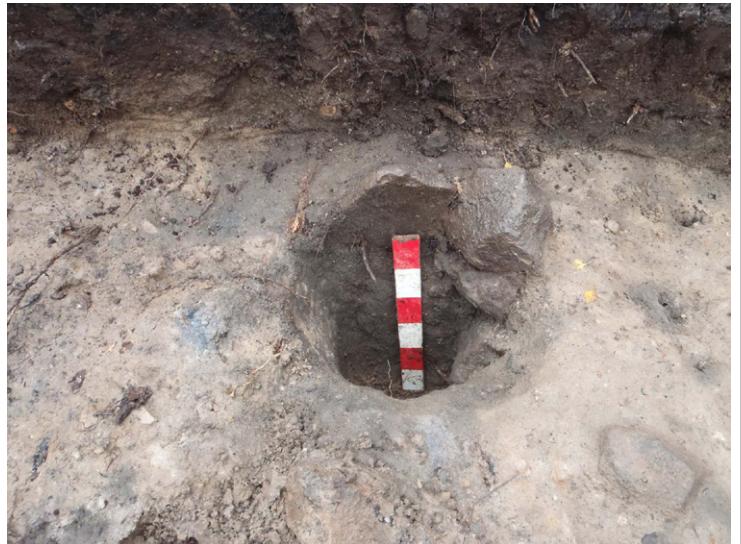
Fig. 9 - Trench 1, post-hole 022

A post-hole (**022**) (Fig. 9) had been cut into the surface of the rampart. It measured c.0.3m in diameter by 0.3m deep, and contained a number of packing stones. The entire fill (**023**) of the post-hole was retained for analysis.

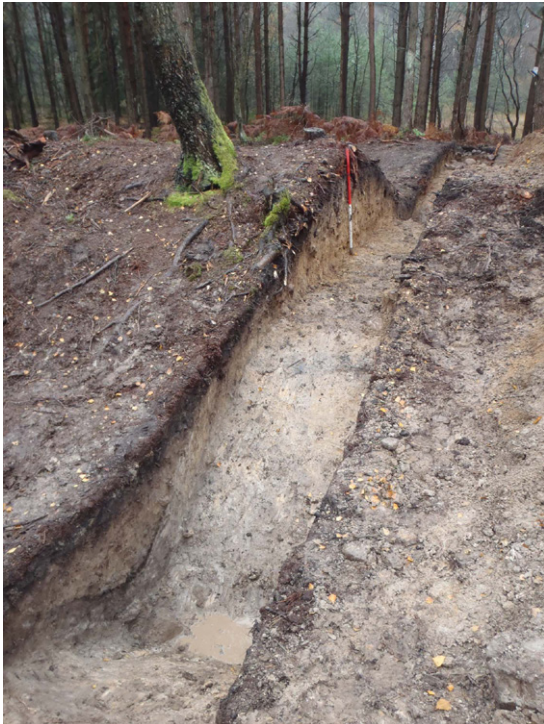
Fig. 10 - Trench 1, oblique shot showing Ditch 1 (006) and Rampart 2 (011/012/021)

Ditch 1 (**006**) (Fig. 10) was situated at the base of the slope dropping down from rampart **003/004**. It measured 3m wide by 0.8m deep, giving a 2.2m height difference between the top of the rampart and the base of the ditch.

The fill of this ditch from the base upwards consisted of light grey-brown sandy clay (**007**) overlain by dark grey-brown sandy clay (**008**) and mottled slightly orangey-brown silty clay (**009**). A bulk sample of deposit **007** was retained for analysis.

Rampart 2 (**011/012/021**) (Fig. 10) sloped upwards from ditch **006**. It measured 4.25m wide and was upstanding to a height of 0.95m above the level of the natural substrate (**002**). This meant that there was a total height difference of 1.9m between the top of the rampart and the base of ditch **006**.

The material forming the rampart consisted of slightly clayey sand (**021**) which was vivid orange in colour. This was overlain by further orange clayey sand (**011**), which was slightly less vivid in colour than **021** and was divided from it by a thin lens of grey sandy material. Deposit **011** was overlain by mottled light grey-brown sandy clay (**012**). The horizon between these two deposits was considerably merged and **012** had been heavily disturbed by bioturbation caused by root action.

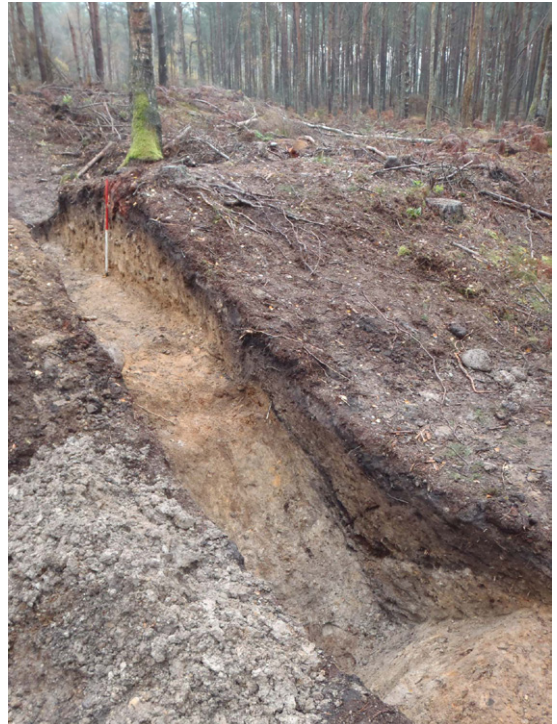
Fig. 11 - Trench 1, oblique shot showing Ditch 2 (014) and Rampart 2 (011/012/021)

Ditch 2 (**014**) (Fig. 11) was situated immediately down from the intermediate rampart (**011/012/021**). It measured 3.5m wide by 1m deep, giving a height difference of 2.15m between the base of the ditch and the top of the rampart.

The fill of this ditch from the base upwards consisted of light grey clay (**018**), mottled grey/orangey-brown sandy clay (**017**), a thin band of black silty clay (**016**), and mottled orangey-brown clayey sand (**015**). Deposits **015**, **016** and **017** had been affected by an area of bioturbation caused by root action, which had resulted in a pocket of dark-brown sandy silt (**013**) forming between the edge of the bank material (**011** and **21**) and the edge of the ditch. A bulk sample of deposit **018** was retained for analysis.

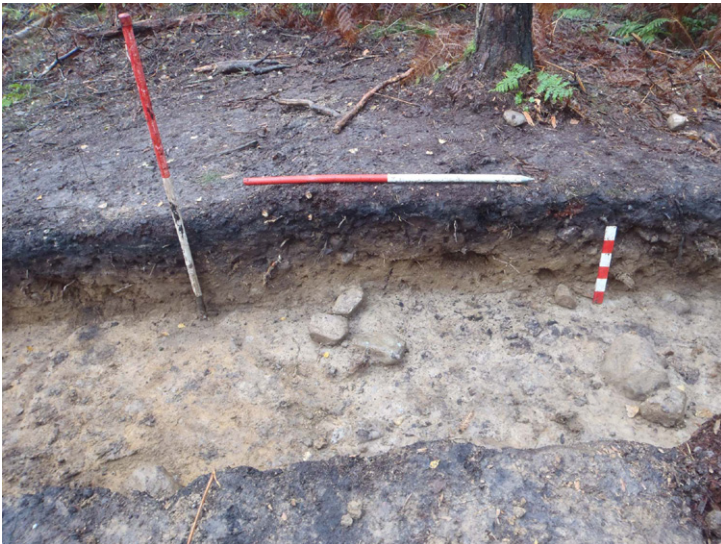
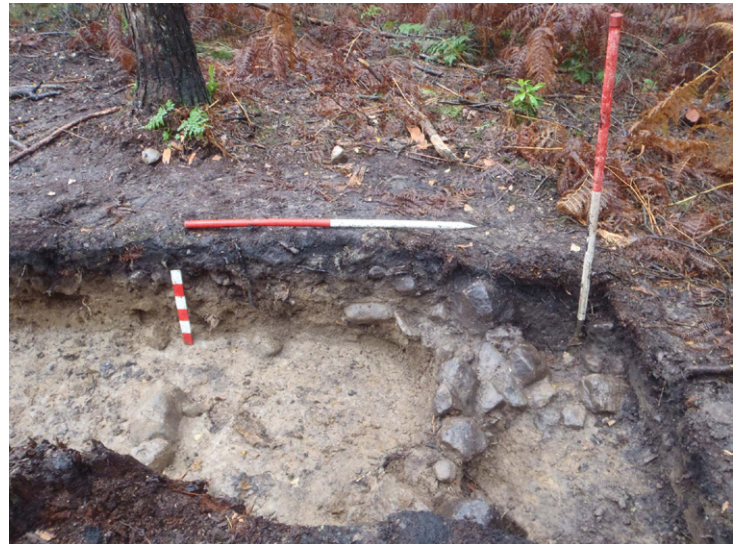
Rampart 3 (**019**) (Fig. 12) sloped upwards from the edge of ditch **014**. It measured 4.2m wide and was upstanding to a height of 0.35m above the level of the natural substrate (**002**). The rampart had been constructed from orange-brown clayey sand (**019**), which was more vividly orange and less compact than the underlying natural. Along the outside edge, the rampart had been faced with undressed stones and boulders (**020**) (Fig. 13). These stones appeared to have been piled up roughly against the edge and did not show any evidence of formal construction.

Fig. 12 - Trench 1, Rampart 3 (019) from NW

Fig. 13 - Trench 1, Rampart 3 (019) showing edging of stones 020

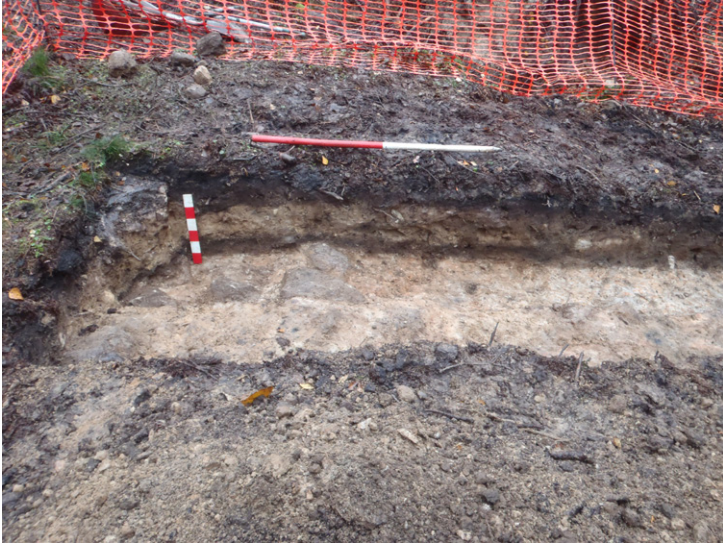
Fig. 14 - Trench 2, Rampart 1 (026/027) from SW

Rampart 1 (**026/027**) (Fig. 14) was partially uncovered within this trench. It measured >2.5m wide and was upstanding to a height of 0.2m. Rampart material **026** consisted of pale yellowish-orange sandy-silt, and **027** consisted of mottled yellow-brown sandy-silt. Deposit **027** partially overlay deposit **030** which had built up against the face of the escarpment, but this would suggest a degree of erosion within **027** rather than indicating that **030** pre-dated **027**.

The rampart overlay buried soil **028** (dark reddish-brown sandy silt), which in turn sealed a lens of mottled orange-grey sandy-clay re-deposited natural (**029**). Deposit **029** is thought to represent an isolated lens of banking material which was engulfed by the former topsoil (**028**) during the construction process.

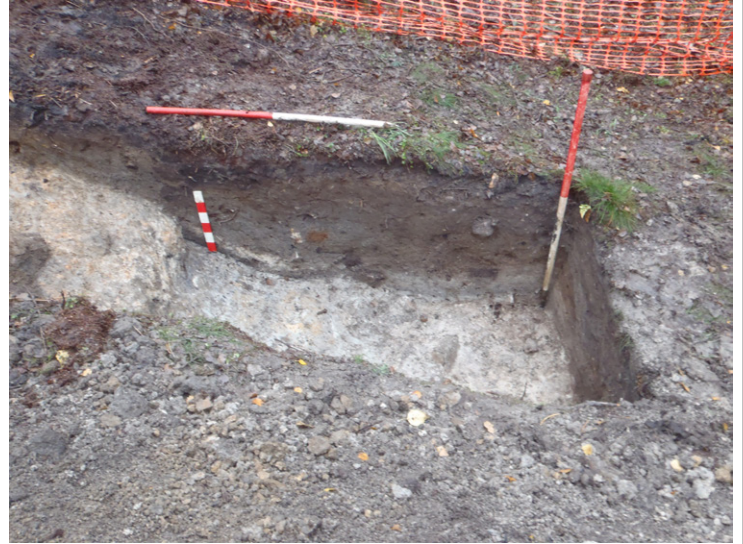
Fig. 15 - Trench 2, escarpment 038 from SW

Escarpment **038** (Fig. 15) appears to have been artificially created by cutting into an existing natural slope in order to create the steeper gradient required for defensive purposes. This gave a height difference of 1.75m between the top of the surviving rampart (**026/027**) and the base of the escarpment.

A number of thin lenses of material (**032**, **033**, **035** and **036**) had built up at the base and up the side of the escarpment. These were overlain by a number of more substantial deposits (**030**, **031**, **034** and **037**). Charcoal was present throughout most of the material that had accumulated within the escarpment cut. Samples of charcoal-rich deposits **030** and **035** were retained for analysis.

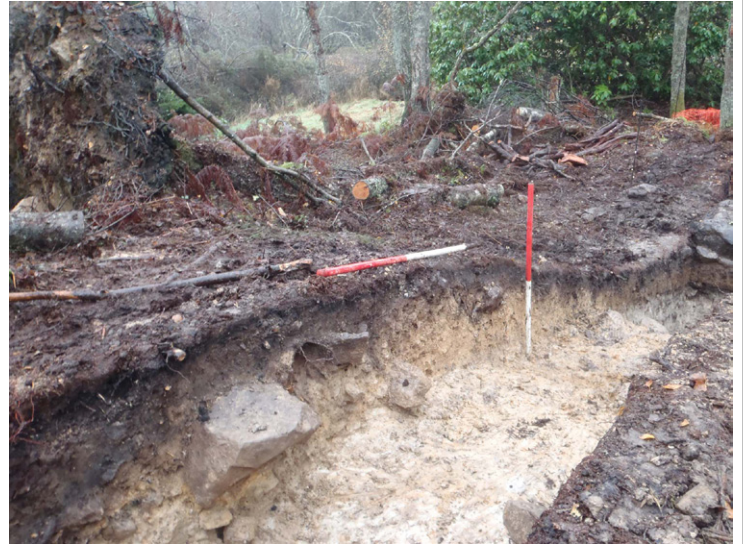
Fig. 17 - Trench 3, Rampart 1 from SW

Rampart1 (**041**) (Fig. 17) measured 5.5m wide and was upstanding to a height of 0.5m above the level of the natural substrate (**002**). However, some of the recorded width may represent material that had slumped down the escarpment, with the bulk of the rampart material measuring nearer to 4.5m in width. The rampart material consisted of orange-brown sandy clay (**041**), which was overlain by subsoil **040** and topsoil **039**.

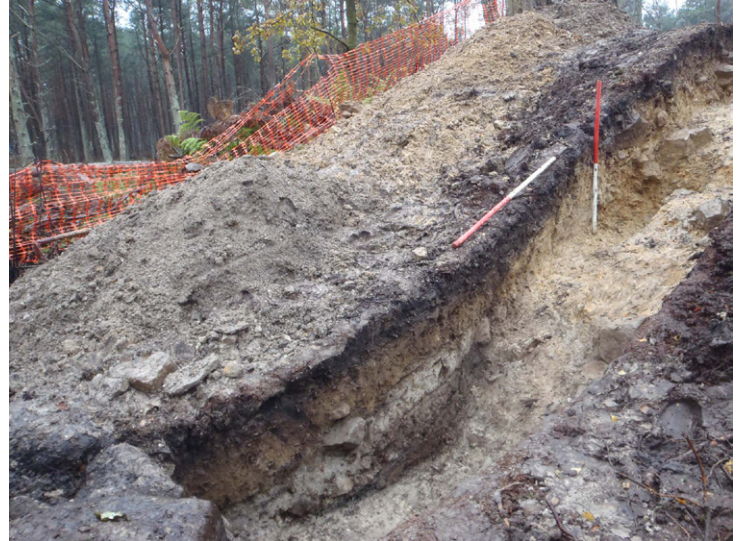
Fig. 19 - Trench 3, escarpment 047

Escarpment **047** (Fig. 19) appears to have been artificially created by cutting into an existing natural slope in order to create the steeper gradient required for defensive purposes. This gave a height difference of 2.7m between the top of the surviving rampart (**041**) and the base of the escarpment.

A number of thin lenses of material (**043, 044, 045, 046, 051** and **053**) had built up at the base and up the side of the escarpment. Samples of charcoal-rich deposits **046** and **053** were retained for analysis. These were overlain by a more substantial deposit (**050**) of yellow-brown sandy silt. This deposit merged into subsoil **040** suggesting that it post-dated the rampart. A single sherd of medieval pottery and a fragment of possible fired clay were recovered from deposit **050**, but the aforementioned stratigraphic relationship suggests that the finds post-date the usage of the fort. Further details of these finds are contained in Section 3.5 below.

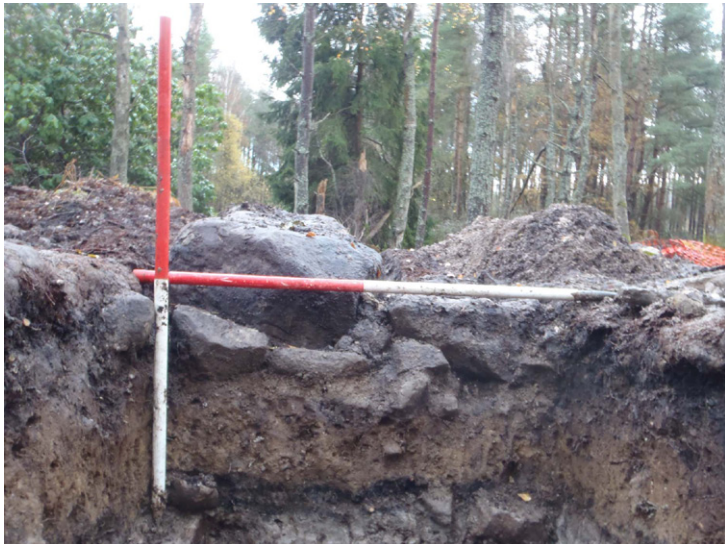
Fig. 20 - Trench 3, wall 042

A substantial stone wall (**042**) (Fig. 20) was identified sitting on top of the fills at the base of the escarpment. The wall measured 1.25m in width and stood a single course high (c.0.45m max). Sitting on top of deposit **050** and abutted by topsoil **039**, this feature almost certainly post-dates the original use of the fort.

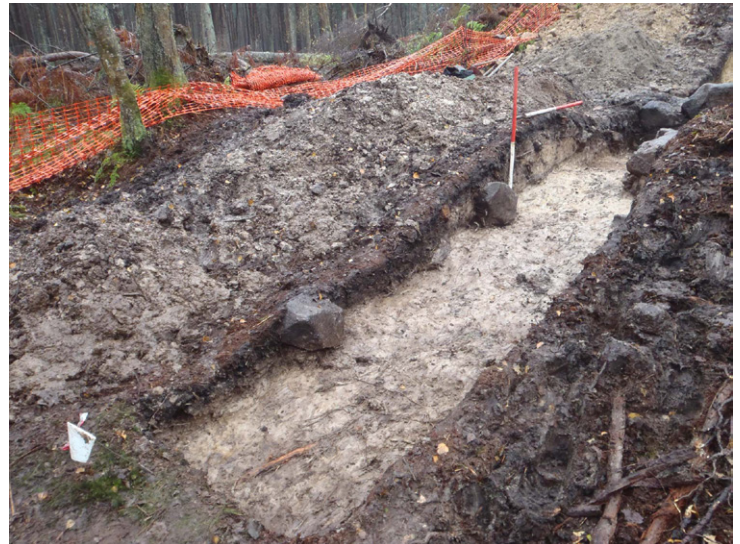
Fig. 21 - Trench 3, Rampart 2 (049), oblique shot

Rampart 2 (**049**) (Fig. 21) measured c.4.5m in width and was upstanding to a height of 0.25m. This gave a height difference of only 0.5m between the base of the escarpment and the top of the surviving rampart. The material forming the rampart (**049**) consisted of mottled orangey-white silty clay and is probably re-deposited natural. Overlying subsoil deposit **048** may also have contained a degree of banking material, but this had become considerably merged into the subsoil which extended well beyond the edges of the rampart and consequently could not be accurately deciphered.

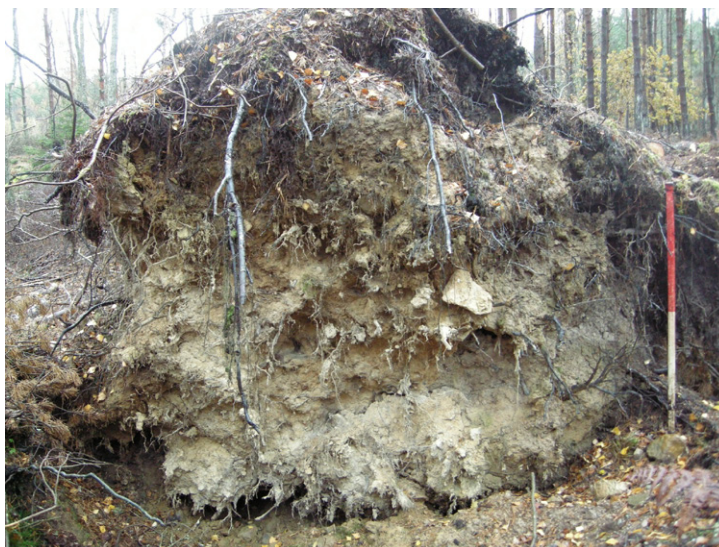
In the case of Keir Wood Fort there has been a negative impact on the ramparts which has not led to the total loss of the earthwork profiles. Fig. 22 shows a windblown mature birch tree (*Betula pendula*) which has lifted up a great deal of soil with medium to smaller sized boulders within its root plate. Fig. 23 shows the same impact caused by a fairly young pine tree (*Pinus sylvestris*). Both are relatively shallow rooting species but nonetheless the impact is the same.

Fig. 22 - Windblown Birch

Fig. 23 - Windblown Pine

The fort has been compromised by poorly executed thinning operations which have resulted in a number of windblown trees. This damage is particularly apparent on the well preserved ramparts on the south-western side. Damage has also been inflicted by the timber extraction machinery utilised during thinning operations. A clearance operation is planned to fell and remove all remaining trees and wind-blow from the site and within a 5-10m buffer zone surrounding it. As part of this operation, all brash and discarded timber shall be removed from the site.
