St Nicholas House, St Andrews, Fife

Archaeological Watching Brief

Report No. 2036

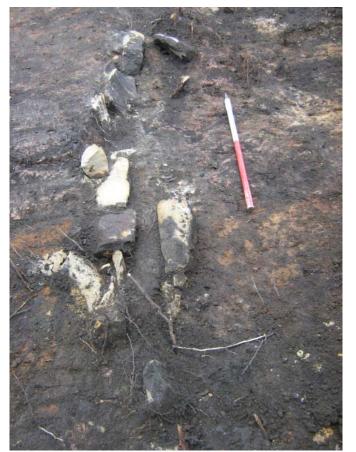
Fig 2. Drain 007

The remains of a NE-SW aligned drain (007) were uncovered. It was cut into the natural subsoil (002) and constructed using light yellow quarried sandstone slabs (003). It had filled up with a lower fill of compact yellow grey mottled clay (005). Overlying this was reddish-brown mixed silty (004) fill and this was itself overlain by grey-brown silt (006) a deposit which also filled areas where stones had been removed by later disturbance.

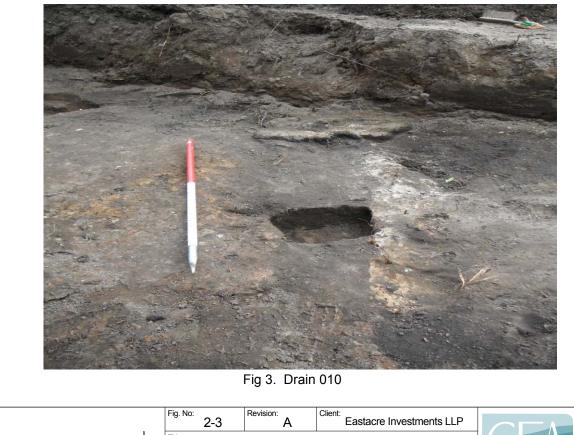
Drain (010) was aligned initially NW-SE but turned towards the South as it crossed the area. The drain cut into the natural subsoil (002) and was filled with brown sandy silt (011). A small part of the drains original sandstone capping (012) survived.
