## **Wind Turbines, Cousland Park Farm, Cousland, Midlothian**

### **Archaeological Monitored Strip**

**Report No. 2154**

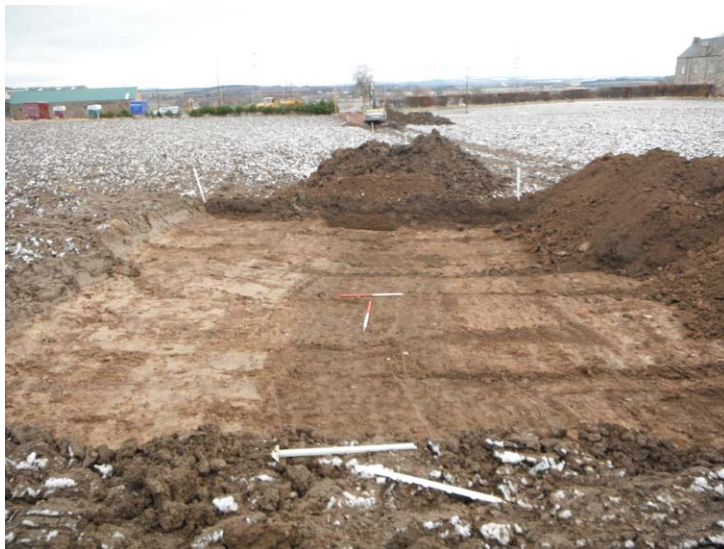
Fig. 2 - Turbine Base 1, looking E

Turbine 1 was the easternmost of the two, and the area excavated measured 10m by 10m. The topsoil (**000**) was 0.3m thick and overlay 0.2m of subsoil (**004**); the natural geology comprised of sticky orange clay with fine gravels.

A linear ditch (**001**; Figs. 4 & 5), 2m wide and 0.6m deep, was aligned east-west. The ditch contained a fill (**002**) of sticky brown-grey clayey silt with frequent charcoal and small stone inclusions.

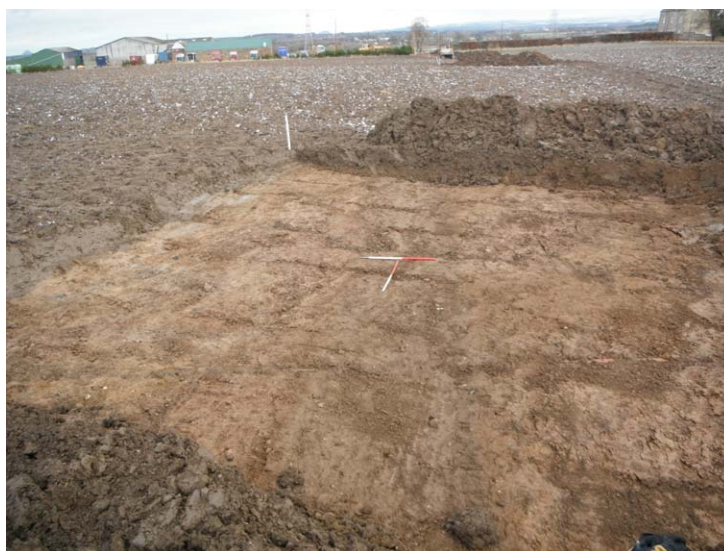
Fig. 3 - Turbine Base 2, looking E

Turbine 2 was situated to the west of Turbine 1. The excavated area measured 10m by 9m. The topsoil (**000**) was 0.3m thick and overlay 0.2m of subsoil (**005**), below which was the natural geology.

A linear ditch (**003**; Fig. 5), 2m wide, was aligned east-west and contained a fill (**004**) of sticky brown-grey clayey silt with frequent charcoal and small stone inclusions. A ceramic field drain pipe was discovered within the ditch. Whilst the pipe is at the centre of the ditch, it is somewhat above the base of the ditch and thus may be a later insertion into the backfill, of the ditch. Given that the linear ditch (**003**) is probably the same as the linear ditch (**001**) at Turbine 1 and that no pipe was found within the ditch fill at Turbine 1, it seems most probable that the pipe within the ditch at Turbine 2 is not contemporary with the original ditch cut, but rather represents a fortuitous or deliberate insertion at a location that may have been visible as a linear hollow on the ground surface or as less firmly packed ground.

A further field drain, aligned north-south, was present at a shallower depth at the western end of the trench.
