**Land at Whalley Road, Sabden,
Lancashire**

Archaeological Strip and Map

Report No. Y091/13

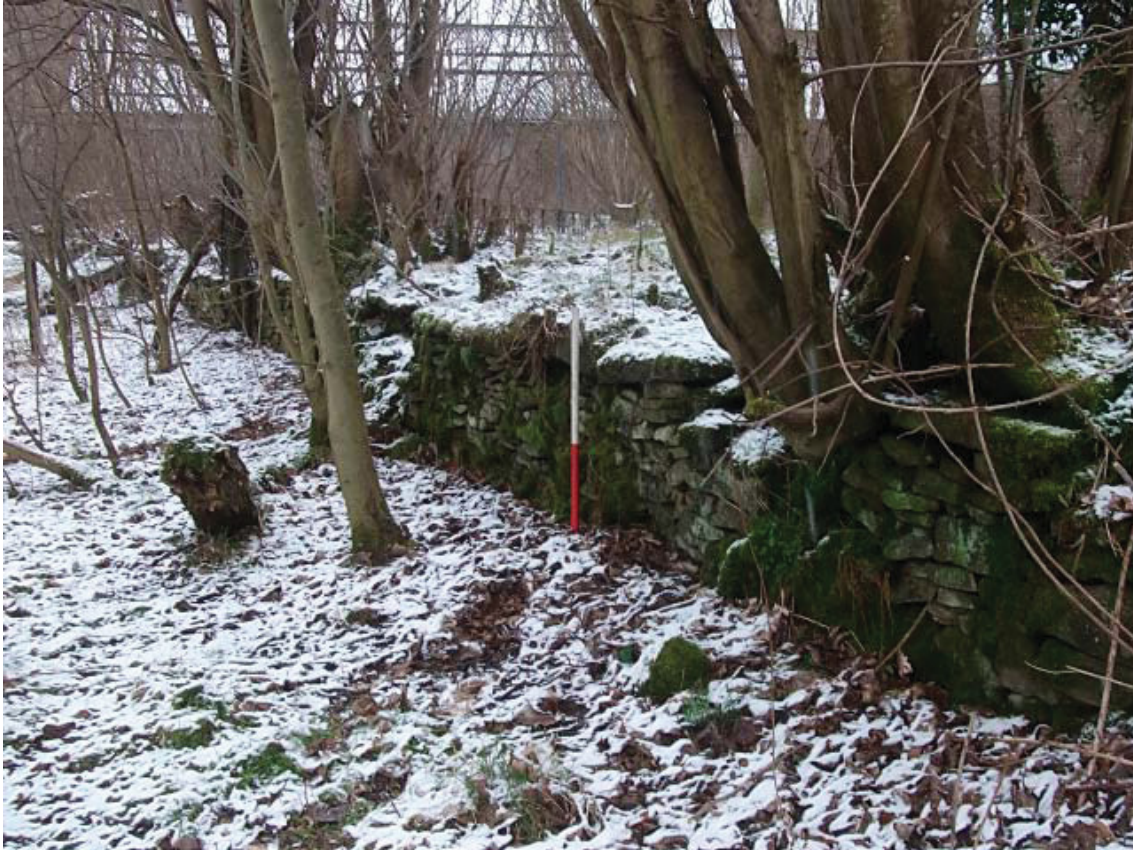
The site comprised a steep bank at 143m above the Ordnance Datum (AOD) to the north that sloped sharply to a level area adjacent the Sabden Brook at 140m AOD. The development site was located across part of a former reservoir or mill pond. The reservoir is depicted on historical maps of the area and survives in good condition to the east of the site as an overgrown earthen bank revetted by a north-west facing sandstone wall (Plate 1).

Plate 1 - Upstanding north-west-facing interior reservoir wall at east of development

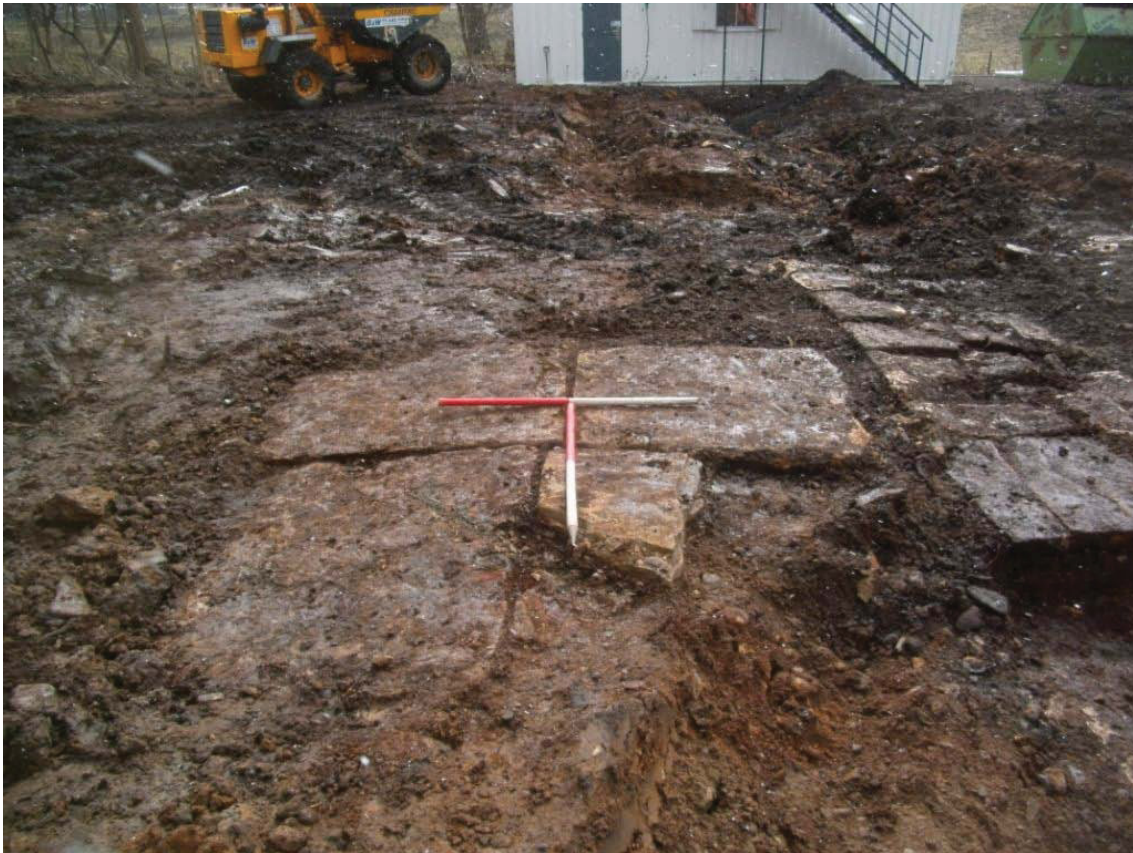
A relict stone surface consisting of four square flagstones (006) was recorded to the east of Wall 007 (Plate 2). Three of the flagstones were fully intact. The surface was set within the re-deposited clay (005) of the former earth banking.

Plate 2 - South-west-facing shot of flagstone platform 006

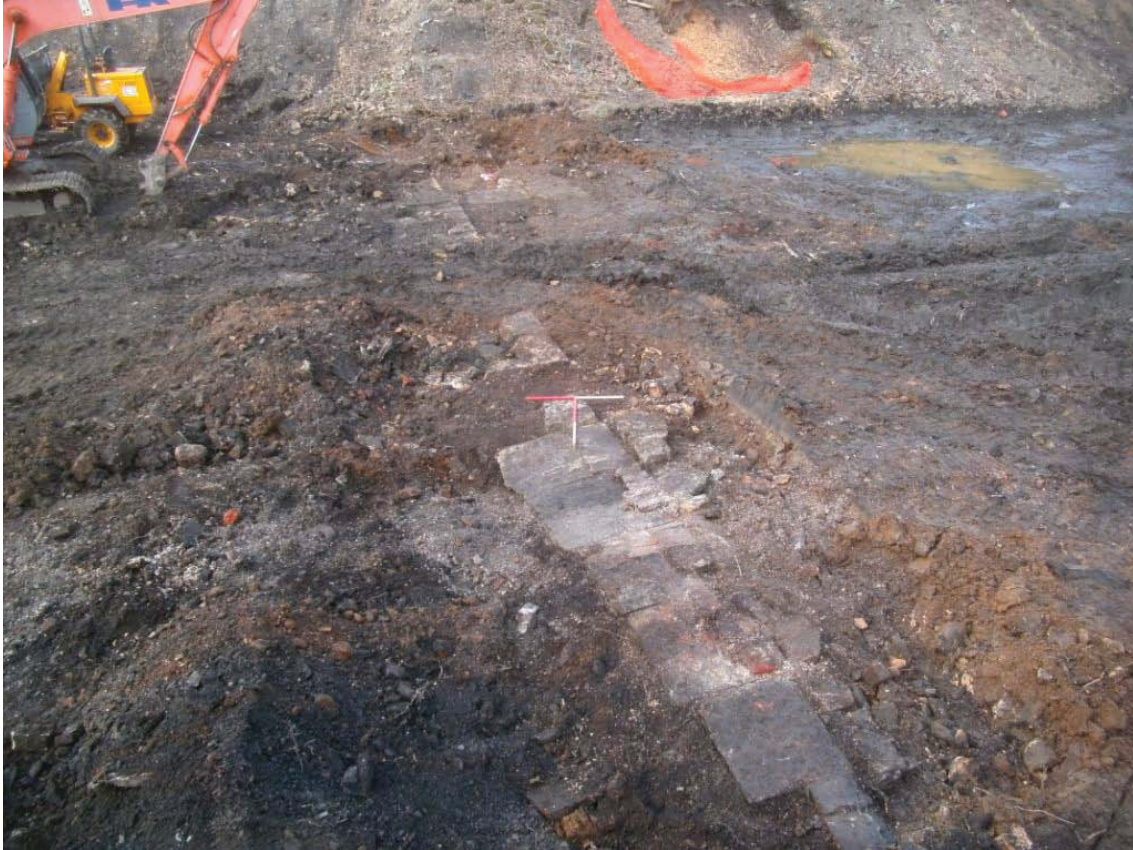
On the south-west corner of the reservoir a narrow paved area (010) and a sandstone wall (013) were revealed on the same orientation as the retaining wall (007/008, Plate 3). The paved area (012) consisted of a number of flagstones 0.1m thick that abutted the heavily truncated sandstone wall (013). The sandstone wall was south-west-facing, 4.4m long and consisted of at least one course of regular sandstone blocks between 0.2 and 0.4m (length/width). Three raised sandstone blocks had been set within the paved area (012) and may represent the truncated remains of a threshold or buttress that abutted Wall 013. The remains of a vestigial brick surface comprising whole bricks and a number of half bricks (009) were also identified abutting Wall 013.

Plate 3 - Shot of western exterior wall of reservoir showing paved surface 010

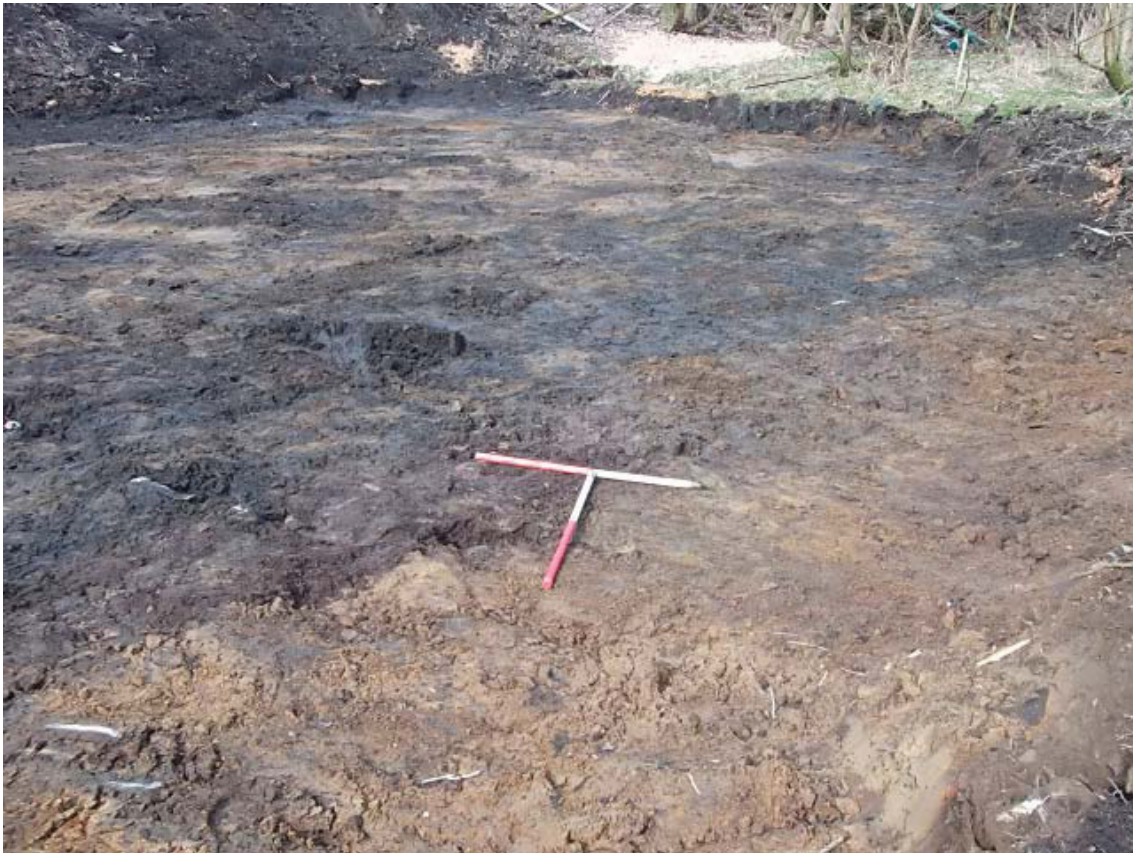
Although a section of the interior north-facing revetment wall survives at the east extent of the site (Fig. 1), there was no evidence of the wall surviving intact within the limit of excavation. The wall had been entirely robbed out and survived only as a 0.8m wide L-shaped scar of friable greyish-purple sandy-silt (Plate 5, 004). Part of a heavily truncated wooden channel (014) was exposed to the east of this deposit (Fig. 1). The wooden channel was constructed of timber planks and filled with a waterlogged deposit of greyish-brown silty-clay (Plate 6, 015). The feature was 0.3m

Plate 4 - North-facing shot of robbed out revetment wall deposit 004

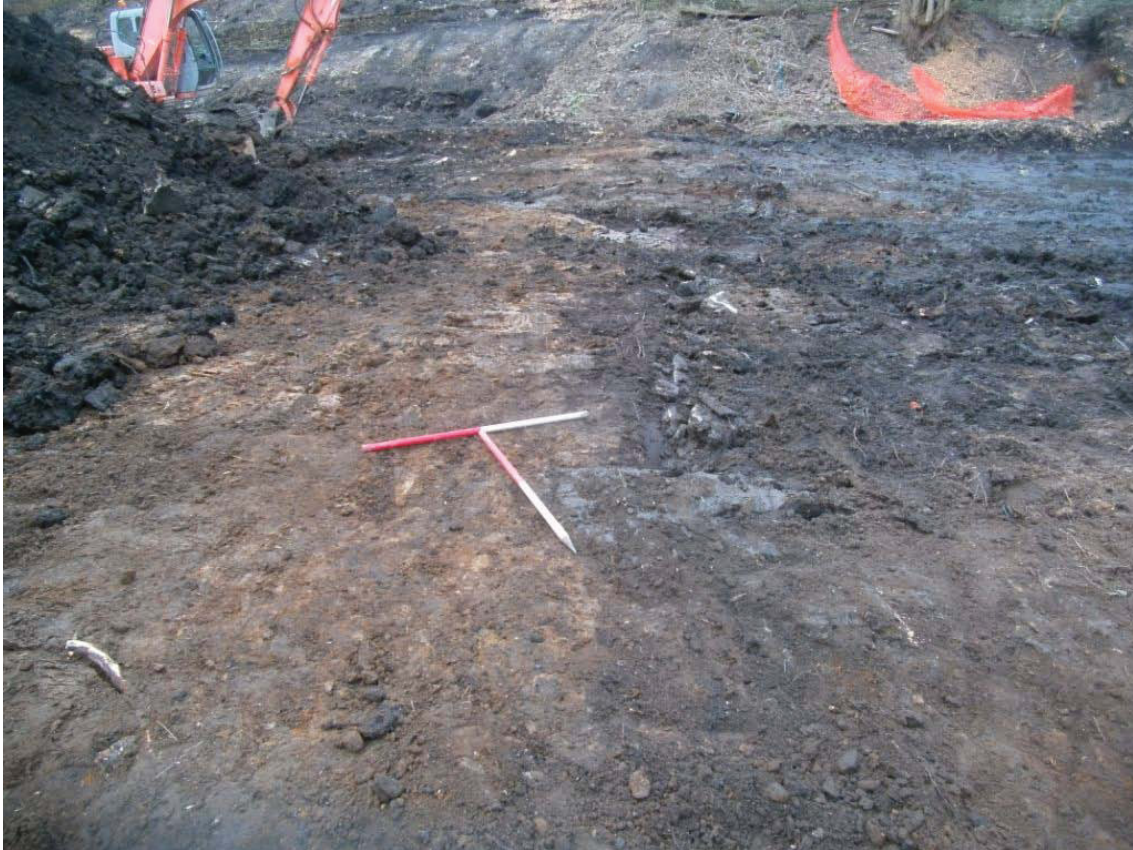
Plate 5 - North-west-facing shot of robbed out revetment wall 004

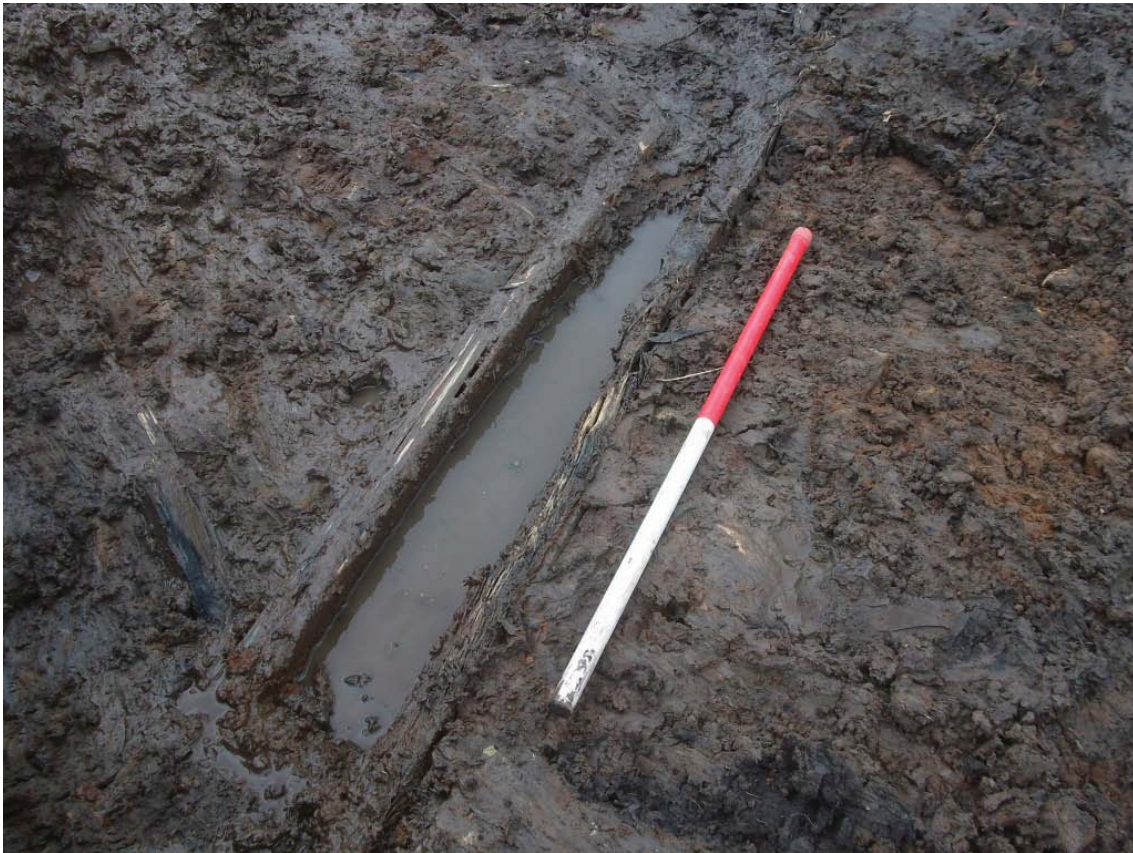
wide and extended for around 7m. The wooden channel may have acted as a possible sluice or spillway.

Plate 6 - North-west-facing shot of wooden drainage channel 014

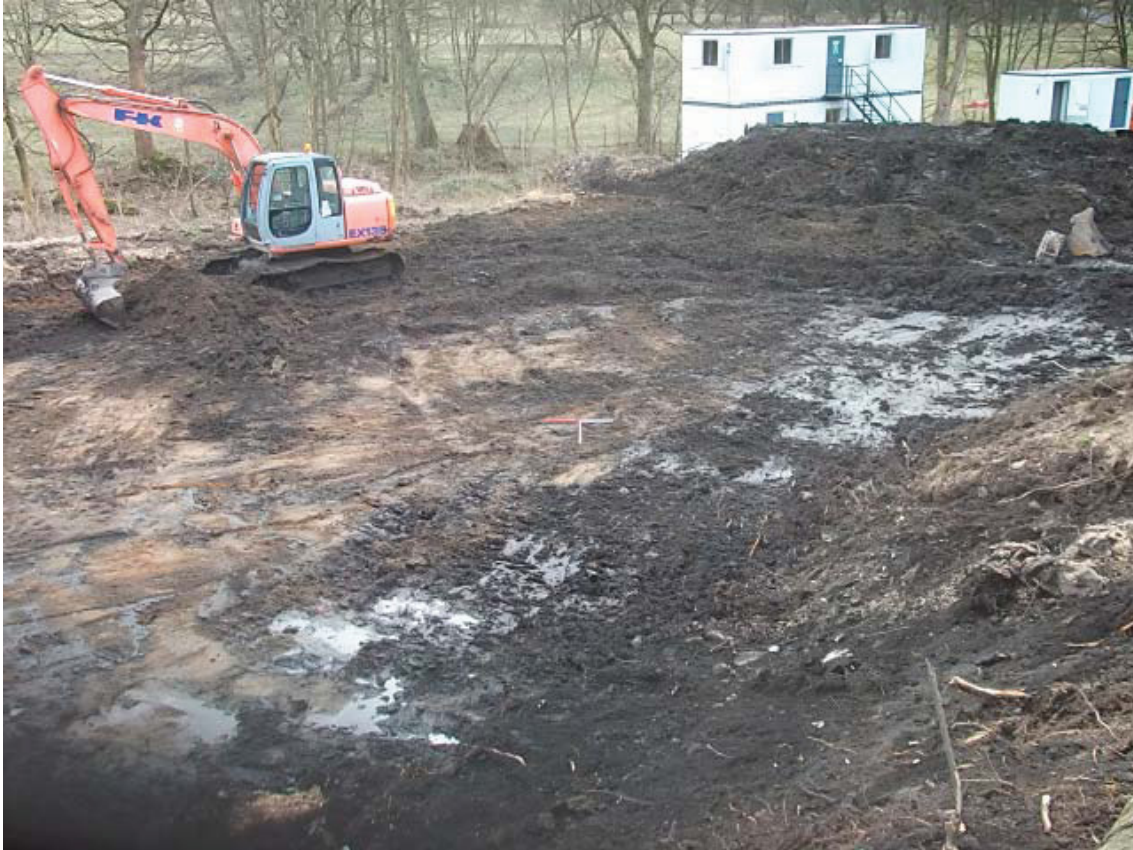
Topsoil removal at the east of the development revealed sediments associated with the reservoir basin. An alluvial deposit of well compacted greyish-orange coarse sand, within bands of pale greyish clay was recorded (002) as well as patches of firm homogenous dark-grey clay (Plate 7, 003). The firm dark-grey clay was probably the puddle-clay membrane that functioned as the lining of the reservoir (Reeves *et al.* 2006, 377). Ground water appeared upon exposing this clay deposit.

Plate 7 - South-east-facing shot of east part of site following topsoil removal

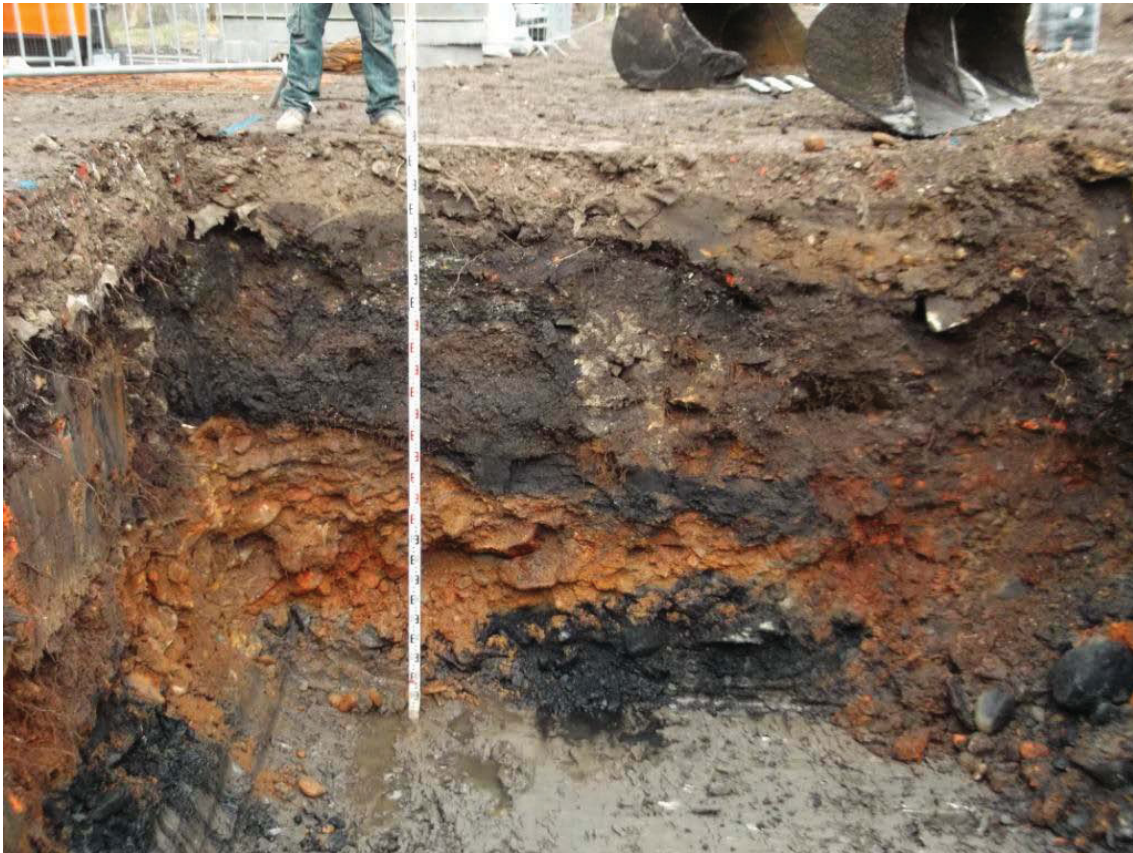
A 4 by 4m square trench was excavated for a drainage slot to the west of site (Centred: SD 77462 37237). The excavation removed topsoil (001) 0.3-0.4m thick which overlay a well-compacted demolition deposit between 1.2 and 2m thick (016) comprising sandstone fragments, brick fragments, shale and sand within a mid-brown clayey-silt matrix. The natural substrate (000) which comprised greyish-orange alluvial sandy-gravel was reached at 136.4m AOD (Plate 8). The extensive overburden in this part of the site probably represents the demolition and subsequent levelling of the reservoir once it had become redundant in the mid 20th century.

Plate 8 - East-facing section of drainage trench
