**Warrington Road, Wigan**

**Archaeological Desk-Based Assessment  
and Watching Brief**

**Report No. Y092/13**

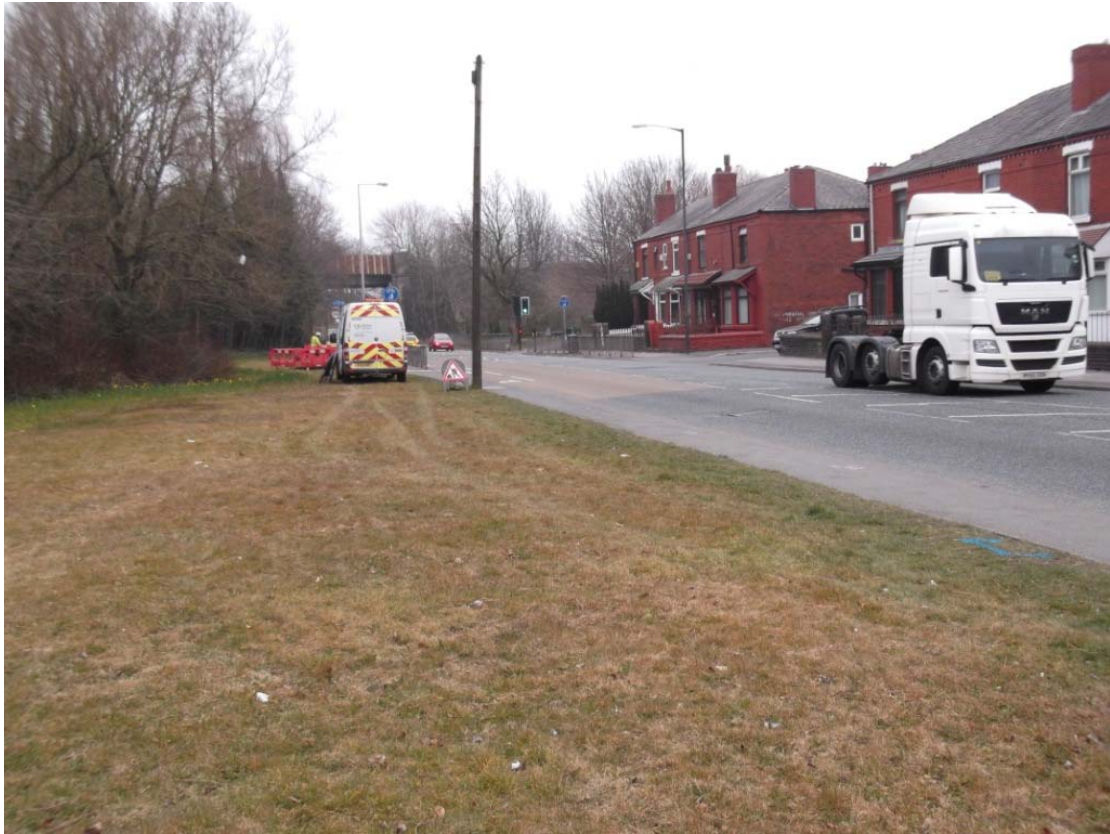
Plate 1: Warrington Road looking north showing location of Test Pits 1-3

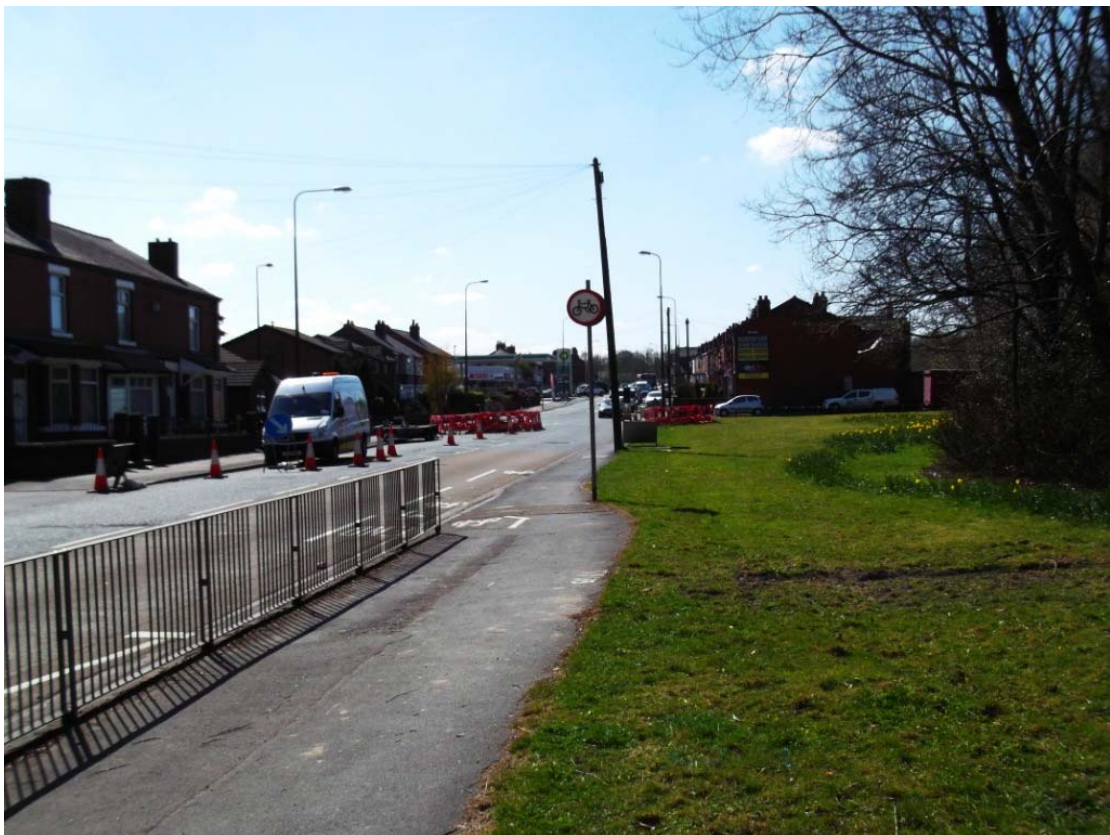
Plate 2: Warrington Road looking south showing location of Test Pit 5

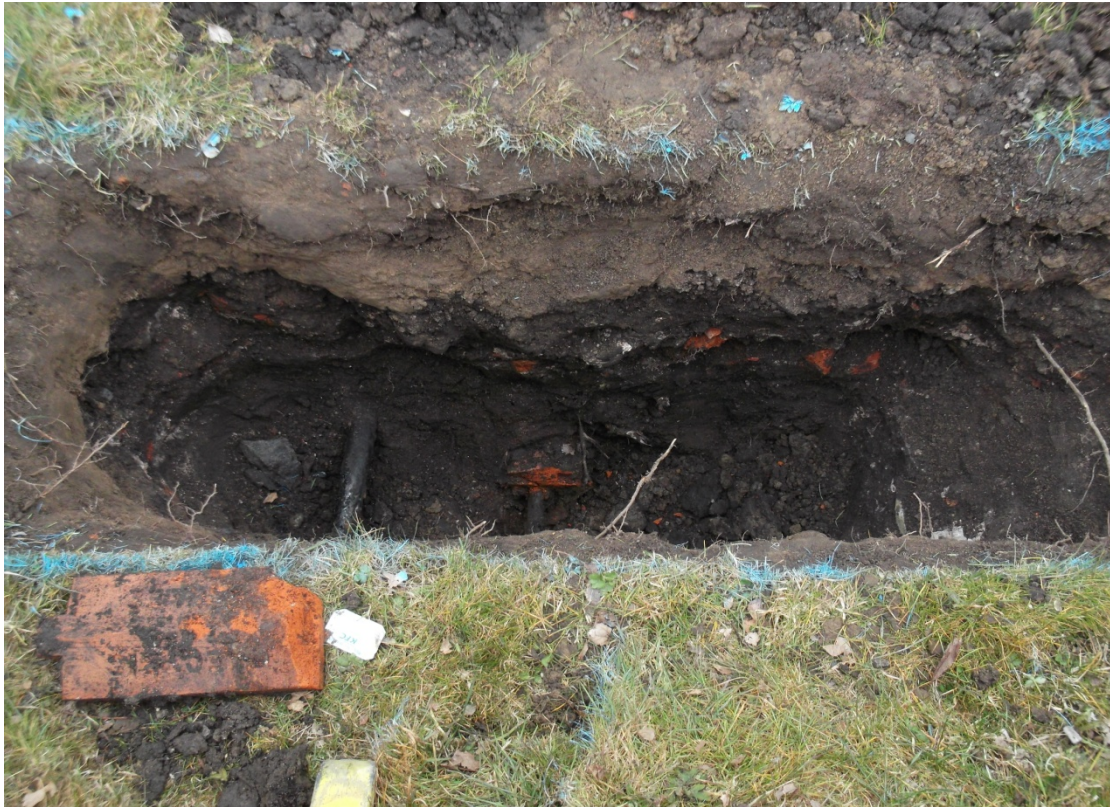
Test pit 1 (Plate 3) was excavated to a maximum depth of 0.9m below the existing ground surface with the earliest layer encountered a grey-black silty clay that contained modern plastic waste (102). Overlying this layer was yellow-grey silty clay (101) which was sealed by dark brown topsoil (100). No archaeological remains were recorded and no finds recovered.

Plate 3: Test Pit 1, east facing section showing demolition layer 102 and exposed services

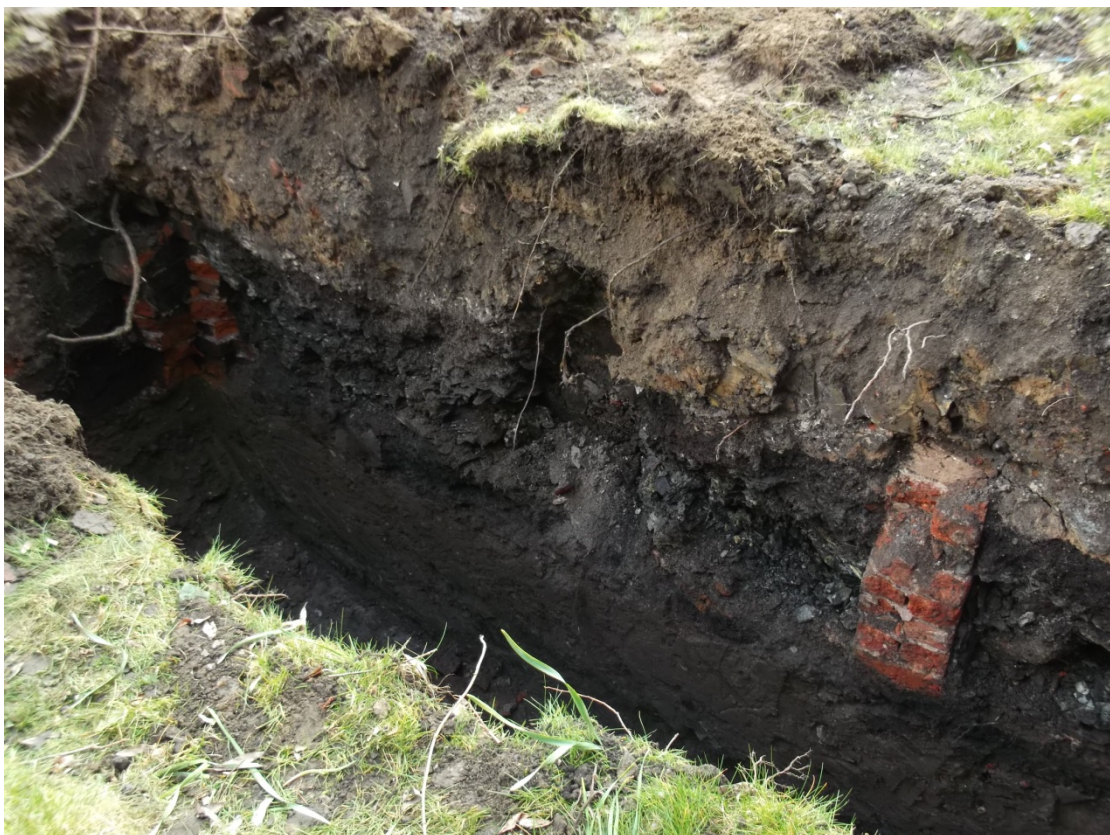
Test Pit 4 was dug to a depth of 2.4m with the earliest layer encountered green-grey silty clay (108) which was sealed by a thin band of black silty clay (107). Towards the western end of the test pit, and at a depth of 0.4m below the existing ground surface, were the remains of a cellar structure with a possible coal chute (118) likely remains from one of the houses pictured on the 1894 OS map (Fig 2b).

The cellar wall itself was on a rough east-west alignment with a north-south return at the eastern end of the test pit, and survived to a height of 9 courses. The cellar was constructed of red unfrogged machine cut brick bonded by a cement mortar, with the bricks measuring 9 x 4.5 x 3 inches in size. The coal chute butted the cellar wall on its southern side and survived to a similar height, and was constructed of the same materials as the cellar itself. The whole cellar structure was filled by brick and concrete rubble within black silt (105) overlain by grey-white silty clay (104). These layers are likely to be materials from the demolition of the houses in this area (Plate 4).

Plate 4: Test Pit 4, oblique shot of north facing section, east end of test pit, showing layers 104, 105 and cellar wall 118

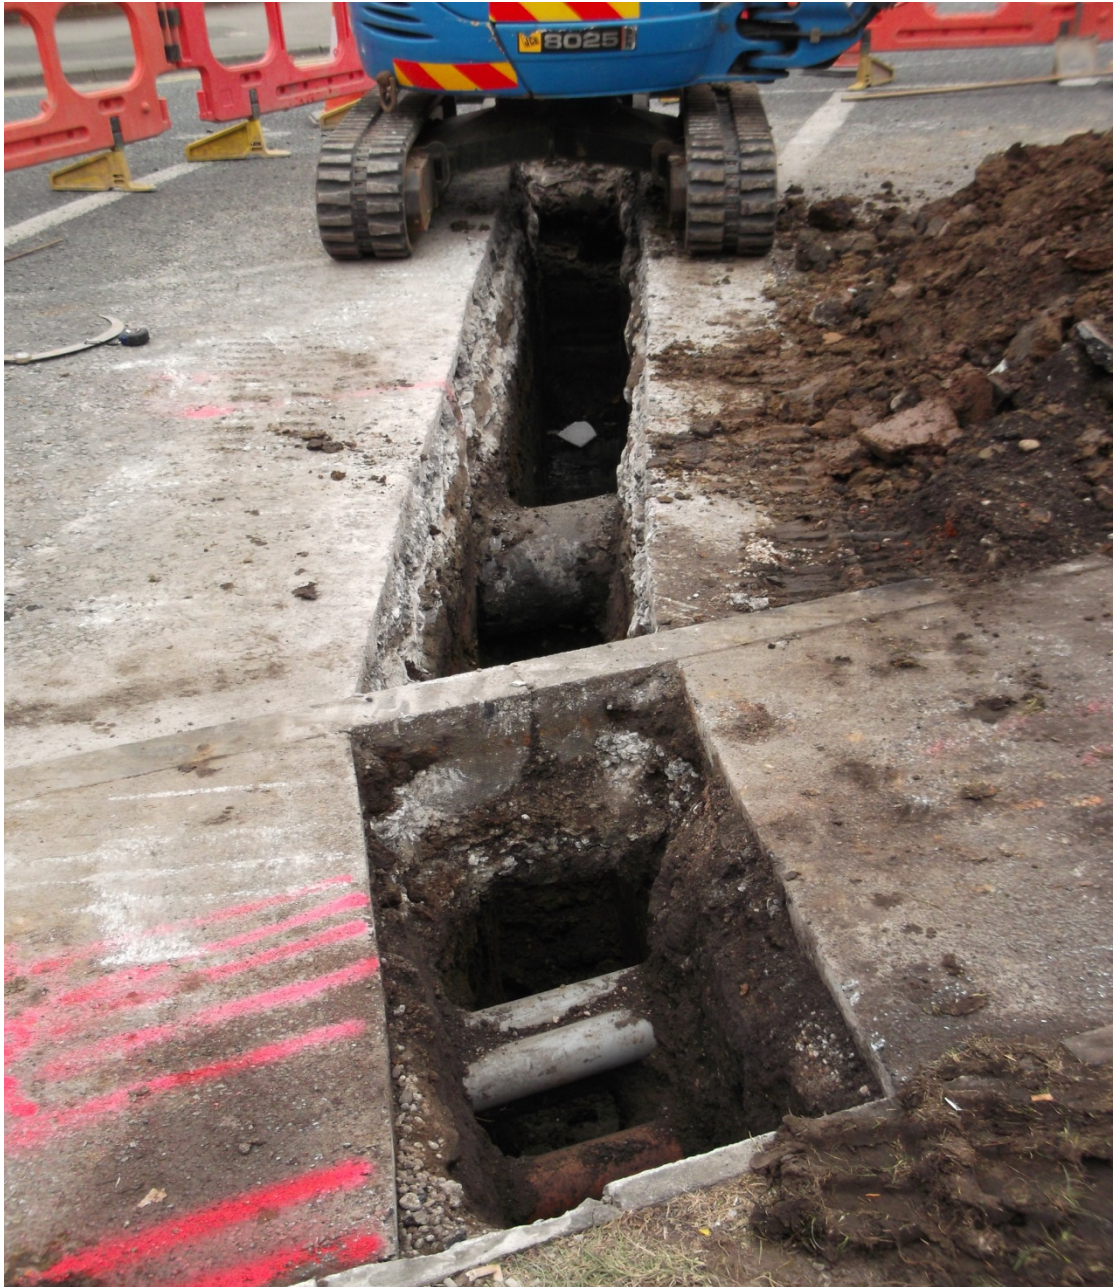
Test Pit 5 was dug on a northwest-southeast orientation, and crossed the Warrington Road and adjacent pavement towards the southern end of the proposed development area (Plate 5). The test pit was dug to a depth of 2m, with the earliest layers encountered green-brown silty clay (123) overlain by yellow-gray silty clay (115) through which two modern sewer pipes (117 and 122) were cut. Overlying this was grey silty clay (114) sealed by a thin band of orange silty clay (113) which in turn was sealed by black silty clay (112). These layers were truncated by a modern sewer pipe (116).

Overlying the sewer pipe (116) was a grey concrete/tarmac surface (111) probably a previous surface of the modern Warrington Road. Overlying this surface was a band of stone hardcore made ground (110) overlain by the tarmac surface (109) of the existing Warrington Road.

Plate 5: Test Pit 5, oblique plan shot showing existing pipe work including sewer pipe  
116

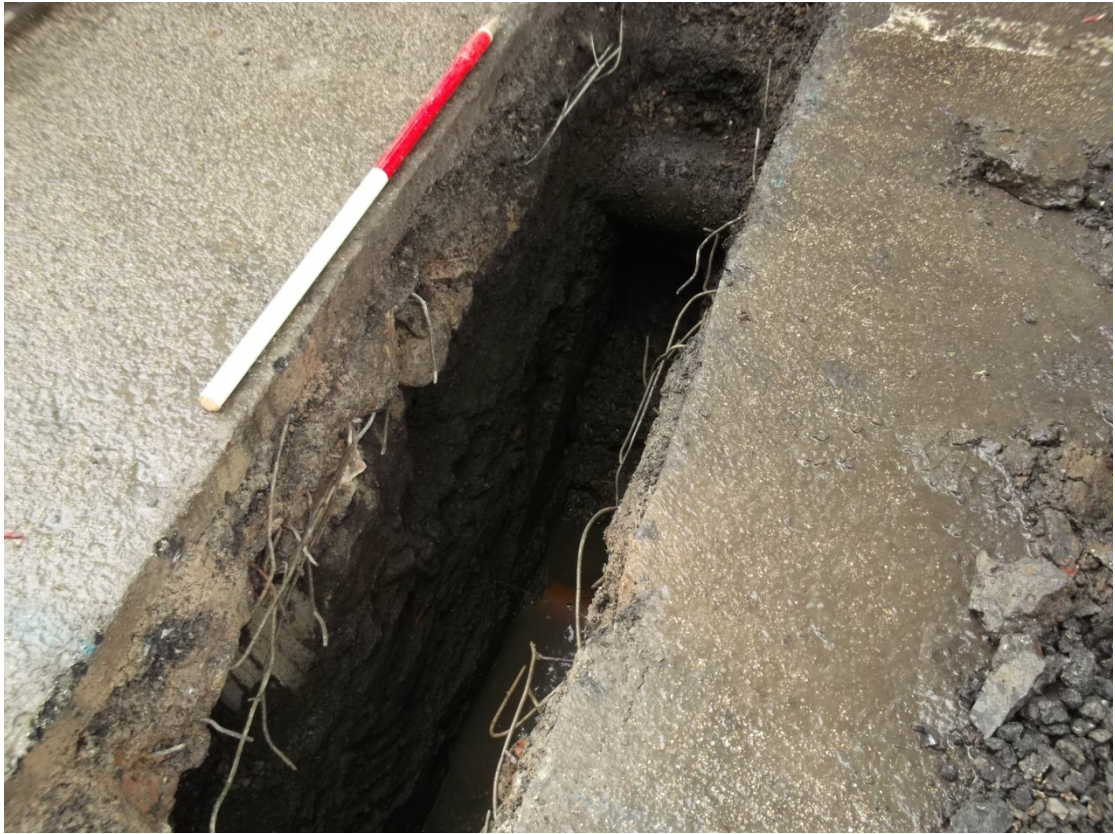
Test Pit 6 was dug on an east-west orientation, and crossed the west side of the Warrington Road and the adjacent pavement towards the northern end of the proposed development area, with an extension later excavated 3m to the south, crossing the east side of the Warrington Road (Plate 6).

The test pit was dug to a depth of 2.5m below the existing ground surface with the earliest layer encountered a green-grey silty clay (120). Overlying Layer 120 was black silty clay (119) overlain by a thin band of orange silty clay (113), through which three large modern pipes (121, 124 and 125) had been cut.

Plate 6: Test Pit 6 extension, oblique shot showing existing pipe work including sewer pipes 124 and 125

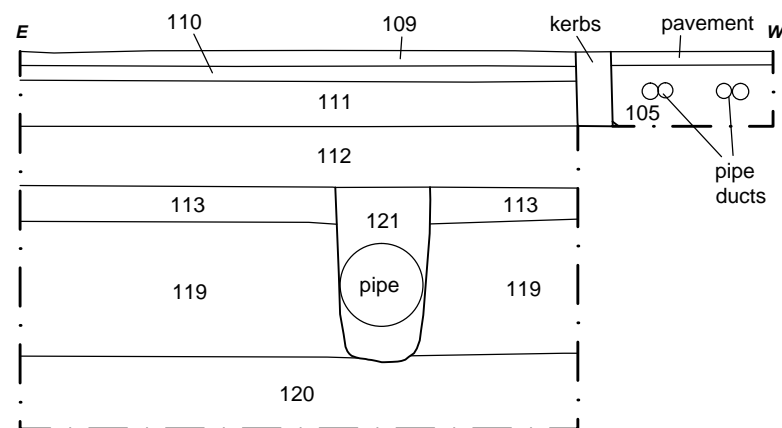
Test Pit 6

Overlying these layers was another black silty clay layer (112) which was sealed by a thick concrete surface (111) which was likely a previous carriageway surface (the same as in Test Pit 5). Overlying this surface was a modern hardcore layer (110) and the tarmac layer of the current Warrington Road (109).

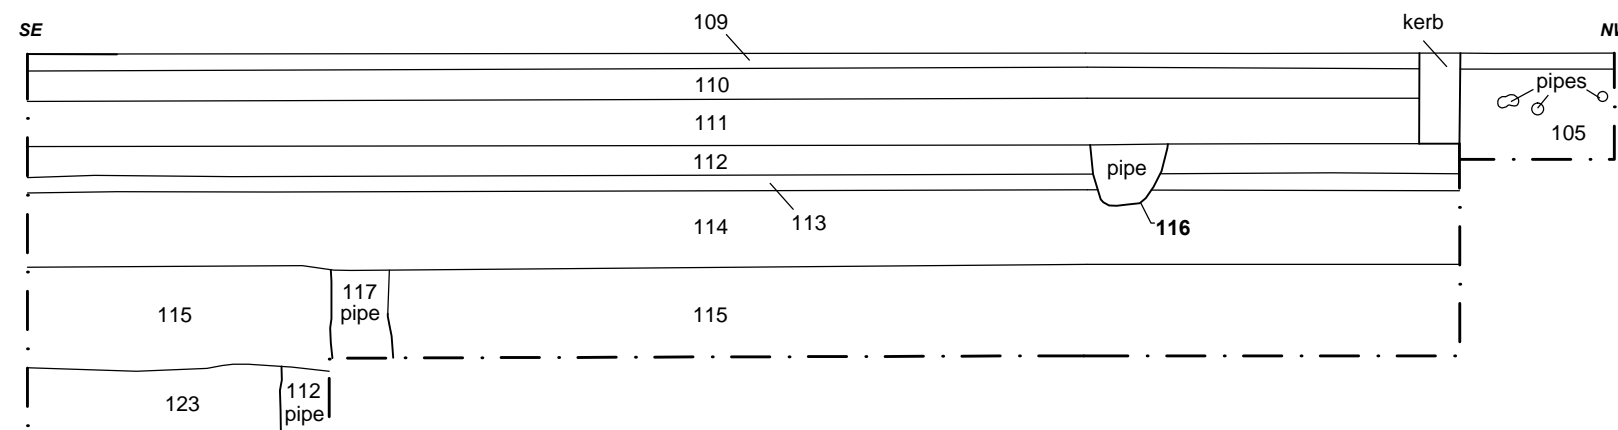
Test Pit 5

No evidence for a surviving portion of the Roman road was noted beneath the modern road surfaces, and no other archaeological remains were recorded.
