**Sovereign Street, Leeds,
West Yorkshire.**

Archaeological Evaluation

Report No. Y089/13

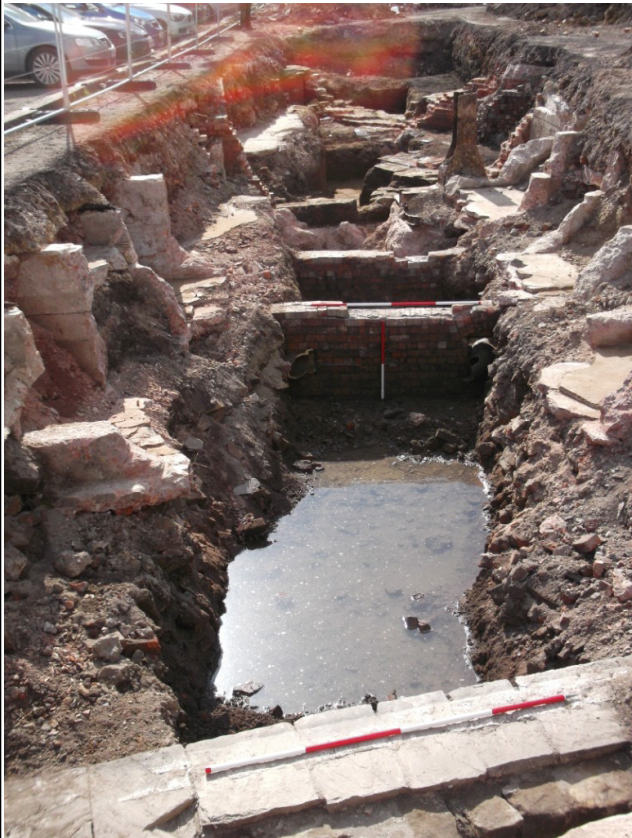
Fig. 5 - South-west-facing shot of trench

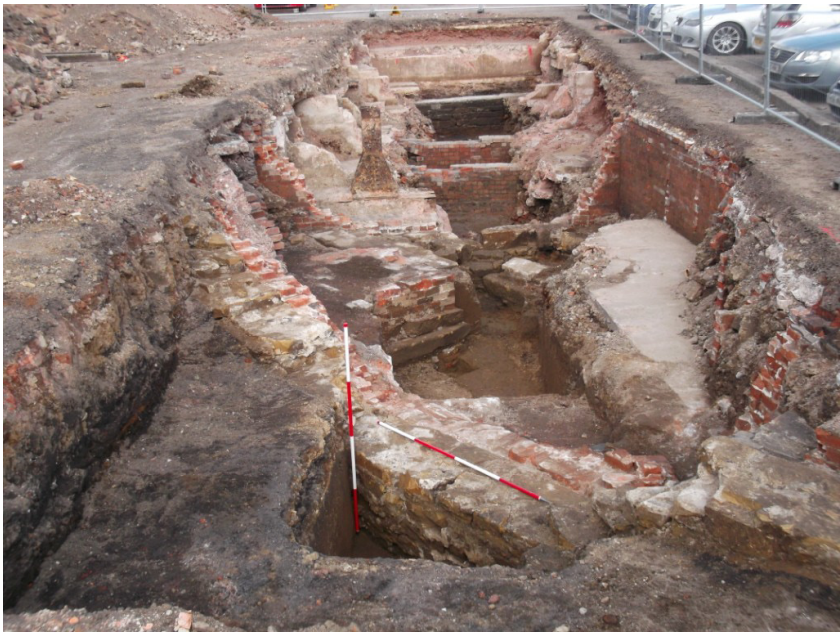
Fig. 6 - North-east-facing shot of trench

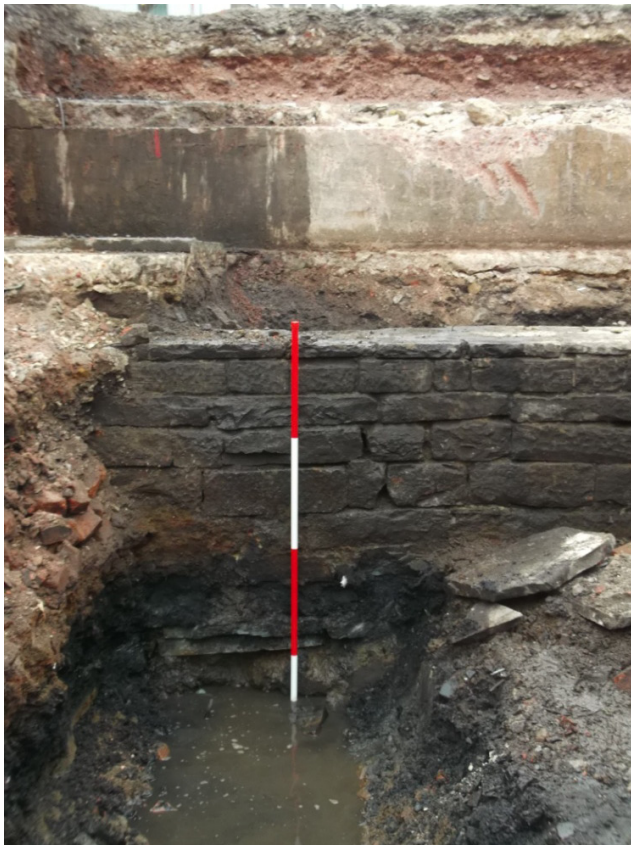
Fig. 7 - South-west-facing elevation of goit wall 028

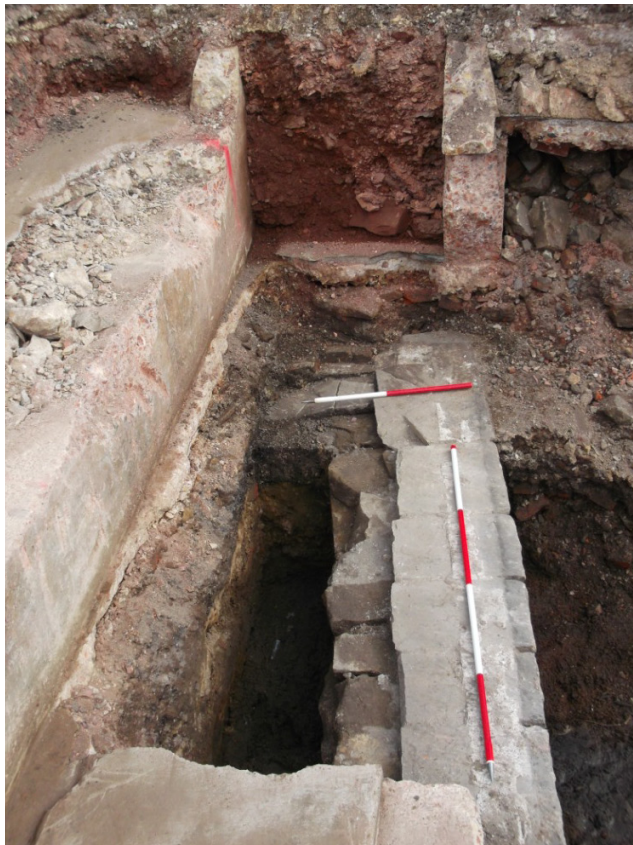
Fig. 8 - South-east-facing shot of stone slabs 027 and goit wall 028

A course of sandstone flag stones (027) had been mortared to the top of the goit's north-east wall. The flagstones had a narrow mortar scar which indicated further coursing. From the width of the scar this would probably have been a narrow brick wall. This structure using the goit wall as a foundation may have been a boundary wall. A 0.1m wide lip between the flagstones (027) and the goit wall (028) indicated a scarcement was present, which was weathered, and thus suggested this had, at least for a time, been the working level of the goit (Fig. 8).

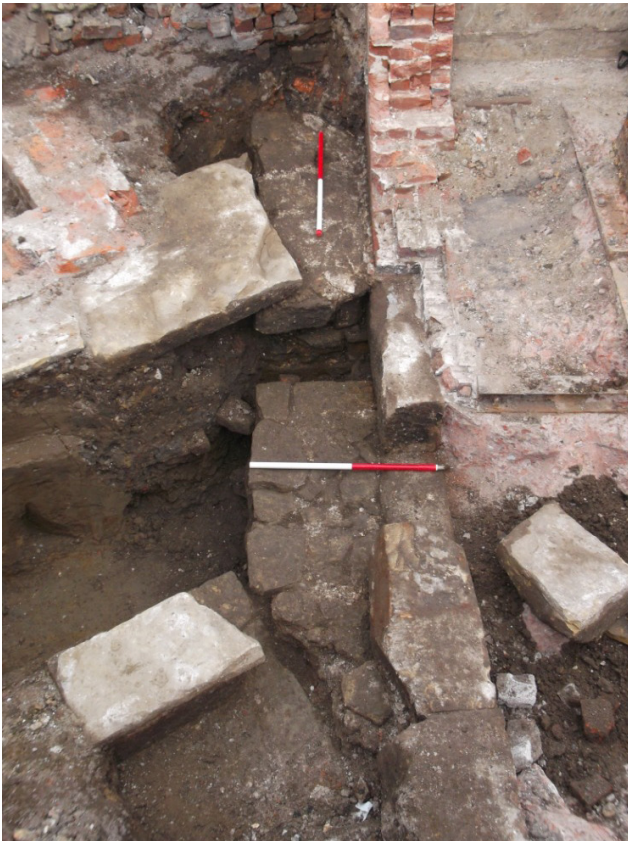
Fig. 9 - North-west-facing shot of south-west goit wall showing gap between sandstone walls 007 and 048

The south-west wall of the goit (003, 007, 048) was constructed in sandstone although it was also partially obscured by later structures of early 20th century date and the internal north-east-facing elevation was entirely obscured by the concrete foundations (040) for the later tram depot (Fig. 9).

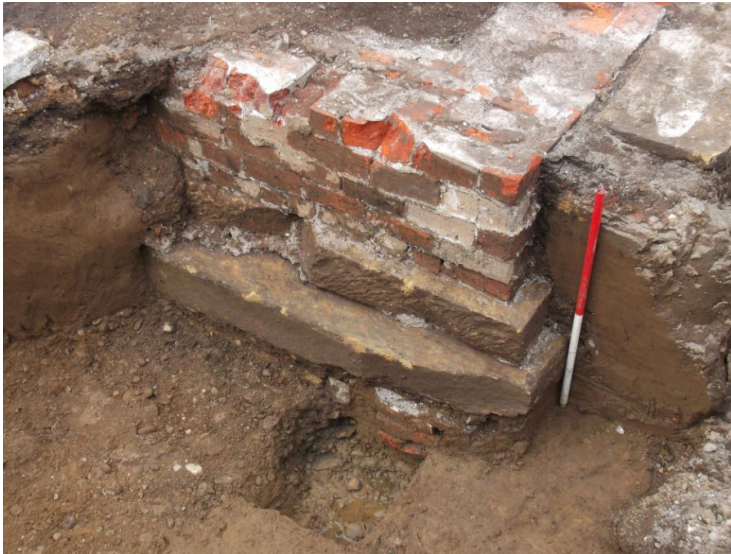
Fig. 13 - South-facing elevation of chimney structure 008 and sandstone slabs 021

The chimney was constructed in reused red brick, with some hand-made examples clearly visible. The dimension of the masonry was c. 1.8m x 1.8m. Two courses of reused sandstone blocks were used as the foundation. The surrounding alluvial sandy silt (043) had been cut (038) (Fig. 11) to insert the chimney's masonry and the foundations were built directly upon the natural sandy gravel substrate. The area was backfilled with granular debris (039), and a levelling deposit of redeposited natural silt (044) (Fig. 12). However, the natural in the base of the trench was variable, and a sondage exposed varying bands of shelving alluvial gravels and sands. The southern corner of the chimney was built onto soft sand and this had required the builders to construct a brick pad under the sandstone foundations to support this corner (042) (Fig. 12, 13).

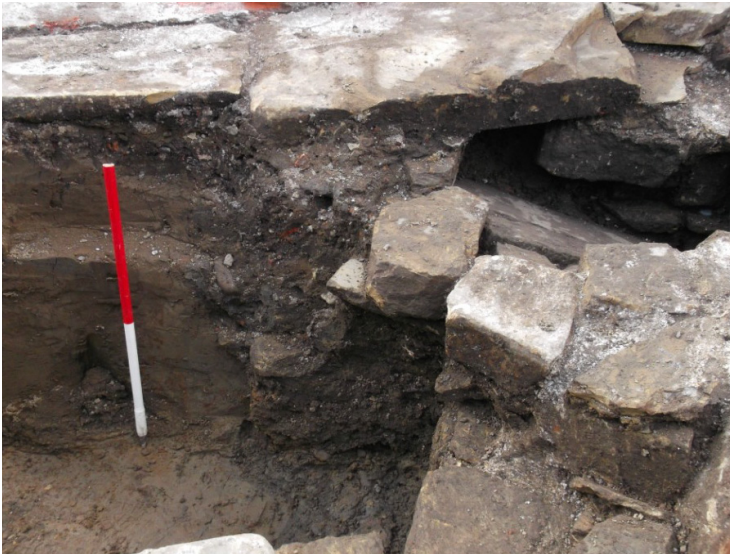
Fig. 14 - East-facing section of construction cut 012 showing sandstone culvert 011

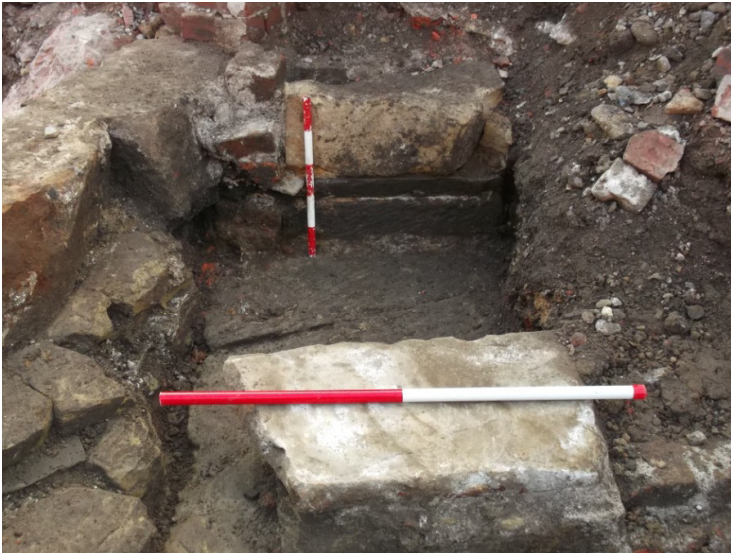
Fig. 15 - East-facing shot of sandstone drain 006

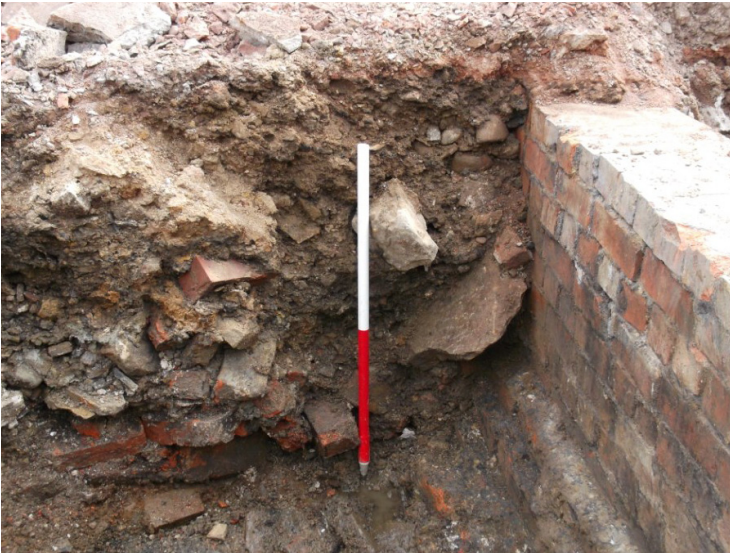
Fig. 16 - Shot of wall 035 and foundation cut 051

A gas stove works was built on the site after the goit had been filled in. The only surviving evidence for this building was two parallel red brick walls (030, 035) (Fig. 3c). The remains of construction cuts (033, 051) through the goit infill for both walls were visible in section (Fig. 4). Wall 030 was 0.85m high which included a foundation of at least four courses of brick headers (Fig. 16) and wall 035 was c. 1m high and had been constructed around an existing ceramic sewerage pipe (032) (Fig. 17). The cartographic evidence shows wall 030 was an external supporting wall; hence the requirement for more substantial foundations.

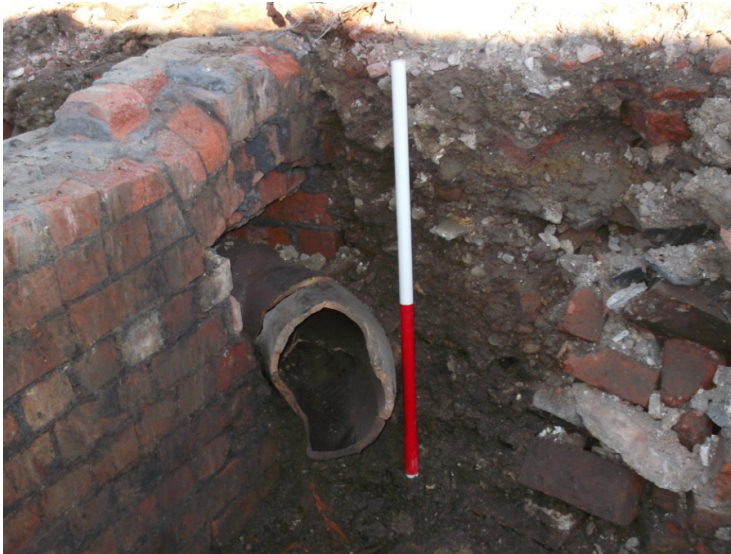
Fig. 17 - Shot of brick wall 030, arch 031 and ceramic pipe

036		Masonry	Opening in wall 030 for pipe 032. 0.37m W x 0.65m H. Created by archway 031.
037		Masonry	Salt glazed drainage pipe. 0.23m Diam. Continuation of pipe 032.
038		Cut	Construction cut for chimney foundation 021. >1.8m L x c.1m D. Irregular, near vertical sides. Flat base. Cut into alluvial silt deposits 044 and 043. Filled with backfill deposit 039.

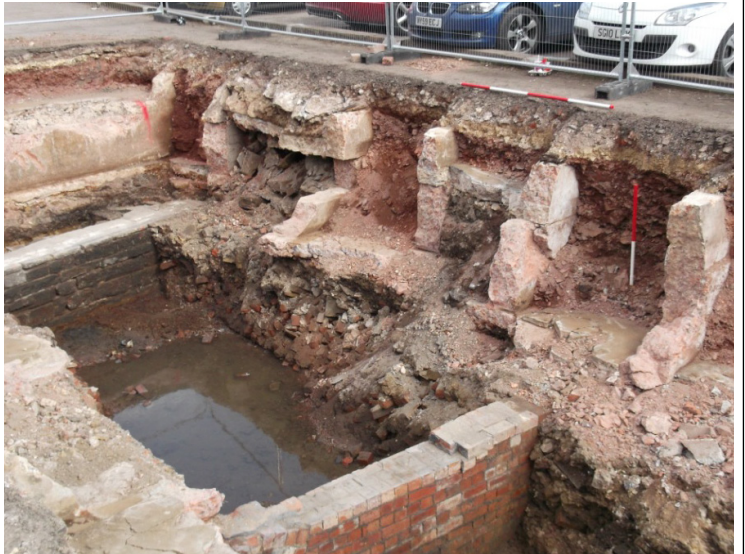
Fig. 18 - Oblique shot of north-west-facing section of trench and concrete bays of former tram depot

series of north-west to south-east orientated concrete bays uncovered between 0.45m and 0.5m below the car park surface (Fig. 4). The concrete was not reinforced and had been poured using wood shuttering. The modern deposits contained a high proportion of brick, sandstone and grey mortar fragments. These bays were interpreted as service pits for trams (Fig. 18). A screed of concrete provided a finished upper working surface within each bay. A shallow gutter was noted in the deeper bays to allow for the run off of liquids. The bays had been filled with an assortment of made ground deposits including burnt shale, with occasional gravel lenses and demolition deposits more prominent to the south-west.
