**Wellhill Farm and Hall of Auchincross Farm,  
Greenburn Surface Mine (Wellhill Extension)  
New Cumnock,  
East Ayrshire  
Archaeological Evaluation**

**Data Structure Report  
No. 3012**

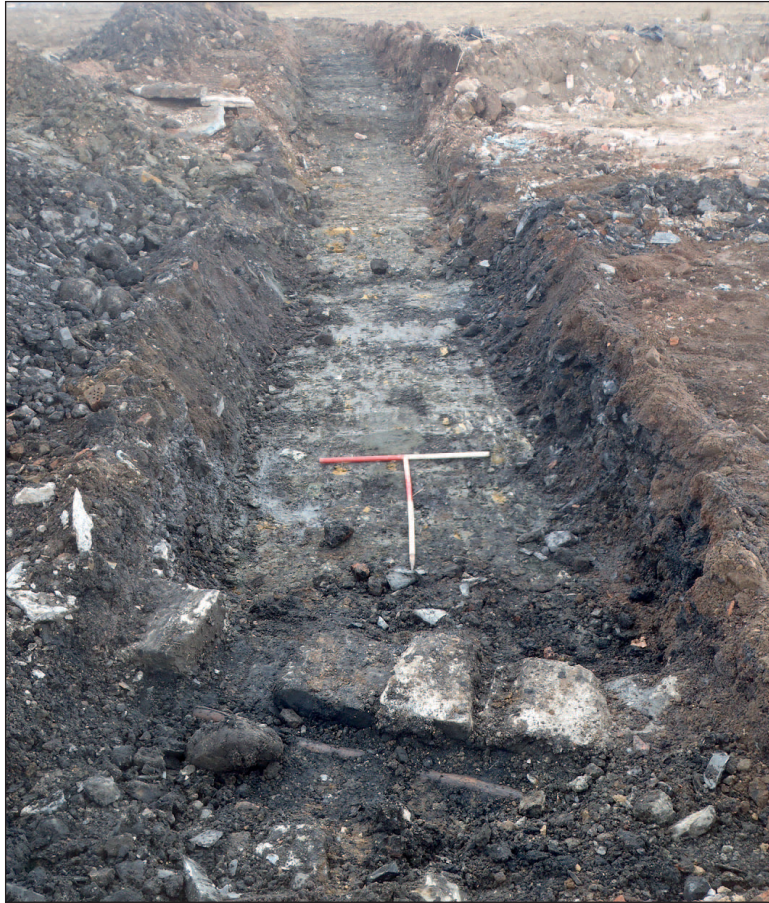
Wall **004** (Fig.5) was located 0.3m below the ground surface within Trench 1 and was aligned north-west to south-east. This wall measured 0.4m wide by 0.19m high and had been constructed from rough-dressed sandstone blocks measuring up to 0.4m by 0.4m and survived as a single course. It was constructed on a concrete foundation **005** which measured 0.5m wide by 0.08m thick and sat on top of a layer of made ground (**006**) measuring 0.15m deep. The made-ground (**006**) sat directly on top of natural **002**. The wall could not be related to any known or mapped structures but the use of concrete as a foundation suggests that it is of no great antiquity.

Fig.5 - Trench 1, wall 004 from the south

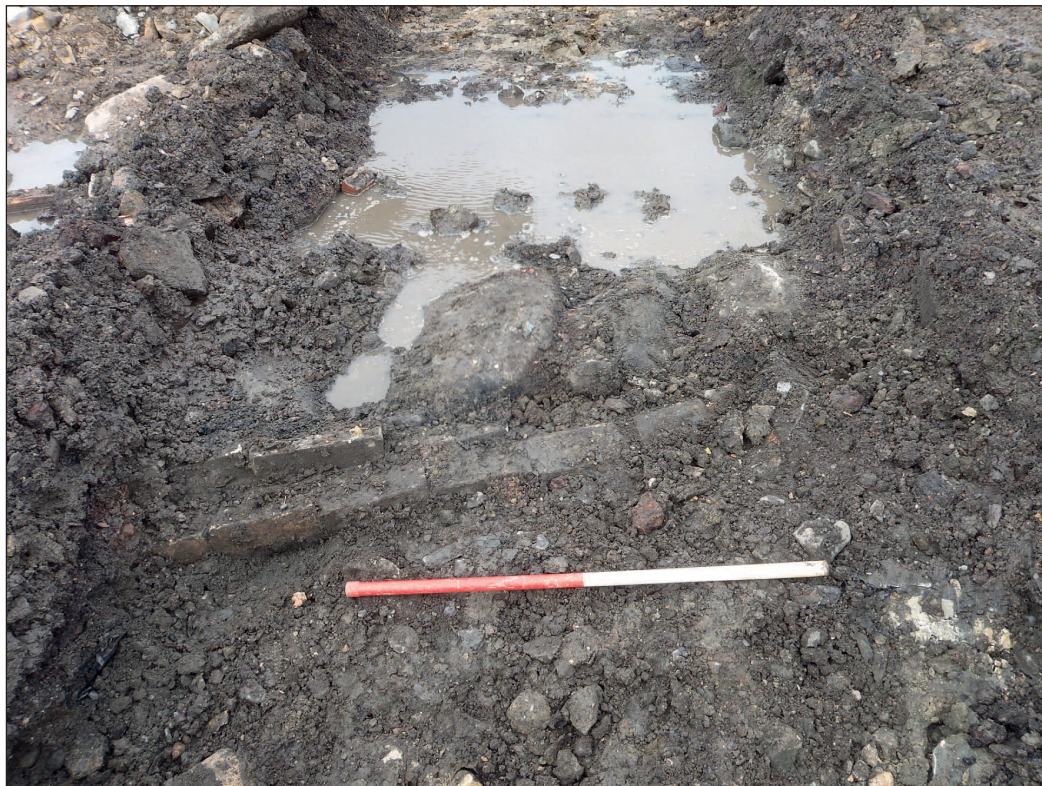
Wall **011** (Fig.6) was identified within Trench 19 and was aligned NNW to SSE parallel with the recently demolished byre. It consisted of a single foundation course of undressed boulders faced on the eastern side by a course of unfrogged brick. This foundation measured 0.9m wide by 0.2m high and sat directly on the natural (**002**). The location of this wall corresponds with the outer edge of a structure depicted on the 1857 First Edition Ordnance Survey map (Fig.4) abutting the recently demolished 19<sup>th</sup> century byre (Building 3 in Cressey 2012).

Fig.6 - Trench 19, wall 011 from the east

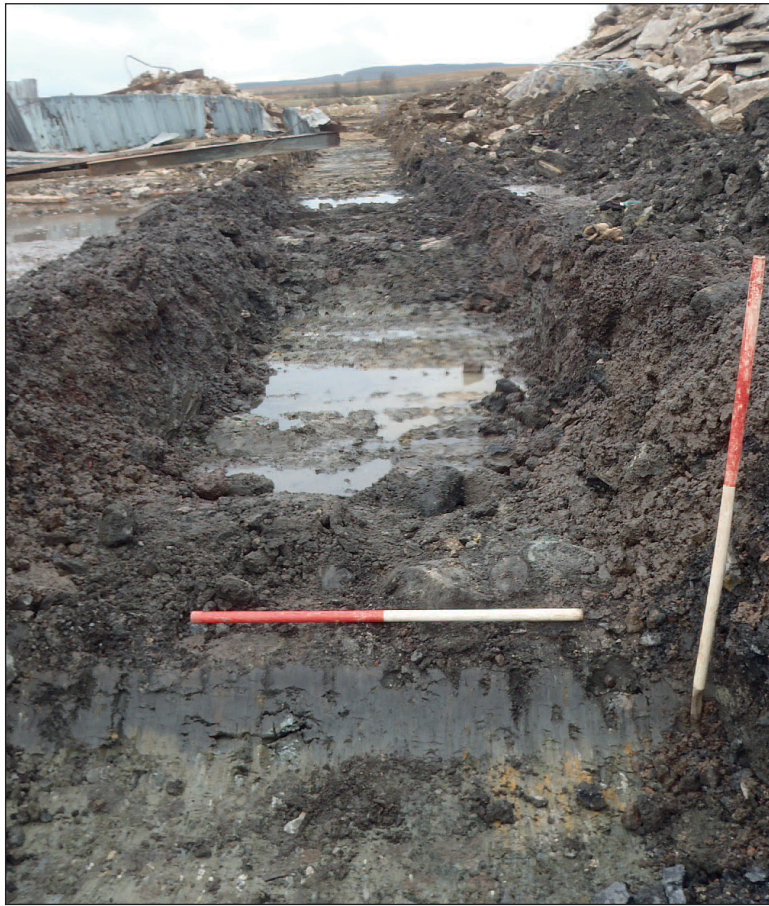
Wall **012** (Fig.7) was identified in Trench 19 and was aligned north to south. It consisted of a single foundation course of undressed sandstone blocks. It measured 0.9m wide by 0.2m high and sat directly on the natural (**002**). The location of this wall corresponds with the eastern wall of a small square structure which is depicted on the 1857 First Edition Ordnance Survey map (Fig.4).

Fig.7 - Trench 19, wall 012 from the east

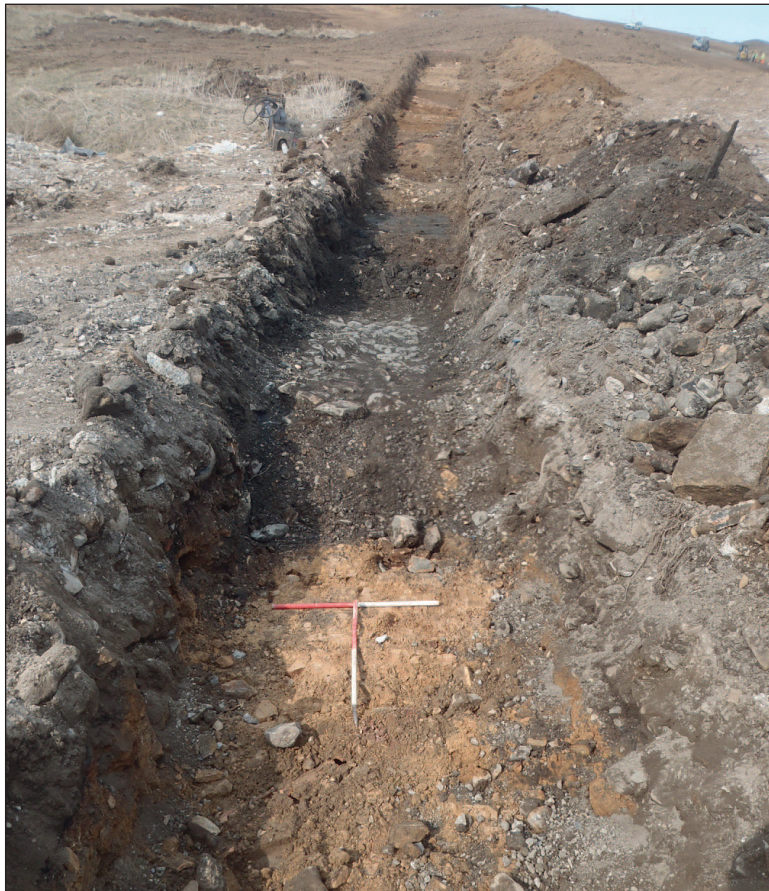
The cobble surface **008** (Fig.8 and 9) was located in Trench 9. It sloped downwards towards the culverted watercourse that bisected the north-eastern part of the evaluation area. The surviving remains within the trench measured 5m in length, with further possible cobbling having been removed by more recent services. This surface was constructed from rounded/sub-rounded stones measuring up to 0.3m by 0.2m set within a matrix of dark-brown gravelly silt, which sat on top of a 0.5m deep layer of made-ground (**007**). Made ground **007** sat directly on the natural, with the cobbles being overlain by a further 0.5m of made ground (**001**). This cobbled surface is likely to relate to the early usage of the farmstead and might represent part of the access track depicted on the First Edition Ordnance Survey map (Fig.4).

Fig.8 - Trench 9 from the south showing cobbles 008

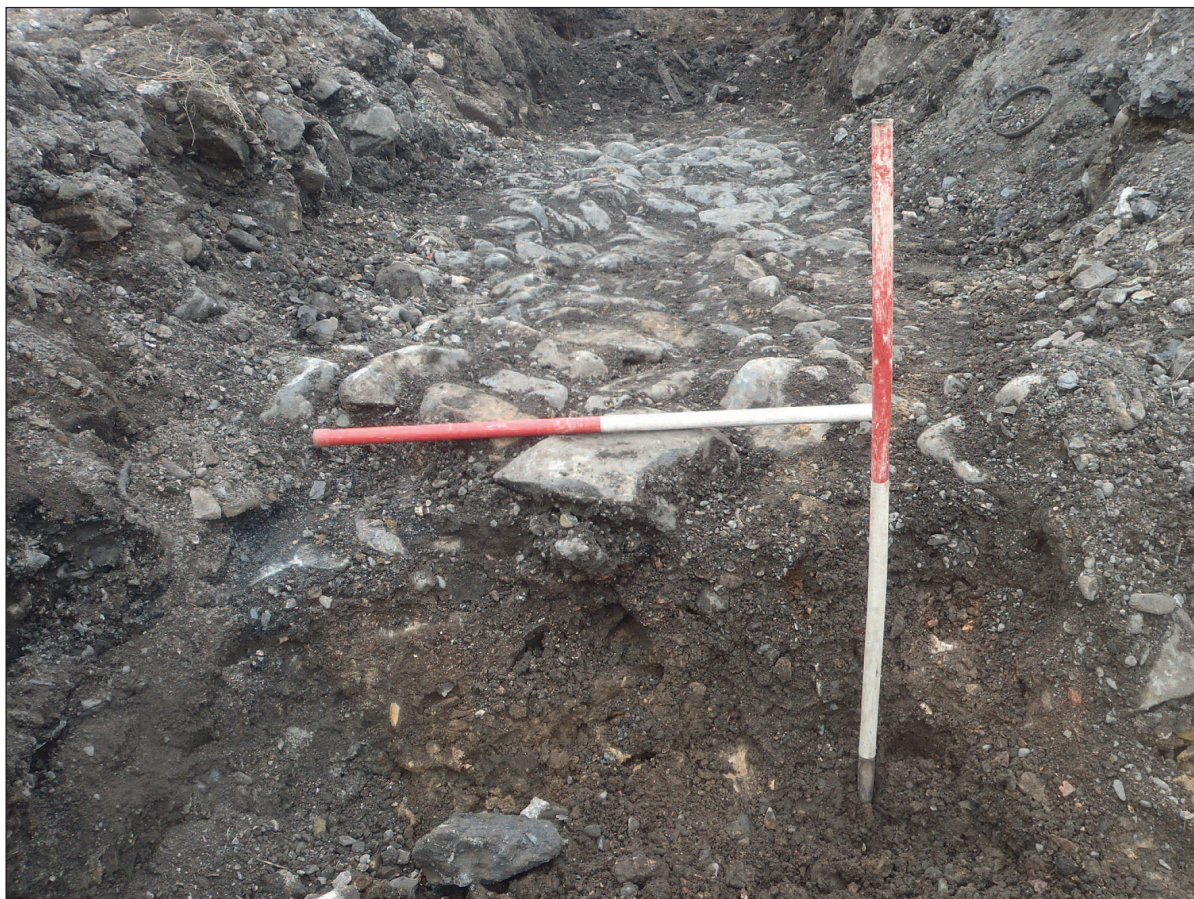
Fig.9 - Trench 9, detail of cobbles 008 sitting on made ground 007
