Meteorological Mast at Knockendurrick Hill, Gatehouse of Fleet, Dumfries and Galloway

Archaeological Watching Brief

Report No.3006

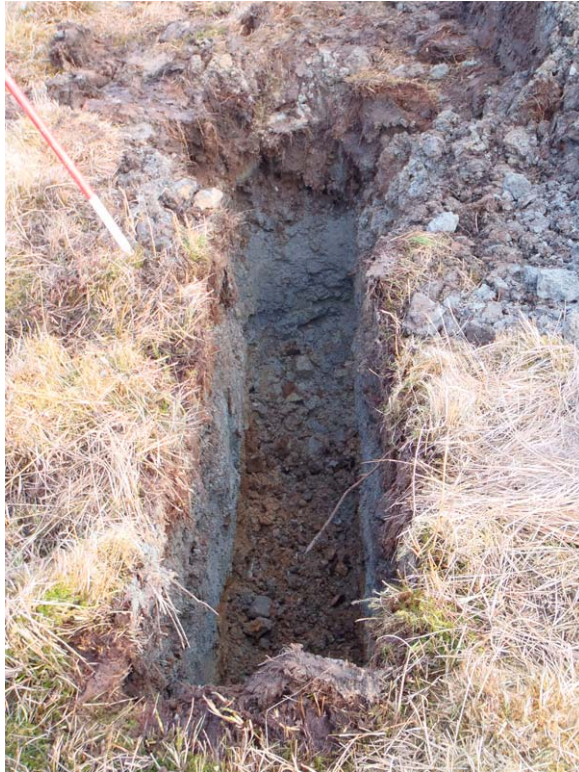
Fig. 4 - Anchor Pit 1

The excavation of all of the anchor pits (Figs 3 & 4) was monitored by the attending archaeologist. All of the pits measured approximately 2.5m-3m long, 0.5m wide and 1.5-2m deep. No archaeological deposits, features or artefacts were found during the excavation of the pits. The table below records the stratigraphy of each pit.

Anchor Pit	Stratigraphy
1	0.1-0.2m topsoil, onto natural geology consisting of blue-grey boulder clay
2	0.2-0.25m topsoil, onto natural geology consisting of blue-grey boulder clay
3	0.15-0.2m topsoil, onto natural geology consisting of blue-grey boulder clay
4	0.05-0.1m topsoil, 0.05m subsoil, onto natural geology consisting of blue-grey boulder clay
5	0.05-0.1m topsoil, onto natural geology consisting of blue-grey boulder clay
6	0.05m topsoil, onto natural geology consisting of blue-grey boulder clay

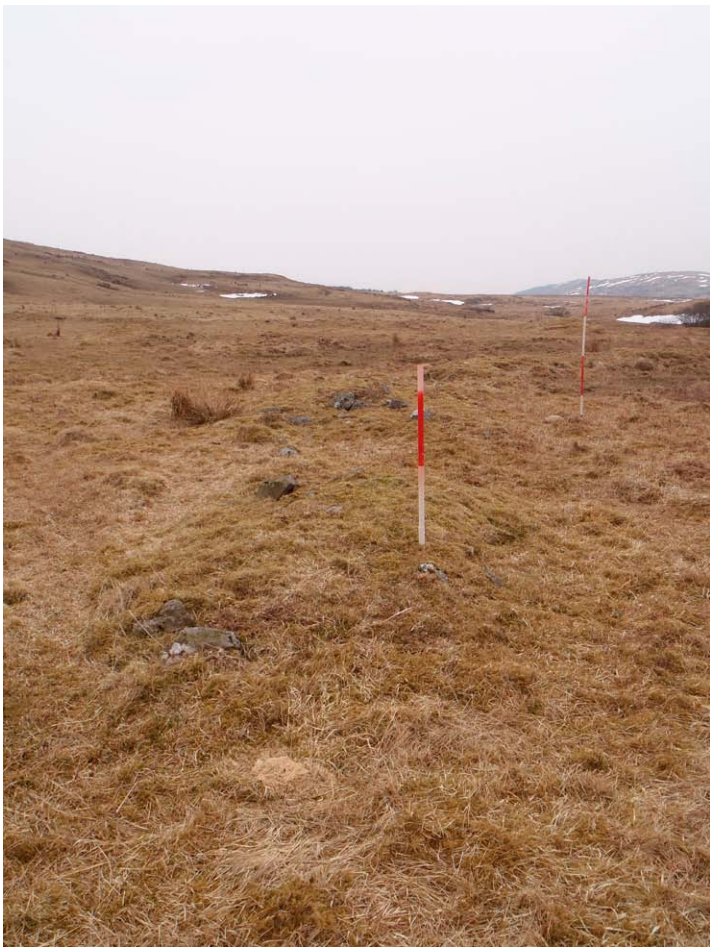
location of the anchor pits for the mast guide ropes were micro-sited to avoid these features (Fig. 8).

Fig. 8 - Field bank (SE section showing location of Anchor Pit 4 indicated with 2m ranging rod)
