Wester Dalmeny Steading, Dalmeny Archaeological Evaluation & Baseline Building Survey

Report No. 725

Commissioned by bell grant
June 2002

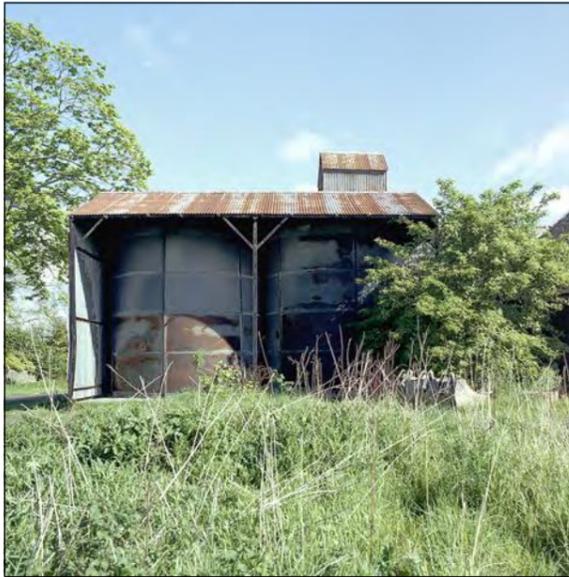
Plate 1 - Range A, South elevation. Modern grain silos.

4.2.2 The west end of the range is masked by the modern grain silo (Plates 1-2). Access for photography behind the silos was limited due to dense vegetation. The principal features identified at the upper level were two open square-headed windows measuring 1.60m by 1.60m with chamfered ashlar surrounds and sandstone sills and lintels (Plate 3). Towards the adjoining horse-engine house at the ground-level is another smaller window now blocked with red brick and measuring 0.60m by 0.60m (Plate 3).

- 4.3.1 Situated at the southern end of the west range is the gable of the steel-framed barn housing the two grain-silos (Plate 1). The barn has been built against a one-and-a half storey cart shed with slated roof and sandstone ridges (Plate 36). Four segmentally-arched cart-bays 2.6m wide and 2m high each have a square loft opening above (Plate 39). The surrounds of the cart-bays are of exceptionally high quality ashlar (plate 39). Coursed sandstone rubble has been used to construct the wall between the loft openings. A date stone of 1828 is present on the skewput below the ridge on the gable at the north end (Plate 37).

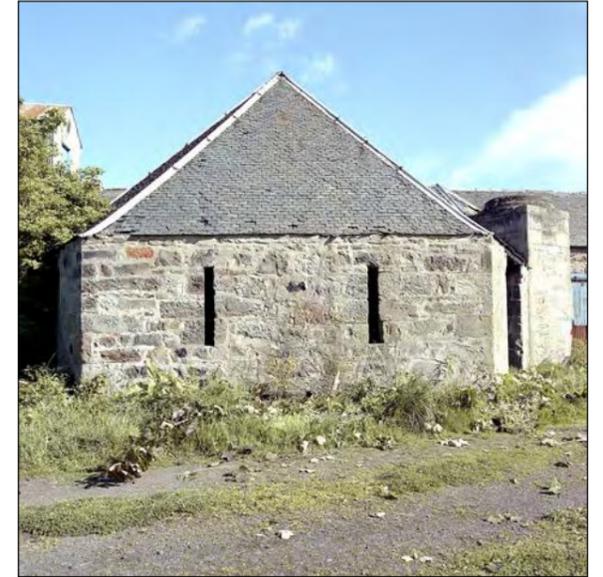
Plate 4 - Range A, South elevation. Horse engine house and chimney base.

4.2.3 The horse engine house is constructed of randomly coursed sandstone rubble with well-dressed sandstone quoins surrounding the ventilation slits and doorways (Plates 4-5). The walls are 0.60 thick and the wall-heads stand to a height of 2.5m. Seven courses of sandstone surround three rectangular doorways that are 2.5m wide and 1.70m high. The lintels above the doorways are wooden and appear to be recent replacements. The horse engine house has been divided internally by the construction of a steam-engine house (Plate 44). Its southern wall is on an east-west alignment and stands to a height of 2.75m and is 6.5m in length. The wall is constructed of uncoursed rubble with well dressed ashlar surrounds. A brick-blocked window measuring 1m by 0.54m occupies the centre of the wall. The east wall has been pierced by the insertion of a flue with a segmented arch (Plate 42). The flue has an internal measurement of 0.80m high and 0.48m wide and 1.70m long and is lined with white fire-clay bricks leading up to the aforementioned chimney base. The bricks are stamped with *John Crievie Bank Park Fire Brick Works*. On the floor of the horse-engine house are the vestigial remains of wall footings some 6m in length and 0.40m wide (Plate 43). The relative position of this wall and its relation to the horse-engine structure is not clear.

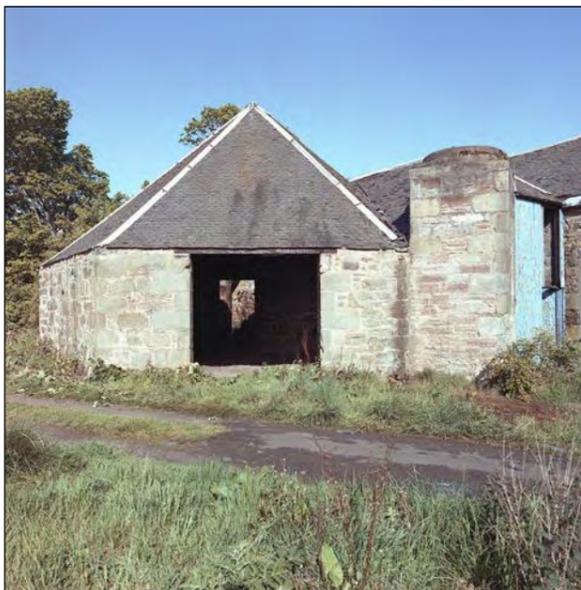
Plate 5 - Range A, South elevation. East side of horse engine house and chimney base.

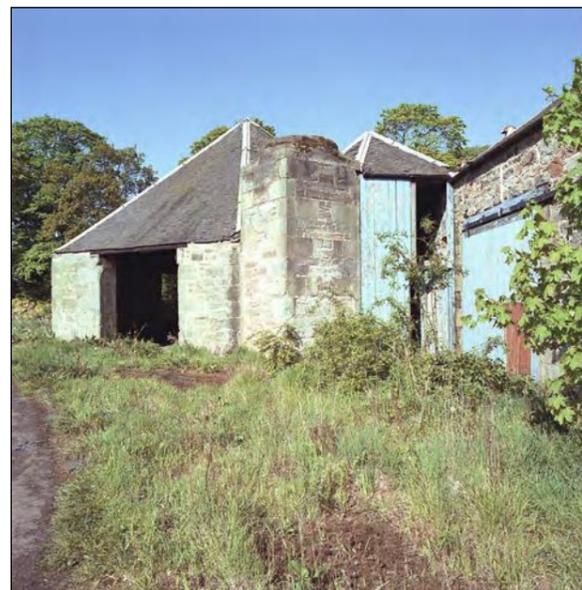
Plate 6 - Range A, East elevation showing doorway into the steam engine house.

4.2.4 The steam engine house is accessed by a west-facing doorway measuring 0.90m wide and 2m high (Plate 44). The door has ashlar sandstone surrounds and lintel. The room has an internal concrete floor measuring 8m by 2.9m. The eastern end of the building has a dog-leg to incorporate the base of the chimney (Plate 6). A 0.70m long

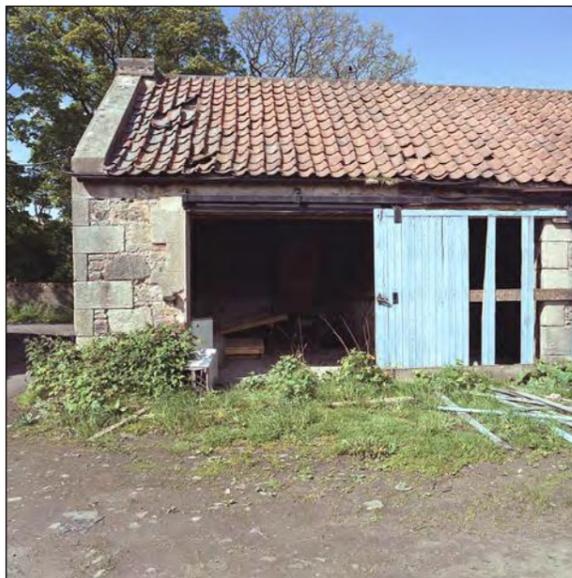
Plate 21 - Range C, East elevation of tack-room and stable entrance.

- 4.5.2 The tack-room faces onto the courtyard and has a large central opening measuring 2.15m by 2.76m (Plate 21). The room has a concrete floor with pine planking as wall panelling. A small cast-iron grate is present on the south wall. The walls contain a saddle rack and pegs for hanging tack. To the right of the tack-room entrance is a doorway leading into a stable (Plate 22). The stable adjoining the tack-room is lit by a square-headed window with ashlar surrounds (Plate 22 & 55) and has plastered walls. All internal wooden stalling has been removed (Plate 55). The floor has been laid with concrete and it is assumed that there was room for at least two horses.

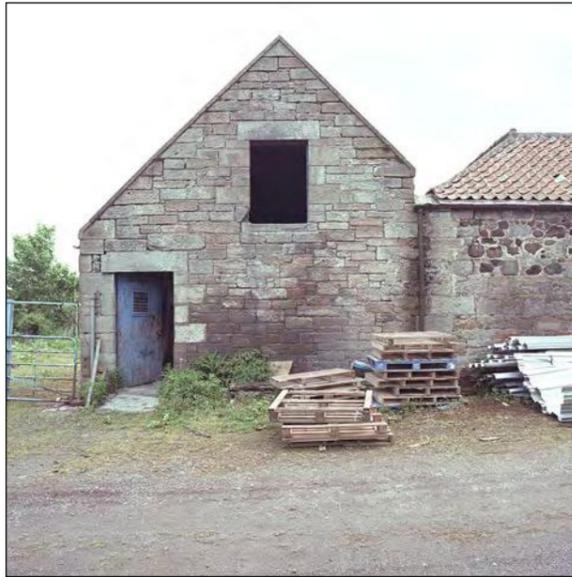
Plate 32 - Range E, Interior of north facing doorway.

4.7.2 The internal north elevation of this building incorporates five square recesses each measuring 0.20m by 0.20m which may have acted as lantern shelves (Plate 32). It is presumed that an arrangement of stalls were present but have been since removed. At the eastern end of the building the southern portion of the floor is cobbled and this may well be a fragment of original byre flooring (Plate 31).

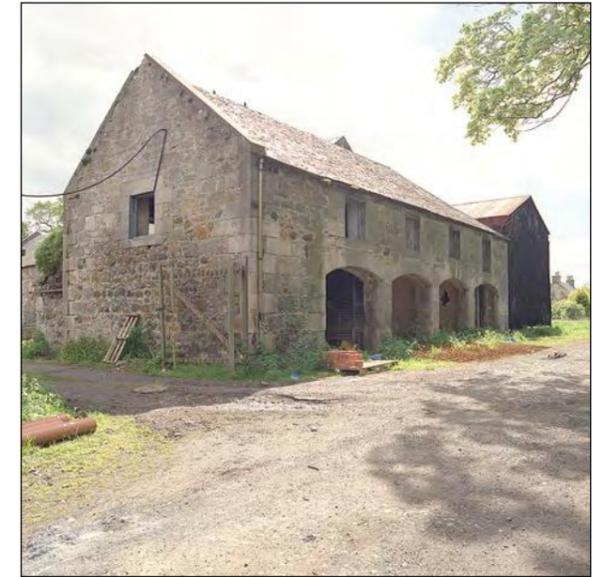
Plate 36 - Range B, North facing gable end and the arched entrances to cart sheds.

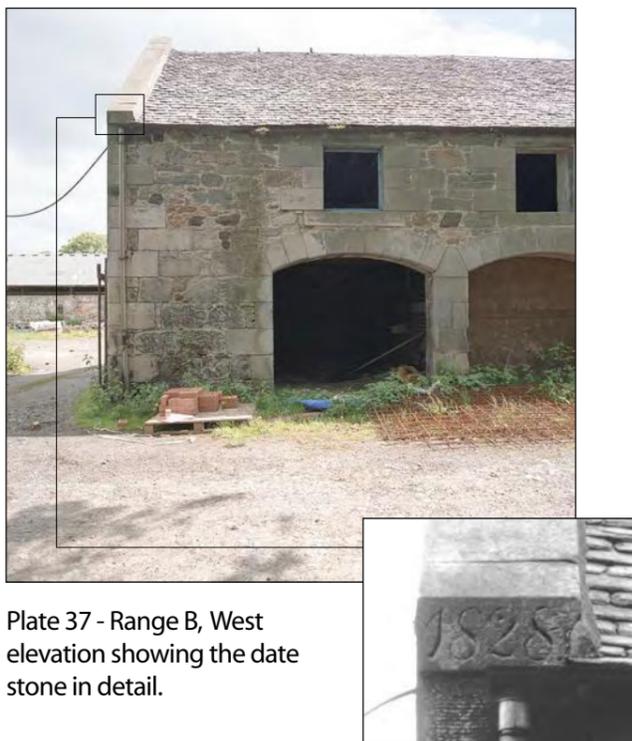
Plate 37 - Range B, West elevation showing the date stone in detail.

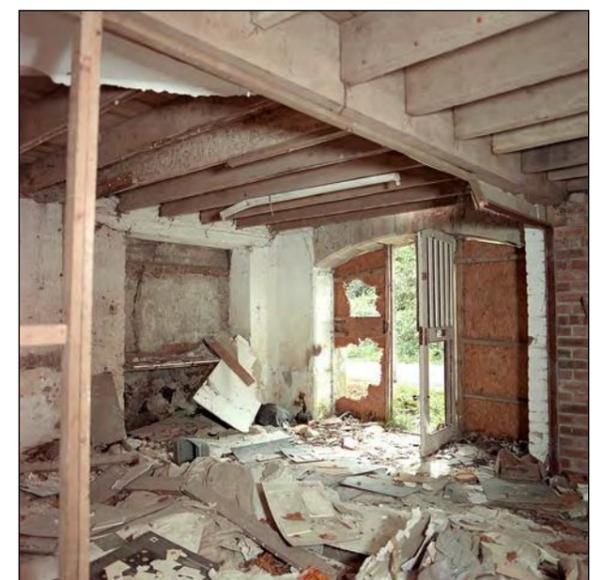
Plate 40 - Range B, cart bay internal detail.

- 4.4.2 The internal walls of the ground floor in the cart shed are masked by wooden panelling and recent plasterwork (Plate 40). The loft accessed by the stair in the south range has plastered walls and no details of interest. The wooden floor appears to be recent. The roof timbers are exposed and are A-frames sat directly on the wall heads (Plates 53-54).

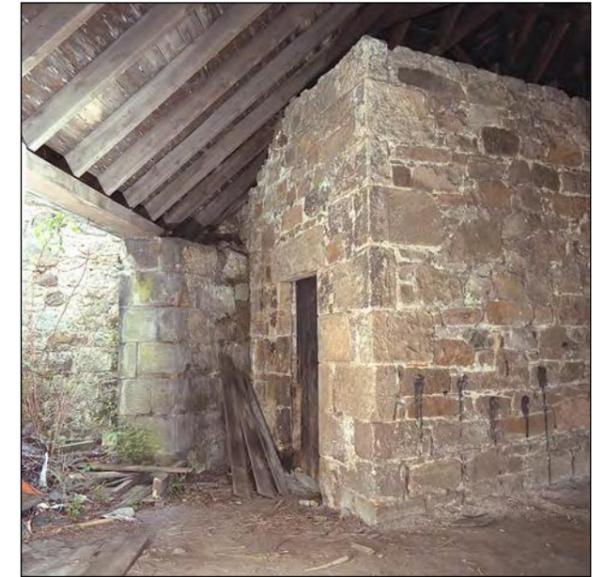
Plate 44 - Horse Engine House interior showing the entrance to the Steam Engine House.

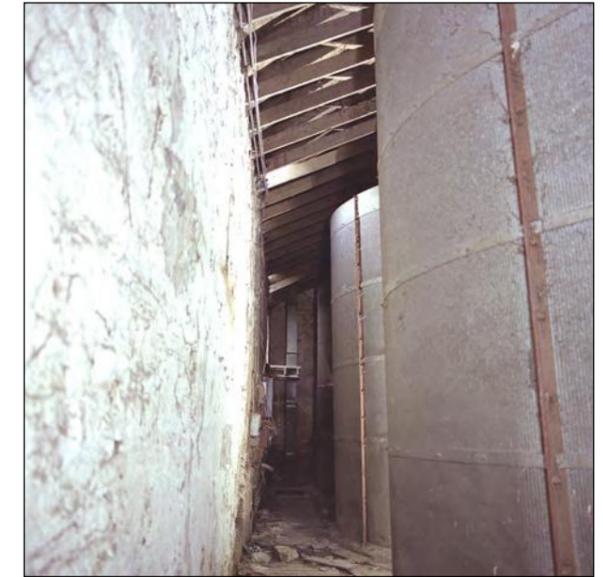
Plate 52 - Detail on large grange silos and south wall of Range A, looking west.

- 4.2.7 The last phase of use of this building involved a major conversion from a series of individual stables to a grain-drying house. Three large drum-silos (Plate 52) extend up into the A-framed roof that incorporates vents for each of the three silos (Figure 2, Plate 51). A wooden inspection gantry runs the length of the interior of the north wall along its head. The floor of the stables have been replaced by concrete and incorporate a mesh-covered hopper at the eastern end of the range. There are the remains of cobble-flooring which are assumed to be from the original stable floor surviving at the east end of the range close to the grain feeder (Plate 49). The electric-driven grain feeder was made by Boswells' of Blairgowrie (Serial No.0066) and stands on a brick plinth (Plate 50). A series of drive-belts connected to an oscillating feed box that allowed grain to fall into the aforementioned hopper below the present floor. A blocked doorway is partially hidden by another grain silo at the east end. On the west internal elevation there is a wooden stair leading into the loft above the cart sheds. The internal south elevation has been heavily mortared and whitewashed masking much of the fabric detail with only two square windows present (Figure 1). The previously mentioned sliding door is the only feature at the south-east end of the range along with the slit-vent (Figure 1). The north internal wall contains the aforementioned open square-headed windows and a blocked door.

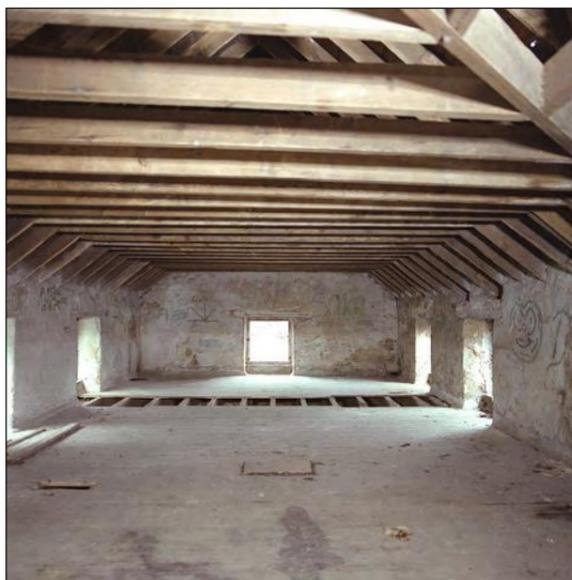
Plate 53 - Range B, Loft area above cart sheds, looking north.

- 4.4.1 The east elevation incorporates the remains of a lean-to building possibly used as a pig-sty. The roof is corrugated asbestos. Above the roof are two square-headed windows with ashlar surrounds lighting the loft above the cart shed (Plate 53).
