**Temporary Bus Terminal
250m North West of the A823 and A9 Junction,
Gleneagles,
Perth & Kinross.**

Archaeological Evaluation

Report No. 3024

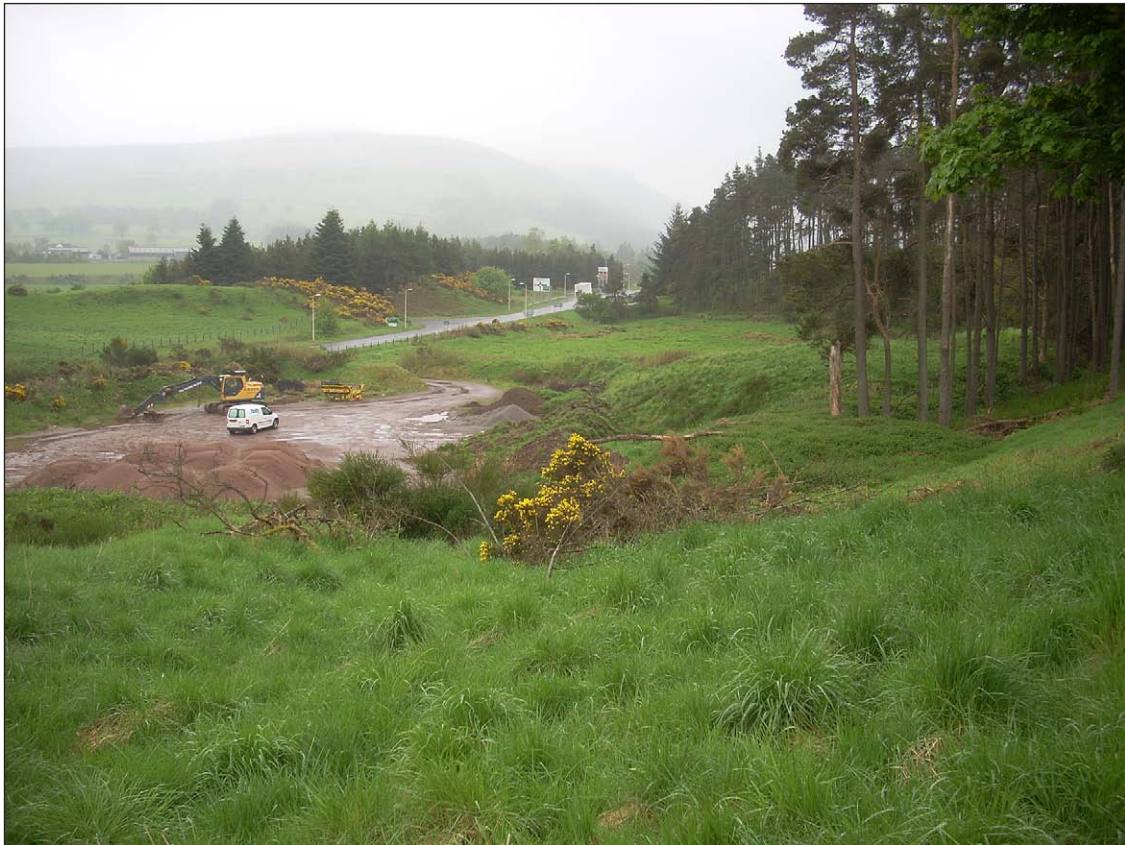
Area 1 consists of a grass field adjacent to Loaninghead Fort (Fig. 2). No archaeological remains were found in Trenches 2-3, 5, 7-13.

Fig. 2 - General view of Areas 1 and 2 from the north-west

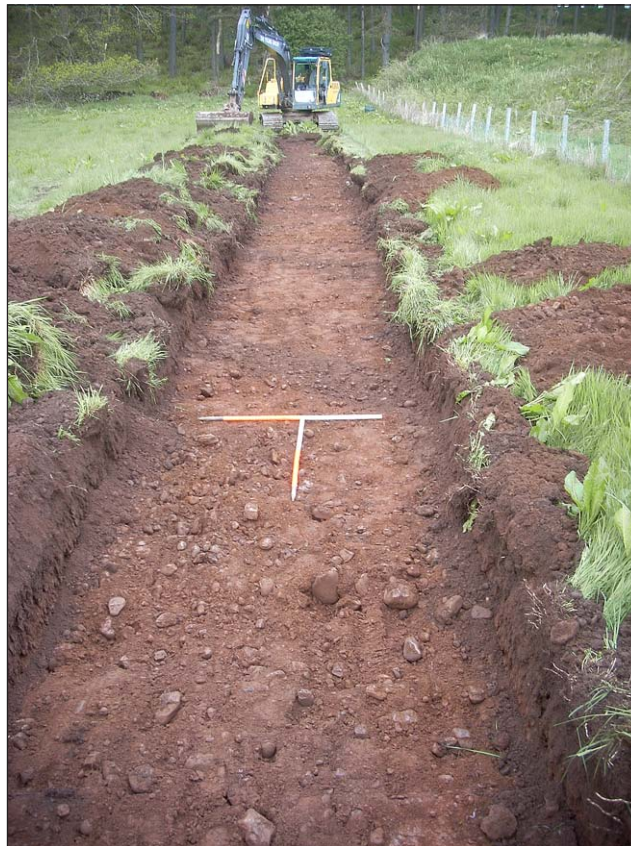
In Trench 1, two parallel linear features (**101**, **103**, Fig. 3) were recorded. Both were aligned NE-SW and were filled with a homogeneous pinkish-brown silty sand with occasional gravel (**102**, **104**). Both ditches were 0.75m wide and they were 2.5m apart. A section (Fig. 4) showed **103** to be <0.1m deep. No finds were recovered.

Fig. 3 - Trench 1, ditches 101, 103 from the east

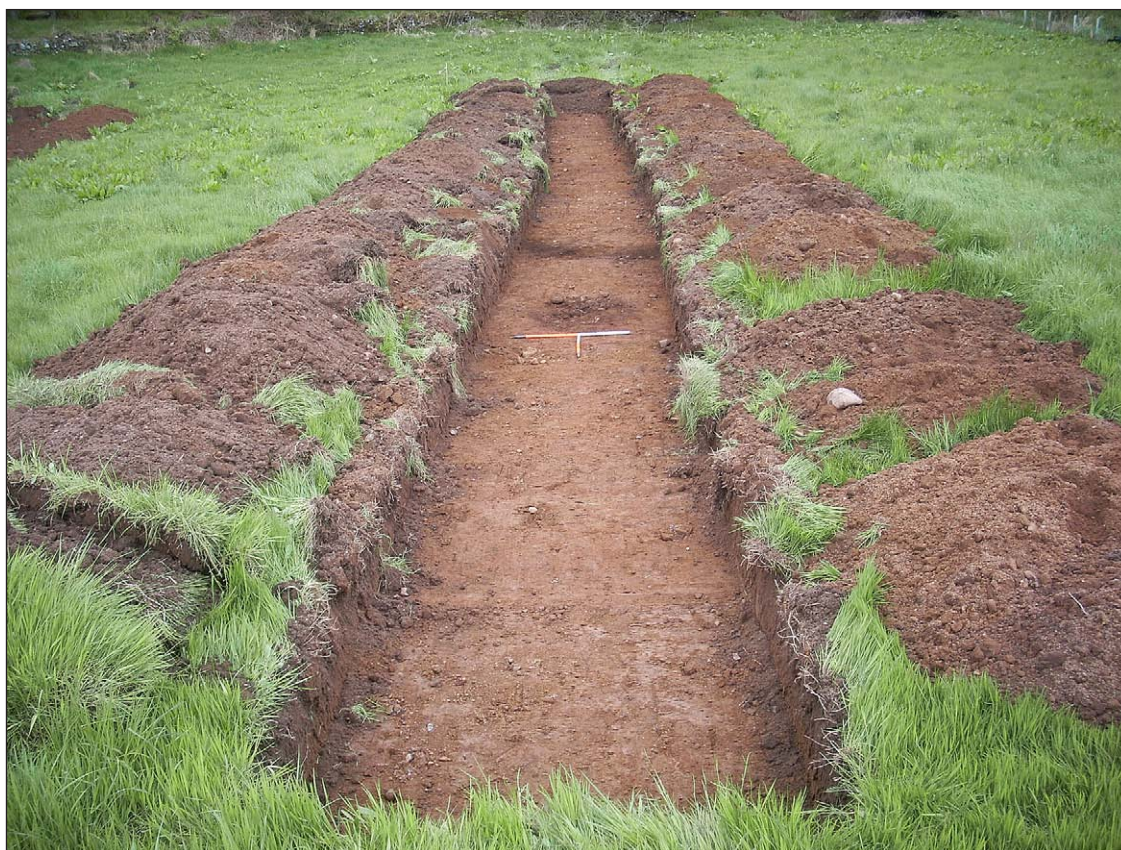
In Trench 4, a pit (**401**) and a linear ditch (**403**) were recorded (Fig. 5). Both were sealed by subsoil (**002**). Pit **401** measured 1.7m by 1.3m and it was aligned ESE-WNW. A section (Fig. 6) showed it to be 0.1m deep. It was filled with a pinkish-grey cobble-rich silty sand (**402**). No finds were recovered.

Fig. 5 - Trench 4, showing pit 401 and ditch 403 in mid-trench

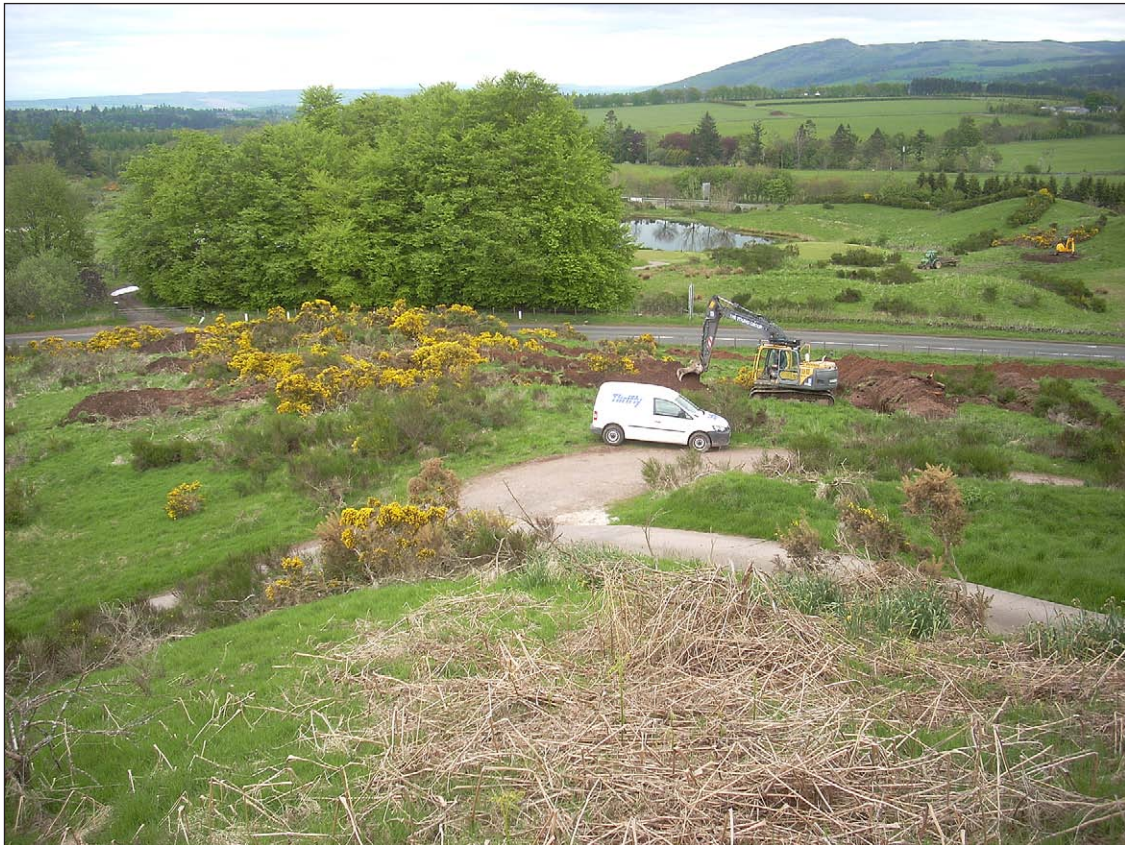
Area 3 is undulating and uncultivated with stands of gorse and broom (Fig. 8). No archaeological remains were found.

Fig. 8 - General view of Area 3 from the west

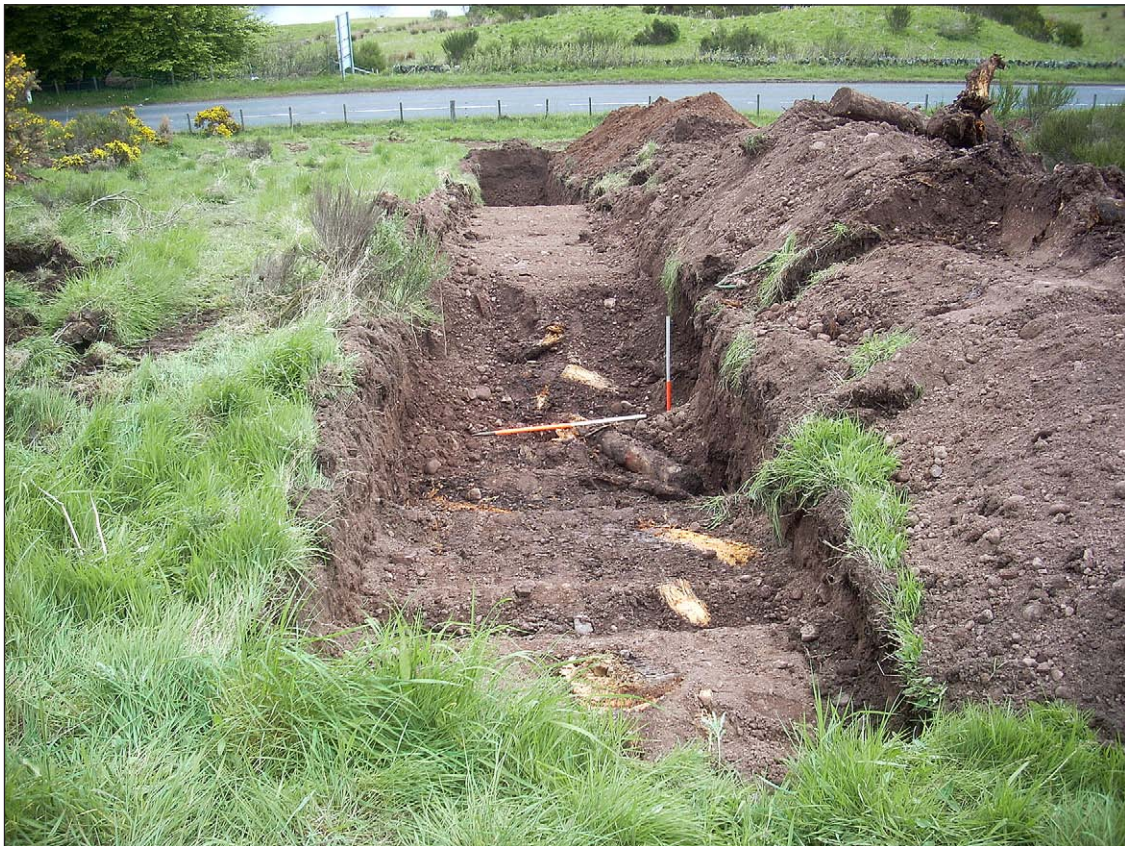
Fig. 9 - Trench 16, dumped trees and soil (1602) capped with gravel (1601)

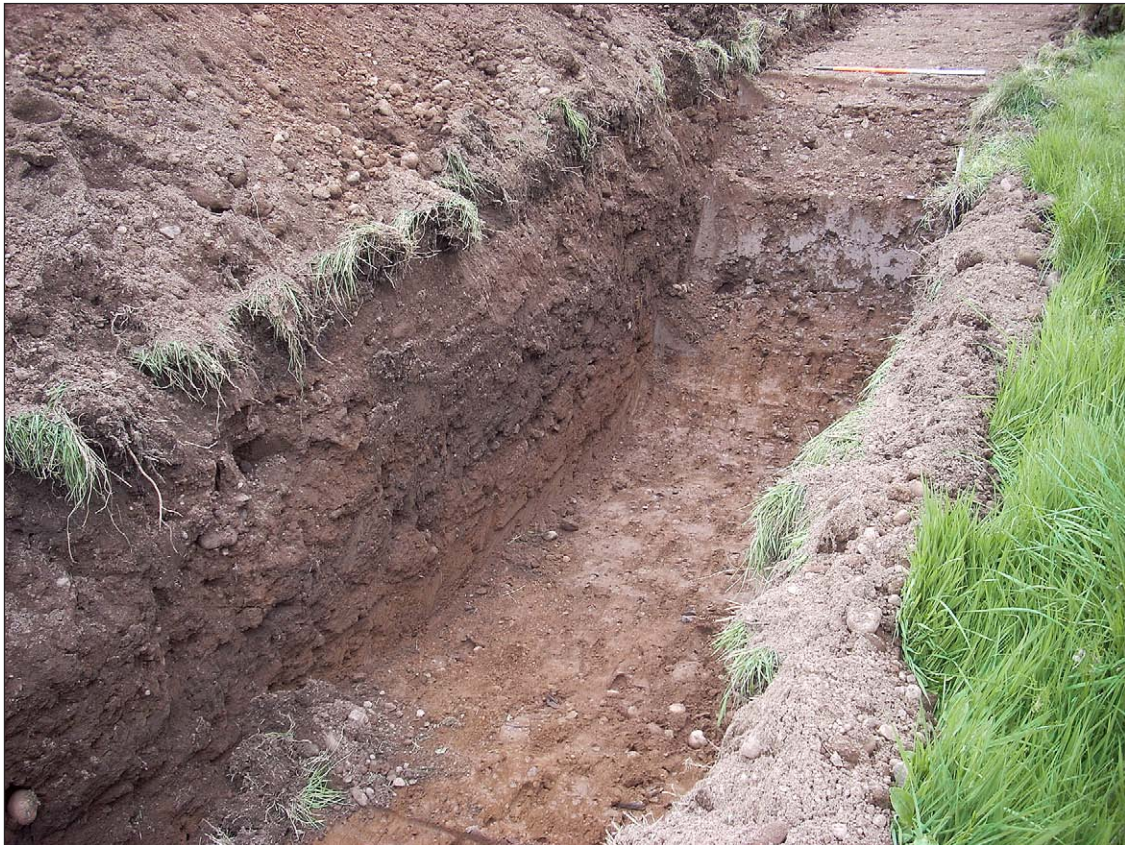
At the western end of Trench 16, under thin topsoil (**001**), this re-deposited sandy gravel made ground (**1601**) was removed by machine (Fig. 10), revealing a dump of substantial pine tree trunks and similar tree stumps in a matrix of peaty soil (**1602**). At the eastern end of the trench, the made ground (**1602**) overlay a buried soil (**1603**) which overlay subsoil (**002**) and natural (**003**). The depth of the trench was 1.8m. The section is shown in Fig. 11.

Fig. 10 - Trench 16, made ground (1601-2) overlying an orange-brown soil (1603) in the base of the section

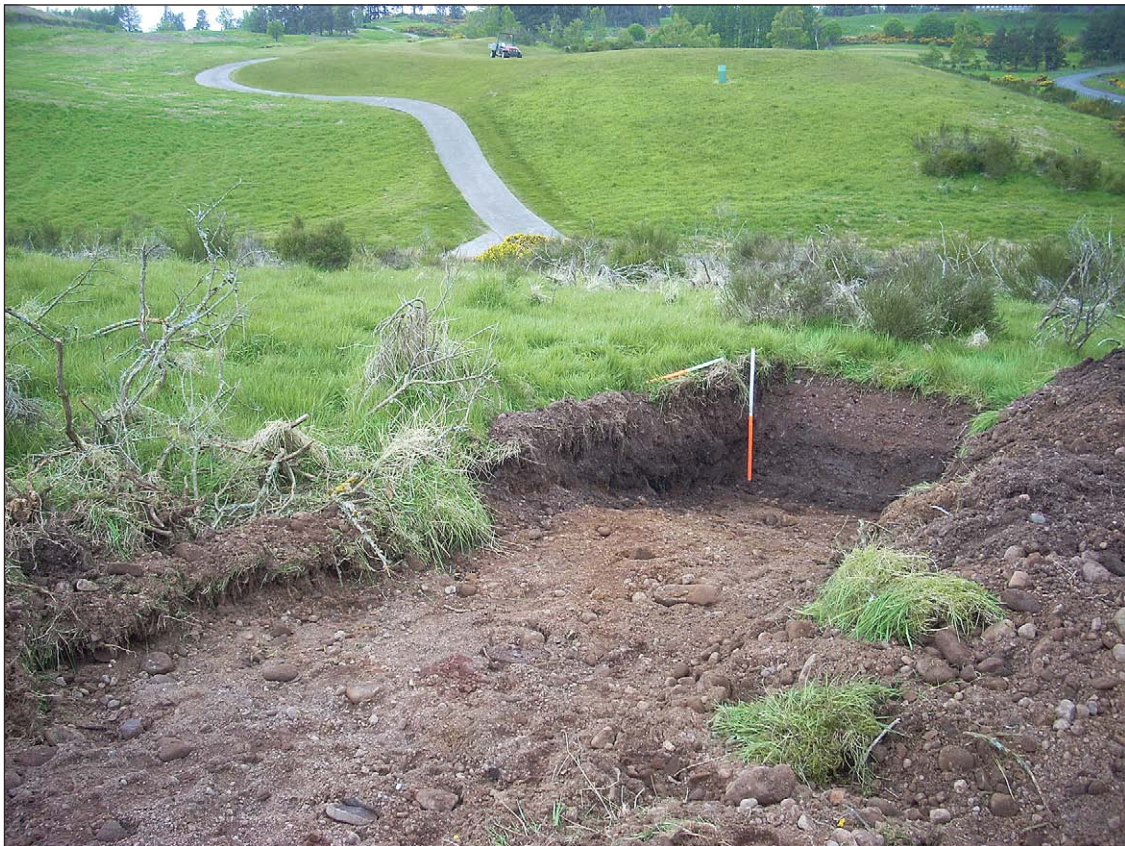
Fig. 11 - Trench 19. Break of slope at the northern end where the natural subsoil has been truncated by the cutting for the underpass

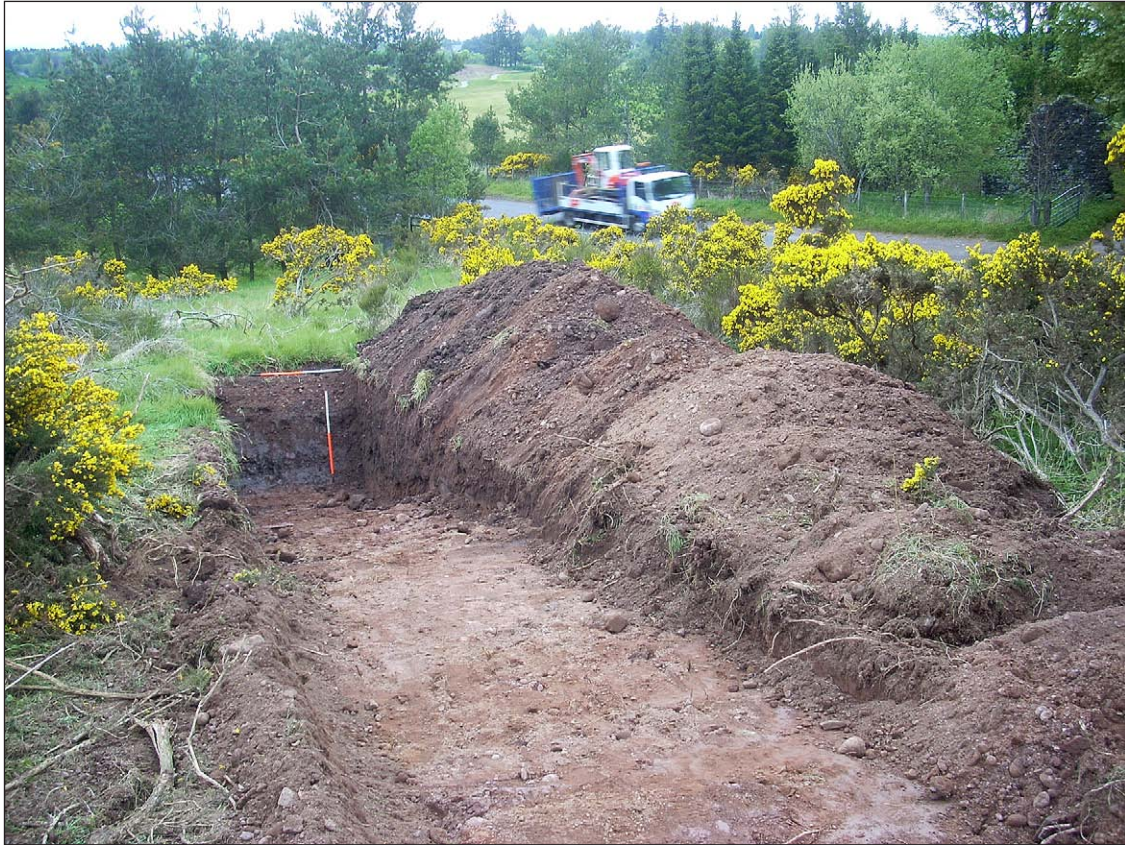
In the northern end of Trench 19, a break of slope in the natural gravels (**1902**) was overlain by alternating layers of topsoil and sandy gravel made ground (**1903**), increasing in depth to the north (Fig. 12).

Fig. 12 - Trench 20. Break of slope at the northern end where the natural subsoil has been truncated by the cutting for the underpass
