Mavisbank House, Loanhead: Mine Ventilation Shaft Works

Archaeological Recording

Report No. 3040

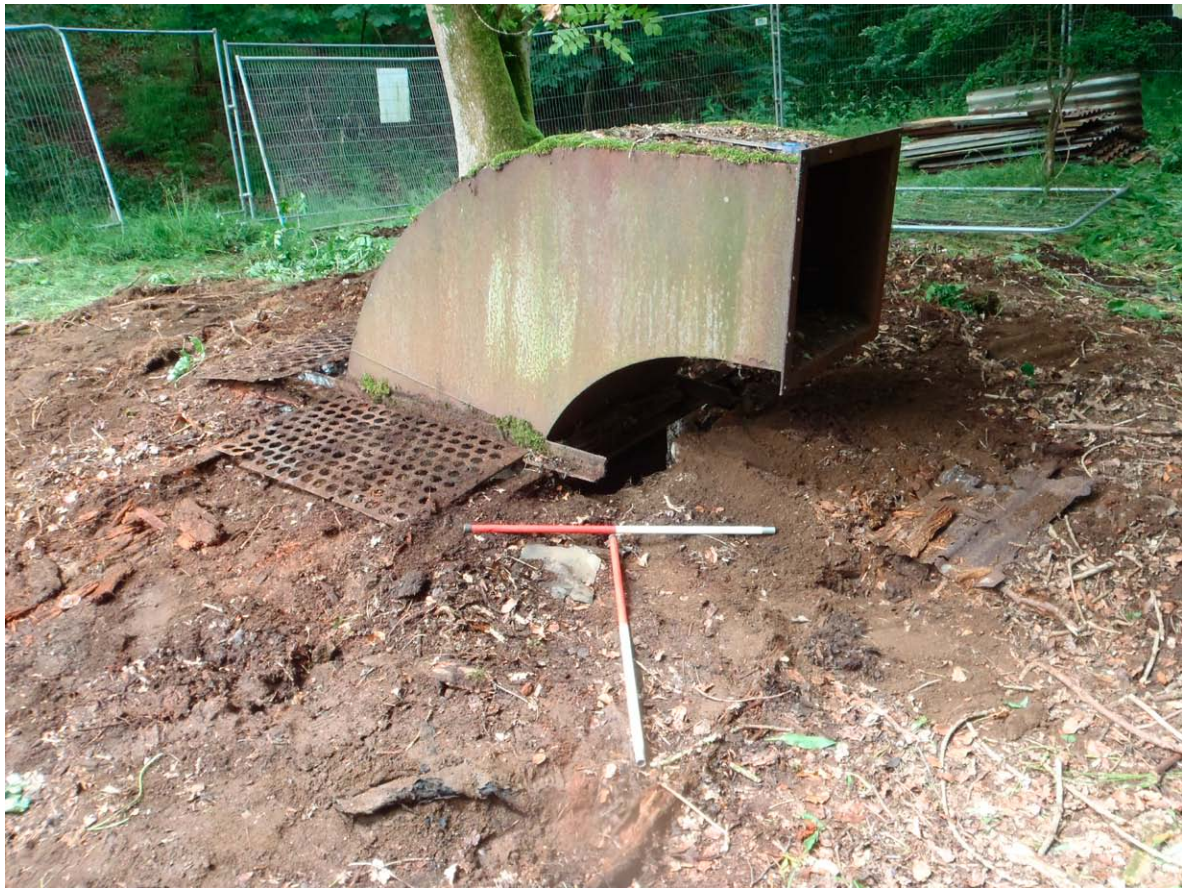
Leaf litter and surface vegetation, consisting of bracken and weeds, was scraped clear of the air shaft prior to excavation works commencing (Fig. 2-3). The air shaft cover was a curved iron vent within a framework of thin iron girders, with perforated metal plates covering the edges of the top of the shaft (Fig. 2-3).

Fig. 2 - Air shaft prior to excavation

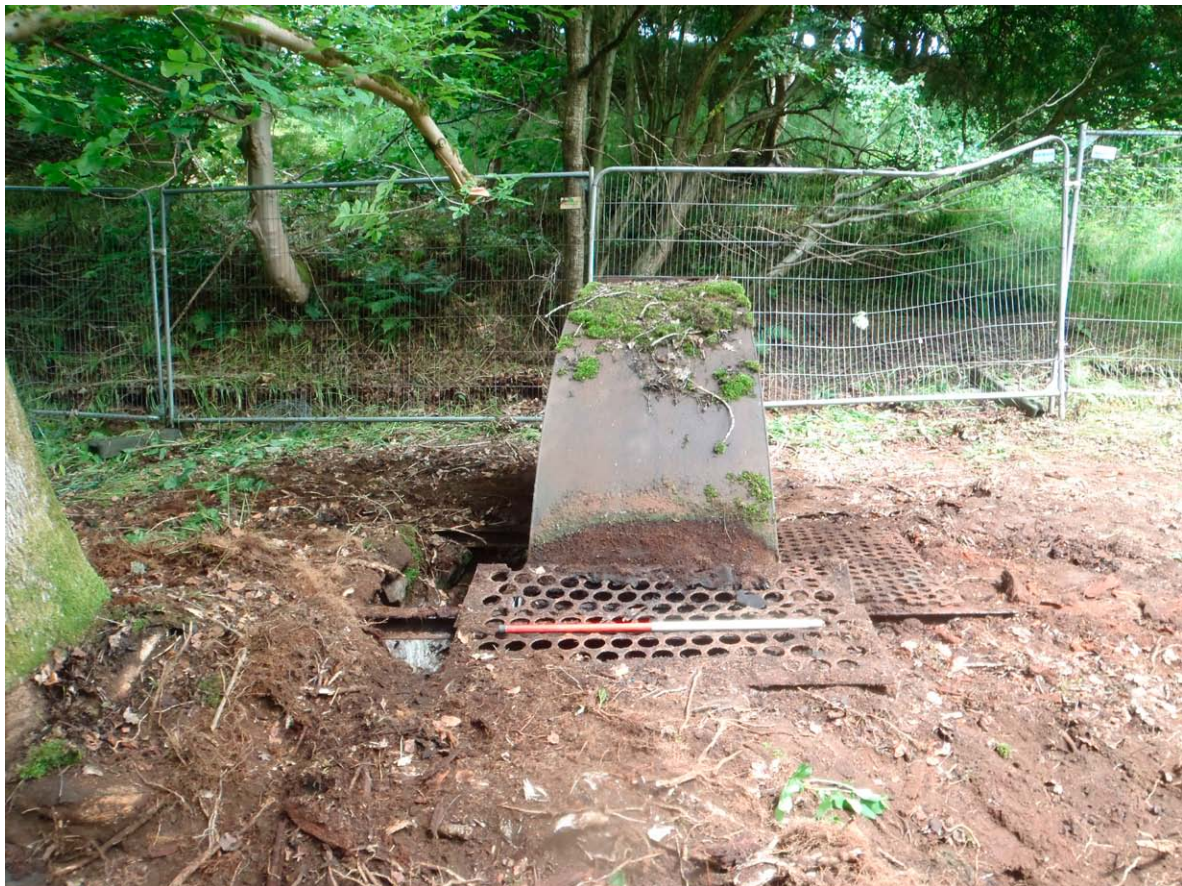
Fig. 3 - Air shaft prior to excavation

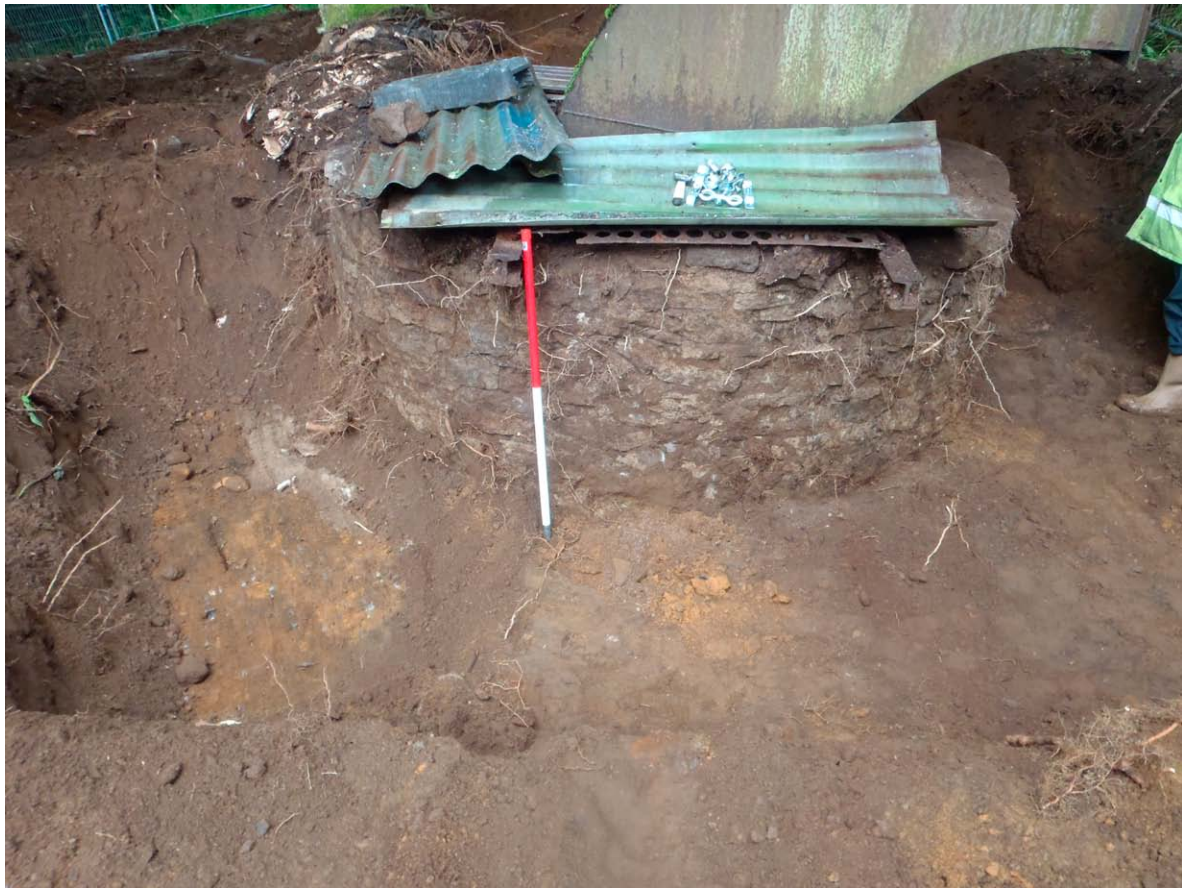
The area excavated around the air ventilation shaft measured approx 3.5m by 3m and was dug to a depth of approx. 1.1m. A tree in the NW corner of the excavated area was left in situ. Roots from this tree had caused some damage to the shaft's stonework (Fig. 8).

The mine ventilation shaft was circular and was exposed to a height of approximately 1m. It was built of roughly hewn, regularly coursed, grey sandstone blocks bonded with concrete. The interior of the shaft was not exposed.

Fig. 4 - Air shaft post excavation

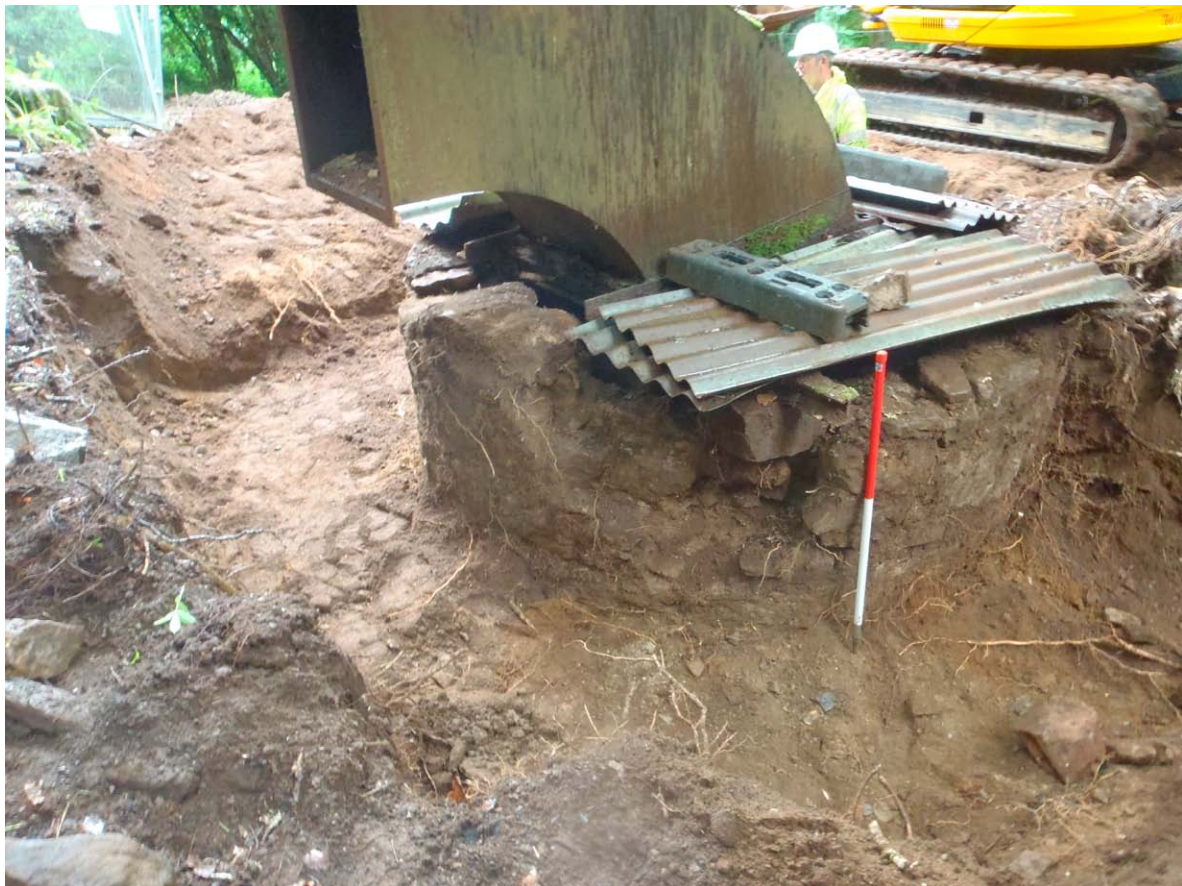
Fig. 5 - Air shaft post excavation
