**Stonehouse, Sprouston, Kelso,  
Scottish Borders**

**Archaeological Watching Brief**

**Data Structure Report  
No. 2169**

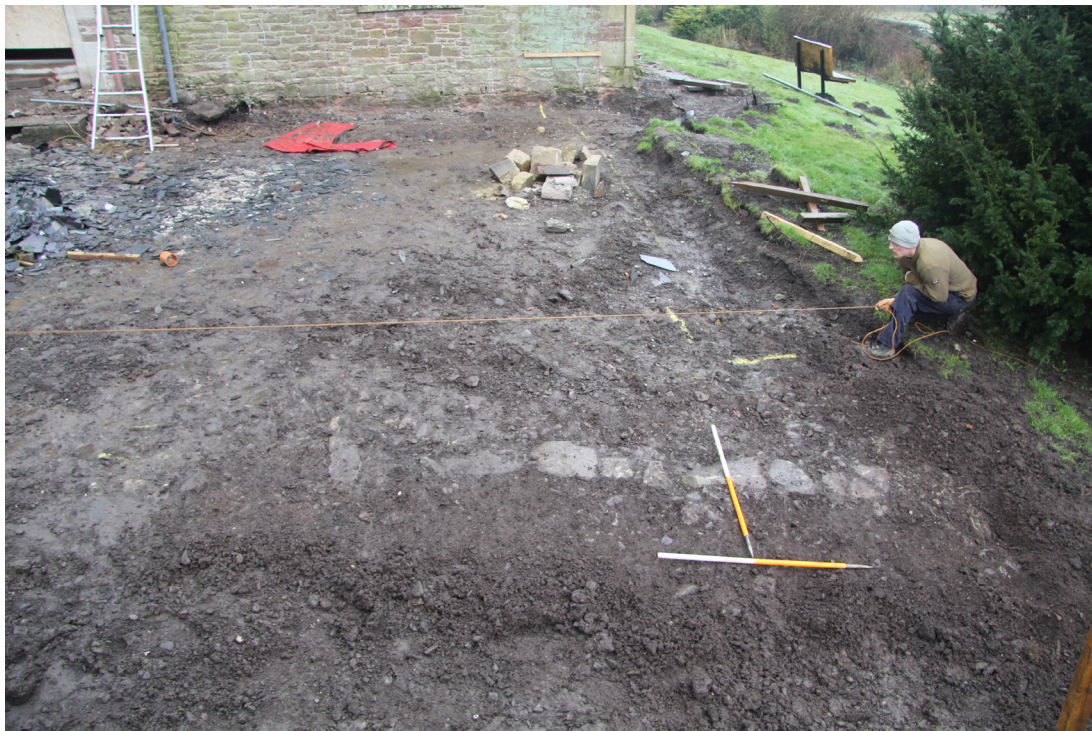
Fig. 7 - Possible wall 51 prior to excavation of foundation trenches

During the removal of a spoil heap, a NNW-SSE alignment of stones was recorded (**51**). This measured 4m long and c.0.3m wide (Fig. 7). It was constructed of un-bonded flat and rounded schist stones and there was no evidence of a foundation cut. This feature could be the remains of a wall. It lay outside of the foundation trenches and this area was not subject to any further ground reduction and so it was preserved in situ following recording.

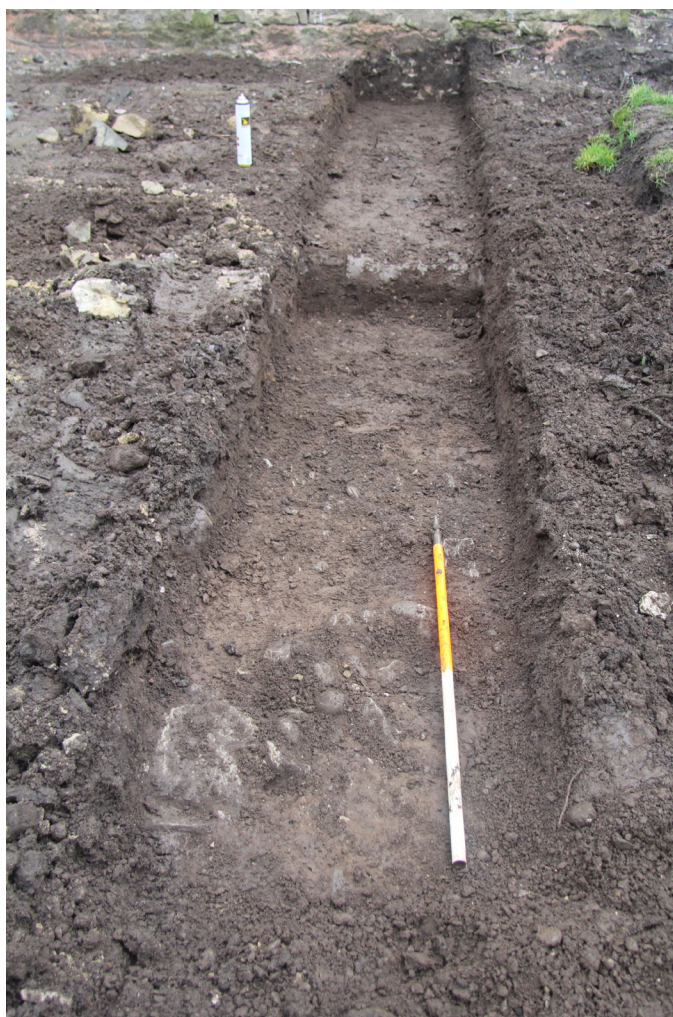
Fig. 8 - Photo showing Trench 1 and feature 52 (facing south-west)

A small rubble drain (**52**) was recorded; this comprised of un-bonded stones set firmly within the reddish-brown clay natural (Fig. 8). The drain overlay a wall (**53**) and this was constructed of large flat rough sandstones, bonded with reddish-brown clay (Fig. 9). The wall appeared to run parallel with wall **51**; however, unlike that wall this was bonded and better constructed. Overlying this wall was a thin deposit of rounded

pebbles (57). As formation level had been reached, no further excavation took place and the features were preserved in situ following recording.

The first edition 25" Ordnance Survey map (1863) shows a path lying to the north-east of the manse and a property boundary wall to the adjoining property. It seems likely that walls **50** and **53** could form the remnants of this boundary wall, and that rubble drain **52** ran along the edge of the path. The second edition 25" Ordnance Survey map (1898) shows an outbuilding built up against the boundary wall and an additional boundary within the development area running NE-SW: these don't appear to be represented by any of the archaeological remains found but could account for some of the demolition rubble, and other garden walls, landscaping and outbuildings may have been present within the development area. It seems likely that the vestigial remains recorded during the watching brief are 19th century in date. The majority of these remains are preserved in situ beneath the footprint of the conservatory.
