## **Hassendeanburn Bridge, Scottish Borders**

### **Archaeological Watching Brief**

**Report No. 3070**

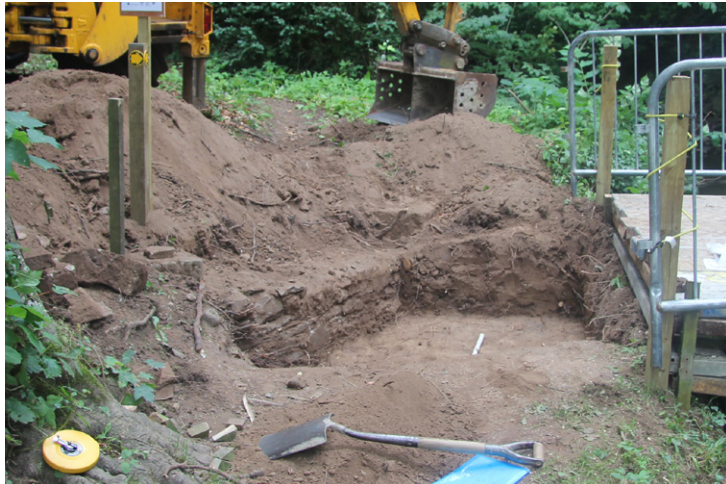
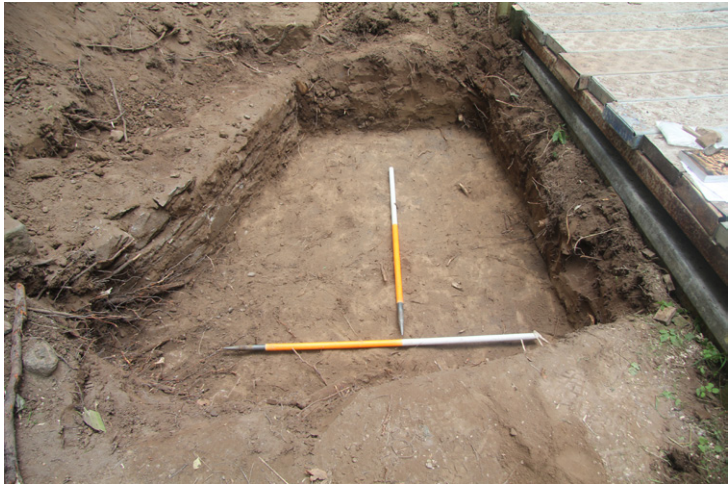
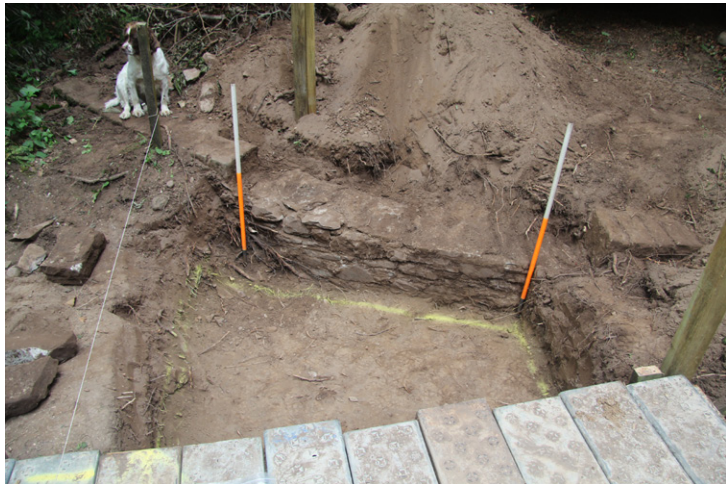
Excavation extended 1.8m N-S by 1.7m E-W on the south side of the trench and 1m on the north side of the trench. The stratification consisted of 0.45m of mid-brown sandy silt topsoil (**100**) over a light yellowish brown sand deposit (**101**) that extended to the bottom of formation depth, 1.5m below the current ground level. The sand deposit (**101**) contained fragments of charcoal and recent pottery, which was not retained, and abutted a curving wall (**105**). The wall (**105**) was constructed of worked sandstone and mortar. Some of the top capstones had been robbed out. The wall continued below formation depth and was preserved to height of at least 0.62m. The sand deposit (**101**) may have been placed to support the wall (**105**) and/or protect it from erosion.

Fig. 2 - Western Bridge Abutment, post-ex

Fig. 3 - Western Bridge Abutment, post-ex

Fig. 4 - Western Bridge Abutment, post-ex

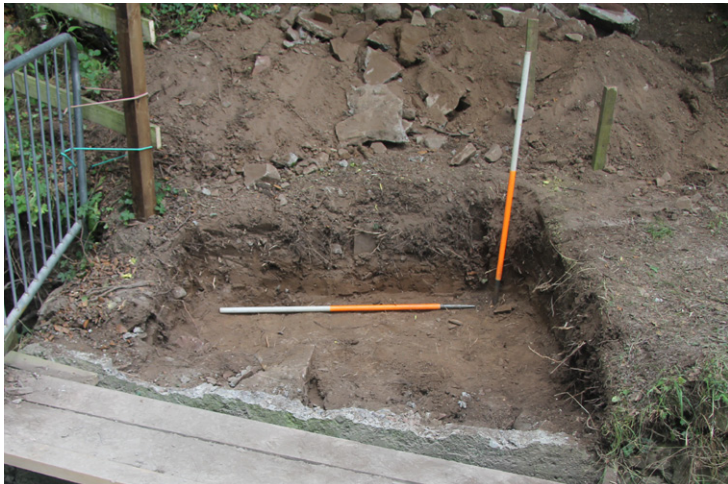
Fig. 5 - Eastern Bridge Abutment, post-ex

The extent of the excavation was 1.7m N-S by 0.9 E-W on the north side and 1.3m on the south side of the trench.

The stratification consisted of 0.5m of midbrown silty sand topsoil (**102**) over mid-brown silty sand (**103**) that continued to the bottom of formation depth, 0.6m below the current ground level. Modern pottery and tile was found in context (**103**), but was not retained.

A concrete retaining wall (**104**), running roughly NE-SW, extended into the trench a few centimetres along its western edge of excavation; this wall overlay deposit (**103**).
