## **Paddlesports Centre at Pinkston Basin, Port Dundas, Glasgow**

### **Archaeological Watching Brief and excavation**

**Report No. 2198**

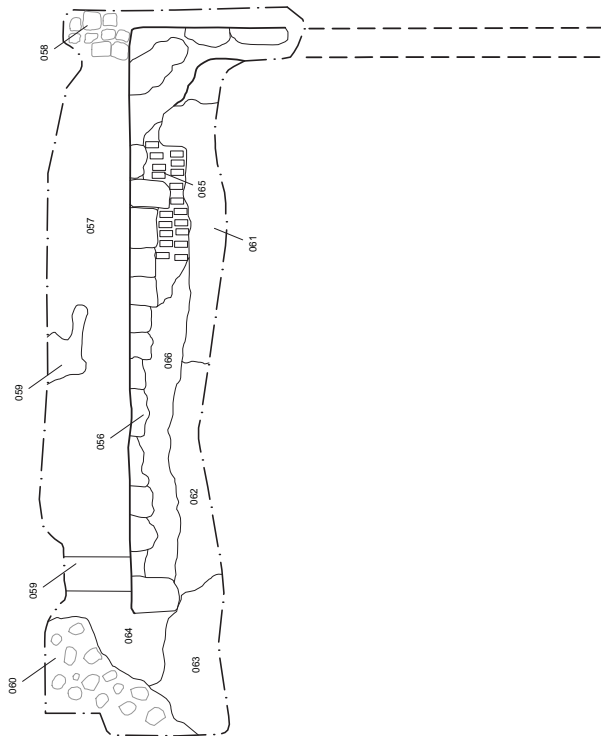
Fig. No: 5 Revision: A

Parts of the western and northern (**056**) walls of this building were uncovered, suggesting it was a rectangular building aligned approx N-S and measuring at least 9m wide by at least 30m long (Fig. 3, 5).

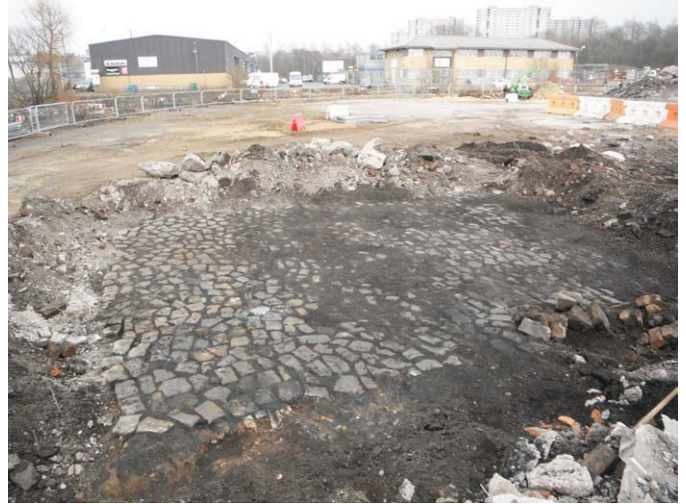
Fig. 10 - General shot of cobbling at east end of island

Underlying the modern tarmac surface and gravel (**001, 002**), large areas of cobbling survived (**028, 038, 039, 048-51, 058, 068, 078, 091**), consisting of setts overlying a coal dross/ash/gravel bedding deposit (**069, 090**). This cobbled surface presumably relates to the earlier use of the site, providing a hard standing surface for the wharf and Iron Depot (Fig. 10-11). The cobbling had been removed in order to accommodate the later buildings (Buildings 1 and 2). Sample areas of the cobbling were cleaned up and recorded in detail. Areas which appeared to have been replaced in brick were recorded (**052**).

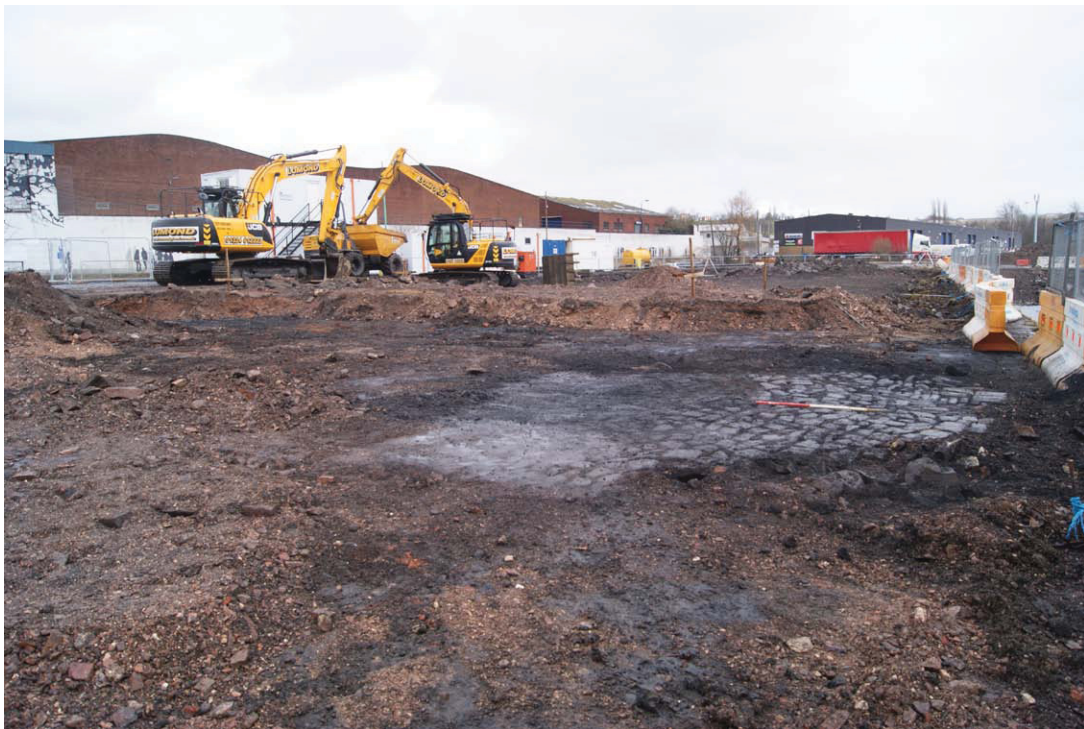
Fig. 11 - General shot of cobbling in centre of island

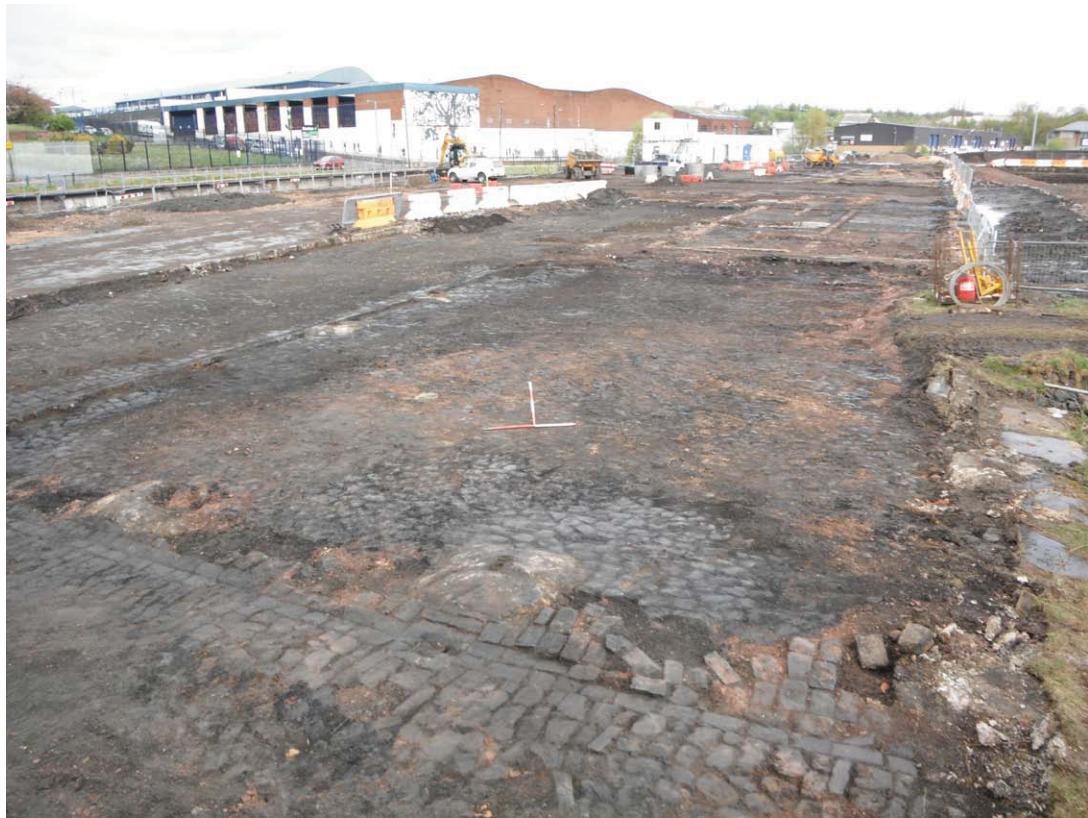
*Fig. 12 - Overview of buildings 1 and 2*

The plan of Building 1 was exposed in its entirety during the programme of works (Fig. 3, 12-14). It consisted of a large, rectangular structure which measured 17.5m ENE to WSW by 9.5m NNW to SSE. The north, west and east external walls (**082, 083/095, 088**) were three rows of mortared red brick laid in a stretcher position, while the south wall was one brick wide laid in a header position (**096**). The walls were exposed to a maximum depth of 0.06m, and each wall measured approximately 0.35m wide.

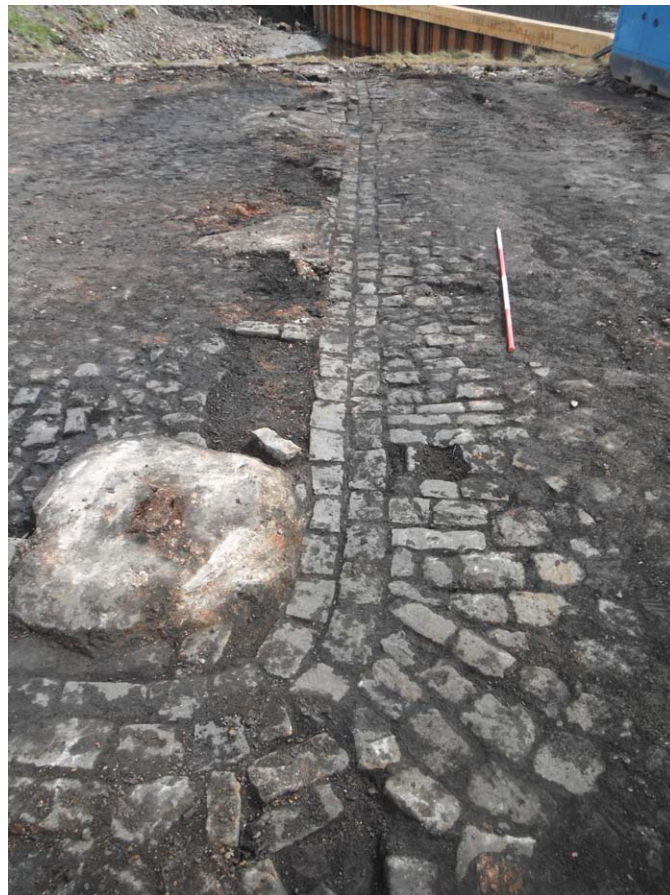
*Fig. 15 - Western edge of building 2 with one of the column bases*

A drainage channel built of setts (**160**) ran around the exterior of Building 2 on the northern and western sides (Fig. 15), and there was a drain within the interior of the building (**161**). The floor surface of the building was randomly laid setts (**091**) bedded into a black ash/gravel deposit. This floor appears to have been the original wharf surface re-used as the interior floor surface when the structure was built.

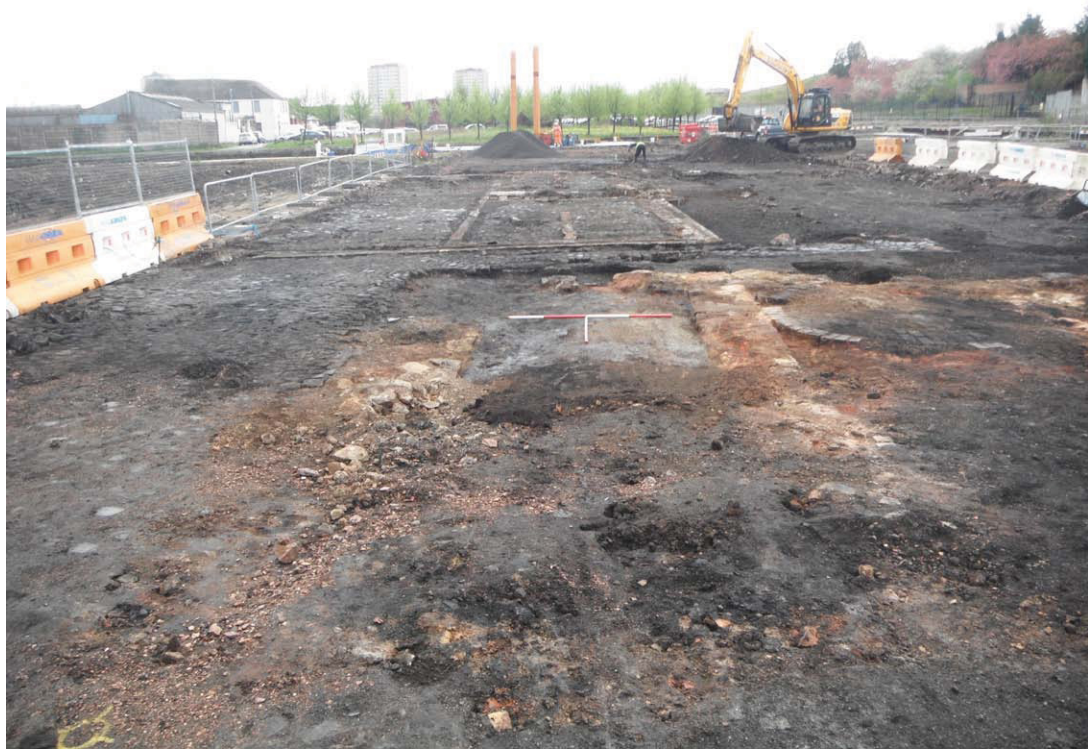
*Fig. 16 - Building 3 in the foreground*

The building was divided internally into three compartments by walls **106** and **119**, also built of sandstone and measuring 4m long by 0.7m wide. The southernmost compartment had a mortar floor (**105**) (Fig. 16).

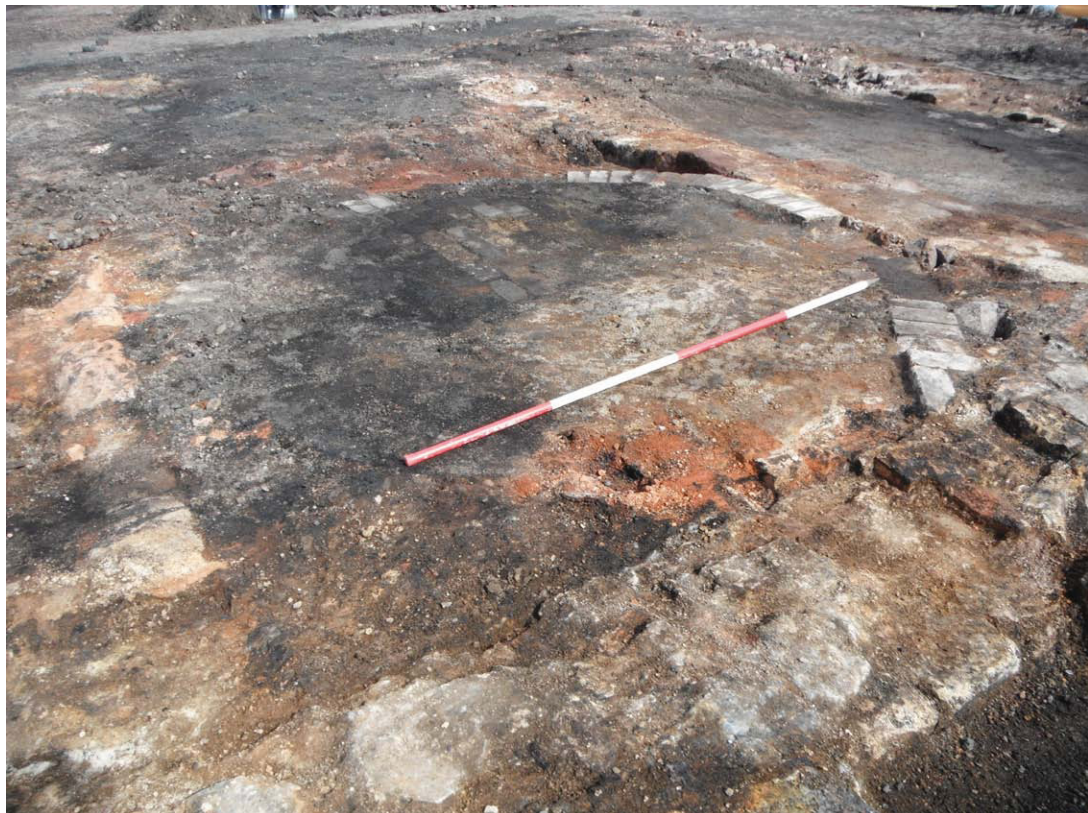
*Fig. 17 - Coke oven 1*

Oven 1 (Fig. 17) lay between walls **106** and **119** in the central compartment uncovered. Oven 1 (**121**) was the best preserved of the three and was sub-circular in form. The interior of the oven was 3m in diameter, whilst the exterior measured 3.2m. A single course of red bricks formed the base of the oven, overlying a 0.68m thick orange/red sandy clay/rubble mix deposit (**163**) (Fig. 18-19). The heat from the oven had produced a greyish discolouration at the interface between the two contexts, and many of the bricks making up the base were blackened and fire damaged.

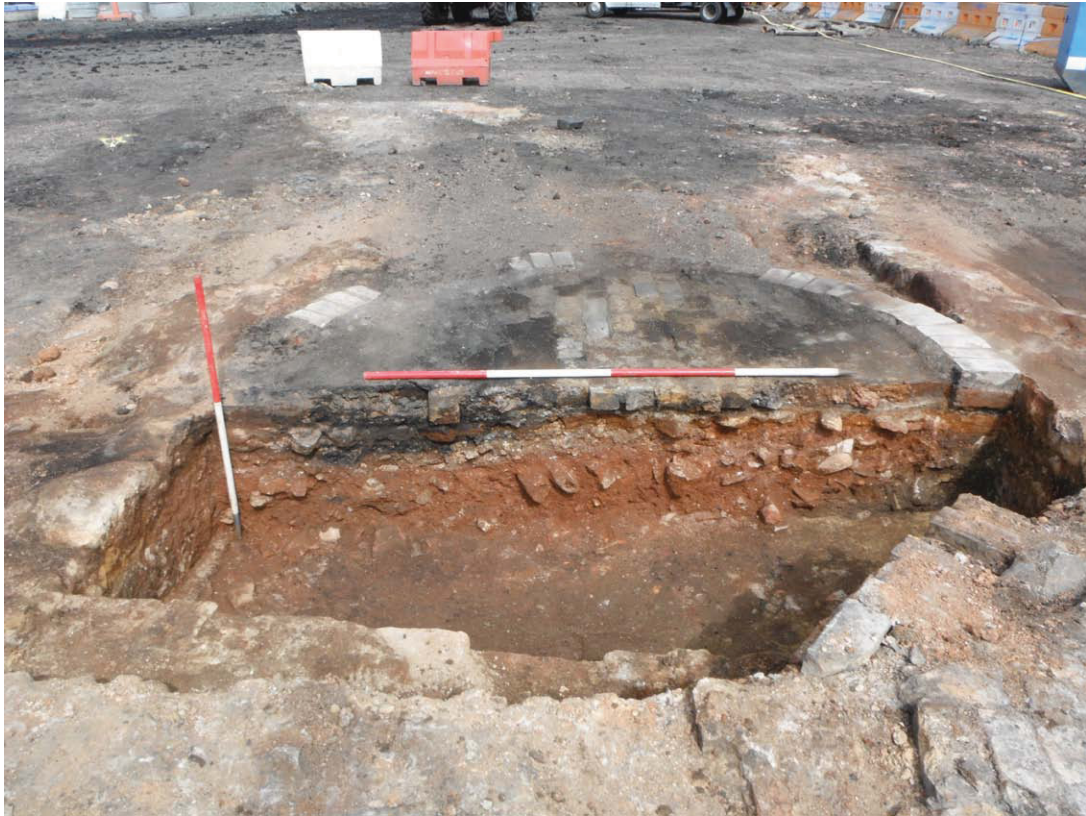
*Fig. 18 - Coke oven 1 half-sectioned*

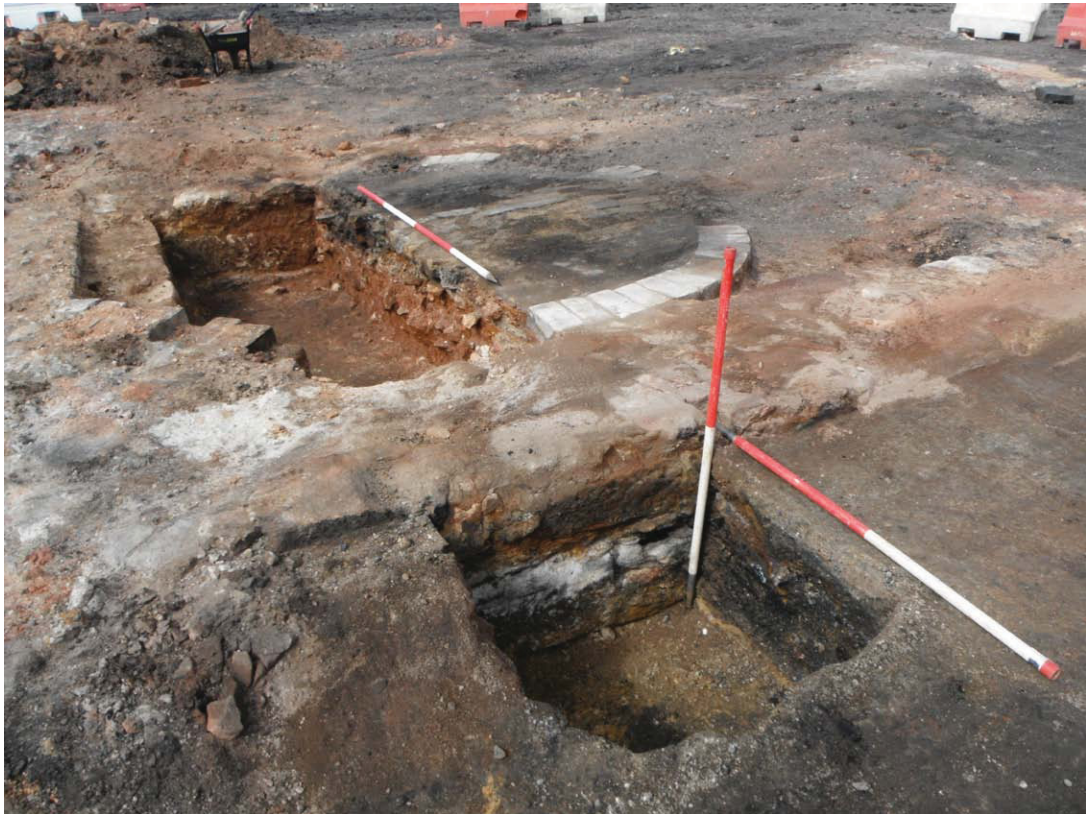
*Fig. 19 - W-facing section through oven 1 and adjacent sandstone wall 106*

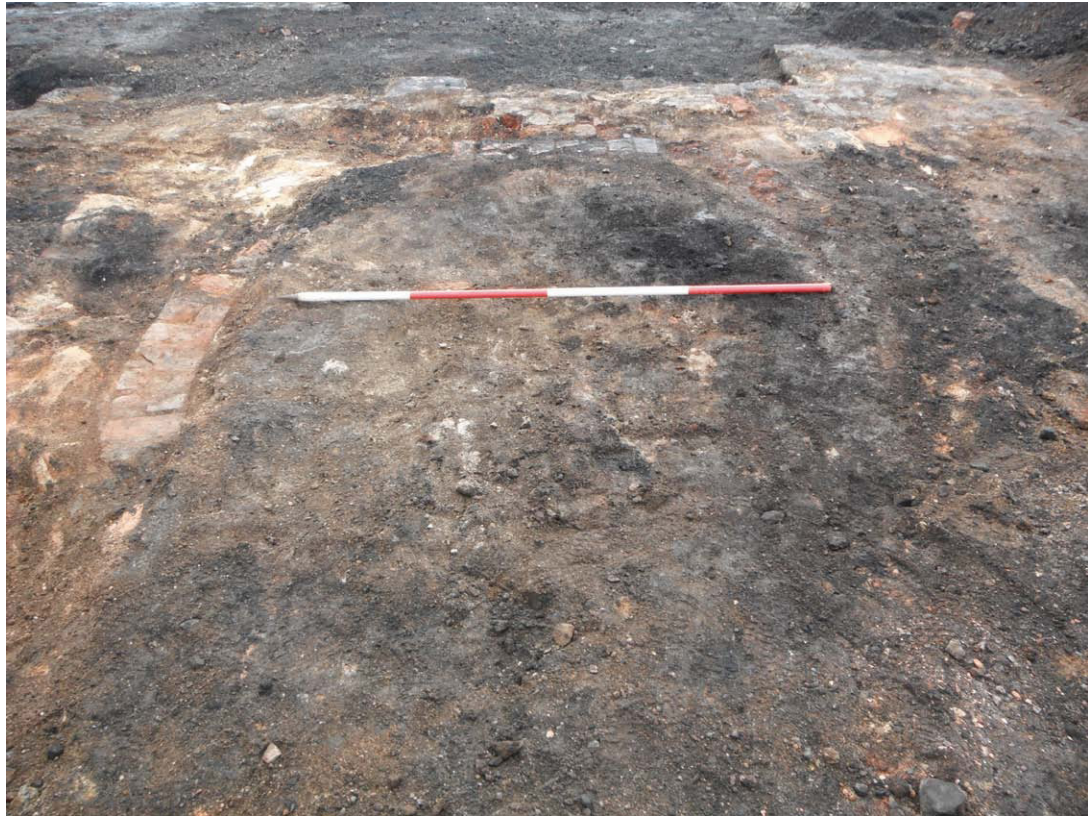
*Fig. 20 - Coke oven 2*

Only the western and southern sections of Oven 2 (**128**) remained (Fig. 20), therefore, it was not possible to ascertain the complete dimensions of the oven. It was similar in construction to Oven 1 with a red brick outer wall and possible opening or stoke hole on the western side, indicated by a NNW-SSE alignment of bricks (**129**).

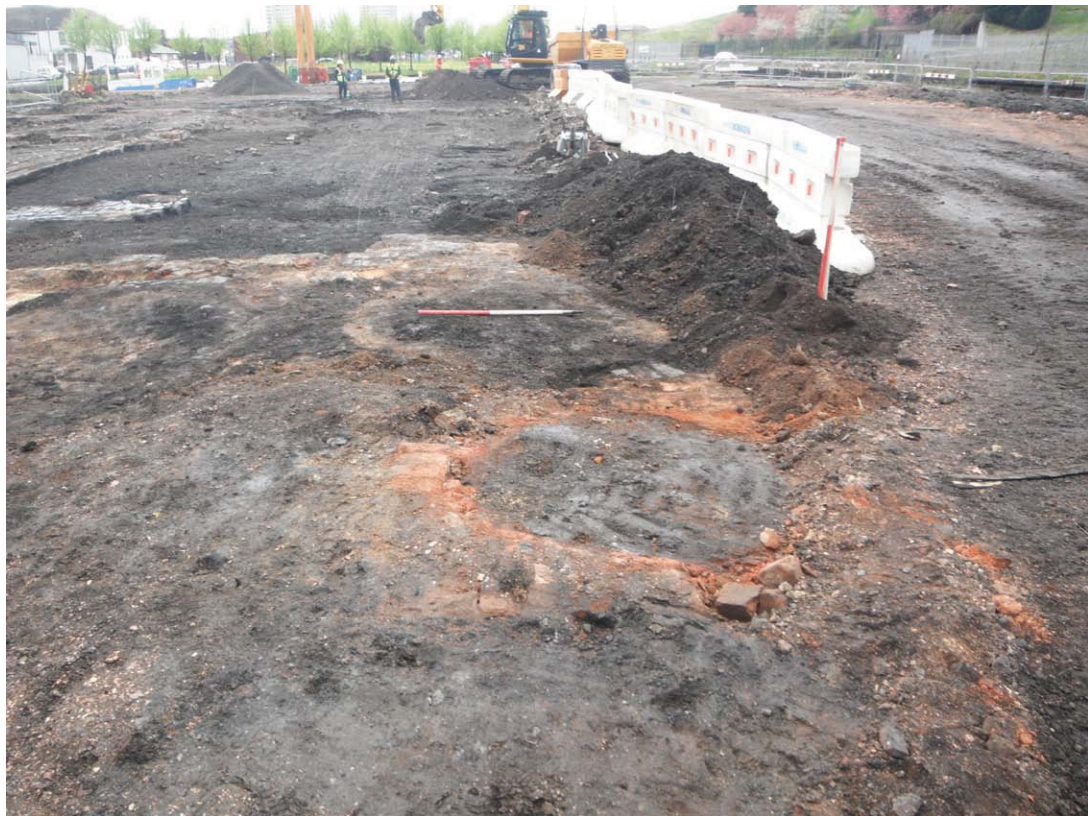
*Fig. 21 - Coke oven 3 and chimney 137 in foreground*

Similarly, only the southern half of Oven 3 (**131**), and possible flooring (**139**) on the exterior of Oven 3 was exposed during the ground works (Fig. 21).

The foundations of a square structure (**137**), measuring 2m by 2m, with a central, circular cavity with a diameter of 1.7m was uncovered during the programme of works (Fig. 21). The brick built structure was 0.25m to the east of Oven 3. The structure was initially thought to be a well. However, given its location, it is more likely to be the remains of one of the chimneys depicted on the OS Glasgow Town Plan and is associated with the structure which housed the coke kilns.
