**Proposed 400KV Series Capacitor Bank  
Compound,  
Land East of Eccles Substation,  
Eccles, Scottish Borders**

**Archaeological Evaluation**

**Report No. 3086**

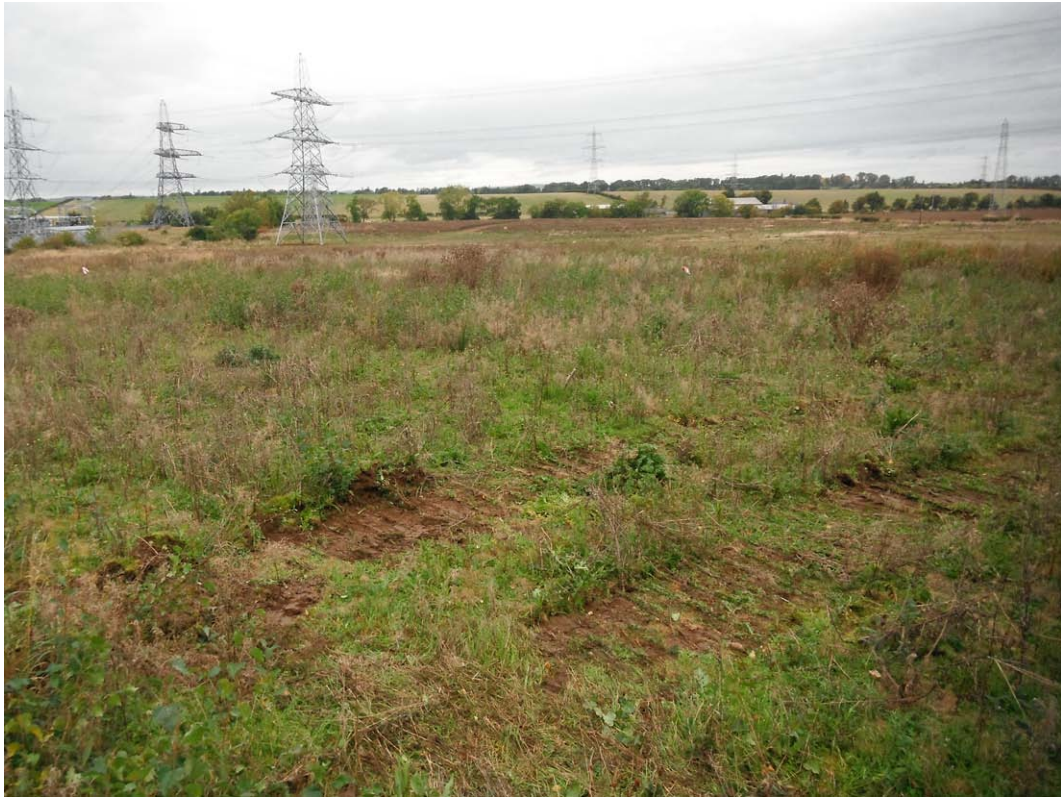
The site was undulating (Fig. 2) with the southern part (Trenches 1-22, Fig. 3) being on a gentle north facing slope. The central part, mostly within the southern pylon exclusion zone (Trenches 23-26) was low-lying and frequently waterlogged. The northern area (Trenches 27-34) included a low East to West ridge.

*Fig. 2 - General view of the site from the south*

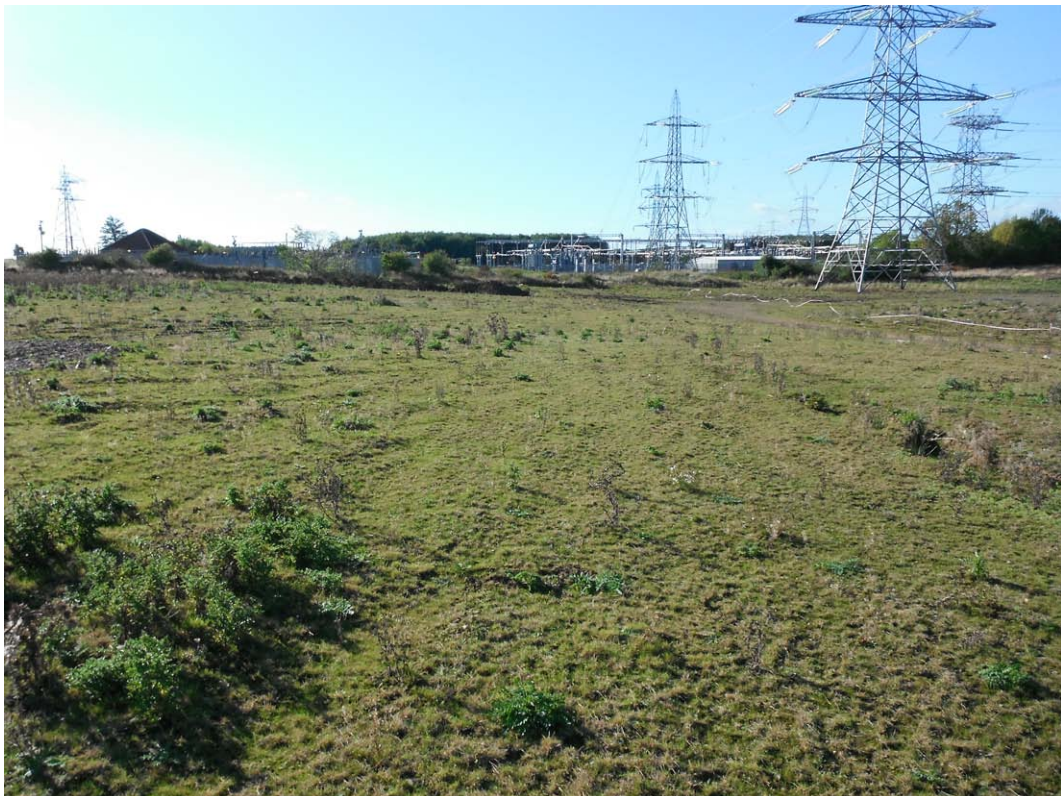
Due to previous work on site the topsoil had been heavily compacted and rutted close to both the pylons and the access track (Fig. 3) but was, in general, 0.35m deep and this overlay a motled pink/red/orange sandy clay-silt natural subsoil containing mostly small greywacke cobbles. Trench 16 is shown in Fig. 5. Deeper deposits were present in the northern end of Trenches 12, 18 and 20. This appeared to be a result of material from nearby excavations carried out during the re-routing of the pylon line being spread over the adjacent land. Clay-piped and stone filled field drains were present.

*Fig. 3 - General view of the area containing Trenches 9-22 pre-excavation*

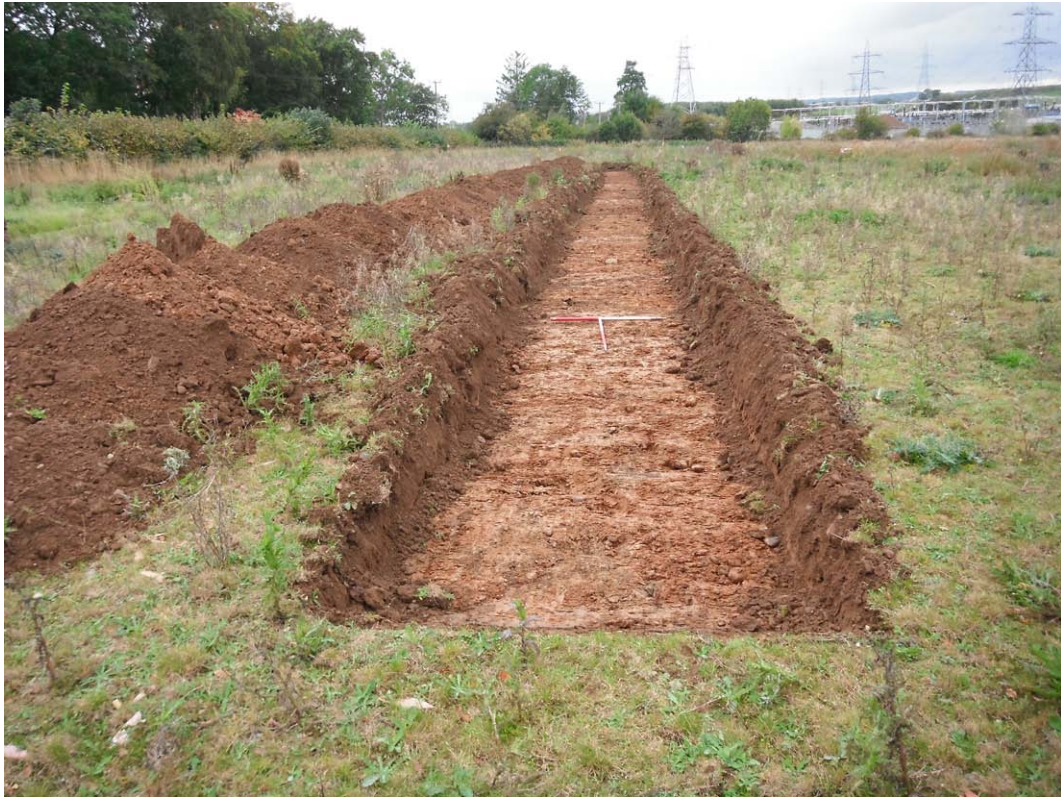
Topsoil was a uniform 0.35m deep and this overlay a mottled pink/red/orange sandy clay-silt natural subsoil containing mostly small greywacke cobbles. Clay-piped and stone filled field drains were present. Fig. 4 shows Trench 1 and the area of the bund.

*Fig. 4 - Trench 1 from the east*

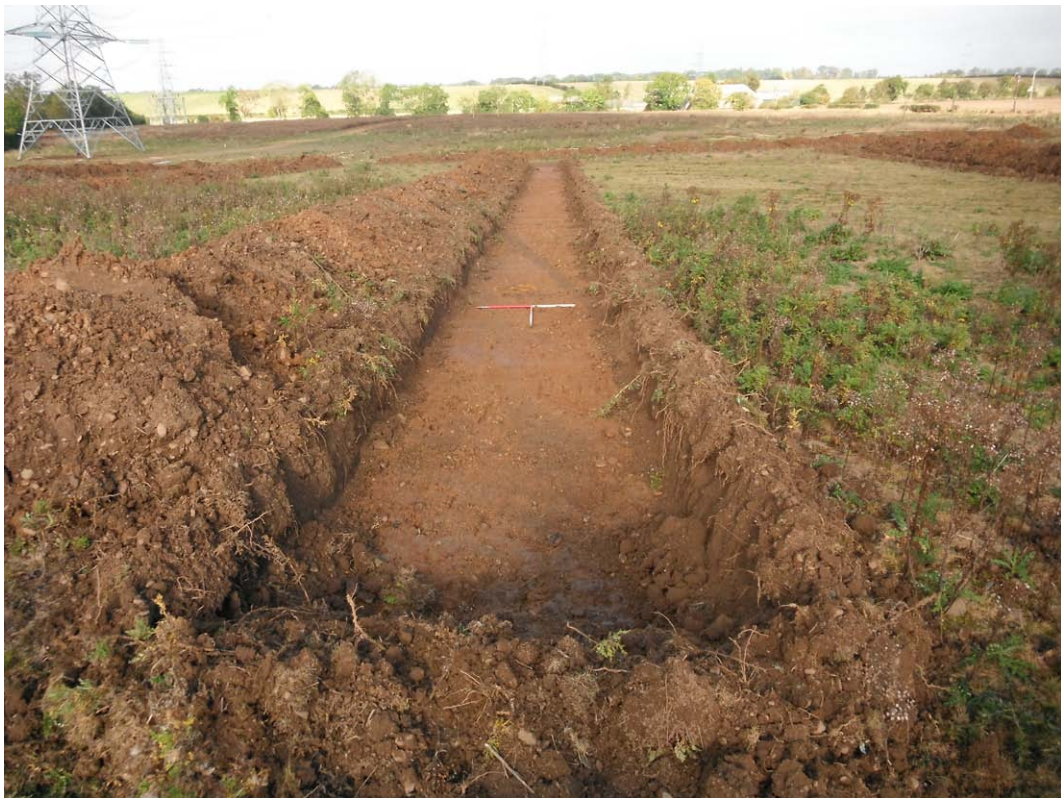
*Fig. 5 - Trench 16 from the south*

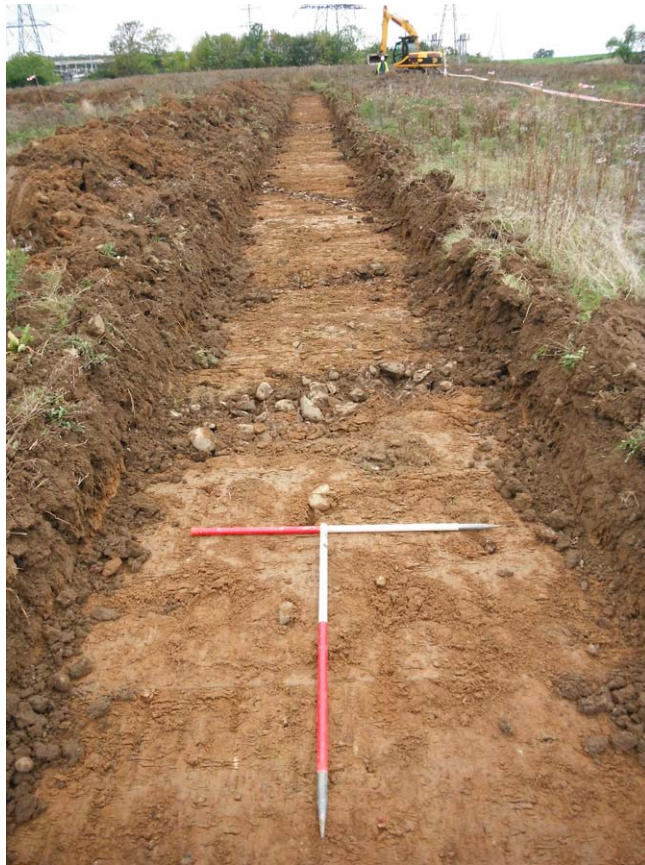
Due to previous work on site the topsoil had been heavily compacted and rutted in the area of Trenches 23 and 26. A general depth of 0.35m was recorded. Deeper deposits were present in the eastern end of Trench 23 and southern end of Trenches 29-31. Again, this appeared to be a result of material from nearby pylon-related excavations being spread over the adjacent land. The natural subsoil consisted of heavy yellow-orange clay in the area of Trenches 23-26, with more gravelly and better drained deposits on the slightly elevated ground to the west. Clay-piped and stone filled field drains (Fig. 6) were present.

*Fig. 6 - Trench 27, stone-filled field drains*

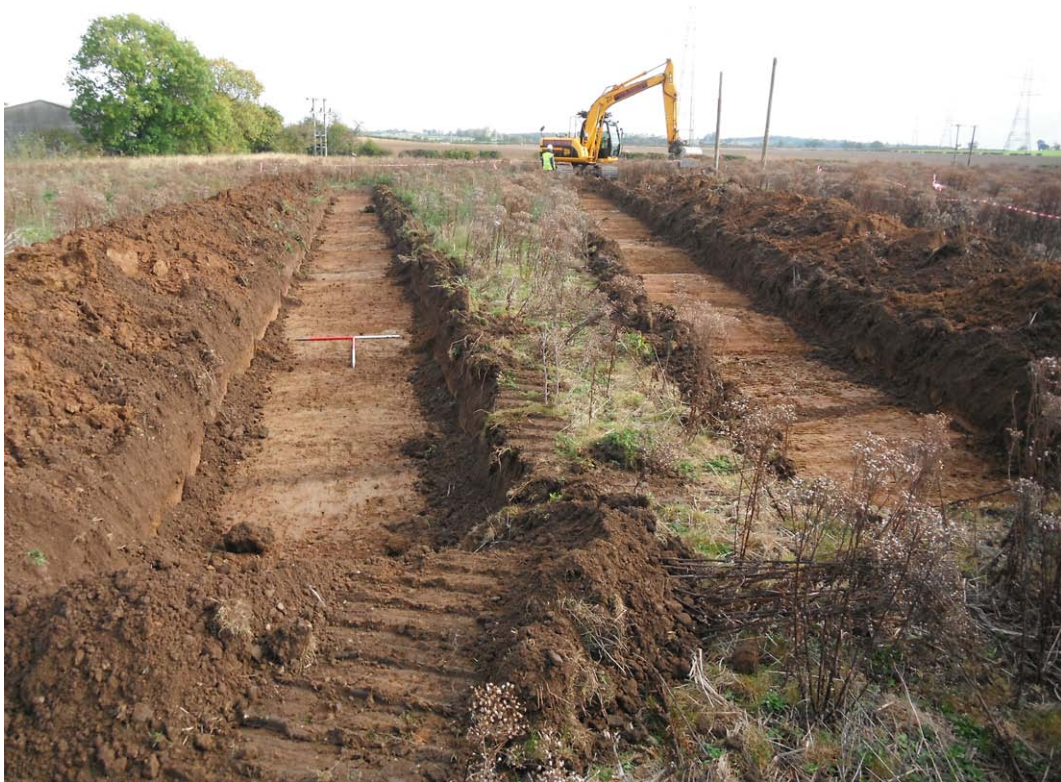
A general view of these trenches from the west is shown in Fig. 7. Topsoil with a depth of 0.35m overlay a more varied natural subsoil, with patches of orange silty sand alongside areas of more clayey and stony deposits. Clay-piped field drains were present.

*Fig. 7 - Trenches 33-34 from the west*
