## **Aberlour Main Street Flood Relief Scheme, Charlestown of Aberlour, Moray**

**Watching Brief**

**Report No. 3085**

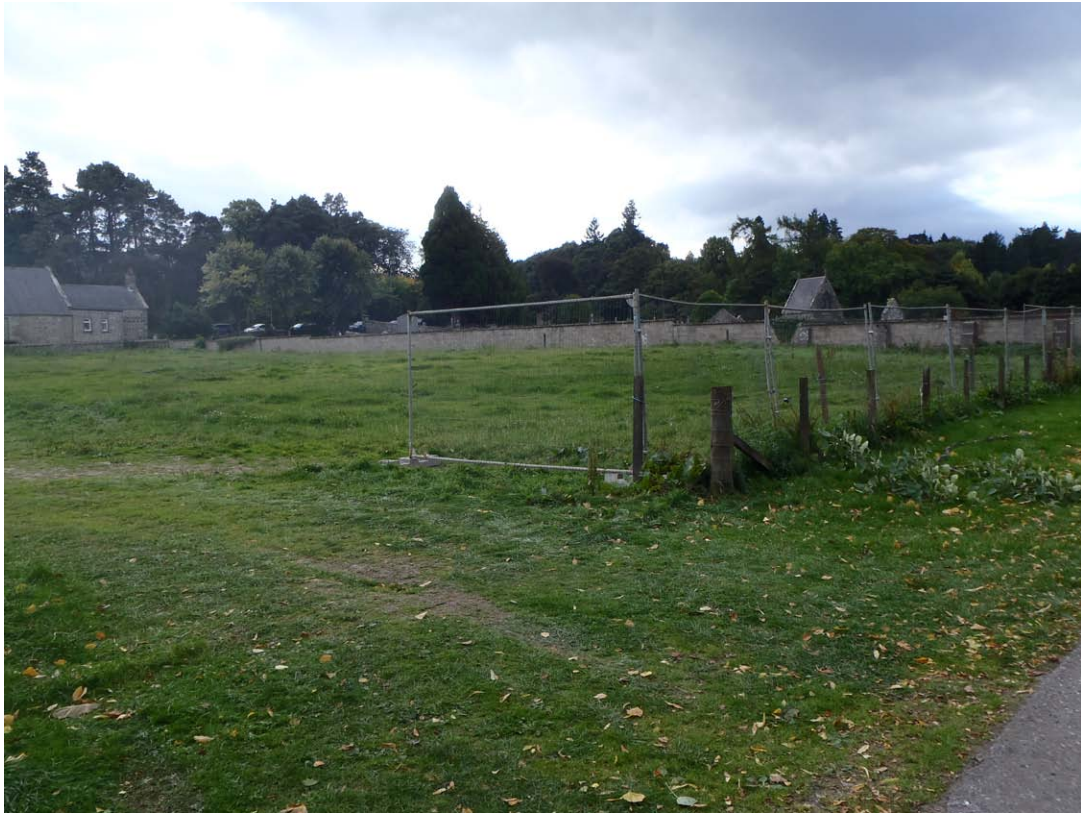
*Fig 2. - Watching brief area prior to topsoil stripping*

An irregular area measuring approximately 2800m<sup>2</sup>, measuring c.84m NW-SE by c.57m NE-SW, was stripped of topsoil (Fig. 1-3).

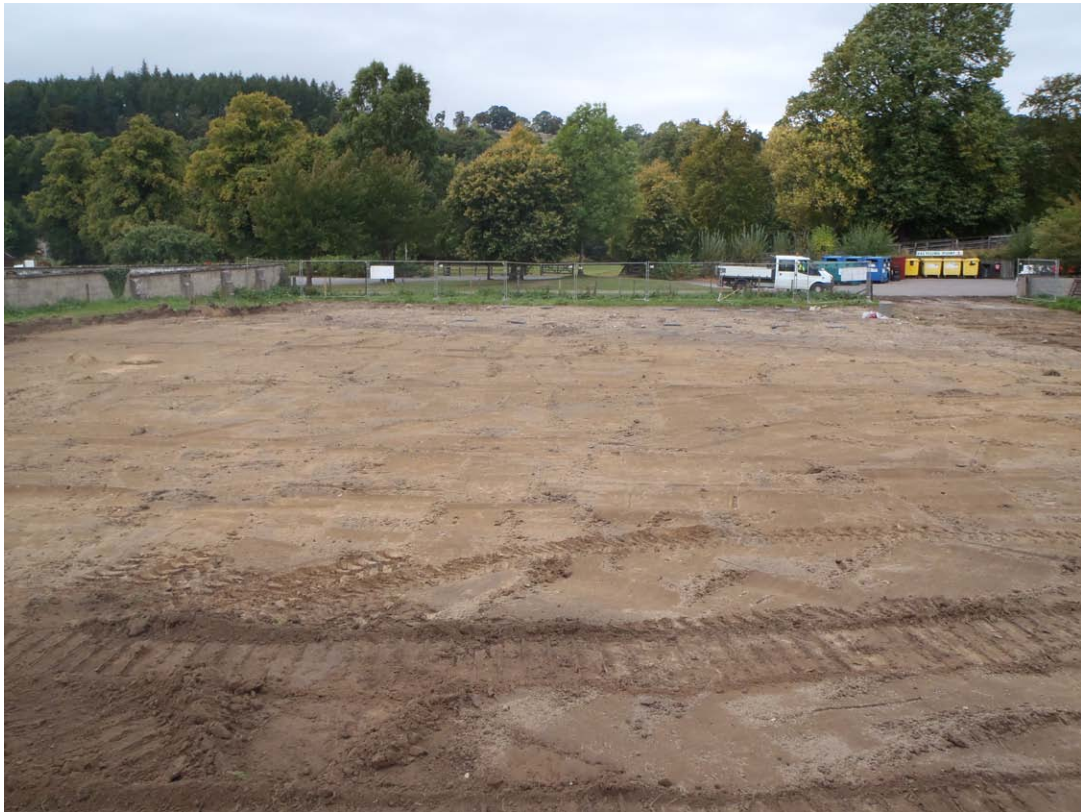
*Fig 3. - View of stripped area*

Topsoil (**001**) was c.0.3m of mid greyish brown sandy silt and overlay made ground (**003**) in the NW of the site, comprising 0.4m depth of yellow-brown sandy silt containing modern detritus and stones. This overlay a subsoil (**002**) of mid brown silt and natural (**004**) consisting of brownish yellow sand.

A single modern test pit and utility services were recorded. No features or deposits of archaeological significance were uncovered.
