Wind Turbine at West Fortune Farm, Drem, East Lothian

Archaeological Archive Assessment & Monitored Strip

Report No. 3095

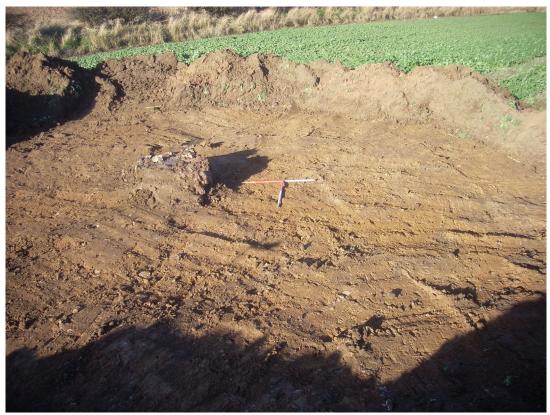
The trench for the turbine base (Figs. 1-2) was circular, with a diameter of 12m. The centre was at NT 52824 79269. Topsoil with a depth of 0.35m overlay a yellow sandy clay natural with occasional stones. No archaeological remains were present.

Fig. 2 - View of the turbine base from the east

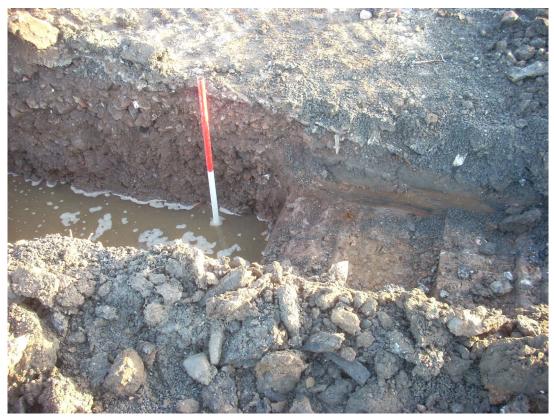
The cable trench ran south alongside the access track to the grid connection point located to the south-west of West Fortune Farm. Over most of this route, topsoil with a depth of 0.35m overlay yellow or orange sandy clay natural. At NT 53070 78950, a cut (**001**) with a depth of 0.5m was recorded in the natural boulder clay (Fig. 3) and this was filled with a compact deposit of crushed concrete and bricks (**002**).

Fig. 3 - View of cut (001) in the farm yard filled with crushed brick and concrete (002)

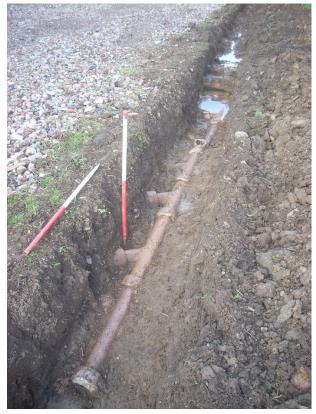
Close to the south-west corner of the field, at NT 52884 78965, two north-south aligned ceramic foul drains with five branches running to the south-west (**004**, **005**, Figs. 4-5) were recorded. To the north, drain **005** led into what appeared to be the base of a brick-built manhole (**007**, **008**) with a concrete floor (**009**). A ceramic rodding-eye (**010**) was set into this concrete floor (Fig. 4). Drains **004** and **005** were laid in a deposit of mixed yellow clay and topsoil (**003**). The manhole contained EDINBURGH stamped frogged bricks which appear to have been made, probably at Wallyford, between the late 1930s and 1947. No artefacts were recovered.

Fig. 4 - General view of the drain remains from the south

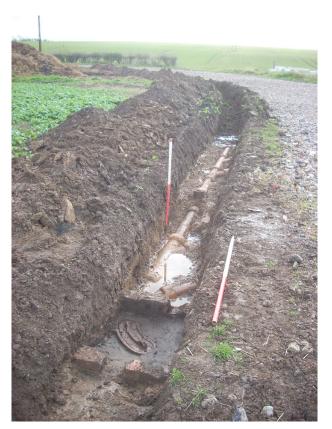
Fig. 5 - General view of the drain remains from the north, with the manhole and rodding eye in the foreground
