Lanton Mill Farm, Nr Ancrum, Scottish Borders Standing Building Survey

Report No. 3091

**Lanton Mill Farm, Nr Ancrum,
Scottish Borders
Standing Building Survey**

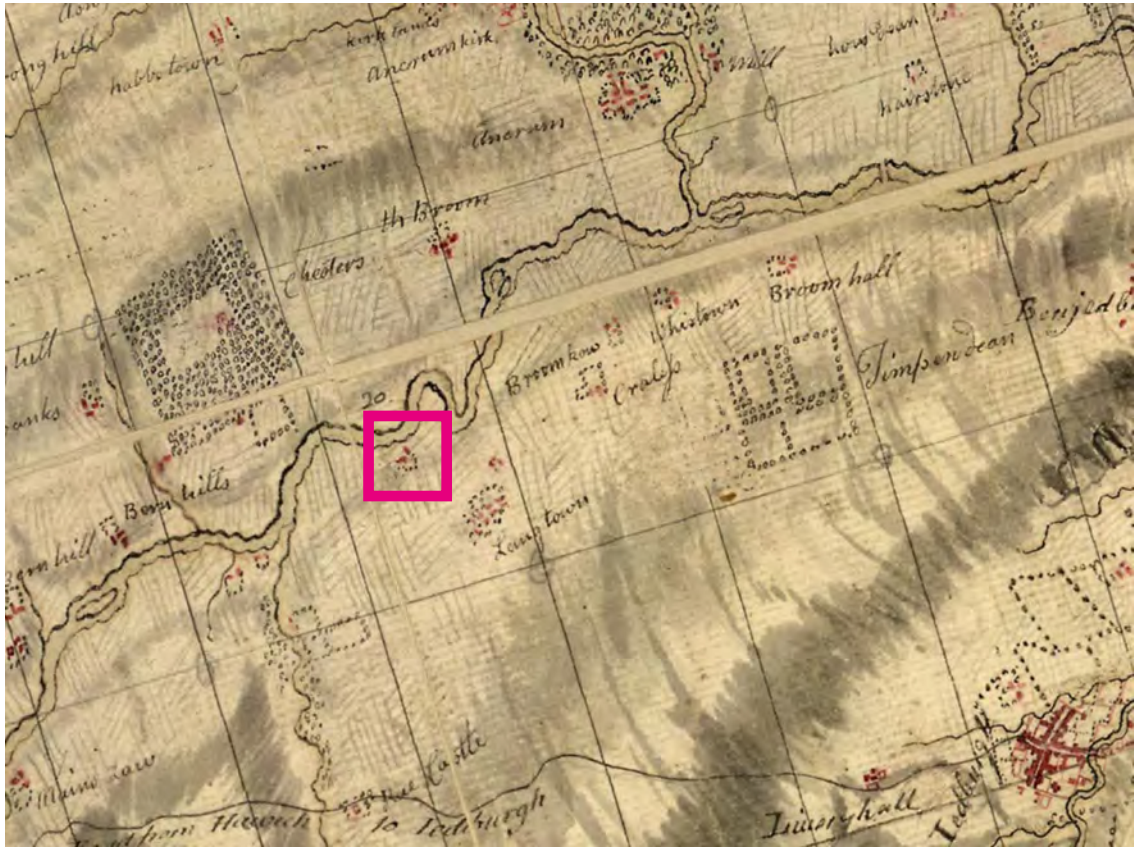
Fig. 2a Extract of map by Roy, 1752-55

Lanton Mill appears on General Roy's Military Map (1752-55) (Fig 2a) as two buildings with a small enclosure but the farmstead is not named. The mill is first named as *Longtown Mill* on Stobie's 1770 map (Fig 2b). The map shows two buildings, one is L-shaped and the other is rectangular. A mill lade running off the River Teviot is shown to the north of the buildings. Ainslie's map of 1821 (Fig 2c) depicts *Mill* at the survey area. John Thomson's 1832 map (Fig 2d) depicts only the placename *Mill* and two schematic buildings. The 1843 map produced by Crawford (Fig 2e) shows Lanton Mill with three buildings, including what is presumed to be the L-shaped mill, the farmhouse and an ancillary building.

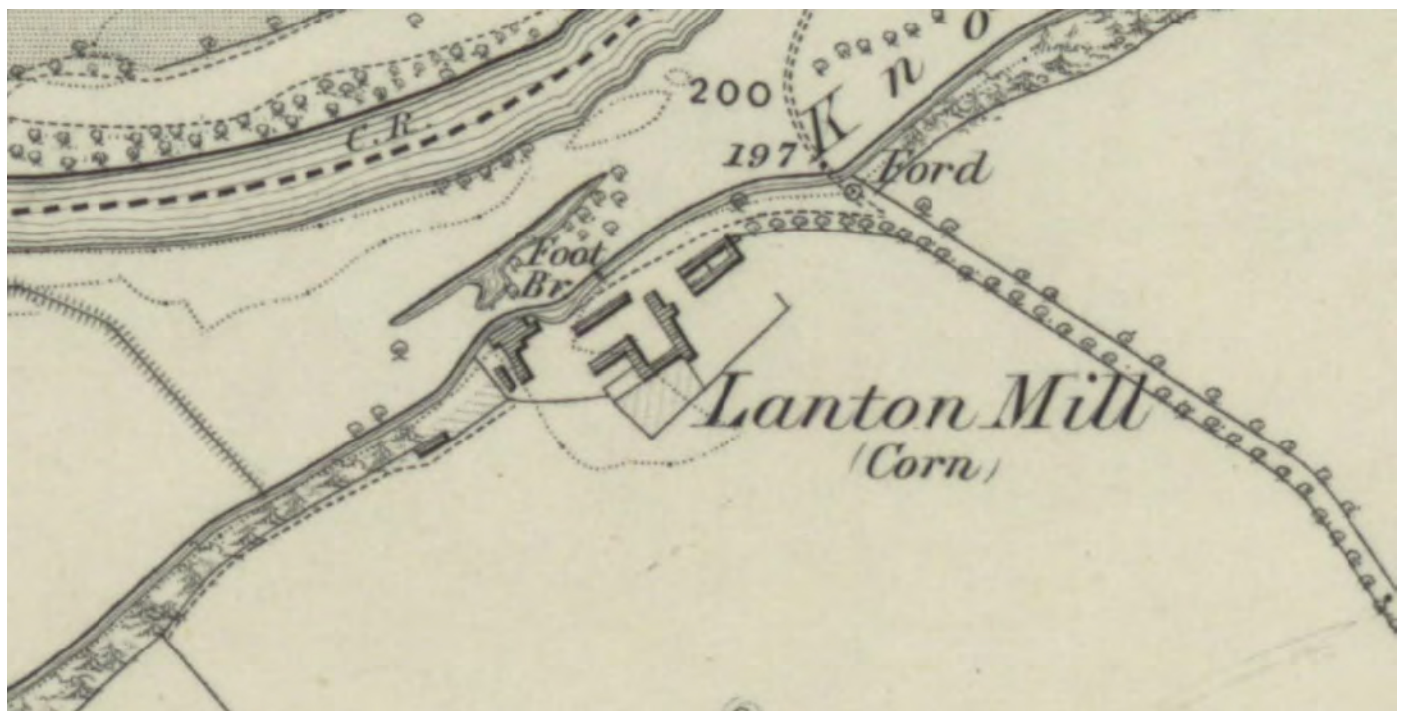
Fig. 2f Extract of map by Ordnance Survey, 1st Edition, 1858

The 1858 First Edition Ordnance Survey map (Fig. 2f) shows that Lanton Mill had by that year undergone a considerable degree of enlargement. The site of the corn mill is depicted as a T-shaped building linked to a mill lade and mill pond on its north side. Three small ancillary buildings are situated on its west side alongside a track. A loose courtyard arrangement is formed by a Z-shaped building that is flanked on its north and east sides by rectangular buildings. The building on the east side incorporated the farmhouse which has two small outshot buildings attached to it. Further to the east, there is a U-shaped rectilinear building.

Building 1 was a detached purpose built stable built after 1858 (Fig 2f). The character of the buildings north-west facing elevation that incorporated regular blocks of snecked sandstone shows that it is late 19th century in design and definitely later than Building 2 and 3. Given the size of the stable doorway it probably housed riding or carriage horses.

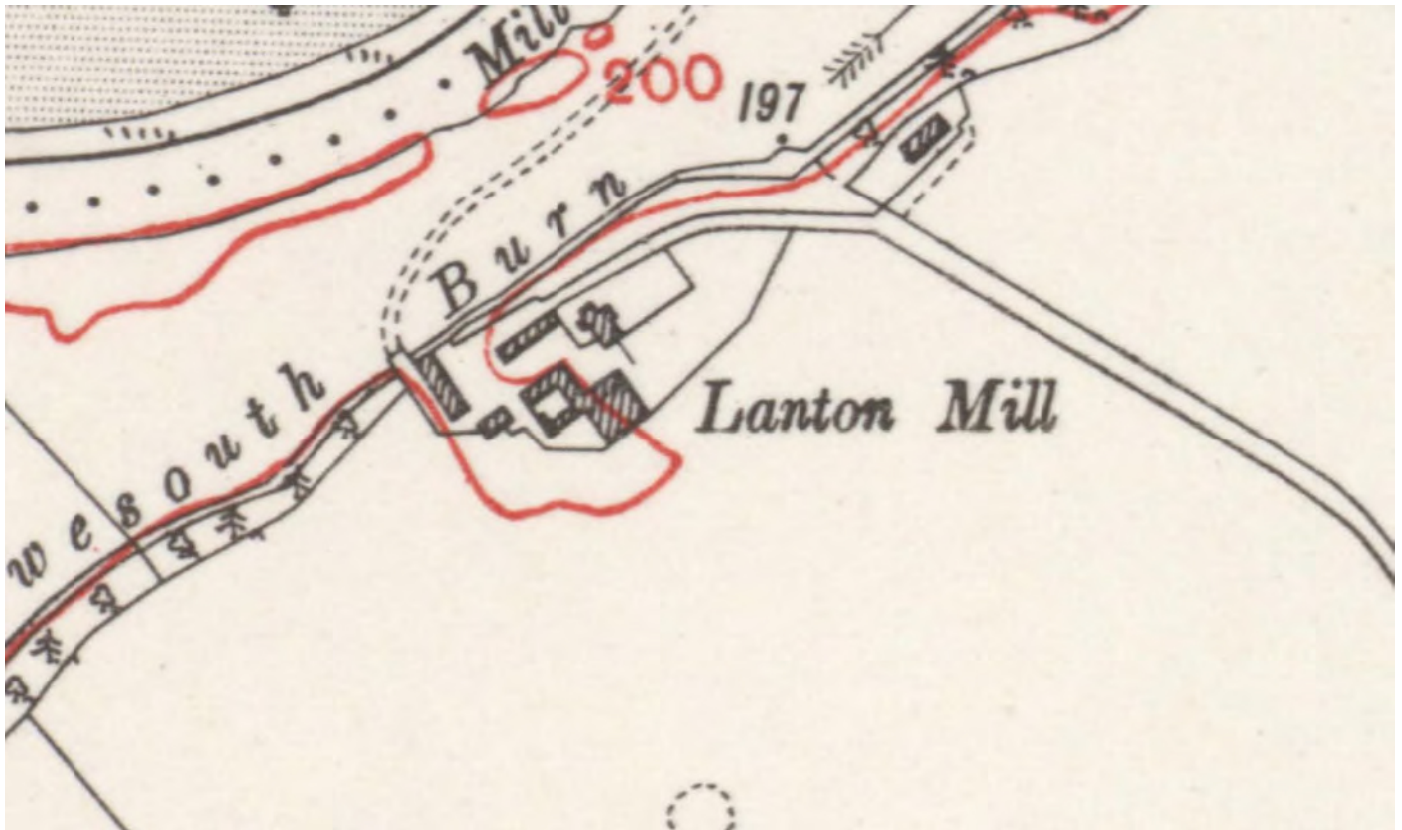
Fig. 2g Extract of map by Ordnance Survey, 2nd Edition, 1921

The 1921 Second Edition Ordnance Survey map (Fig. 2g) now shows that the mill has been reduced to a two-compartment building and a track runs north-eastwards away from it. The Z-shaped building on the south side of the courtyard has increased in size with the addition of an L-shaped building, most probably a lean-to shelter enclosing part of a square cattle yard. The range containing the farmhouse has been reduced in size considerably with two outshot buildings added to its eastern side. The U-shaped narrow buildings on the east side of the main farm complex has been removed.

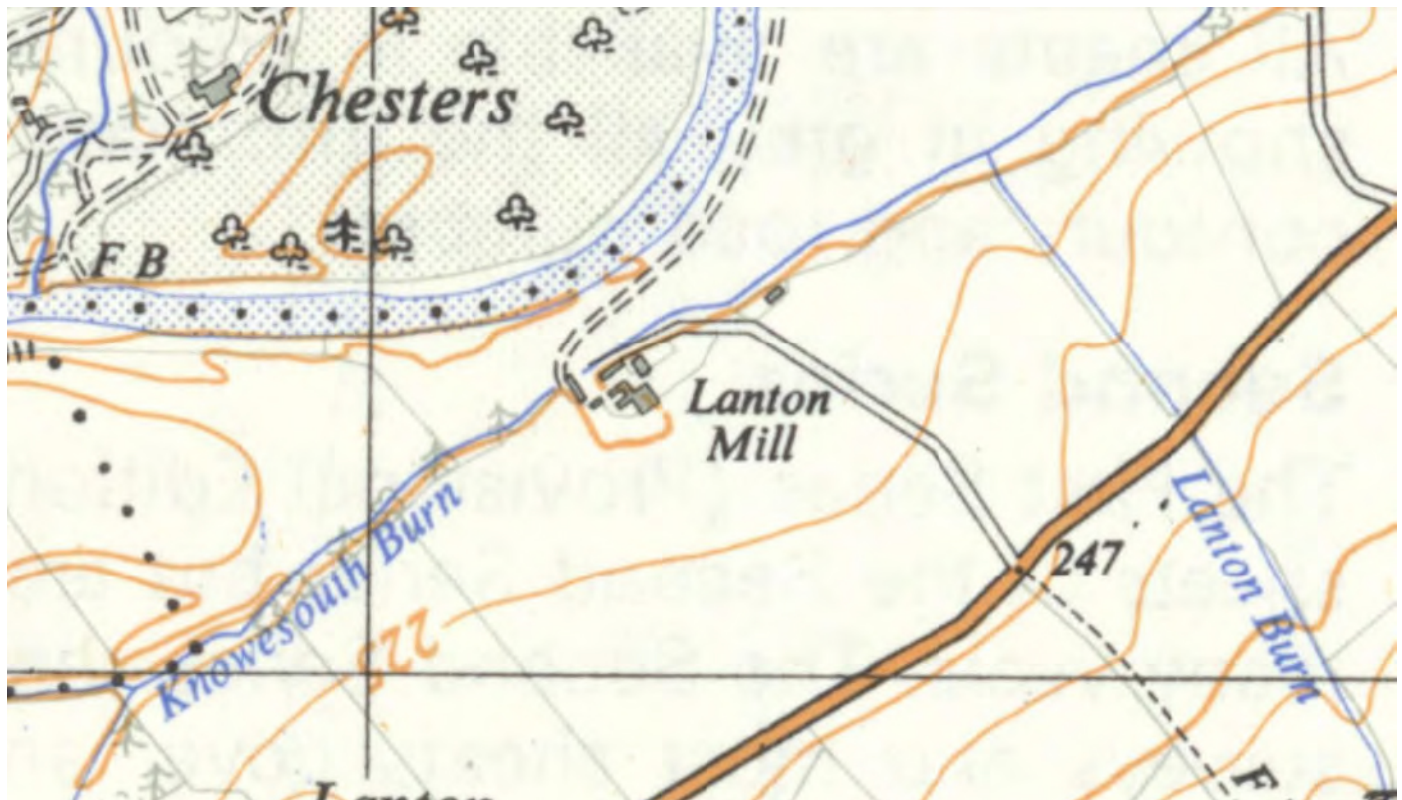
Fig. 2h Extract of map by Ordnance Survey, 1954

The 1954 Ordnance Survey map (Fig 2h) shows the same building layout as the 1921 map showing that the layout of the buildings had not been radically altered during the second half of the 20th century.

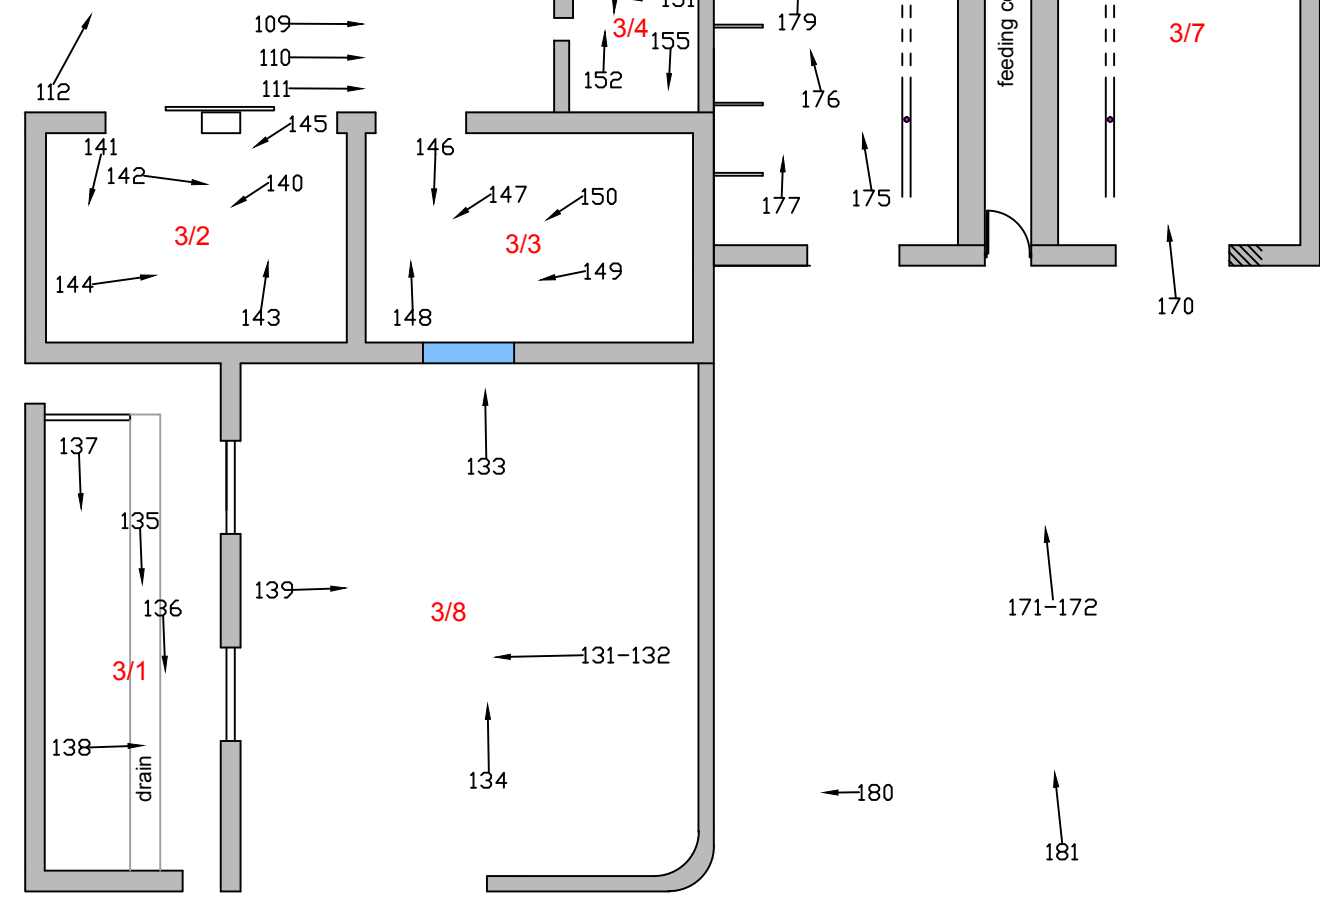
This building complex contained eight individual units that formed a Z-shaped plan. One of the buildings opened out into a cattle yard. On the south-west side of the complex a large cattle court was present.

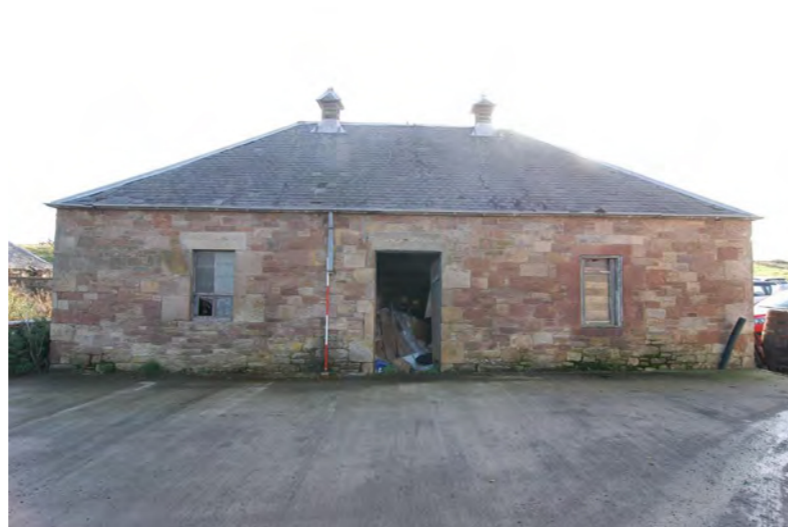
Plate 2: Building 1, north-west facing (front) elevation

The north-east facing (front) elevation measured 12.3m long and was 2.7m high from the ground to eaves level. The elevation was constructed of snecked sandstone with droved sandstone surrounds and quoins. The central door opening was 2m high by 1.1m with a plank-built door. The wooden windows measured 1.1m high by 0.75m.

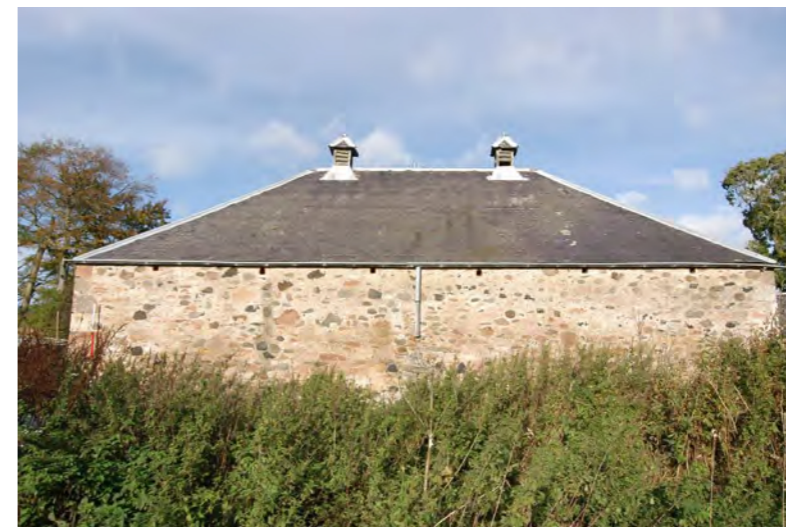
Plate 3: Building 1, south-east facing (rear) elevation

The south-east facing elevation (rear) was random rubble built and measured 12.3m long by 3m high to eaves level. The elevation was uniform in its construction with droved quoins at each end. Six horse-shoe type pipe vents been built into the wall at eaves level.

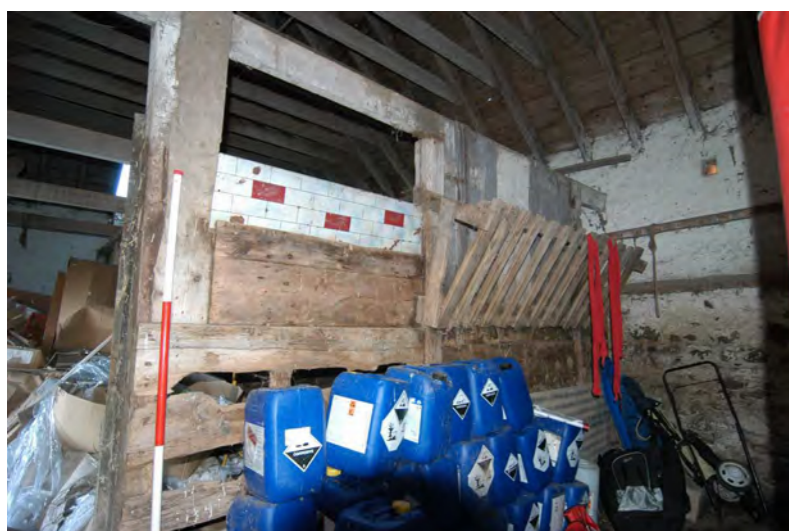
Plate 4: Building 1, interior timber stalling at south-west end

Building 1 was a former single storey detached stone-built stable with hipped slate roof. The building occupied a rectangular footprint measuring 10.3m long by 5.6m wide with walls 0.5m thick (Fig 3a). The building was lit by two windows set within splayed reveals 1.4m wide situated on the internal south-east facing elevation. The rest of the walls were featureless white-washed random rubble and for the most part hidden by debris. Five plank-built stalls each measuring 4m long by 3.6m wide were built against the north-west facing wall. The framework for the stalls was suspended off the common rafters with timber uprights used at each end of the stall. The stall situated at the south-west end of the building had a cobble floor and a stone with a socket for a post (Plate. 5). The cobble floor appeared to run under the timber stalls and was probably contemporary with the construction of the building. The roof comprised scarf-jointed A-frame collar rafters resting directly on the wall heads. The roof had two louvre vents and the ridge was capped by galvanised zinc sheeting. Two cast-iron roof lights were present at the hipped end of the building.

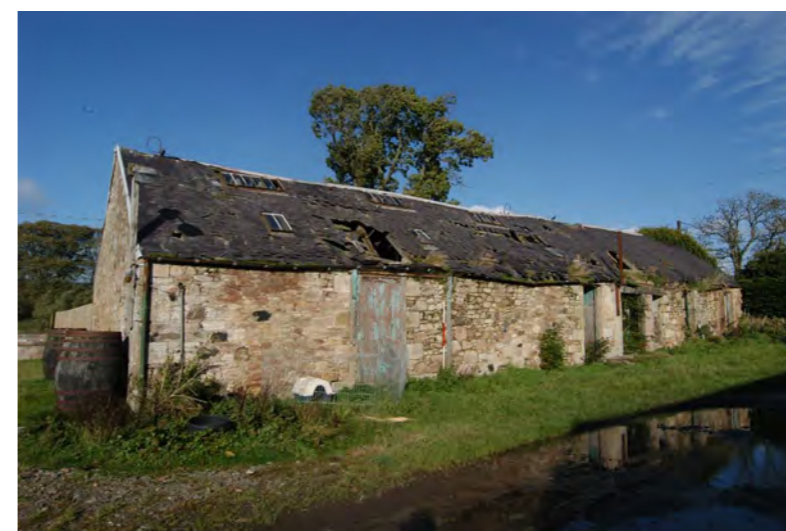
Plate 6: Building 2, south-east facing elevation

The south-east facing elevation was random rubble built with droved sandstone quoins at each end and surrounding the principal openings to Units 2/1, 2/4 and 2/5. Units 2/2 and 2/3 had secondary openings formed by more recent brickwork. The elevation measured 24.5m long and was 2.7m high from the ground to eaves level. The roof was slated with a series of two paned roof lights towards the eaves. Unit 2/1 had three six-paned cast-iron roof lights situated close to the ridge.

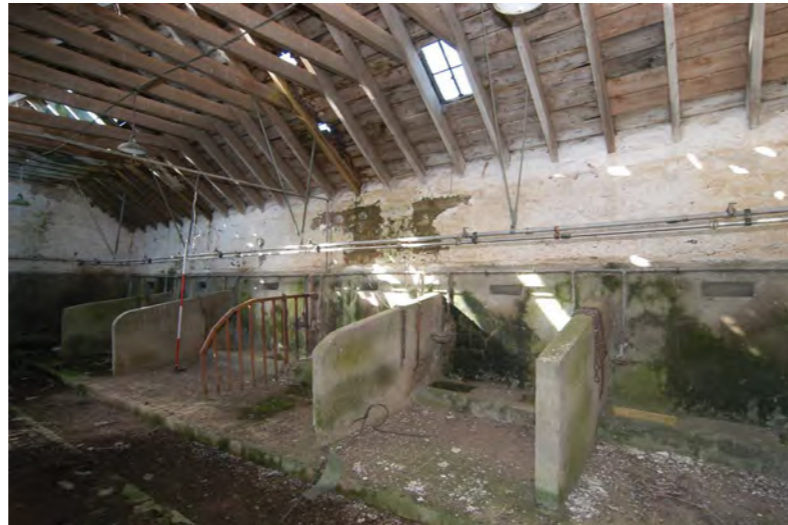
Plate 8: Unit 2/1 milking shed stalls

The milking shed measured 12.4m long and 4.6m wide and had a concrete floor with a central drain 1m wide. On the south-east facing elevation six concrete milking stalls were present. Each was c.2m wide with a pair of ceramic feed troughs installed against the base of the wall. Above the stalling was a vacuum line formerly part of the milking apparatus. The interior of the building had been rendered with cement to a height of 1.5m, the rest of the walls were bare random rubble. The north-west facing wall had two doorways present each 1.1m wide. Approximately 3m from the partition wall between Unit 2/1 and 2/2 was a small square recess built into the wall. This was probably for holding a lantern. The roof beams were exposed and comprised A-frame collar rafters resting directly on the wall heads.

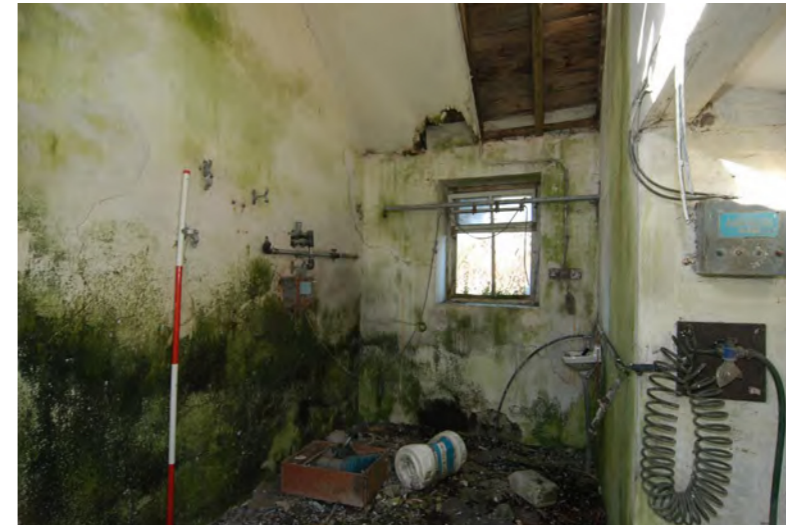
Plate 9: Building 2, Unit 2/2 wash room room

Unit 2/2 measured 5m by 2.1m and had whitewashed cement covered walls. The floor was concrete. A white ceramic sink occupied the north-east corner of the room. The south-west facing interior wall was brick-built with a dog-leg forming a recess. Attached to the interior of the recess was the remains of vacuum and milk storage equipment. The entrance door in the north-west facing elevation was c.2m wide. A small casement window surrounded by brickwork occupied the opposite wall. This room had been created using 20th century brickwork.

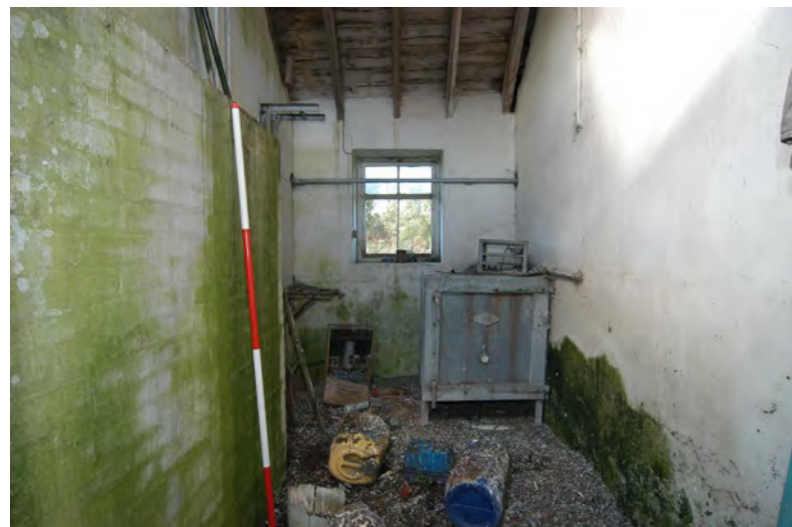
Plate 10: Building 2, Unit 2/3 Sterilising room

Unit 2/3 was an irregular shaped room measuring 2.2m at its widest point and also created using 20th century brickwork. The cement-lined walls were whitewashed. The room was lit by a single wooden casement window on its south-east facing elevation. On the opposite wall was the main doorway measuring 1.3m high by 0.8m wide. The only feature worthy of note in this unit was a large galvanised sterilising oven fed by boiling water supplied from Unit 2/4. The oven had the makers name *Alfa Lavel* and was linked by pipework to the aforementioned adjacent unit.

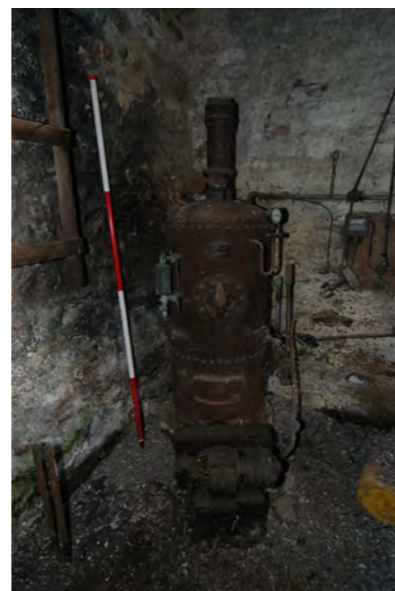
Plate 11: Building 2, Unit 2/4 Boiler room

Unit 2/4 was formerly the milking shed pump room with featureless whitewashed rubble-built walls and no window. The roof beams were exposed and comprised A-frame collar rafters resting directly on the wall heads. Access was via a door on the north-west facing elevation. Occupying the northern corner of the room was a riveted-iron pressure vessel (Plate 11) made by Barford (Agricultural) Ltd, Grantham, England. The vessel had a water pressure gauge and various pipes attached to it along with an electrical motor at its base (water pump?). The vessel had a safety valve and a chimney pipe on its curved top.

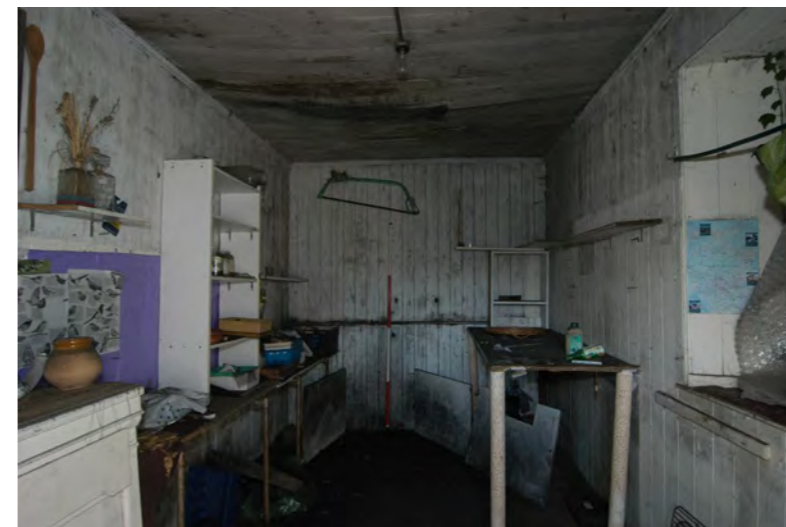
Plate 12: Building 2, Unit 2/5 workshop interior

Unit 2/5 was a workshop measuring 4.5m long and 2.4m wide. The walls and ceiling were lined throughout with tongue-and-grooved timber and painted white. A single wooden sash-and-case window occupied the south-west facing gable wall. The door in the north-west facing elevation was plank-built. The workshop walls were lined with an assortment of fairly modern shelving and cupboards from re-used kitchen units.

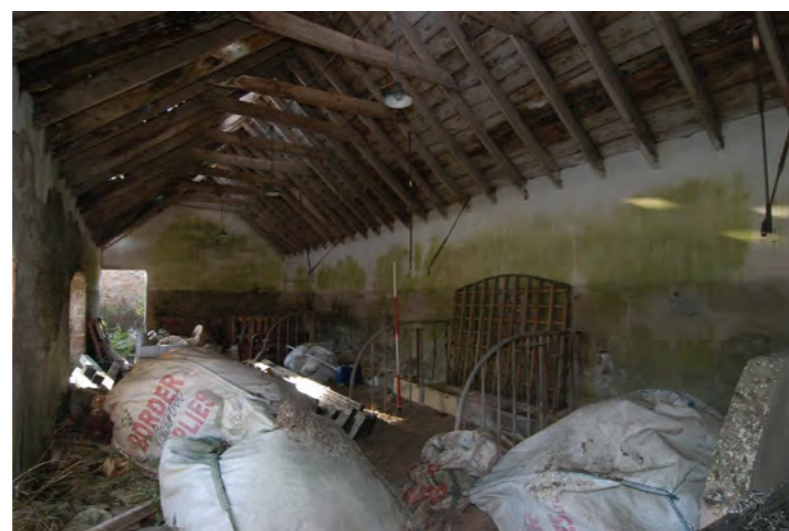
Plate 14: Building 3, Unit 3/1 interior

Unit 3/1 was a formerly a byre measuring 13.4m long by 4.7m wide of single storey rubble-built construction. The interior walls were cement lined and whitewashed. A series of galvanised tubular steel feeding stalls were present on the south-west facing elevation. On the opposite wall two segmented-arched openings provided access into the cattle yard. The A-frame scarf-jointed collar rafters of the roof rested directly on the wall heads.

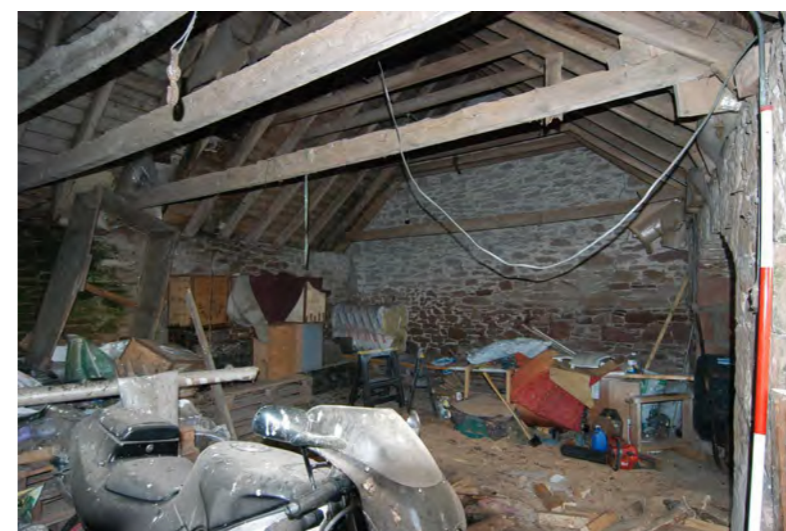
Plate 15: Building 3, Unit 3/2 interior detail

Unit 3/2 was a rectangular barn/store measuring 8m by 5.5m. The walls were rubble built and featureless. Access to this unit was via two segmented-arched openings on its north-east facing elevation.

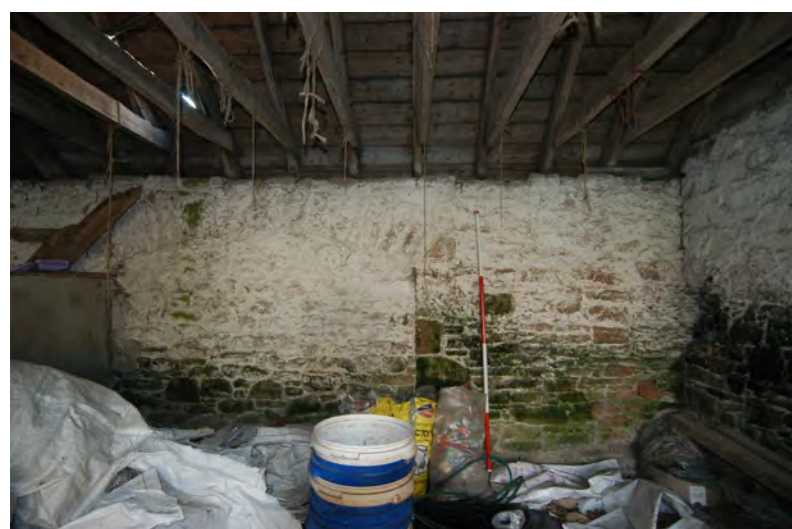
Plate 16: Building 3, Unit 3/4 interior showing blocked arch opening

Unit 3/3 was a rectangular former animal shed last used as a store. The interior measured 8.5m long and 5.5m wide with whitewashed rubble-built walls. The unit was accessed by a large rectangular door on the south-west facing elevation. A wooden partition wall c. 1.5m high had been installed to create two compartments for holding livestock. On the north-east facing wall a blocked segmented arched opening (Plate 16) was present measuring c. 2m wide and 1.8m high. This opening would have allowed access into the cattle yard (Unit 3/8). The roof trusses were fully exposed and comprised nailed collared A-frame trusses resting directly on top of the wall heads.

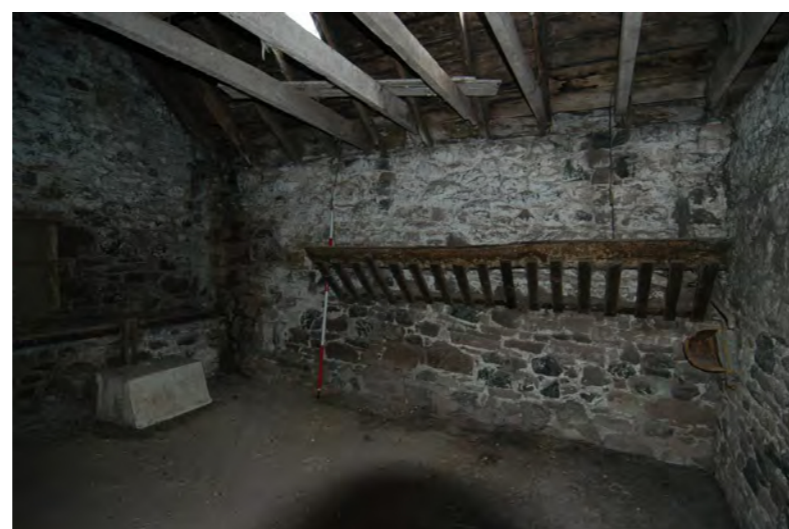
Plate 17: Building 3, Unit 3/5 interior view

Unit 3/5 was a small windowless animal shed/store measuring 4.9m long and 3.5m wide and had featureless rubble-built walls. Access was provided by a plank-built door on the south-east facing elevation.

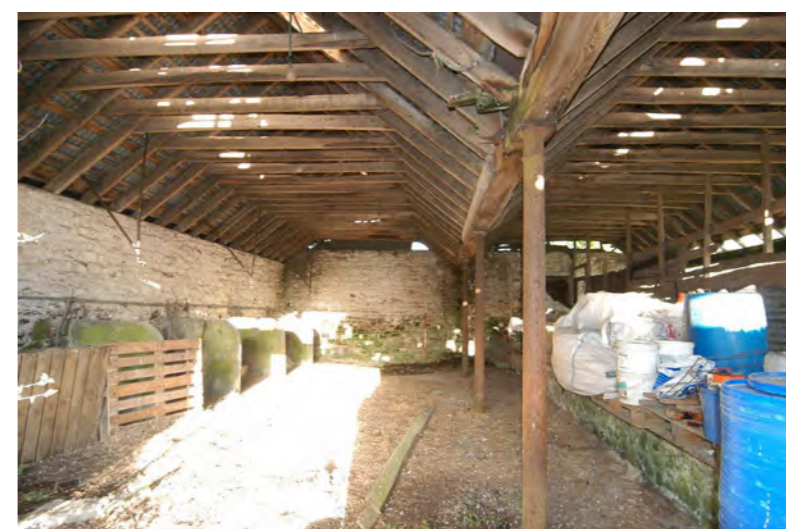
Plate 18: Building 3, Unit 3/7 interior of the cattle court

Unit 3/7 comprised a large square-shaped cattle court covered with a double M-shaped slate roof of which only the western end survived (Plate 19). The existing roof was supported by a two rows of cast-iron pillars (Fig 3c). At the centre of the cattle court was the aforementioned feeding corridor. On the south-east facing interior wall seven feeding stalls were present. On the north-east facing wall was a pair of large bay openings providing the main access into the building. The roof comprised scarfe-jointed collar A-frame rafters resting on the wall heads and part covered with sheets of modern corrugated iron. The walls were constructed of random rubble.

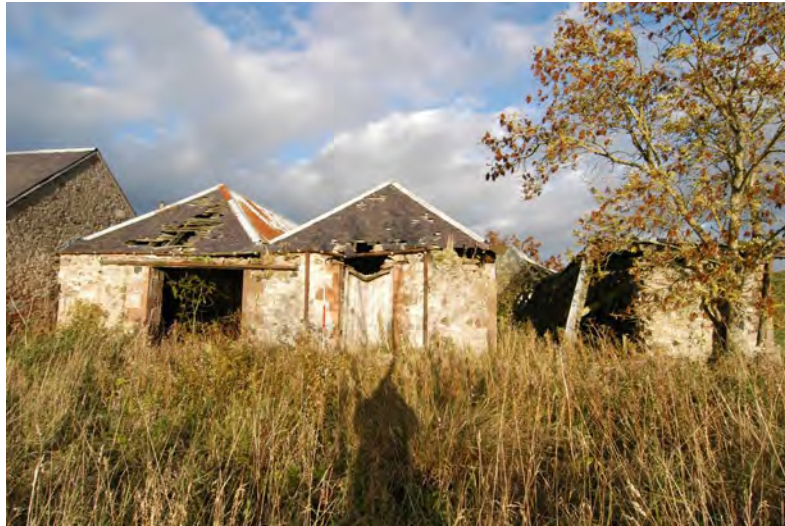
Plate 19: Building 3, exterior of Unit 3/6 with existing hipped rooves

Unit 3/6 is a rectilinear barn measuring c.19m long by 4m wide that was accessed by a rectangular opening on the south-east facing elevation. The roof had collapsed into its interior rendering it unsafe to enter. Part of the south-west facing interior wall was built of snecked sandstone which appears to be contemporary with Building 1. A second centrally placed entrance door on the north-east facing elevation allowed entry into the feeding corridor at the centre of Unit 3/8 the cattle court.
