## **Borders Railway Project Site 625, Sheriffhall, Midlothian**

### **Archaeological Evaluation Data Structure Report**

**No. 2022**

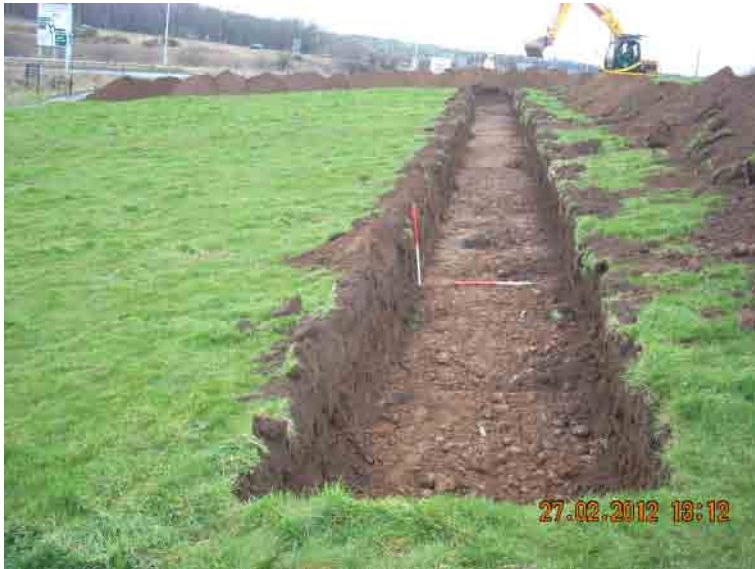
Fig. 2 General view of Trench 1

This trench (Fig. 2) was positioned on a south facing slope and crossed the bank of the rectangular enclosure. On the surface this bank (**110**) was around 2.5m in width and 0.2m in height. The bank was only discernible in the section due to its raised profile but no structure to the bank was observed as it was formed from topsoil material. There was no associated ditch.

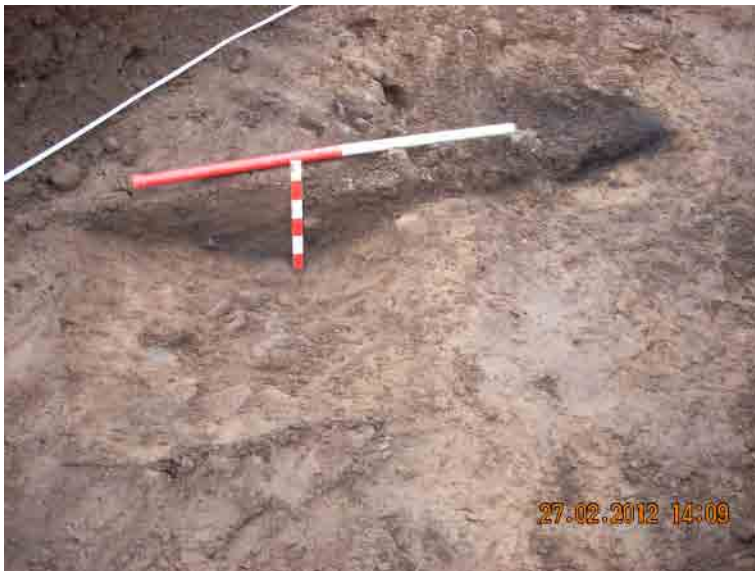
Fig. 3 Trench 1, section through ditch 107 and pit 103

Pit **103** (Fig. 3) was c. 0.8m in diameter x 0.1m deep. It had a primary fill of mottled grey-black silty sand with charcoal flecks and degrading, possibly heated stones (**106**). It had a secondary fill of brown silty sand (**105**). No finds were recovered. Pit **101** also had a diameter of 0.8m.

The ditch (**107**) crossed the trench and was 0.8m wide. It was 0.2m deep (Fig. 3). It had a primary fill of mottled grey-black silty sand with charcoal flecks (**109**) with a secondary fill of brown silty sand (**108**). No finds were recovered.

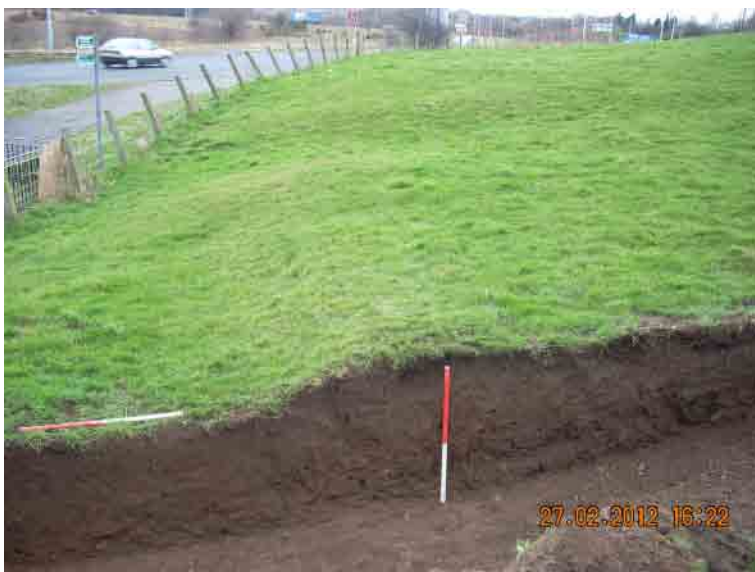
Fig. 4 Trench 2, section through the enclosure bank

This trench was positioned on a south facing slope (Fig. 1) and crossed both sides of the rectangular enclosure. On the surface the enclosure banks (**201**, **202**) were around 2.5m in width and 0.2m in height (Fig. 4). The bank was only discernible in the section due to its raised profile but no structure to the bank was observed as it was formed from topsoil material. There was no associated ditch.

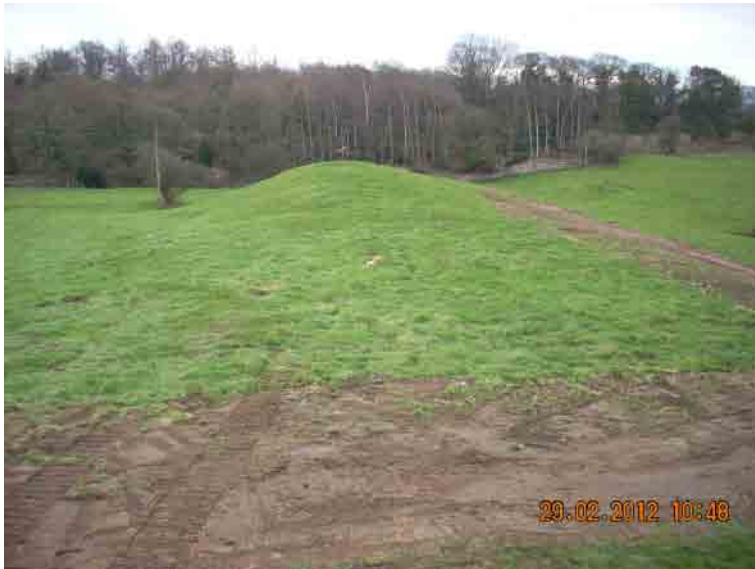
Fig. 5 Trench 7 pre-excitation showing the pit 701 on the summit of the knoll

This trench was located (Fig. 5) on a slope leading NW from the summit of a small knoll and crossed the line of the enclosure bank. An obvious depression was present on the summit. The trench was excavated across one side of this feature

After the topsoil was removed a pit (**701**) was identified in the location of the surface depression, this obviously modern feature ran out of the trench but the exposed extent

measured 1.6m long x 0.6m wide by 0.1m deep. It was filled with topsoil material (**702**). No finds were recovered and there was no environmental content.

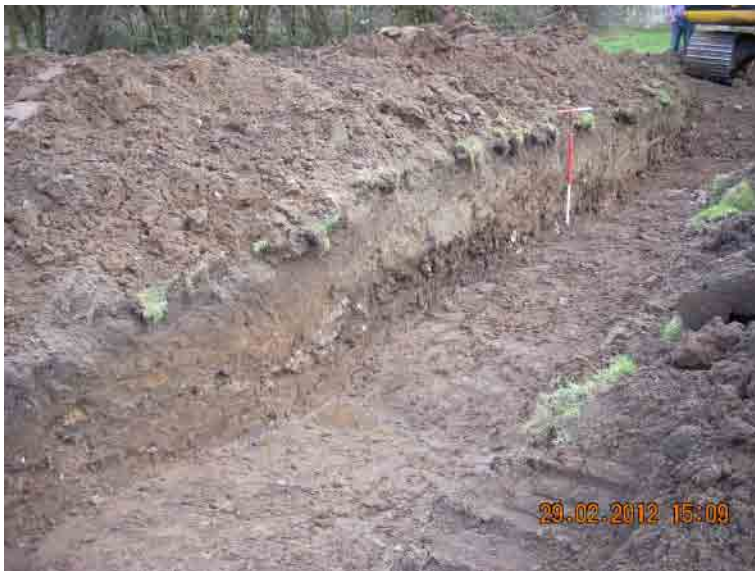
Fig. 6 Trench 9, section showing the made ground 901 overlying older soil 902

Overlying natural stained gravels was a deposit of brown soil containing frequent lumps of broken sandstone (**902**). This was overlain by a deposit of building rubble and mortar (**904**) and an extensive deposit of stiff greenish clay (**901**, Fig. 6). A deposit of mixed brown soil and yellow sand (**903**) was also present. All were sealed by a thin topsoil (**001**). The total depth of these deposits was 1.1m. Occasional modern finds, comprising ceramics, glass, slate, pantile and brick were present within deposits 902 and 904.

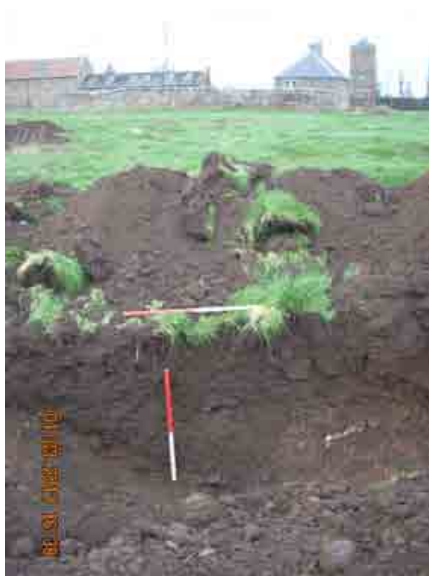
Fig. 7 Trench 12, ditch 1201

Ditch **1210** was 2.2m wide and 0.8m deep with an irregular profile (Fig. 7). The base contained a deposit of cobbles (**1203**) and this was overlain by a gravelly soil (**1202**) similar to the subsoil (**002**) above. No finds were recovered and there was no environmental content. The ditch appeared to run parallel with the turf bank but the stratigraphy in the trench did not support any association between these features and the ditch was not recorded in Trench 3 to the north.

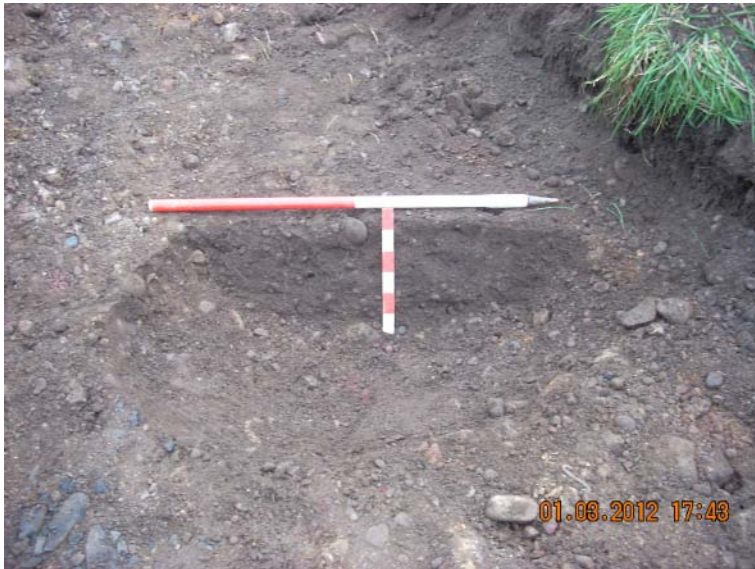
Fig. 8 Trench 12 ditch terminal 1204

In the north of the trench, ditch **1204** was over 2.5m in length and 1m in width (Fig. 8). It was 0.3m deep. The single fill (**1205**) of brown gravelly soil contained neither finds nor environmental content.

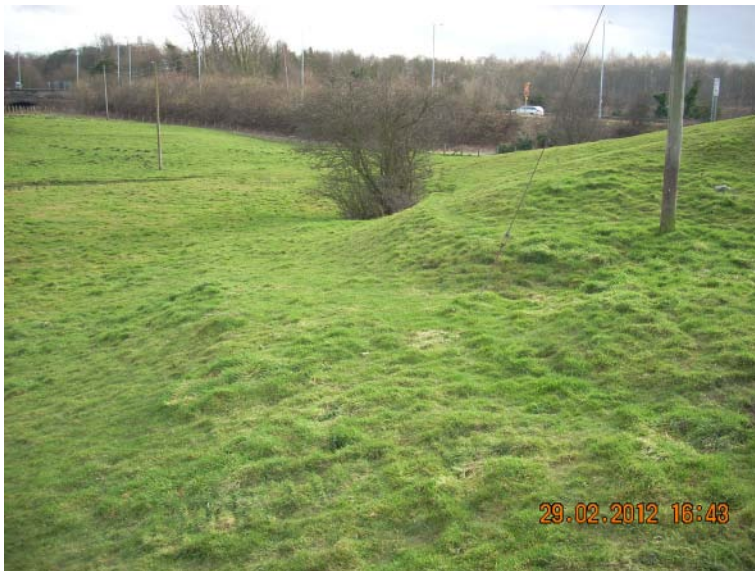
Fig. 9 View from the north of the trackway leading to the well at the trees

This trench cut across the surface remains of the trackway leading from the well towards Sheriffhall Steading.

Made ground (**802**) along with deposits of stones (**803**) and building rubble/mortar (**801**) were present at the east end of the trench. At the west end of the trench deep soil deposits (**001, 002**) were present. The surface of the track was just beneath the turf and lay over the topsoil. It consisted of a spread of coal chips and blaes (**804**) with a width of 2.1m.

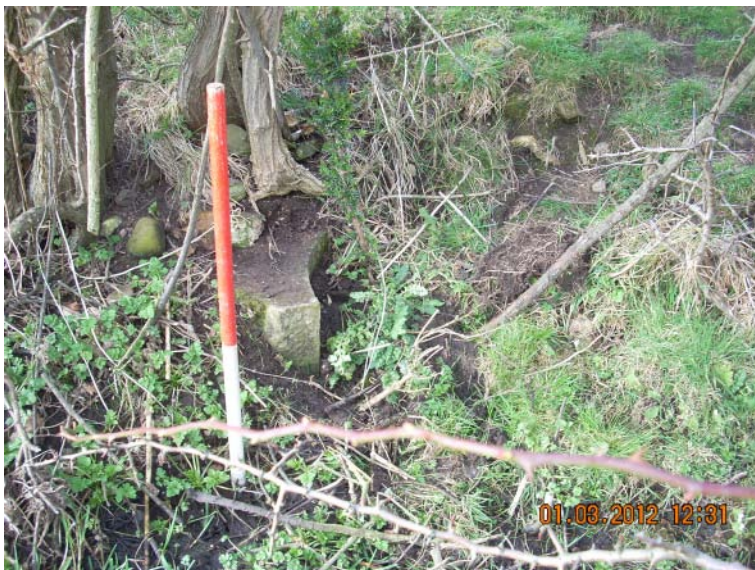
Fig. 10 Cut stone at the location of the well

Surface features including a vestigial rectilinear enclosure surviving as earth banks, an earth field bank, a trackway and a well were present. The presence of these features confirms the details observed on earlier maps. The trackway led from the well towards Sheriffhall Steading. The location of the well and the terraced trackway leading to it from Sheriffhall are shown in Figs. 1 and 9. The well itself lay below power-lines so no evaluation took place. At the well, a stone kerb could be traced in the turf next to the track for a distance of 6m and the well itself is marked by a dressed sandstone block (Fig. 10).
