**The Stables Buildings,
House of the Binns, West Lothian**

Standing Building Recording Survey

Report No. 3037

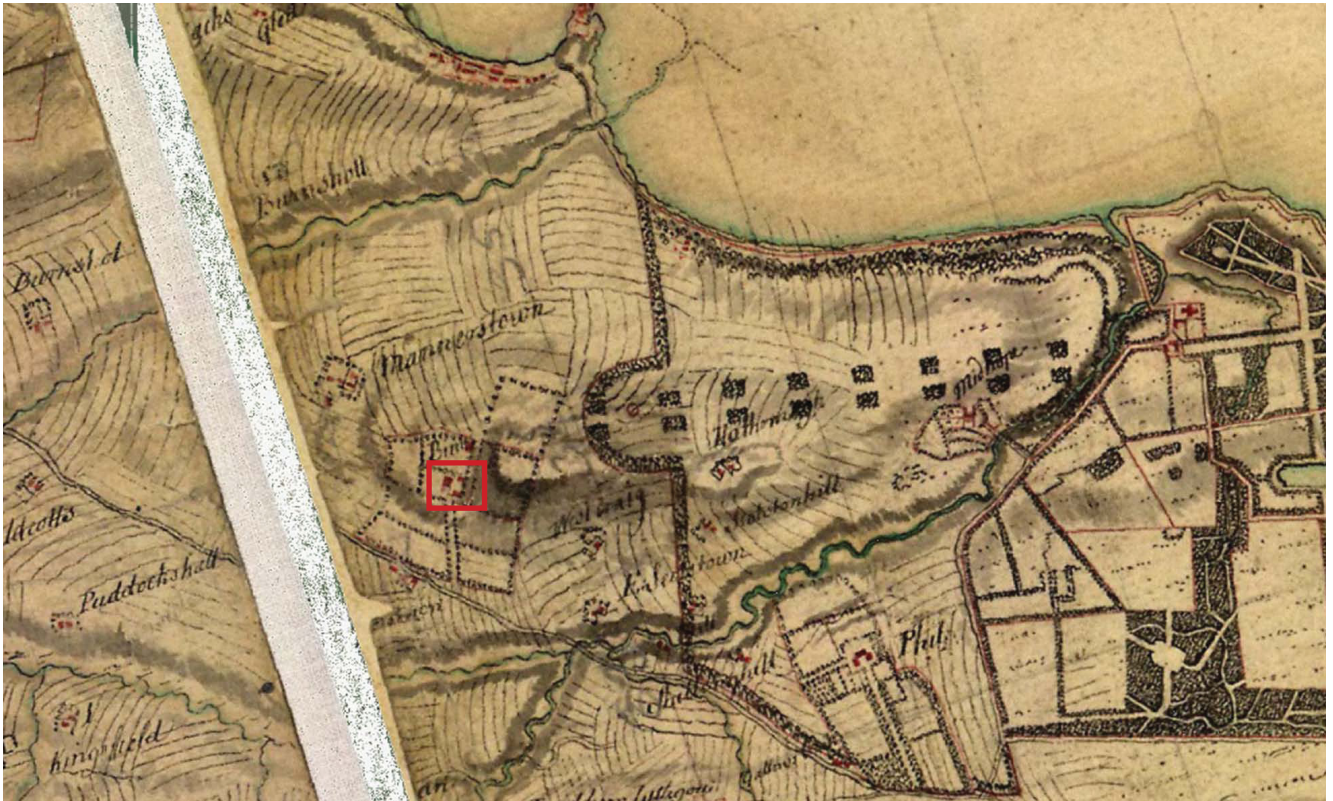
Fig. 2a - Roy Military Survey of Scotland, 1747-1755

Roy's Military map of 1747-55 (Fig. 2a) depicts a rectangular building set within a rectangular field to the south of *Binns*. It is a matter of conjecture if this schematically represents the stable complex.

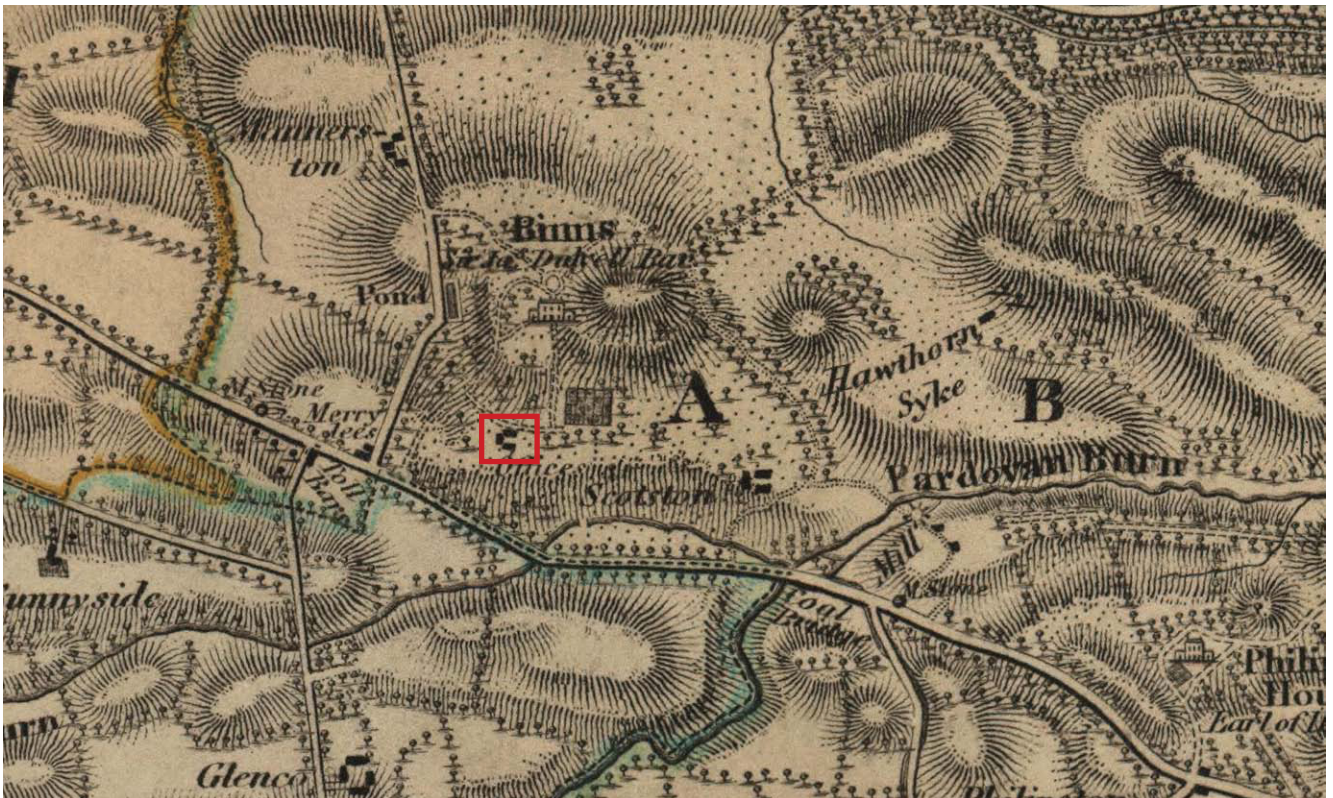
Fig. 2b - Forrest 1818

Forrest's map of 1818 (Fig. 2b) depicts *Offices* to the west of a walled garden. Three buildings are shown forming a crude courtyard arrangement.

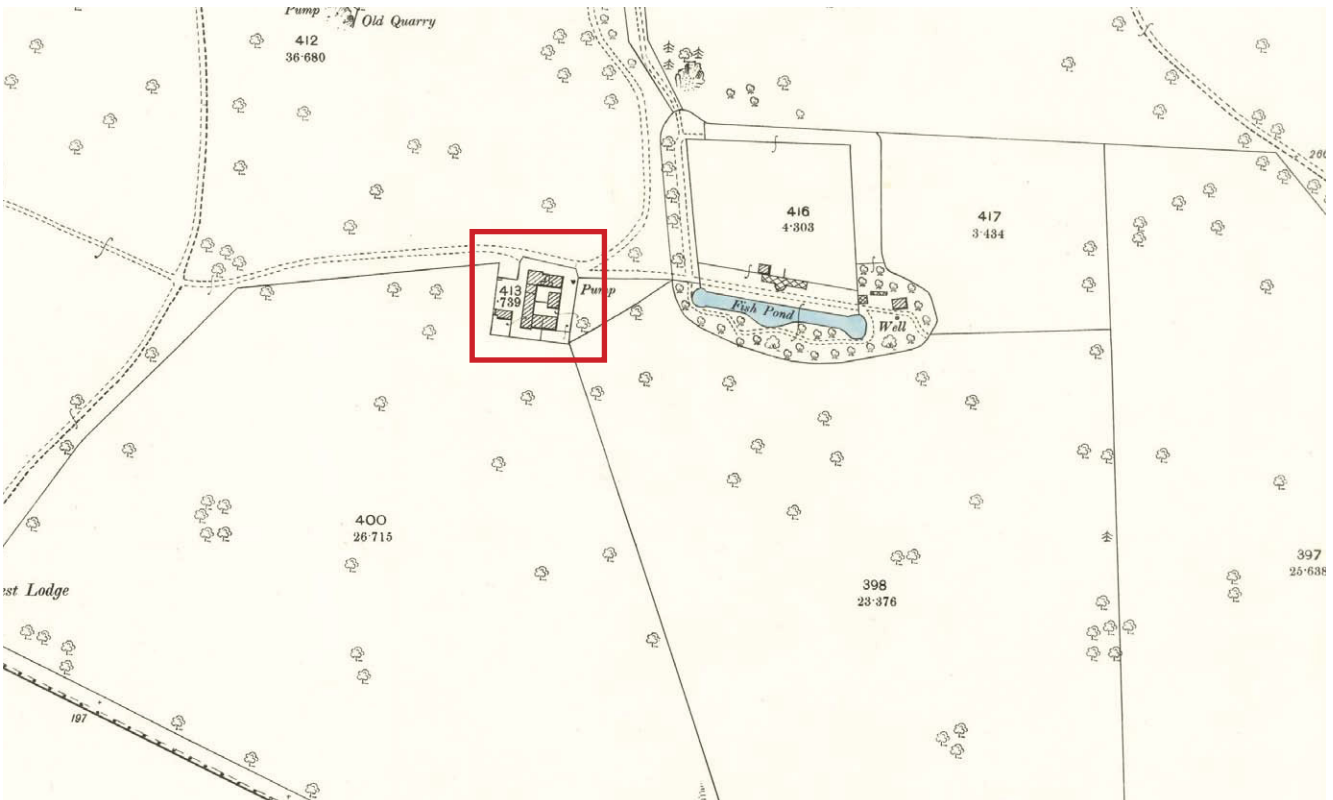
Fig. 2d - 25 inch to the mile, 2nd edition OS Map, 1896

The 1896 Second Edition Ordnance Survey map (Fig. 2d) shows the same U-shaped courtyard arrangement but the building shown in the central opening has been connected to the west range by a wall. Individual partitions walls are also shown. The horse engine has been removed. A pump is also depicted on the north-east side of the stables. The range of buildings on the west side of the stables has been replaced by a single rectangular dwelling with its own property boundary on its south side.

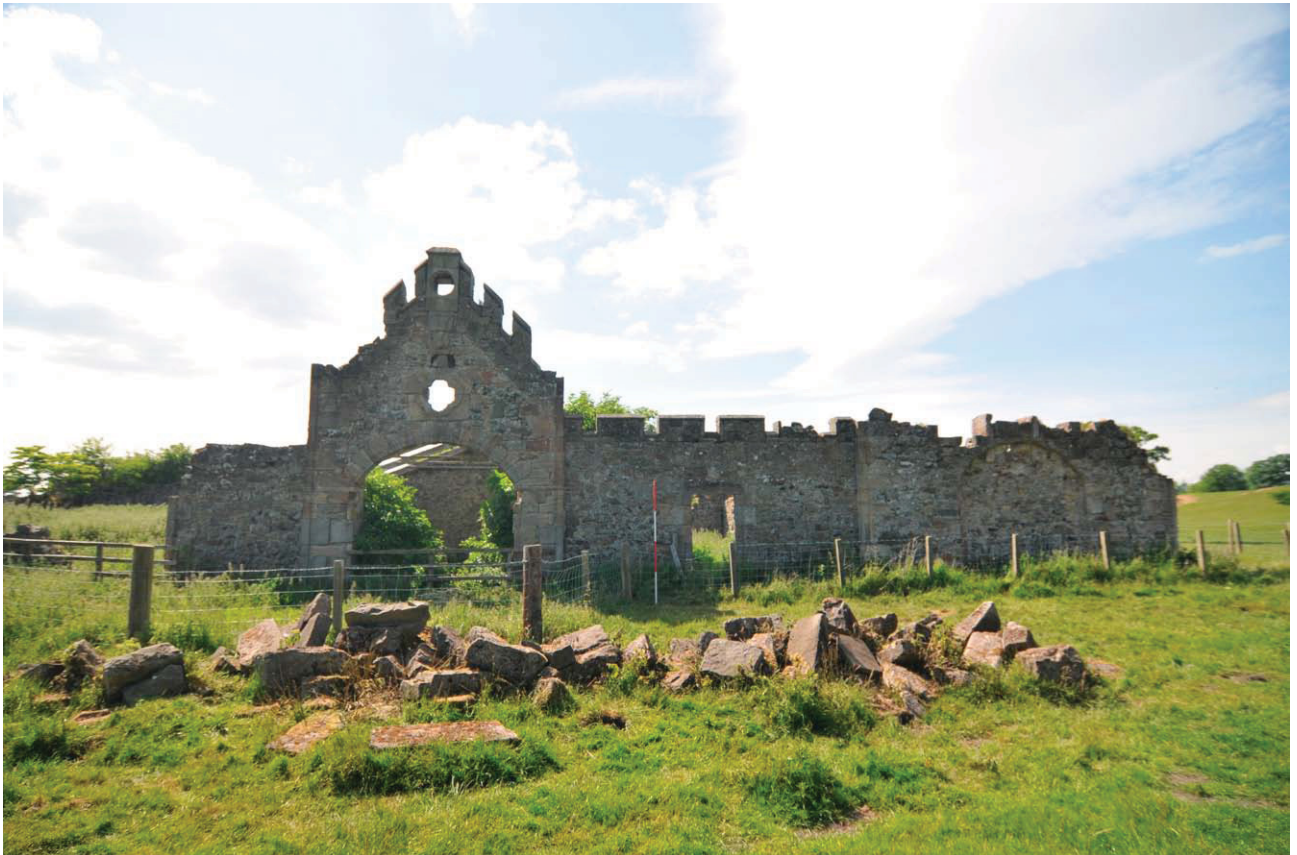
Fig. 5d - East facing elevation

This forms the central and focal point of the east-facing elevation of the Stables Complex. It has an ornate pitched profile and it measures 4800mm wide and 6800 high at the apex and 3900mm high at the returns. The sides are formed by fine ashlar piers (EE4) supporting a segmented arch (EE5), above which is a basalt rubble built spandrel (EE6), framed by ashlar quoins. The spandrel is finished with an ornate crenelated pitched profile (EE7) and has decorative central blockwork (EE8) incorporating a circular oculus and a carved inverted ball finial device in relief. An open quatrefoil oculus is also set centrally in the spandrel directly above the apex of the segmented arch.

The east-facing elevation with its elaborate neo-classical facade including its flanking walls would have been proportionally well balanced with two blind arches set either side of the central arch and crenelated pediment. This design is repeated on the archway to the courtyard at the main House of the Binns and was created by William Burn as part of the house redesign in *c.* 1810 (D Rhodes pers. comm.).

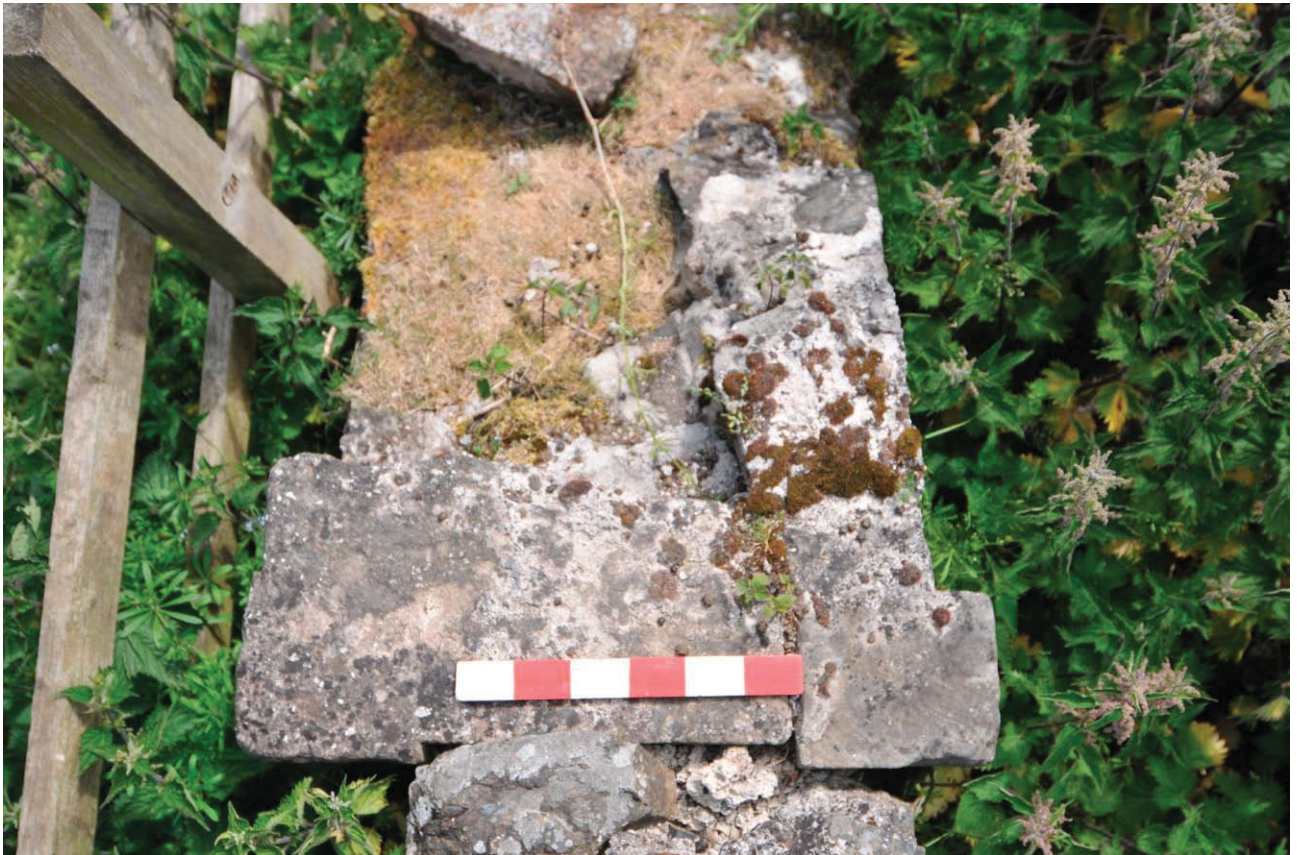
Fig. 5f - Detail of wall thickness and abutment between Courtyard and R2

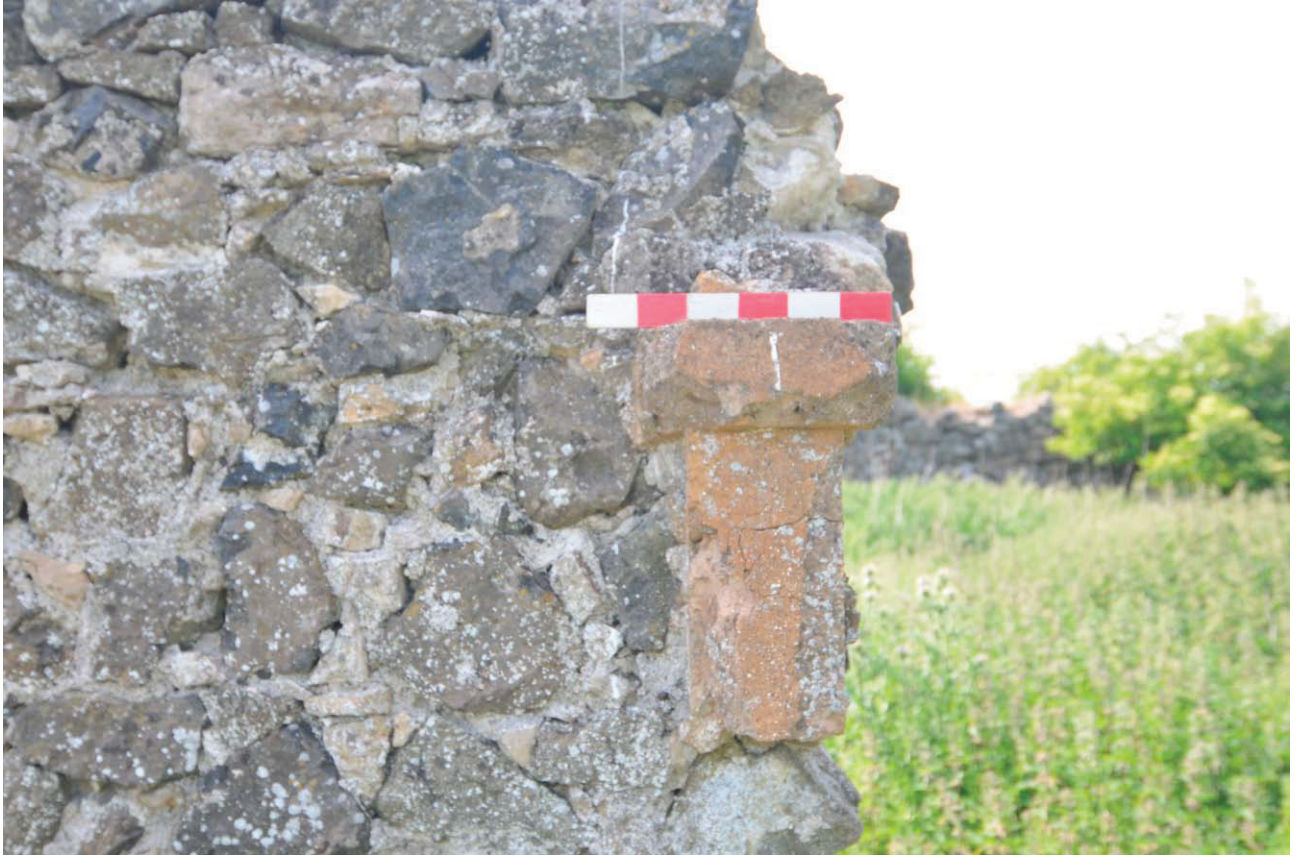
Roman cement archivolt (EE2) indicating a former, now collapsed, blind arch was present.

Fig. 5g - Detail of surviving pilaster on EFE south range

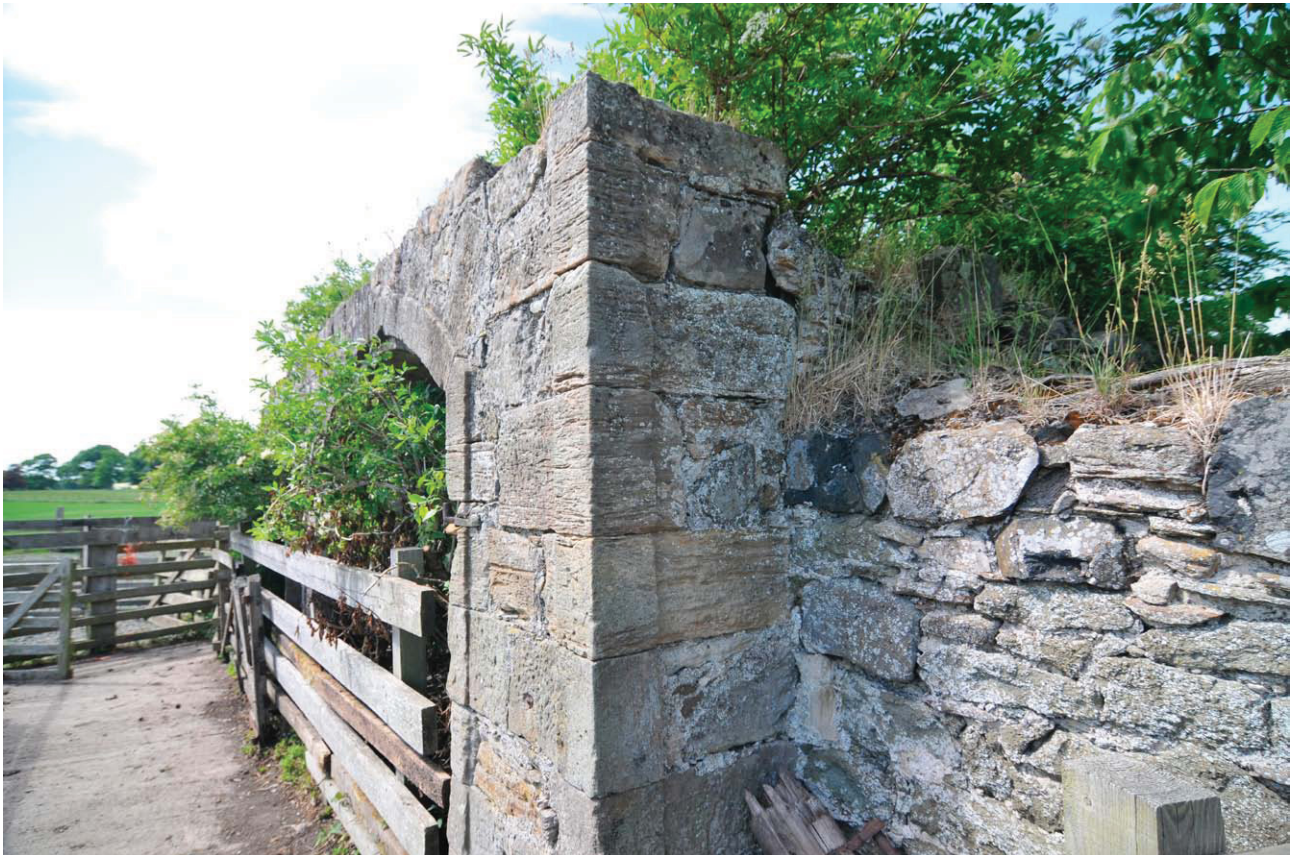
Faces open fields and measures 20000mm long. It comprises the gable of the west range and the side of the south range. The elevation of the west range is advanced by 200mm and measures 7200mm long and survives to a height of 2500mm. It is built of rough ashlar quoins which frame two entrances, each capped by a segmented arch.

Fig. 5h - Detail of outshot carriage entrance, SFE

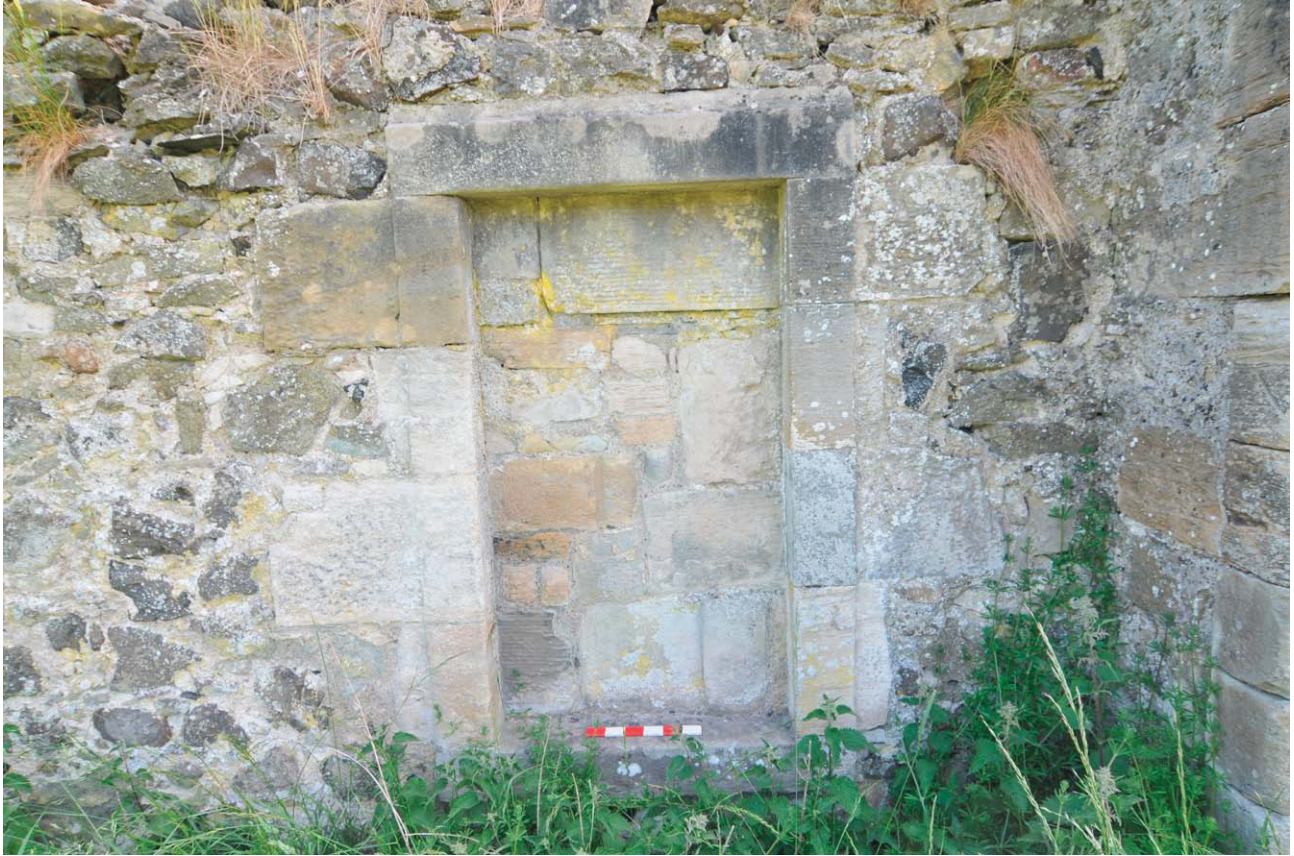
Fig. 5i - Detail of W6

Relatively minor changes are observed during this phase. The roof present truss of the Central Carriage House dates to this period and is likely a replacement for the original. A door (D11) and window (W6) on the north-facing elevation are blocked and R6 is adapted for livestock use by the installation of concrete stalls.

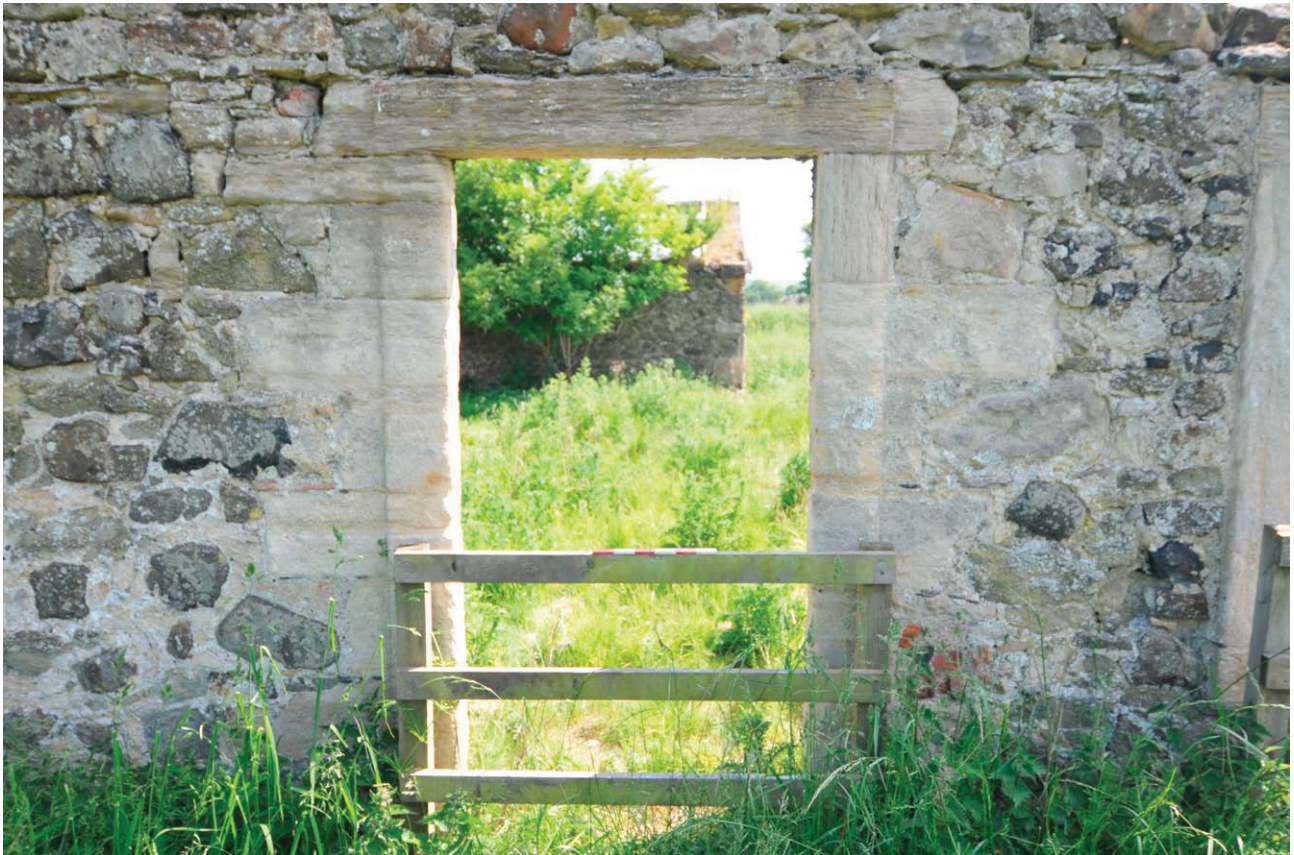
Fig. 5j - Detail of D12

A levelling course runs along the elevation of the north range at a height of 2200mm. The wall remains above this course comprises smaller random basalt boulders (EN2) than in the rest of the build. It abuts the east-facing advancement of the west range indicating a secondary phase of the build. The elevation of the west range contains door D10 and window W5. The north range contains doors D11 & D12 and windows W6-W8.

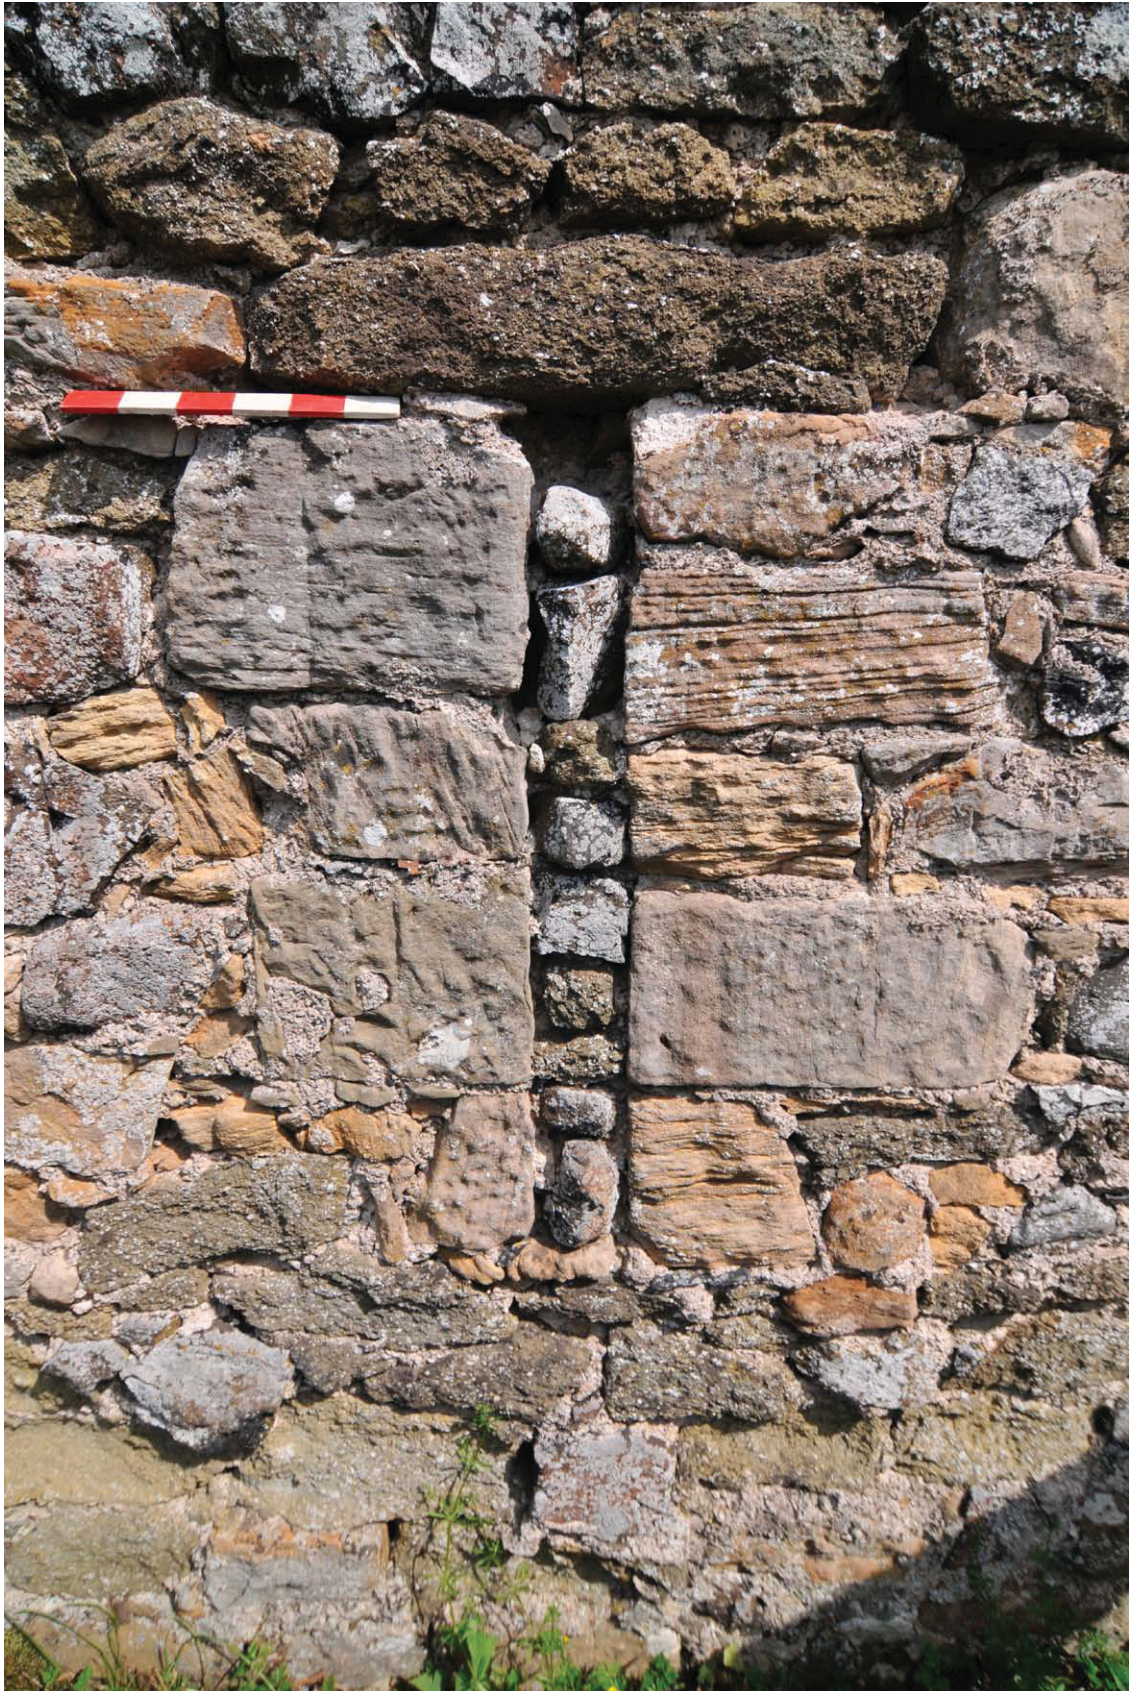
Fig. 5k - Detail of V5

The west-facing elevation (EW1) forms the back of the steading and the entire outside of the west range. It measures 32000mm long and survives up to 2500mm high. It contains three doors (D7-D9), two windows (W3 & W4) and five slit vents (V1-V5).

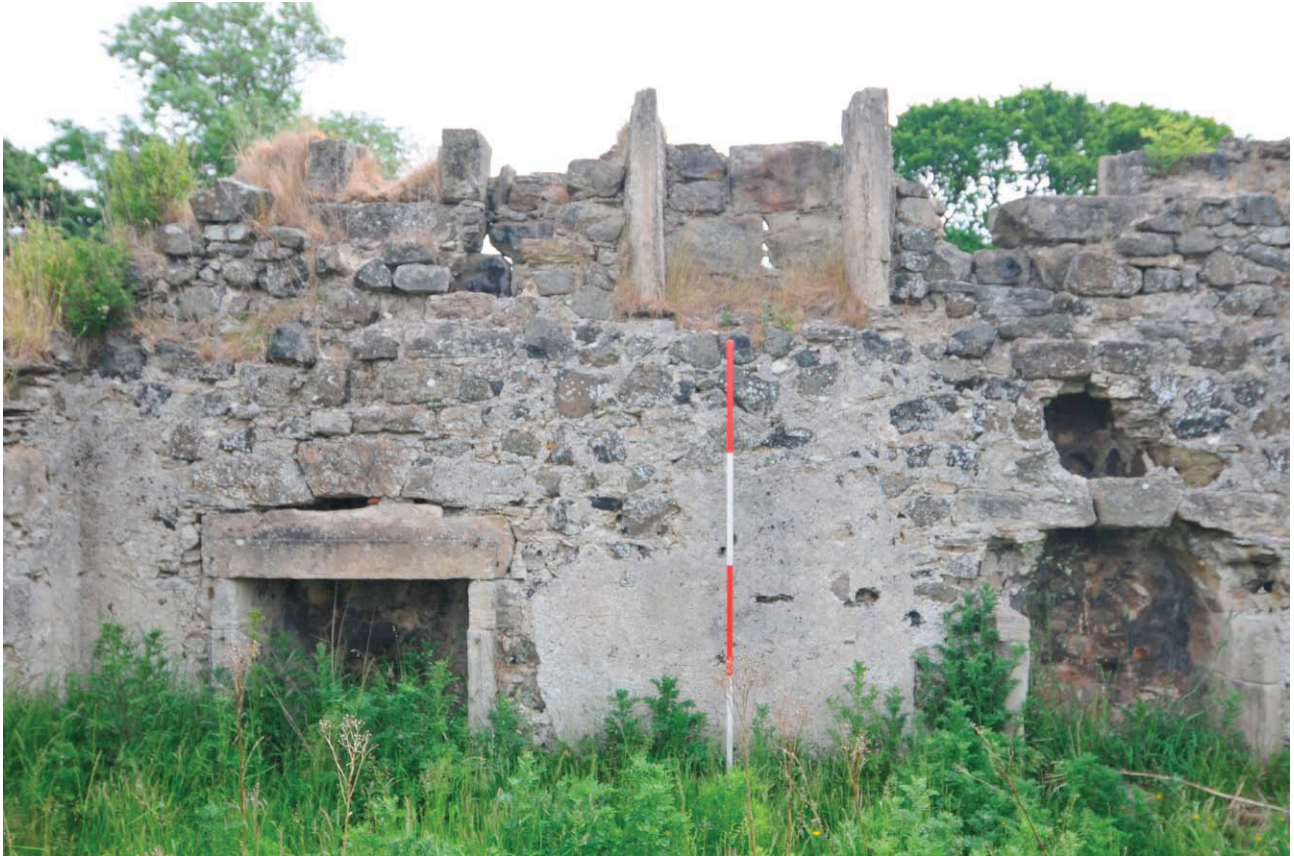
Fig. 5l - Detail of FP1-3

| Feature No. | Location | Summary Description | Dimensions in mm (L x H) |
|---|---|--|---|
| FP3 | IR71W | First floor fireplace built from vertical sandstone orthostats. The lintel is missing as is the wall above the top of the fireplace. | 900 x N/A |

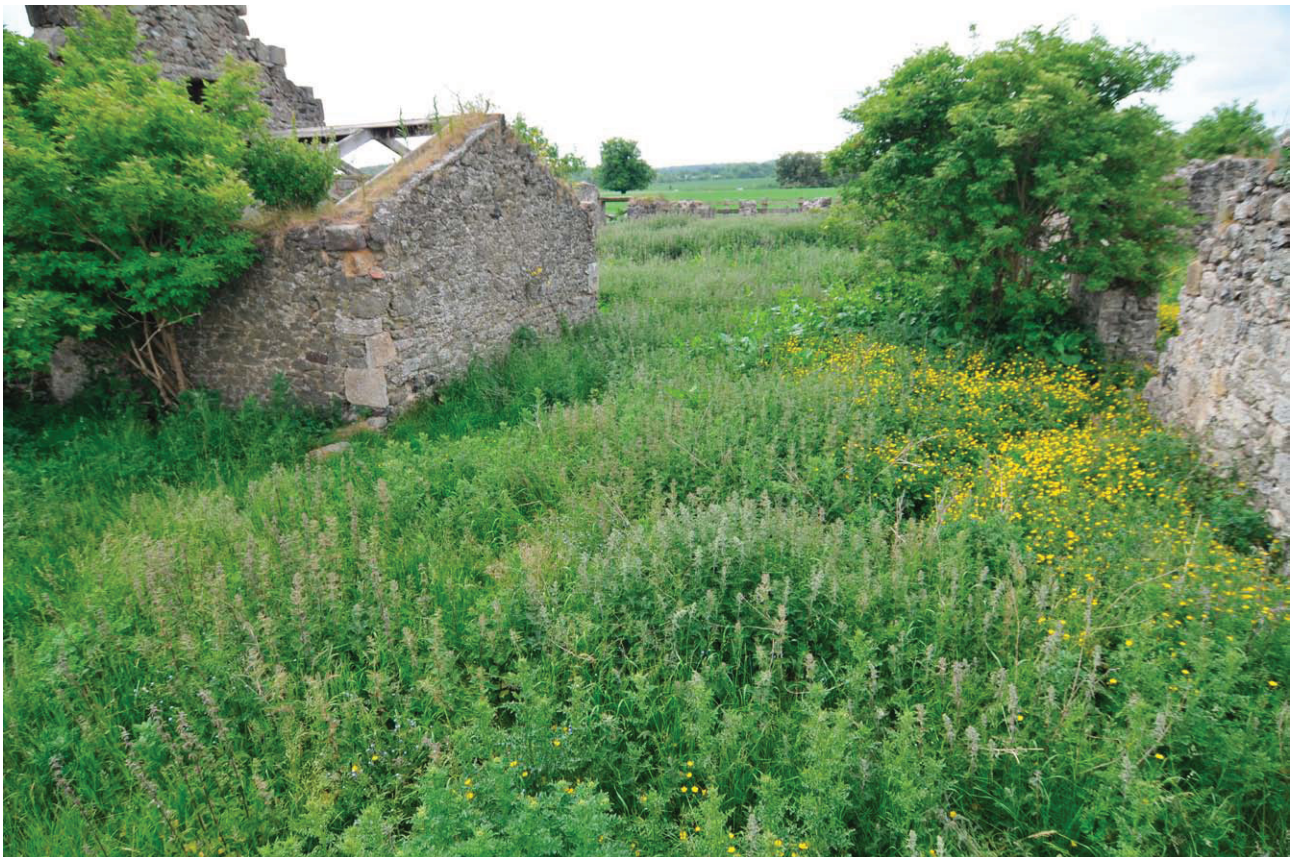
Fig. 5m - View of courtyard from R7 towards R1 & R2

The interior is divided into seven rooms (R1-R7) and a U-shaped courtyard by a series of internal walls. The U-shaped courtyard is bounded by the former exterior walls of the south, west and north ranges.

The floor surfaces are thickly overgrown with up to 1.5m high wild plants (nettle, dock, buttercup, thistle, etc) and occasional small self-seeding trees. R3 in particular is densely overgrown and no access would be possible without substantial clearance.
