Site & Landscape Survey

Borders Railway Project Stagebank Cottage (Site 480) Desk-based Historic Building Assessment Report No. 3083

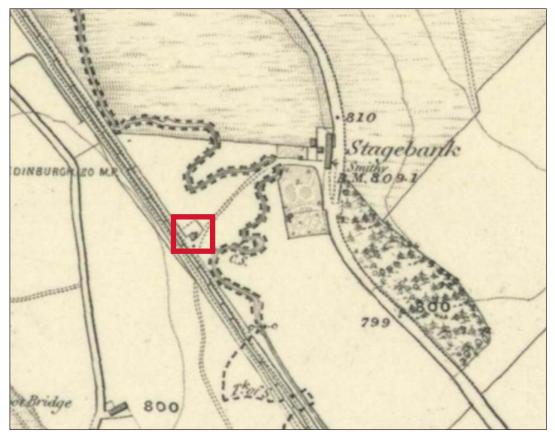
Fig. 2a Map by Ordnance Suvey, 1853

The 1853 First Edition Ordnance survey map (Fig 2a) depicts a rectangular building with a porch on its east side. The cottage is set within a small square plot of land.

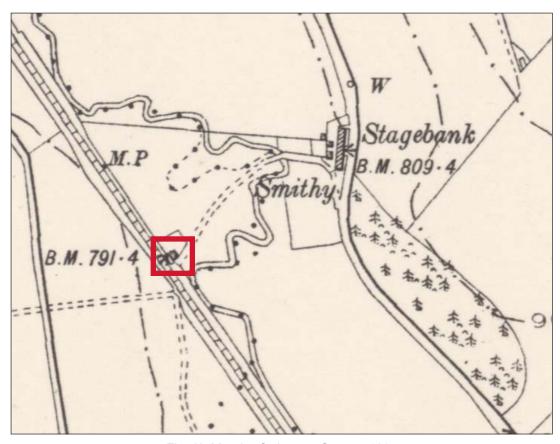
Fig. 2b Map by Ordnance Suvrey, 1894

The 1894 Second Edition Ordnance Survey map (Fig 2b) shows similar detail to the first edition map but the porch on the east side is not shown.

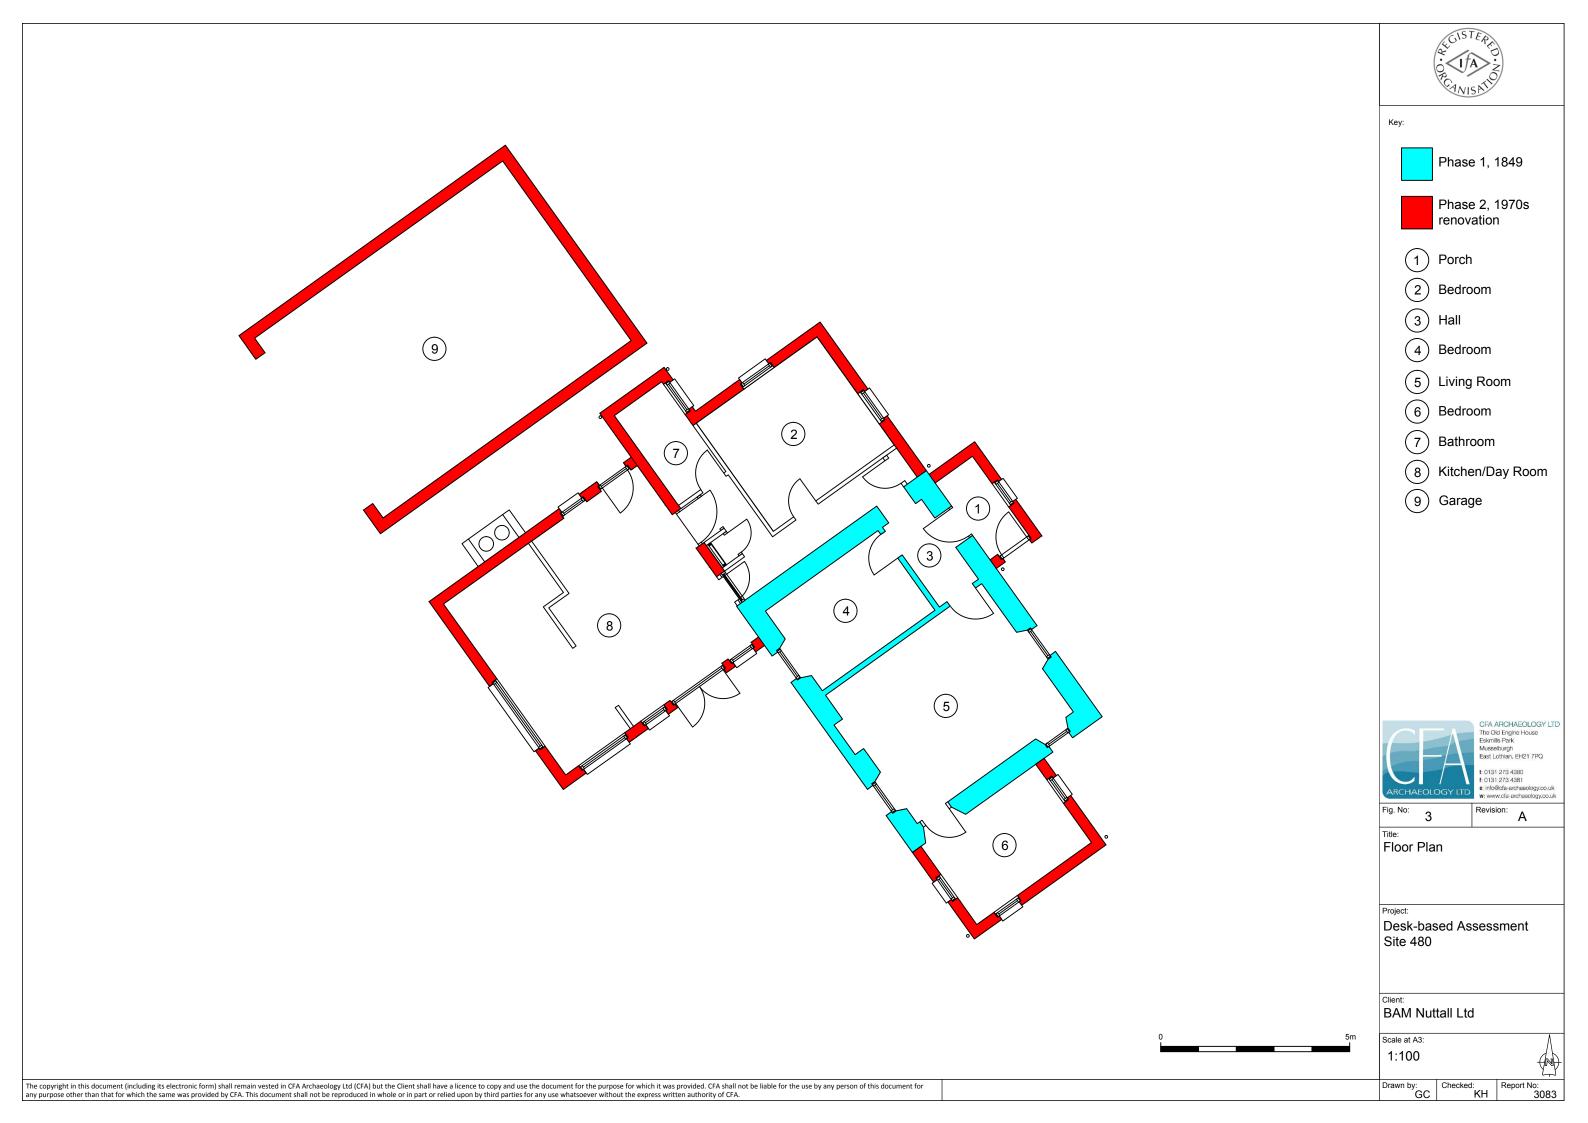
The ground plan of Stagebank Cottage includes three bedrooms, a bathroom, a living room and a kitchen-day room. A porch on the north-east elevation provided access to the hall. The dimensions of each are listed in Table 1 below.

Phase 1: (Late 19th century/ shaded blue) comprising a purpose-built crossing-keepers cottage occupying a simple rectangular two-room plan with a porch situated at the end of the north-east facing elevation. The hall (3) and small bedroom (4) and living room were created by internal partition walls. The living room was lit by windows on the south-west facing elevation and one on each of the north-eastern and south-western elevations. In Phase 2 when bedroom (6) was added one of the windows was replaced by the insertion of a door.

Phase 2: (Late 20th century, probably 1970s/shaded red) comprising 'modern' room additions including a new porch (1), two bedrooms (2 and 6), bathroom (7), and the large kitchen/day room (8). These modernisations effectively enlarged the smaller

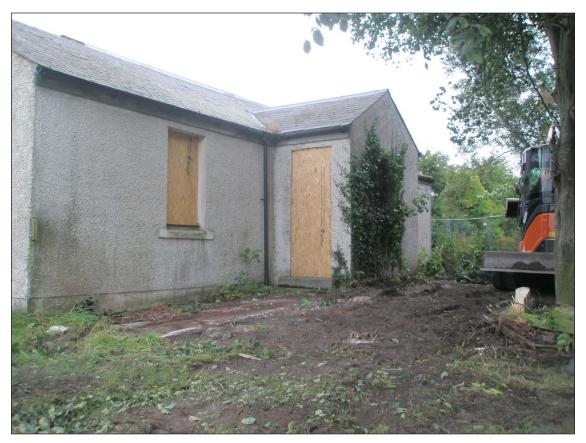
Plate 1 - North-east facing elevation with central porch

The north-east facing elevation measured 17 m long and 5m high, and comprised the central porch that is flanked on either side by the living room (5) and bedroom (2). A bedroom (6) and bathroom (7) both project of the earlier core block (Phase 1 see below).

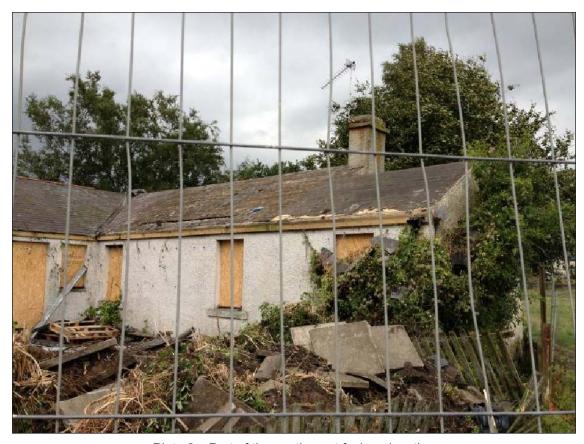
Plate 2 – Part of the south-west facing elevation

The south-west facing elevation measured 17m long and 4.2m high and featured the kitchen (8) that projected off the line of the main elevation. The elevation incorporated bedroom (4) and the living room (5) with bedroom (6) outshot off the earlier core block. The bathroom (7) projected off the south-east end of the elevation.

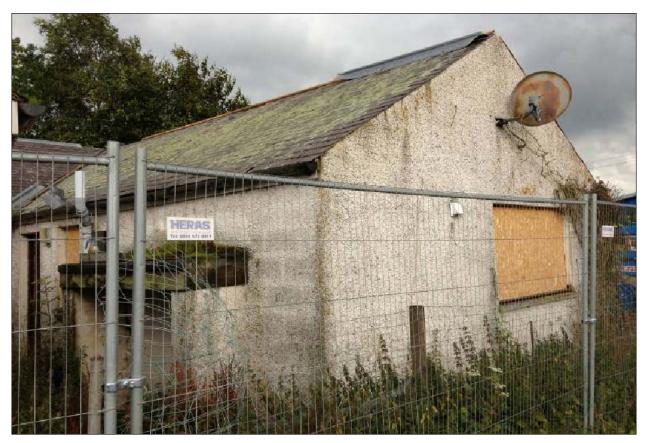
Plate 3 – Part of the north-west facing elevation

The north-west facing elevation measured 14.2m long and 4.2m high and included the gable of bedroom (2) with the outshot bathroom (7). The kitchen/day room (8) occupied the rest of the elevation.

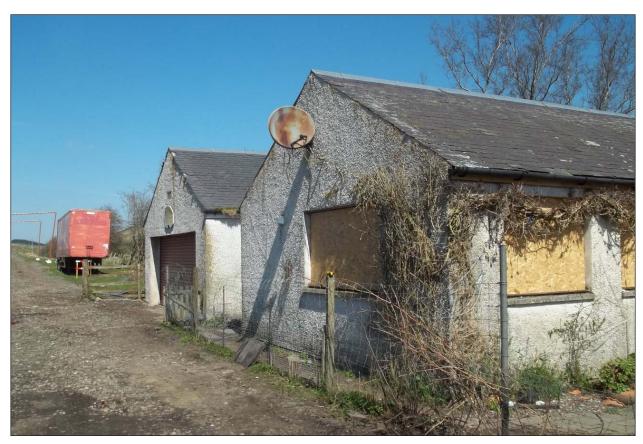
Plate 4 – Part of the south-east facing elevation

The south-east facing elevation measured 14.m long and 4.2m high and included the bedroom gable (6) that was advanced off the living room wall (5). The outshot porch (1) was set further back along with the kitchen/day room (8) that was set further back from the aforementioned bedroom gable.

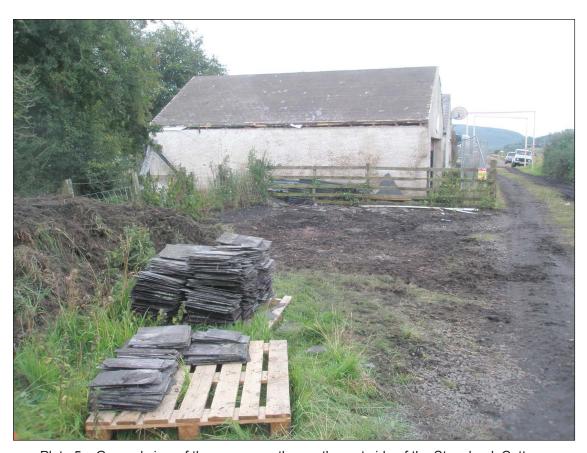
Plate 5 – General view of the garage on the south-west side of the Stagebank Cottage

This was a mono-block-built structure and rectangular in plan. The exterior was harled. A large bay opening was situated on its south-west facing elevation.
