**Clashindarroch Wind Farm,
Huntly, Aberdeenshire**

Archaeological Mitigation Works

**Data Structure Report
No. 3117**

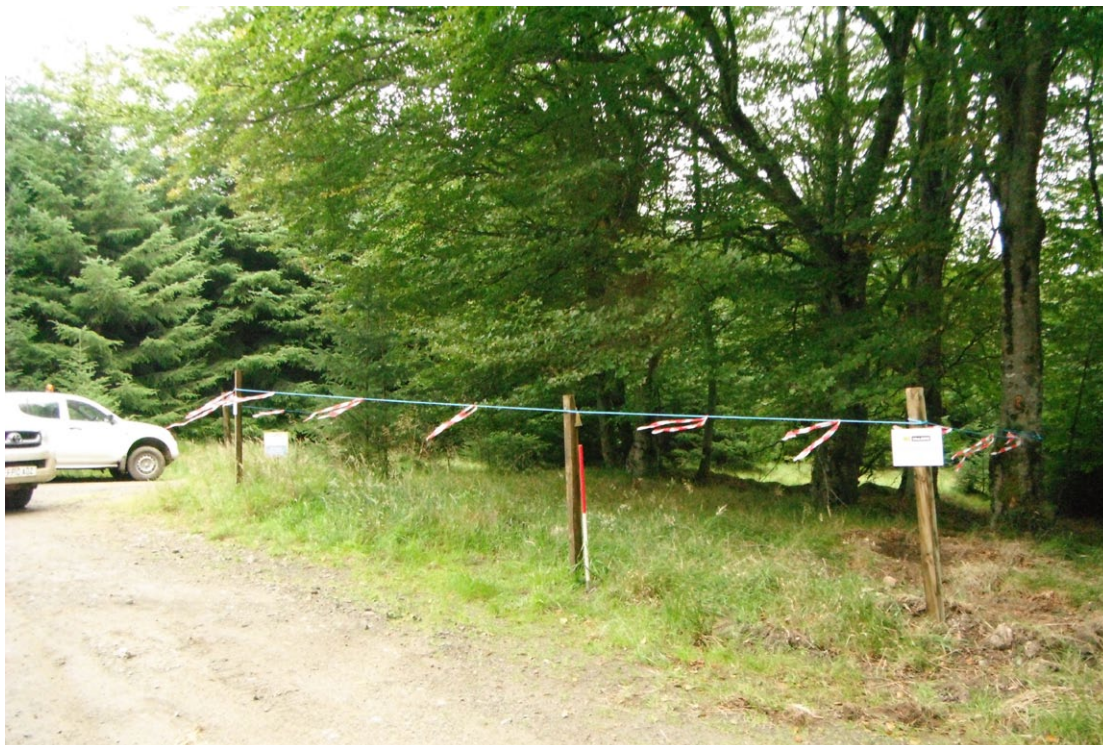
Fig. 6 - Site 15 fenced off next to the access track

Sites 2, 15, 24 and 30 were fenced with appropriate buffer zones (Fig. 6-8). The buffer at Site 2 was reduced, in agreement with ACAS.

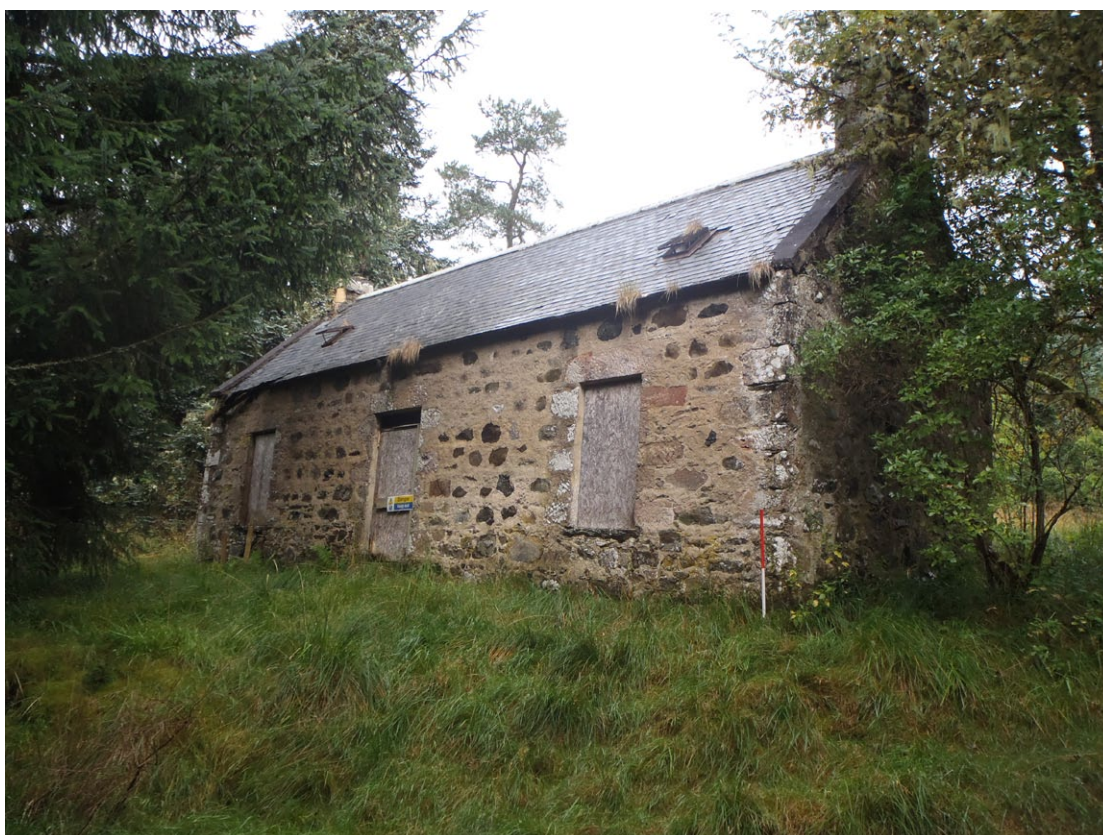
Fig. 7 - View of the farmhouse at Oxter Burn (Site 2)

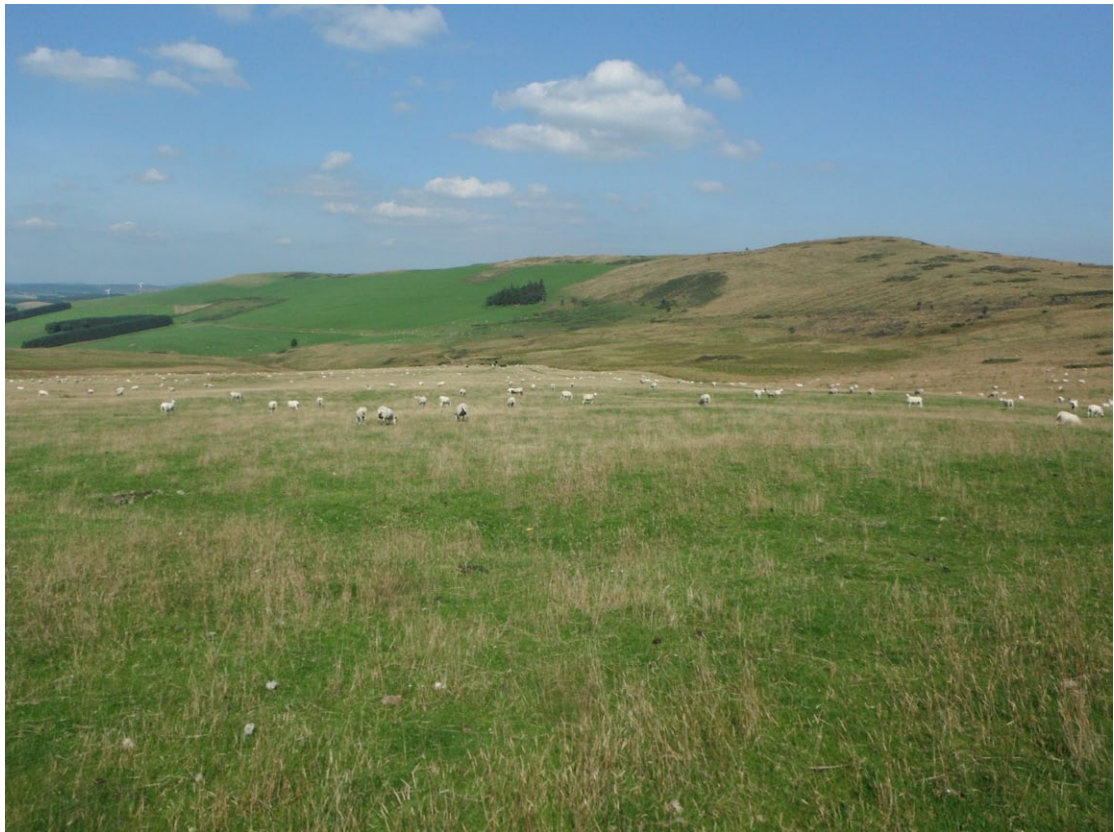
Monitored access roads included the main site access road (Fig. 2) from the A920 to the start of the forested area just north of Kye Hill (Fig. 9). This area also took in the site compound and parking area. This access road crossed improved fields to the east and south of the Collonach Burn. No archaeological remains were recorded.

Fig. 9 - General view of the new access road route looking NE from Kye Hill

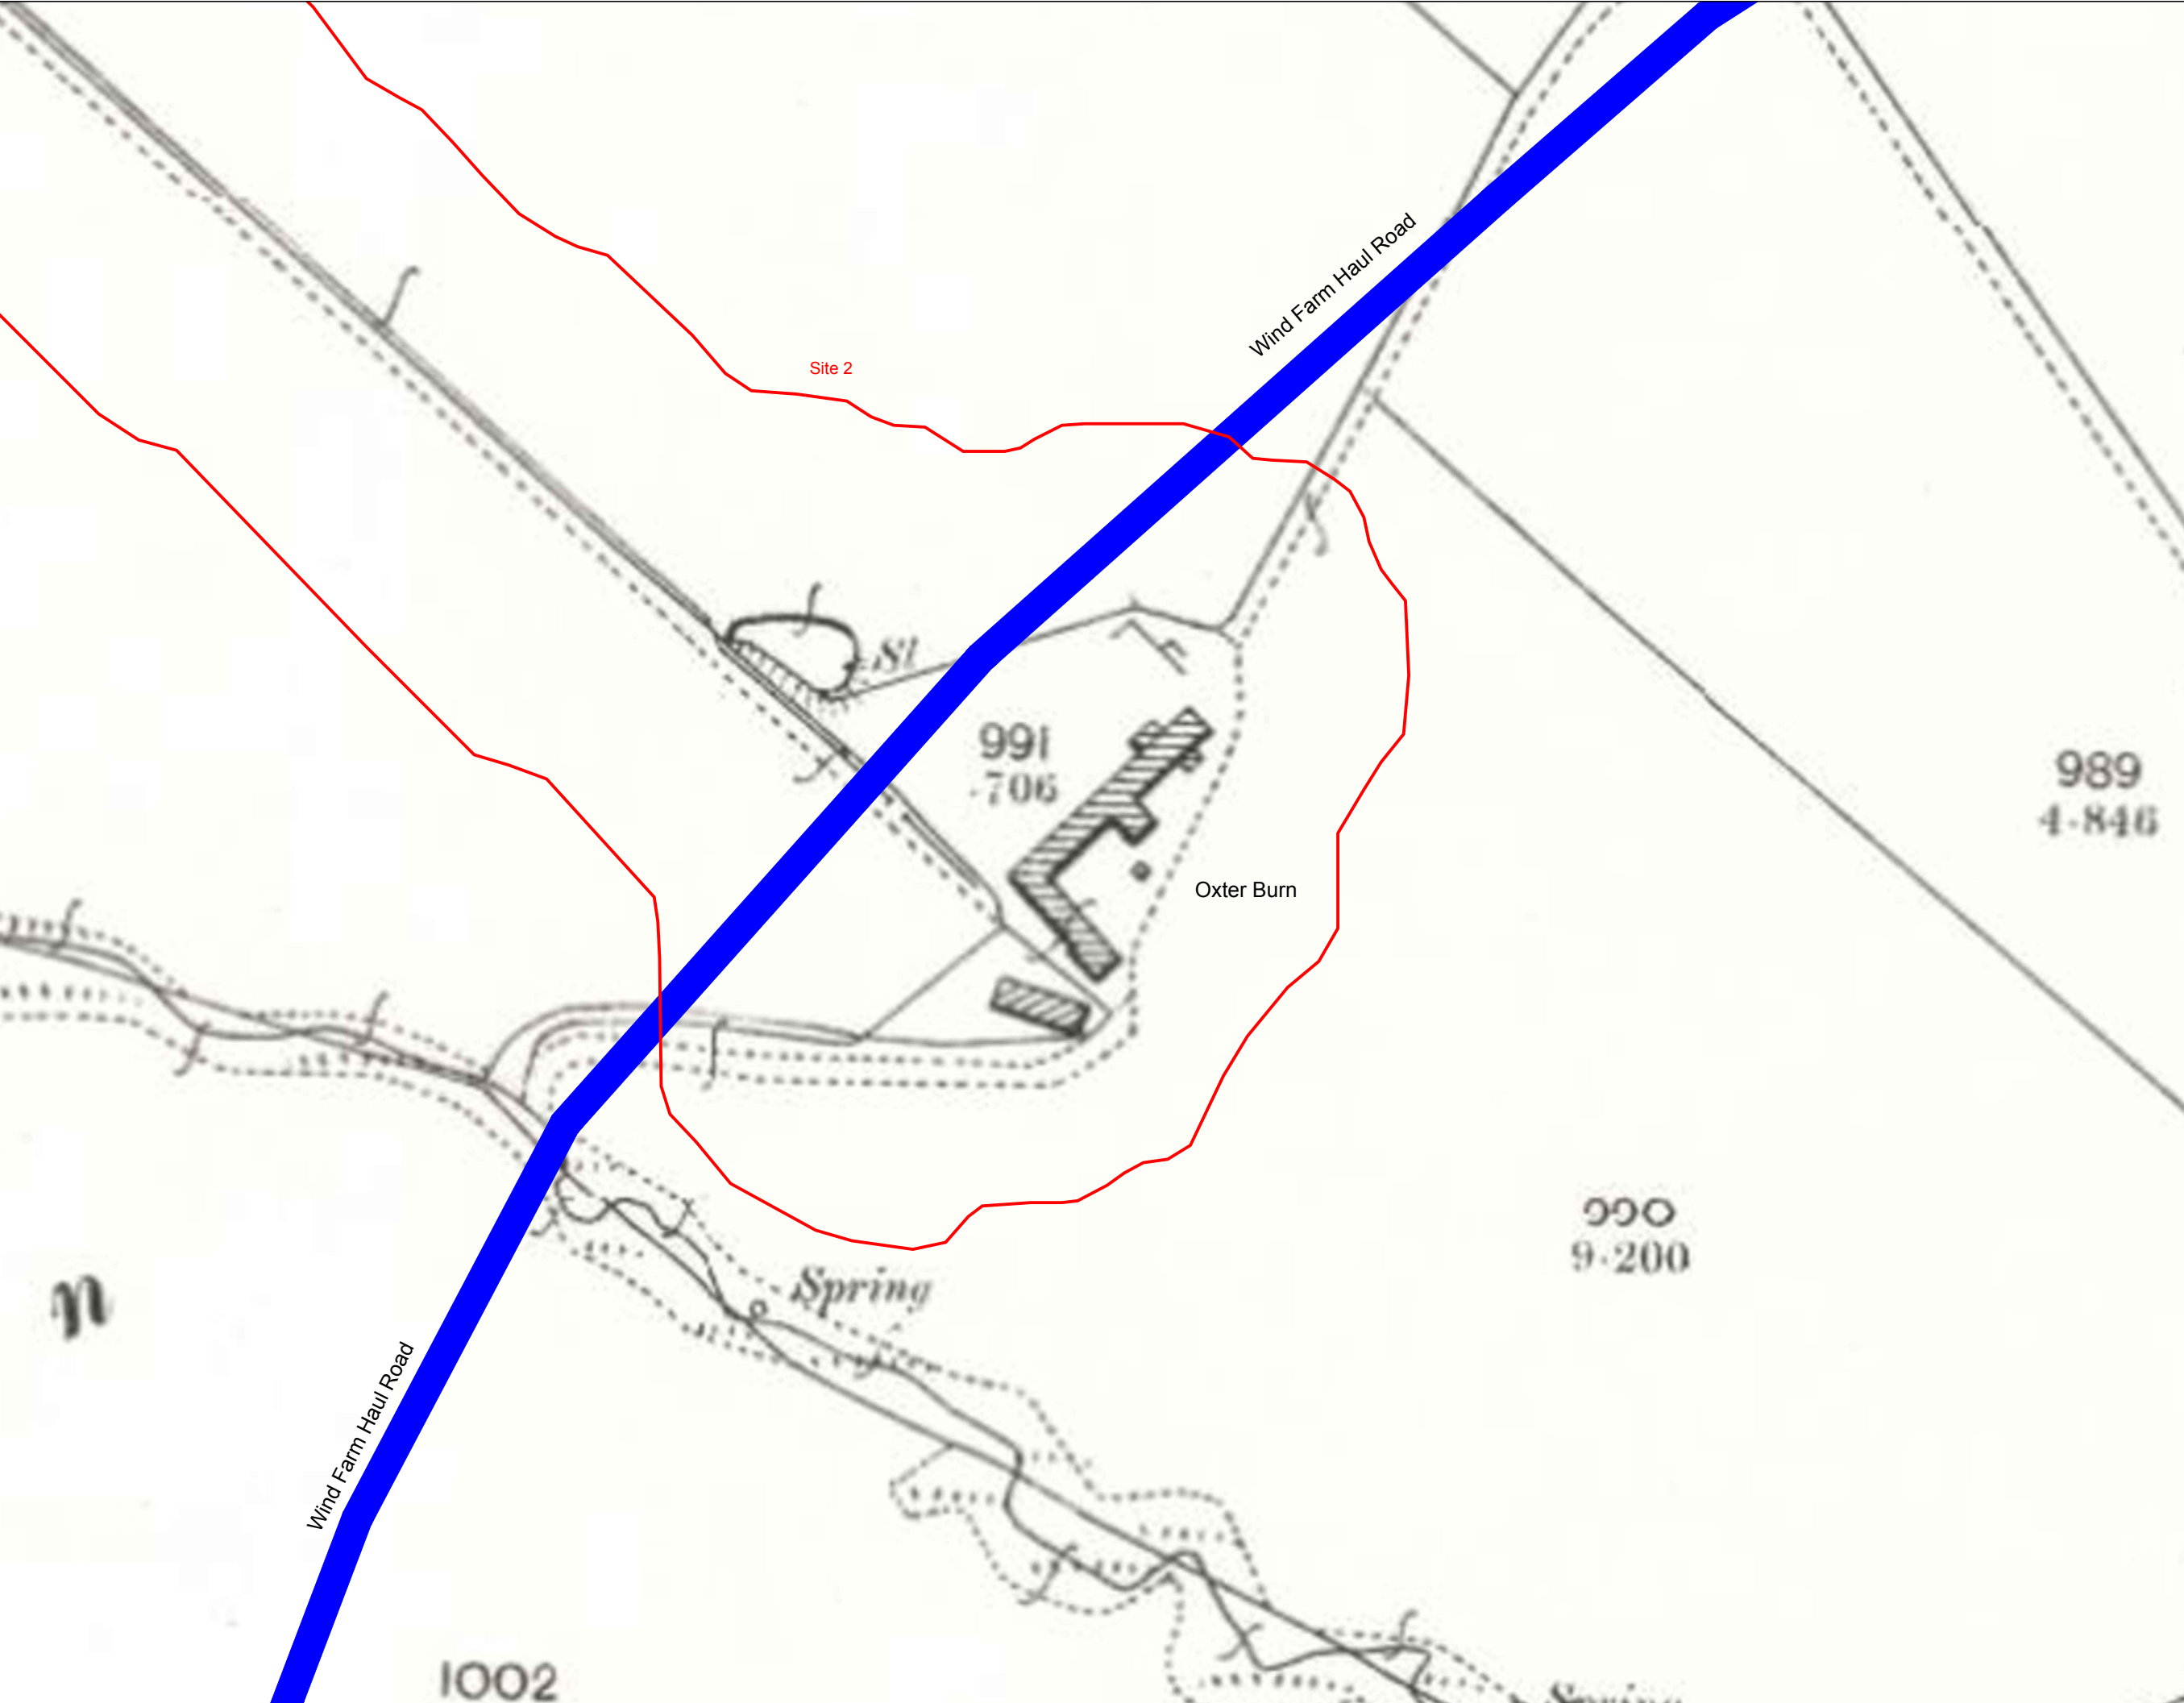
The Oxter Burn settlement was part of Corrydown Township and the OS Second Edition map of 1901 (Fig. 10) shows various farm buildings and other agricultural infrastructure including a pond and sluice ('SI' on the map). The surviving elements of the site were surveyed by GPS and a route for the new road agreed. This aimed to avoid all parts of the site with the exception of a ditch leading east from the pond. Although the area had been badly affected by commercial forestry (Fig. 11), the ditch (or possible mill lead) from the pond was located during the watching brief and a section through this feature (**012**) is shown in Fig. 12.

| Title: OS Second Edition 25 inch Map extract (Aberdeenshire, Sheet 033.10) showing the settlement at Oxter Burn in 1901 | | | |

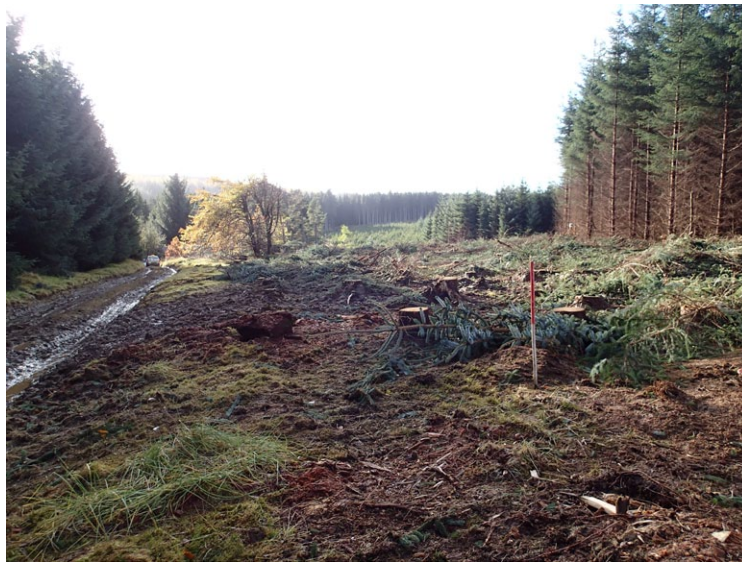
Fig. 11 - The new access track through cut forestry to the N of Oxter Burn

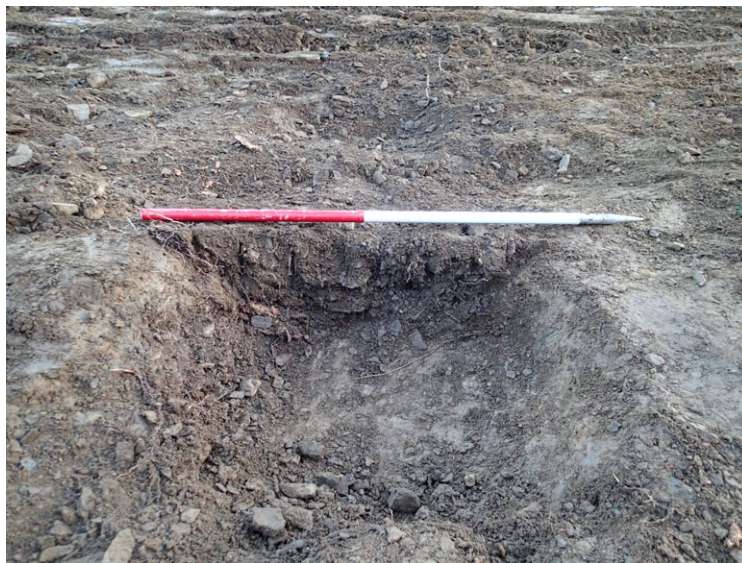
| Context No. | Description |
|---|---|
| 012 | Cut for linear ditch at Oxter Burn |
| 013 | Brownish-grey mottled silt, sand and angular stones in ditch 012 |

Fig. 12 - Section through the ditch 012 at Oxter Burn

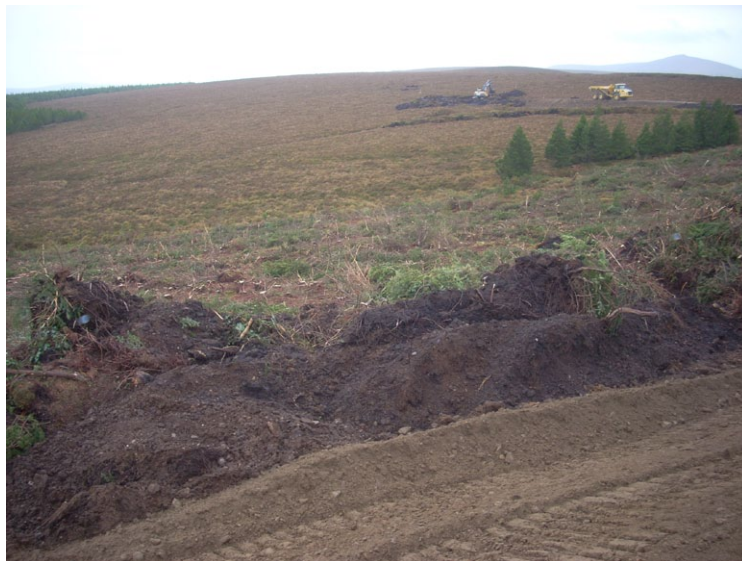
Fig. 13 - General view of the work at T4 from the N

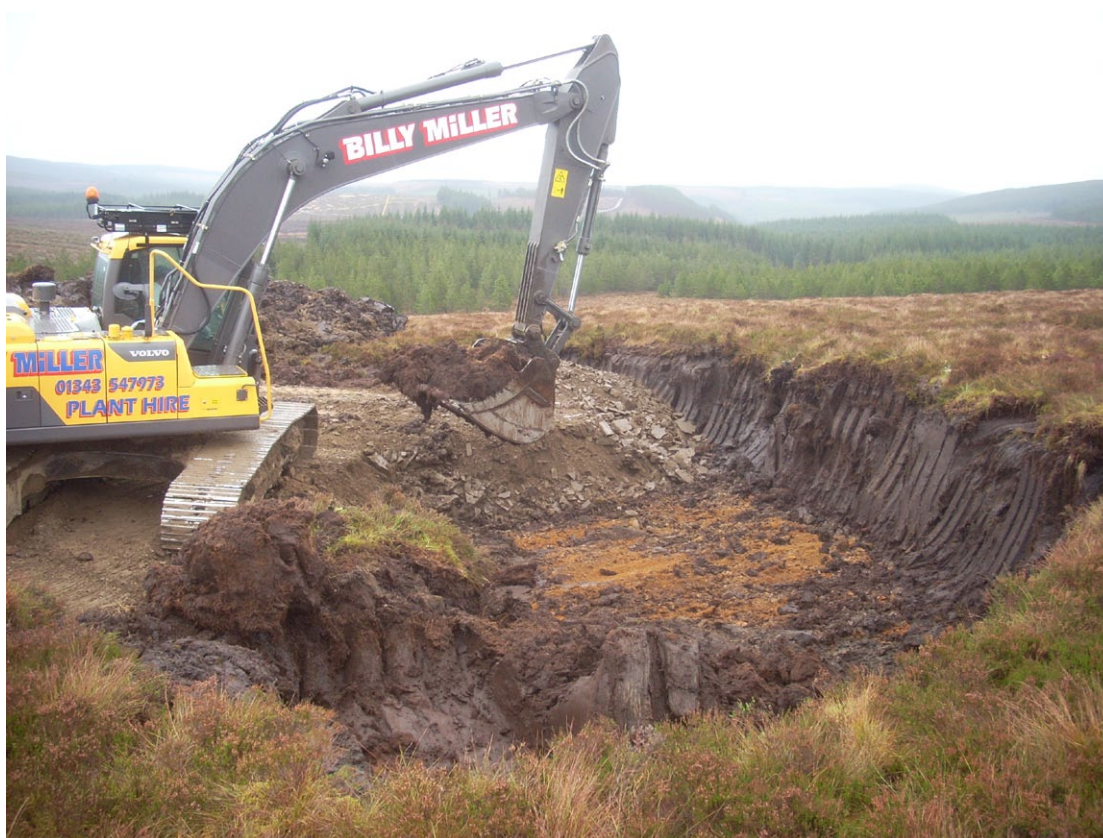
The area between just north of T4 and just south of T3 was monitored (Fig. 5). Elsewhere in this area of open moorland, the access road was floated over the peat and the boundary between the dug and floated parts of the road is clearly visible in Fig. 13. Where the road was excavated, this area contained peat with a depth of between 1.5m and 2.5m (Fig. 14). No archaeological remains were recorded.

Fig. 14 - Deep peat at T4

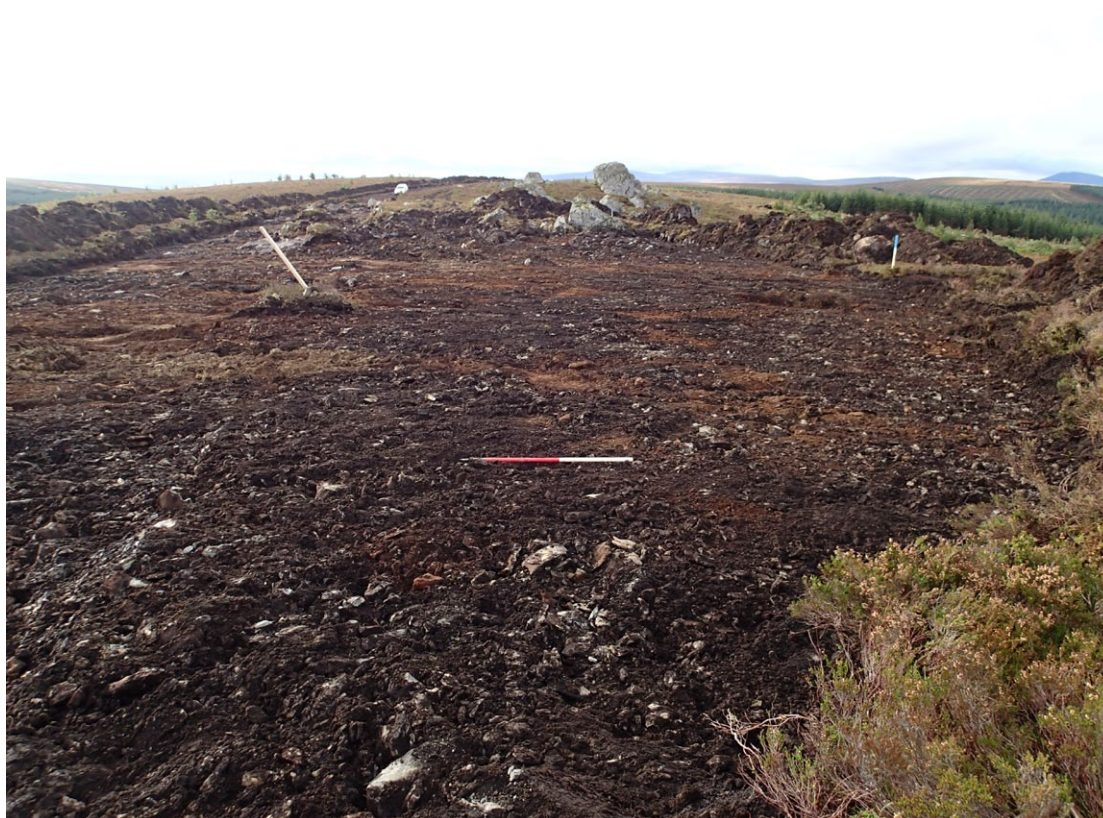
The area from midway between T5 and T8, to T9 was monitored (Fig. 5). This area contained shallow peat with a depth of <0.5m, numerous erratic boulders (Fig. 15) and shattered bedrock. No archaeological remains were recorded.

Fig. 15 - Shallow peat and surface rocks at T9

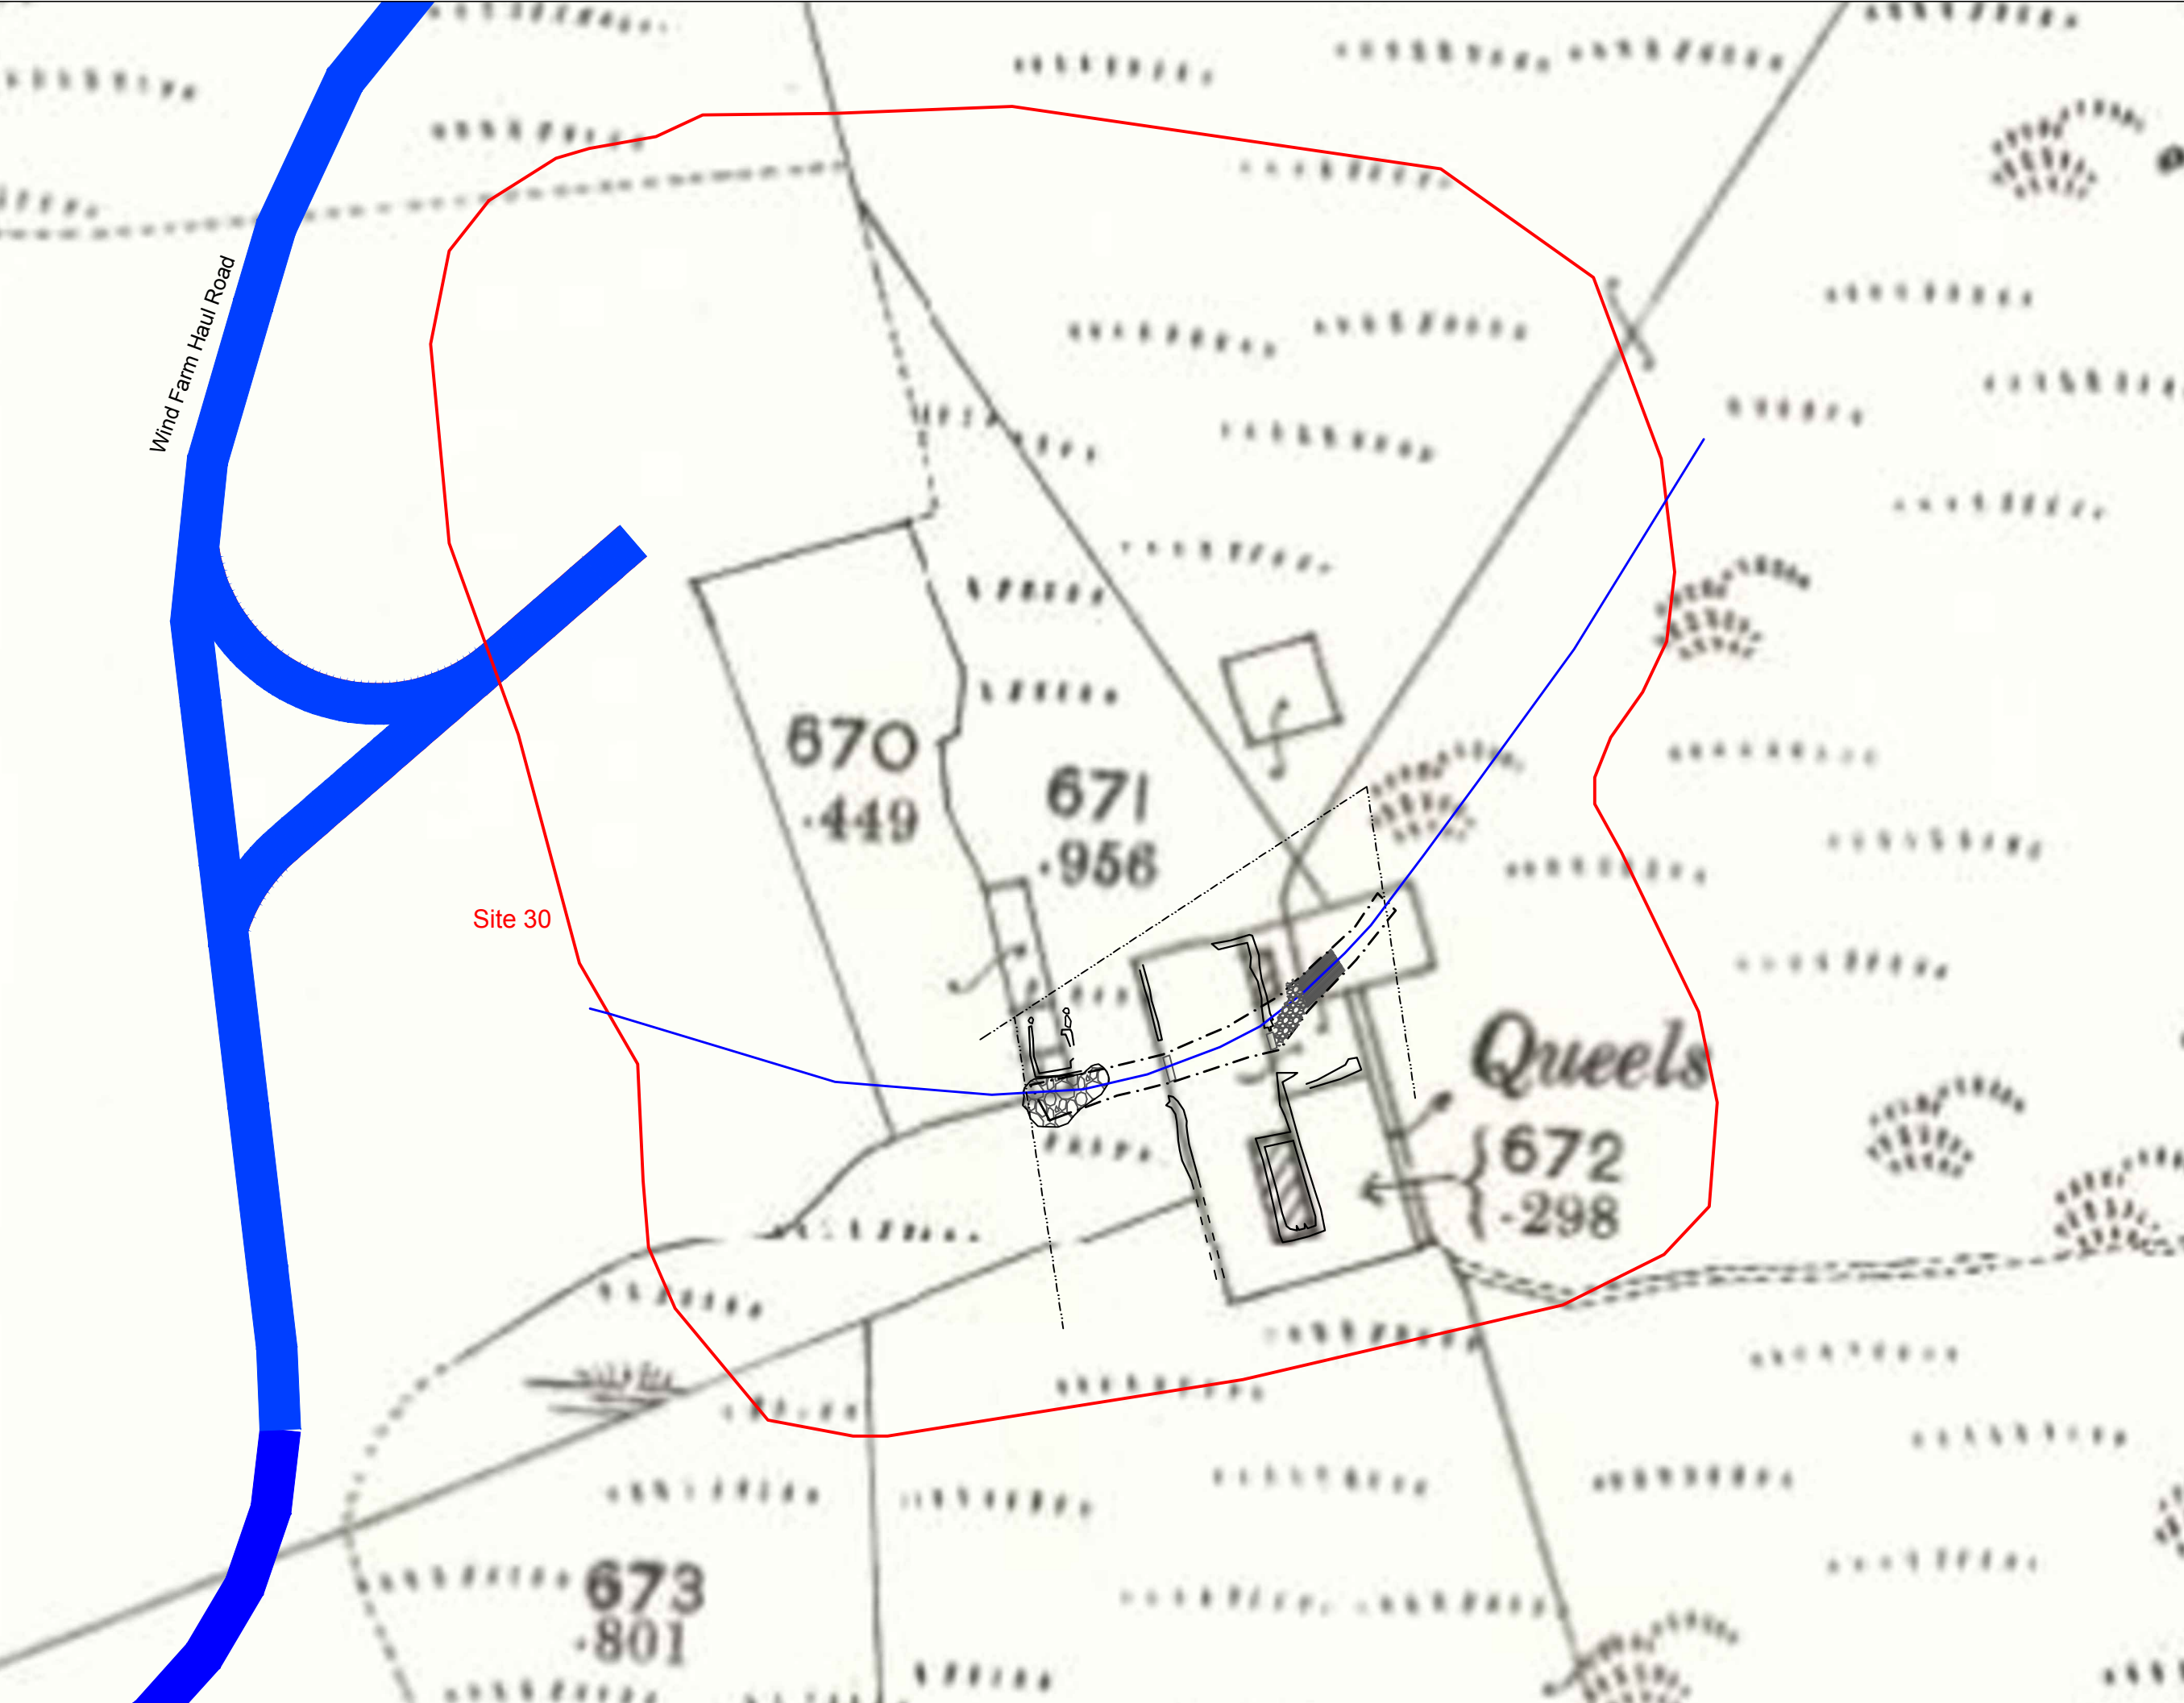
Queels (Site 30) is shown in detail on Ordnance Survey maps from 1874 and 1901 (Figs. 16-17) and the route of the new water pipe has been added to these maps. Numbers in bold and parentheses below refer to contexts further described in Appendix 1.

The recorded remains at Queels correspond well to the structures shown on the 1st and 2nd edition OS maps of 1874 and 1901 (Figs 16 and 17). Structure **007** to the west is shown on both maps as a rectangular building (roofed in 1874, unroofed in 1901) with two square compartments, perhaps storage or cart sheds, on its south end. The surviving remains surveyed correspond to the southernmost of these compartments; the northern one and the rest of the building apparently having been demolished by forestry activity. Walls **004** and **006** appear to fit best with a rectangular enclosure on the 1901 map which replaced a smaller one shown in 1874. Cobbled layer **008** appears to have been a yard surface within the NE part of this enclosure and midden layer **009** corresponds well to a rectangular enclosure, possibly an animal pen, shown on the 1901 map. The building to the south is shown as roofed on both the 1874 and 1901 maps,

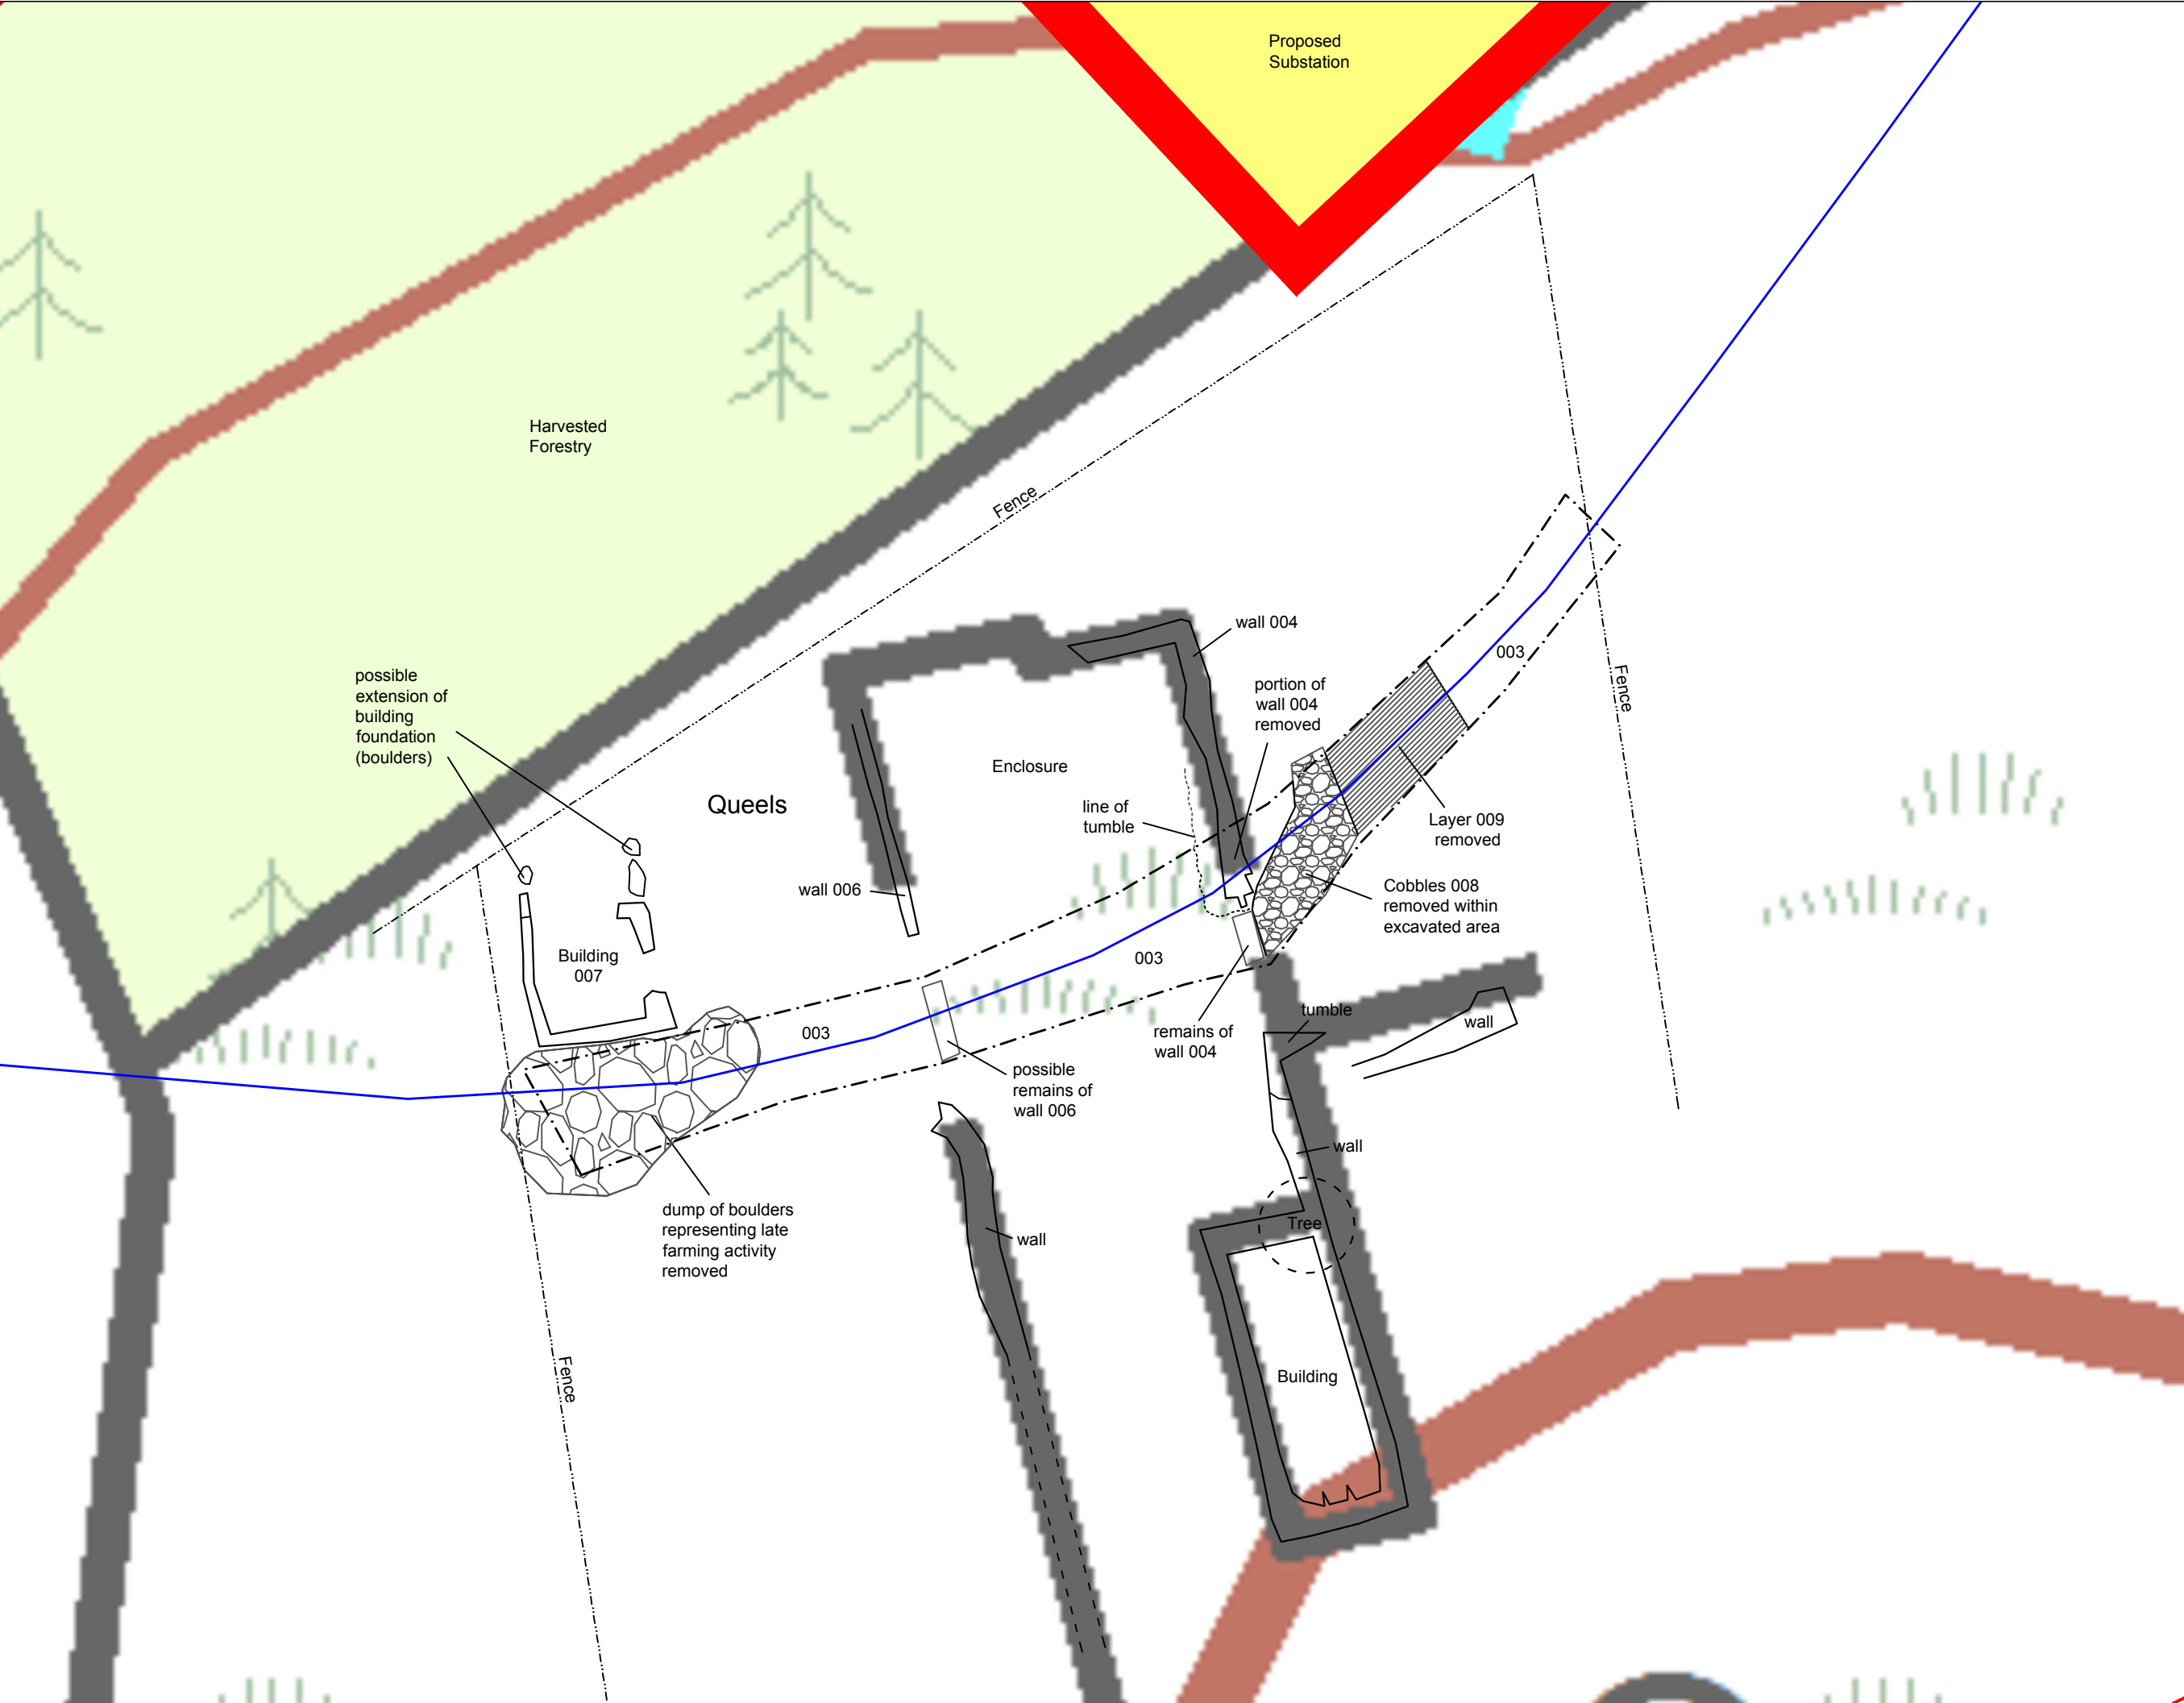
The site survived as the upstanding remains of two rectangular buildings and a rectangular enclosure (Fig. 18), along with a dump of boulders from more recent activity.

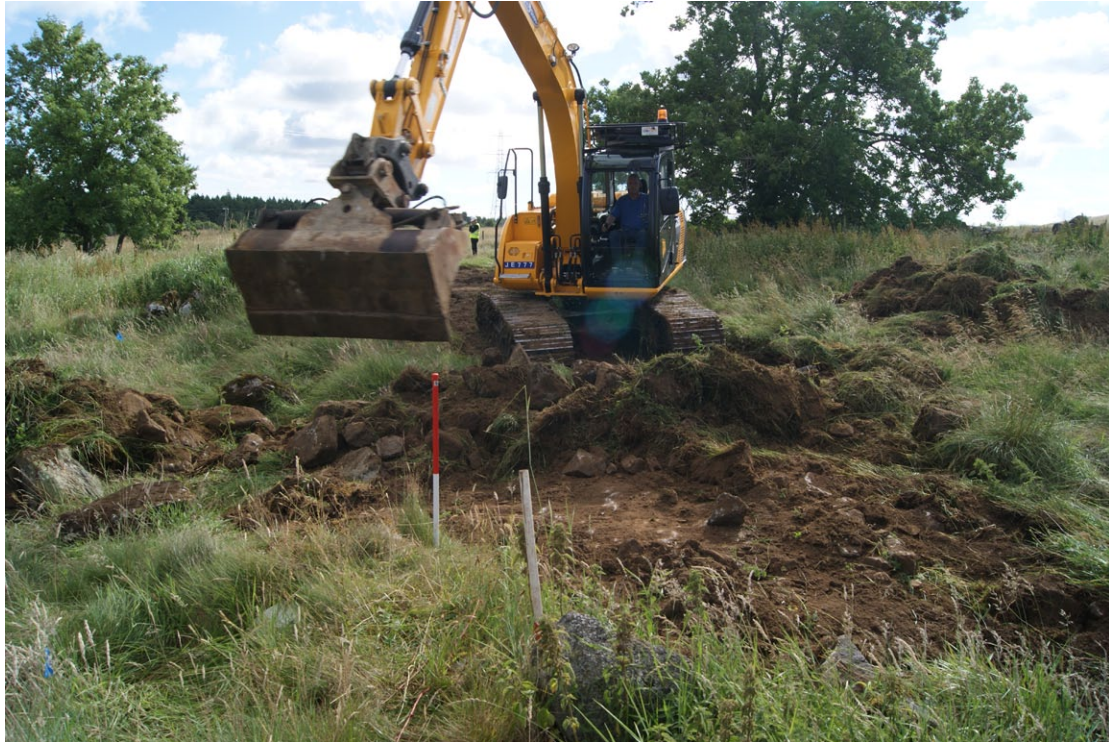
Stripping of the corridor revealed that a modern dump of field clearance boulders had been positioned against the south wall of building (**007**, Fig. 20). These were very large and must have been dumped by a tractor. Further east at the gap in wall (**006**), the possible remains of foundations were exposed (Fig. 21) suggesting that there had not always been a gap here. Similarly, the stripping of topsoil at the gap in wall (**004**) also exposed corresponding wall foundations. It seems likely that both gaps were created by modern farm machinery crossing the site and demolishing the walls.

Fig. 19 - Supervising removal of boulders recently dumped against building 007, Queels

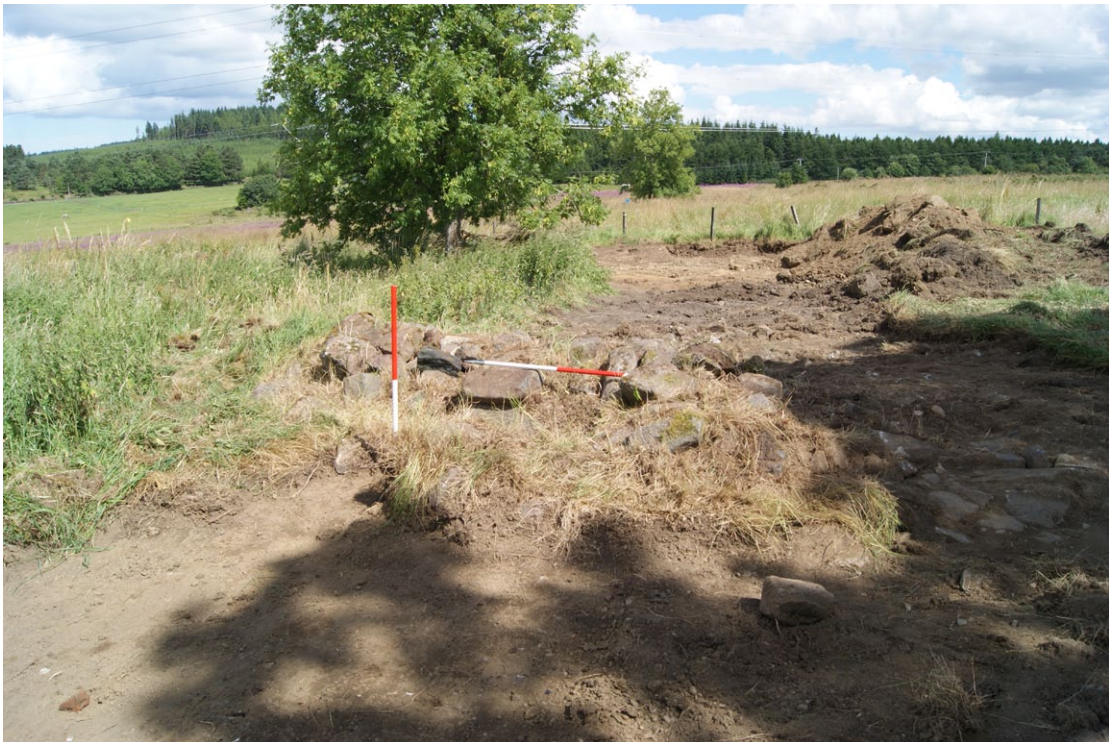
The site was surveyed using a total station to identify a route through the farmstead that would cause the least damage to the surviving remains. This identified a possible route through two existing gaps in the walls of an enclosure north of the main rectangular building. This route also avoided a further building at the west end of the settlement (**007**). Installation of the new pipe required a 3.5-5m wide working corridor along the chosen route and this was stripped of turf and topsoil under archaeological supervision using a tracked excavator equipped with a toothless ditching bucket. The resulting plan is shown in Fig. 18. During the stripping it was realised that the angle of the route was too steep near the east gap in the enclosure wall, so it became necessary to demolish a 3m long segment of the wall (**004**, Fig. 19).

| Context No. | Description |
|---|---|
| 004 | E wall of former enclosure at Queels. Measures 1.4-1.2m wide (excluding tumble) and 0.65m high (max). Structure built from loosely placed angular fieldstones measuring on average 0.4m x 0.3m x 0.15m. Once extended to the S and joined the main rectangular building at Queels, but a gap has been created by recent farming activities. Excavation around the gap revealed the foundations of this wall. Wall abuts cobble layer 008. |

Fig. 20 - Shot of wall 004 prior to demolition, Queels

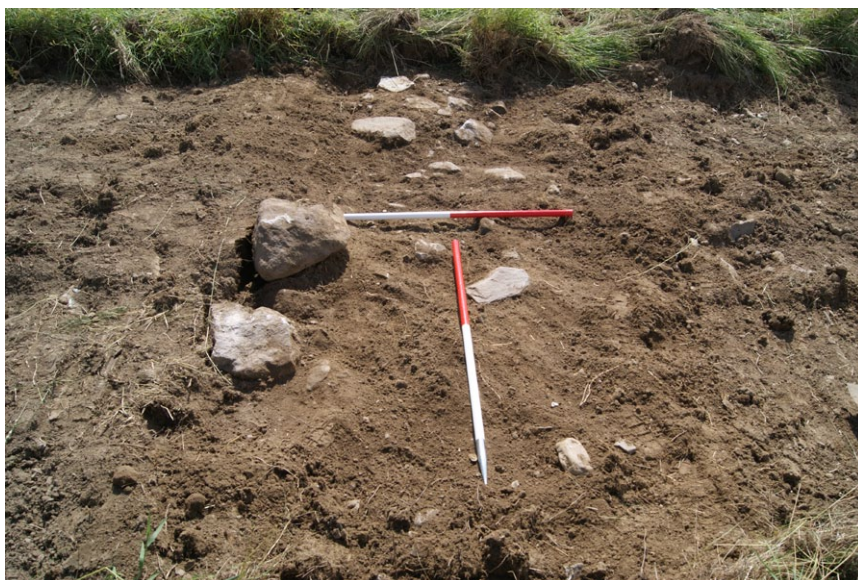
| Context No. | Description |
|---|---|
| 006 | W wall of enclosure at Queels. Stripping of the working corridor through an existing gap revealed possible foundation stones for this wall. The stone layer comprises a single layer of medium to small angular and tabular stones placed on top of natural deposits. Overall the stone deposit measured 3.5m in long and 0.8m wide. Nothing survived in section. |

Fig. 21 - Possible remains of wall 006 revealed within stripped area, Queels

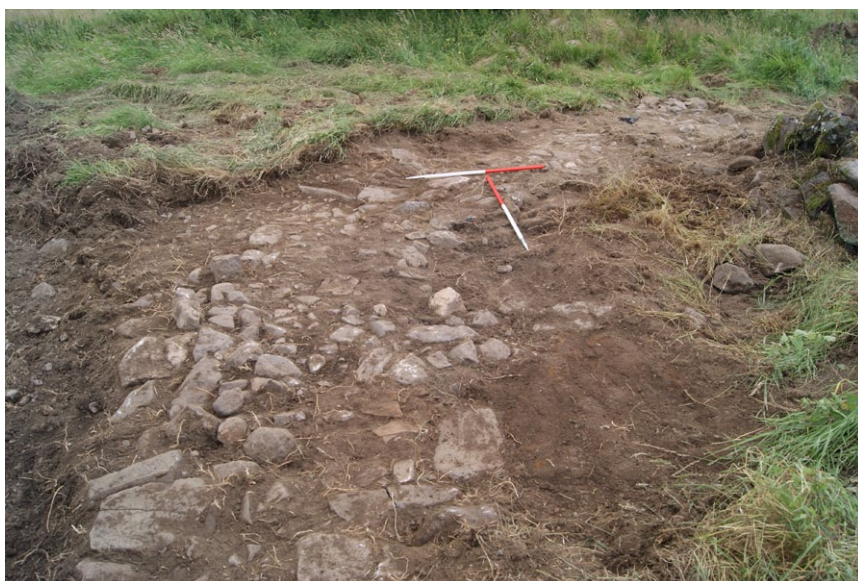
Removal of the 3m long segment of wall (**004**) revealed that it had been constructed from field stones with a turf and soil core; 19th century pottery was found at its base. To the east lay a cobbled surface (**008**, Fig. 22) which extended to the east for 5m before ending in a line of kerb stones. Abutting this kerb and extending 6m to the NW was an organic silty-clay layer (**009**) containing 19th century rubbish. Both layers lay on natural (**003**).

| Context No. | Description |
|---|---|
| 008 | A layer of sub-angular to angular stones randomly laid to the E of wall 004, abutting it in places. The layer comprises small stones, occasional bricks and pieces of unidentifiable iron. Stones vary in size from 0.15m x 0.09m to 0.42m x 0.3m. At the E end the cobbles have been positioned to form a kerb. The cobbled surface lies above natural deposits and abuts midden layer 009 to the E. Finds were not recovered. |

Fig. 22 - Cobbling 008 prior to removal, Queels

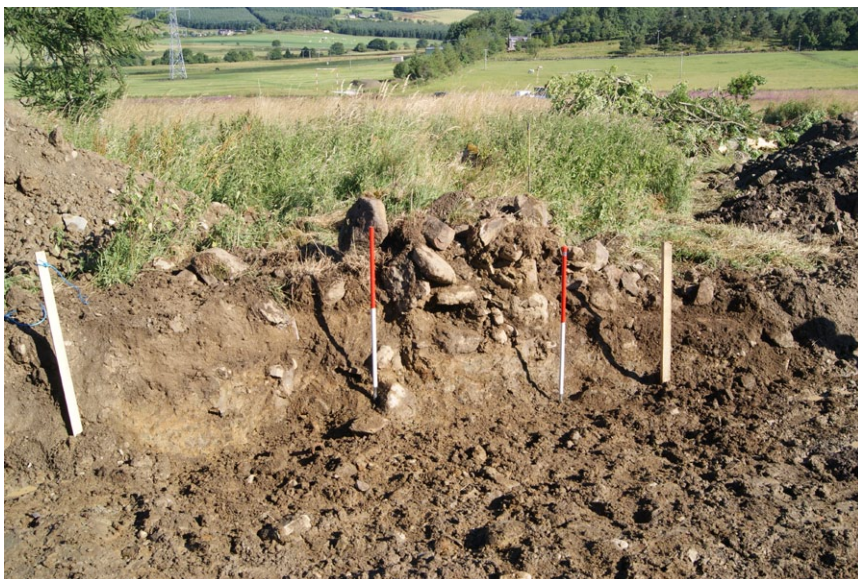
| Context No. | Description |
|---|---|
| 010 | A layer of mixed clay and topsoil in the core of wall 004 with occasional smaller stones mixed in. Layer lies above natural deposit 003 and contains blue-glazed 19 th century ceramic at base. Finds were not recovered. |

Fig. 23 - Shot of section through wall 004 from the SE

Once the corridor had been fully stripped to natural, both the north and south ends of exposed walls **004** (Fig. 23) and **006** were fenced off as were the remains of building **007** in order to prevent accidental damage during water pipe installation.
