**Eckford Mill Cottage,
Kelso, Scottish Borders**

Archaeological Watching Brief

Report No. 3151

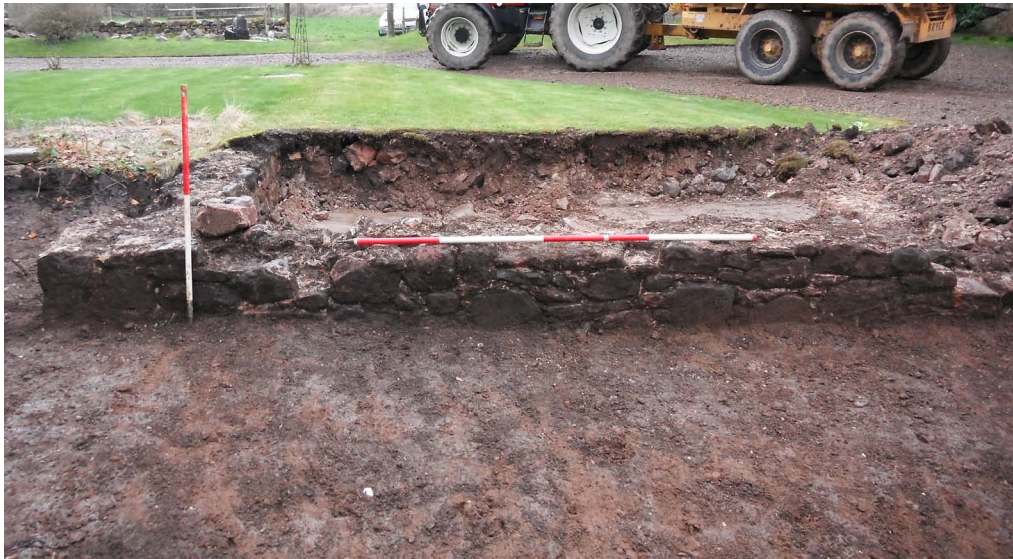
The remains of part of a stone building consisting of mortared sandstone walls were revealed immediately below the turf (Figs. 1, 5-8). The structure was constructed of roughly-hewn, irregularly coursed sandstone within a grey mortar matrix (**003**). The southeast and southwest walls survived to a height of 0.30m high and 0.50m wide. The walls on the northeastern side of the exposed structure appeared to have been largely robbed or destroyed by landscaping within the gardens of the cottage as only the lowest foundations were still visible. An internal concrete/mortar floor surface (**004**) was also found largely intact. The depth of the floor surface from the top of the wall was 0.60m. An earlier service trench (**005**) had been cut through the building remains running northwest - southeast. The excavation of the trench for this service had removed the eastern corner of the building and cut through the floor.

Fig. 5 - Shot of SSE-facing elevation of remains of structure

The surviving remains could not be preserved in situ so they were removed. The walls were not contained in foundation trenches rather they were built straight on to the natural and the floor surface was laid over a thin spread of rubble over natural.

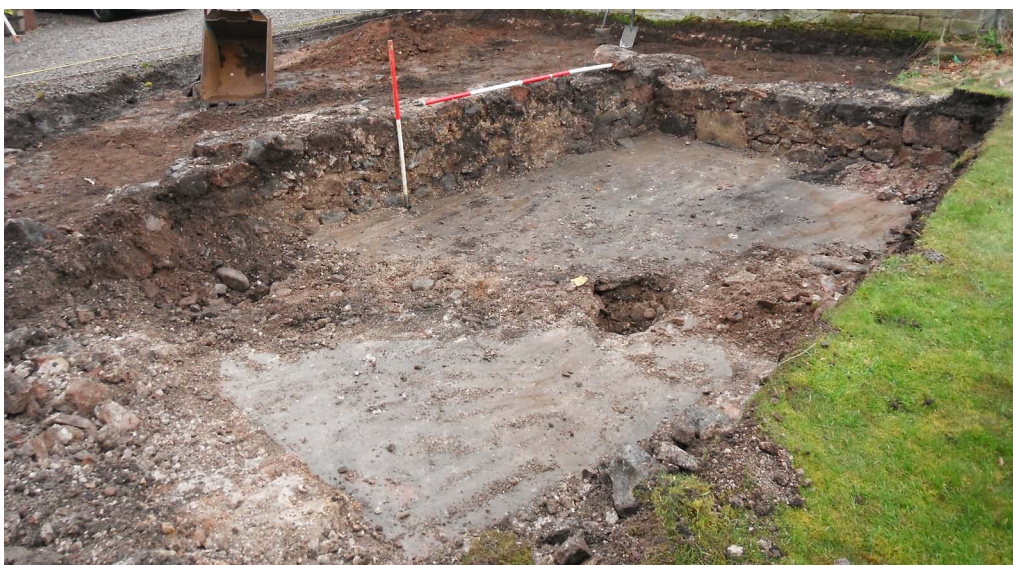
Fig. 7 - Shot of remains of structure from NW
