**66 Buccleuch Street
Odeon Cinema
Edinburgh
Historic Building Survey**

Report No 3140

Authors	Michael Cressey HND BA MSc PhD MifA FSA (Scot) Stuart Mitchell MA AIfA
Illustrator	Leeanne Whitelaw BSc MAAIS
Editor	Tim Neighbour BSc MifA
Commissioned by	Cruden Homes (East) Ltd
Date issued	June 2014
Version	1
Grid Ref	NT 2612 7279
Oasis Ref No	cfaarcha1-177330

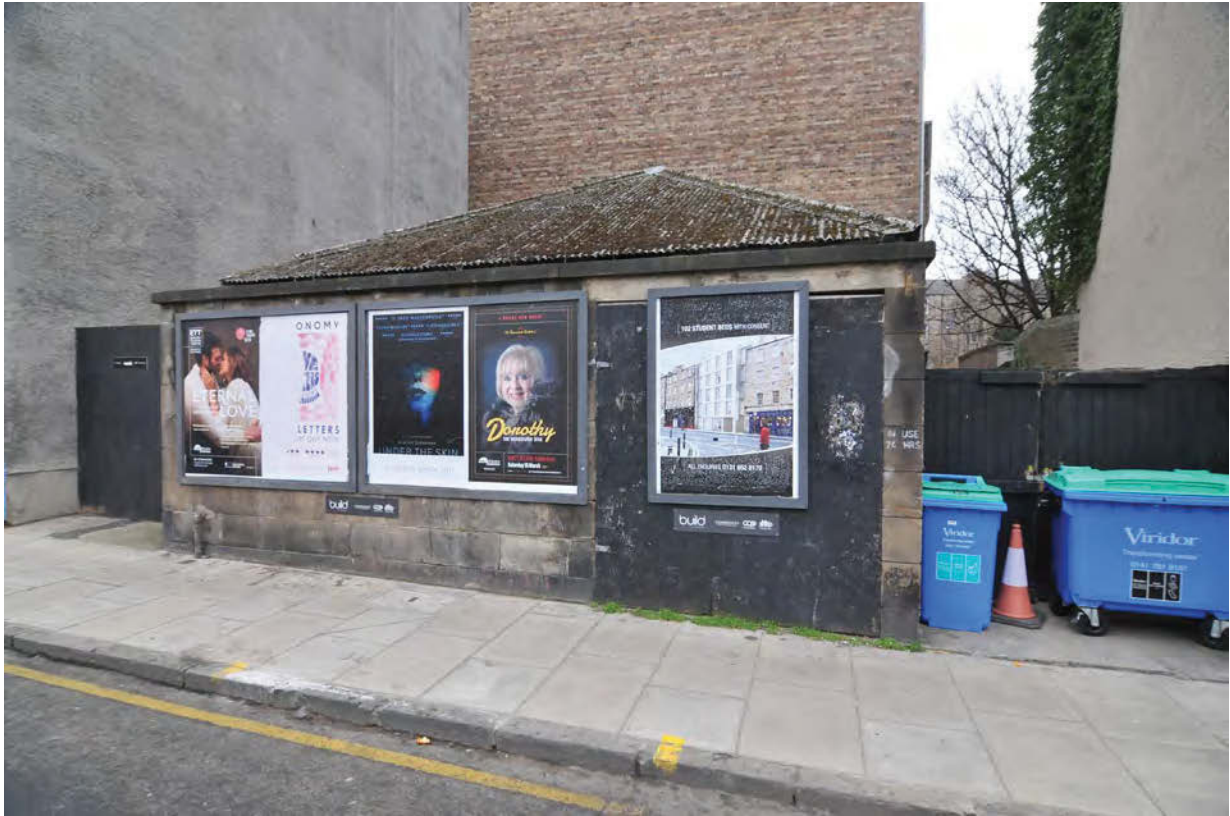
Plate 1. Street-front west-facing elevation of the queue shelter

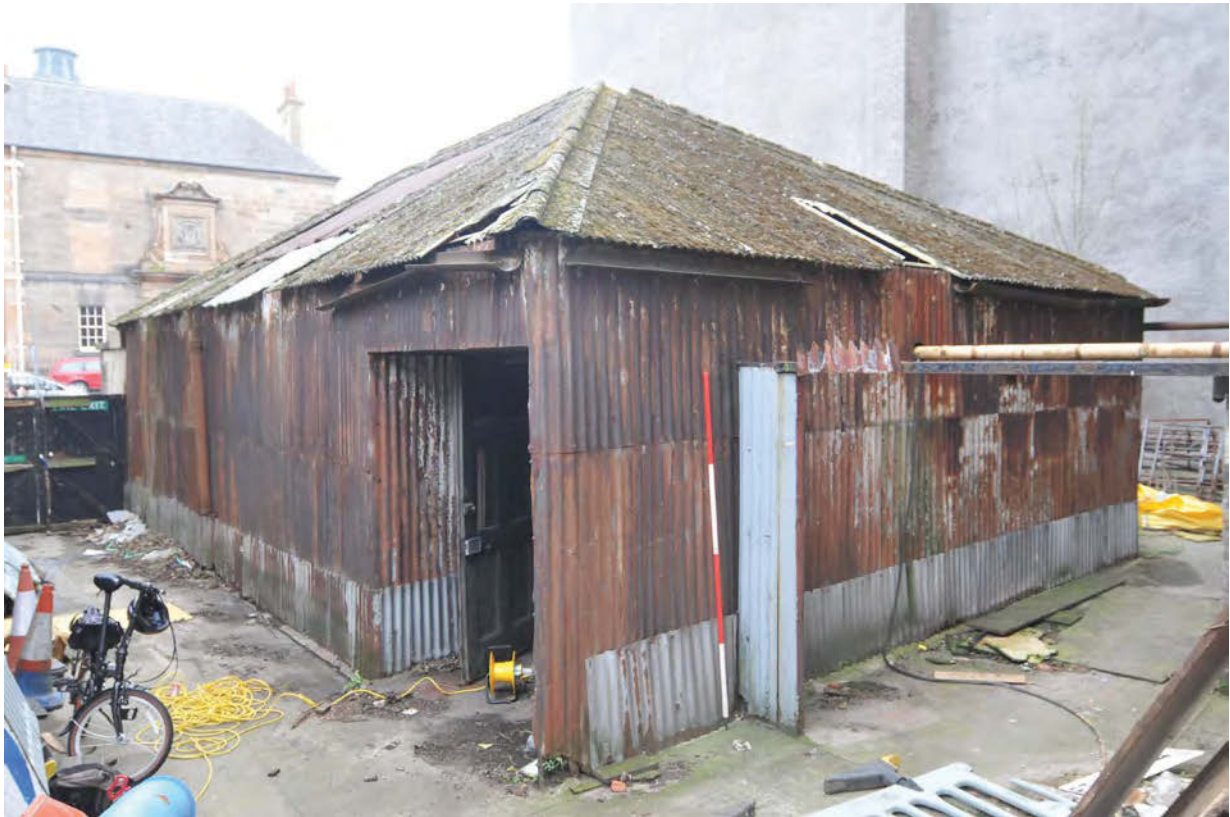
Plate 2. Rear and south-facing elevation of the queue shelter

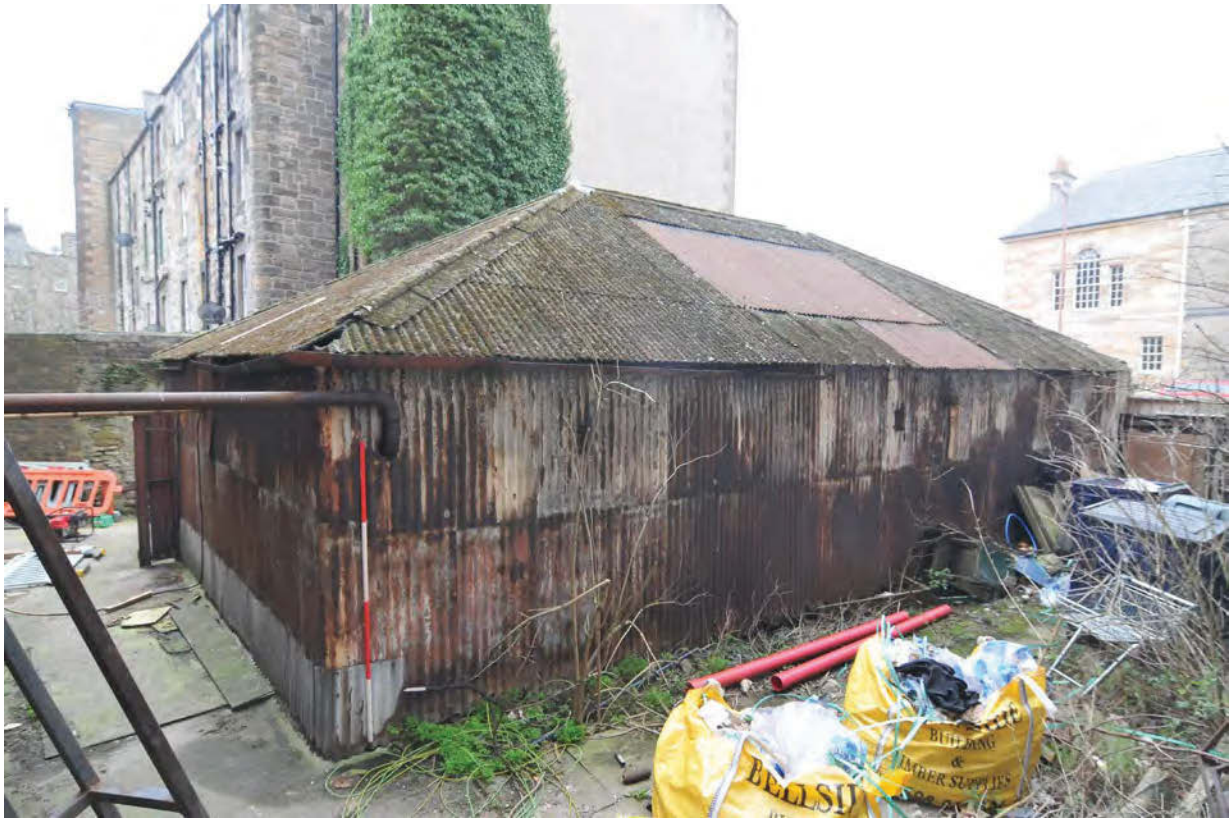
The north-facing elevation is 13.4m long and 2.8m high and clad with sheets of corrugated iron on which traces of cream paint surviving. There is no fenestration on this elevation.

Plate 3. Rear and north-facing elevation of the queue shelter

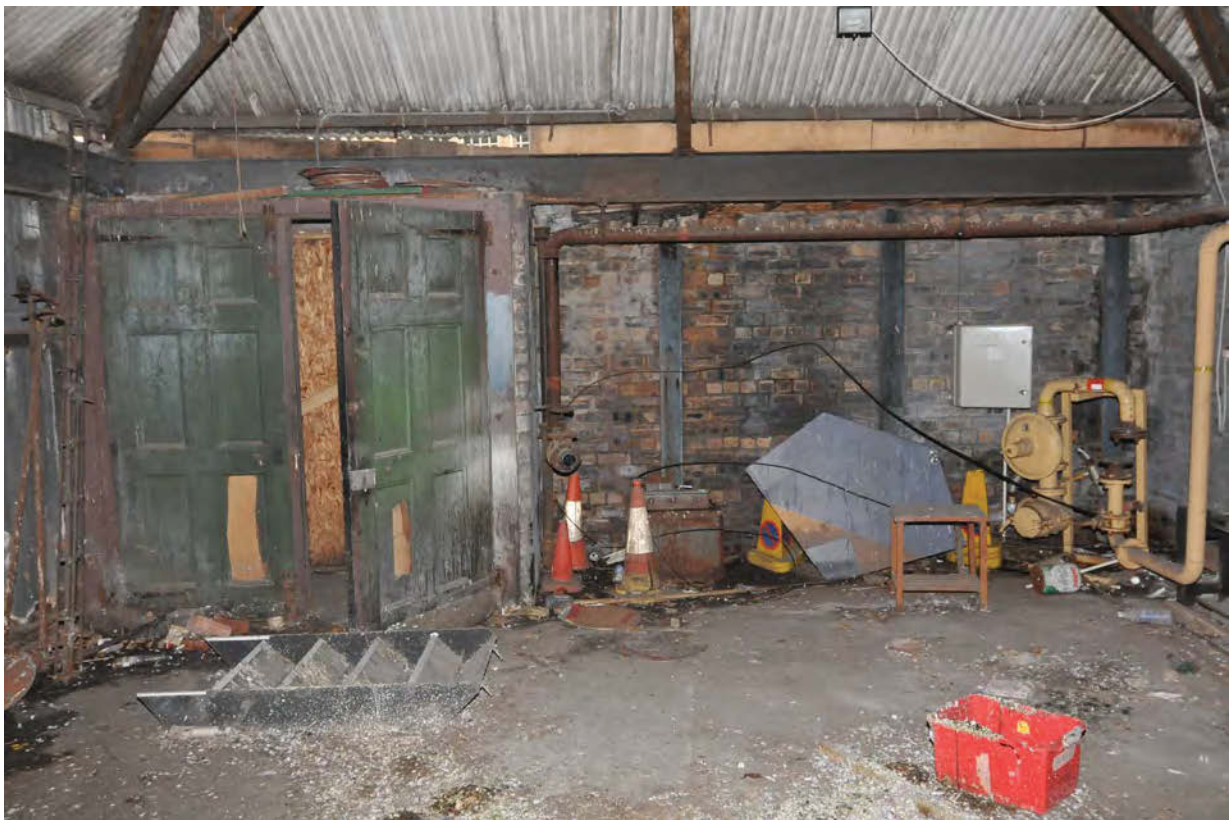
On the west-facing elevation (rear side of the street-fronting wall) the wall contains three timber uprights. The east-facing elevation contains the same steel-framed arrangement and is featureless.

Plate 4. Internal east-facing elevation of the queue shelter

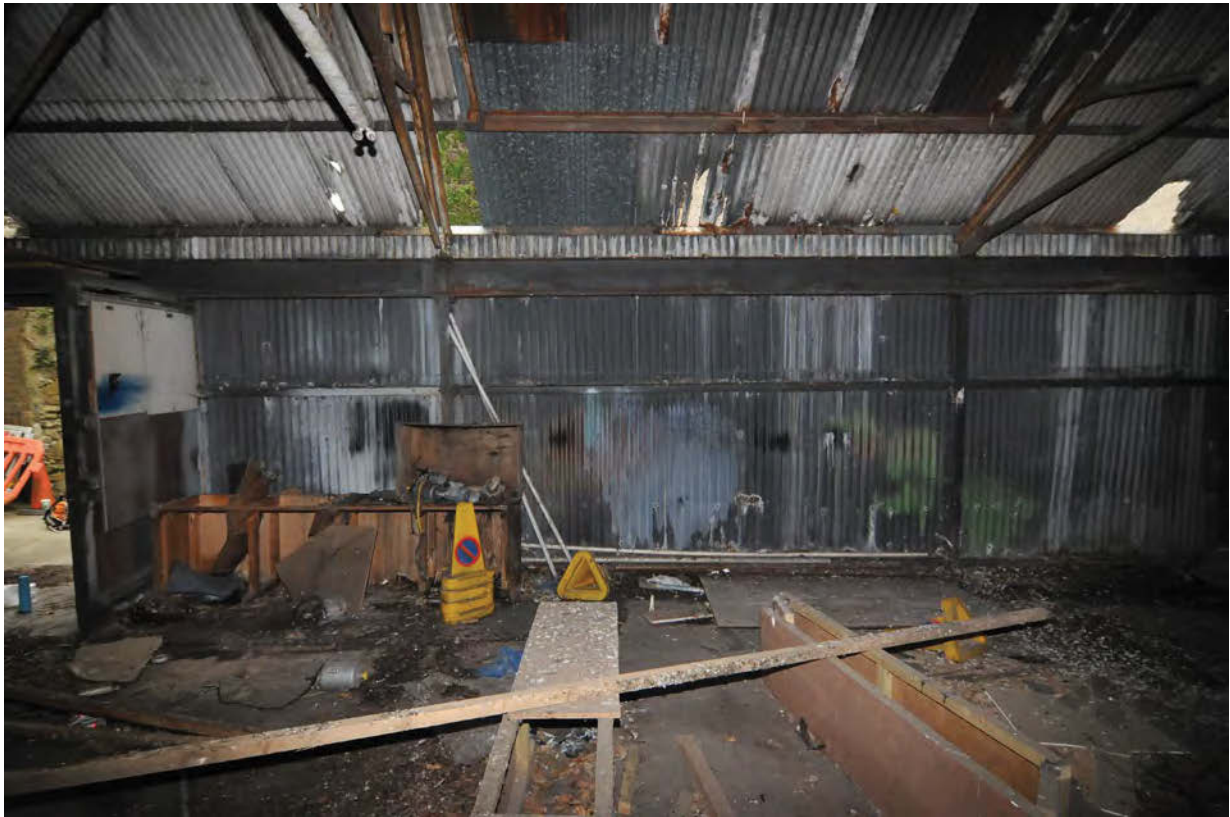
The north and south facing elevations are very similar, with a series of rolled steel I-beams forming the upright stanchions onto which are bolted lateral crossbeams. The topmost beam is 0.40m by 0.14m, the middle and lower have been fabricated using angle-iron and both measure 0.08m by 0.08m.

Plate 6. Interior north-facing elevation of the queue shelter showing its steel frame

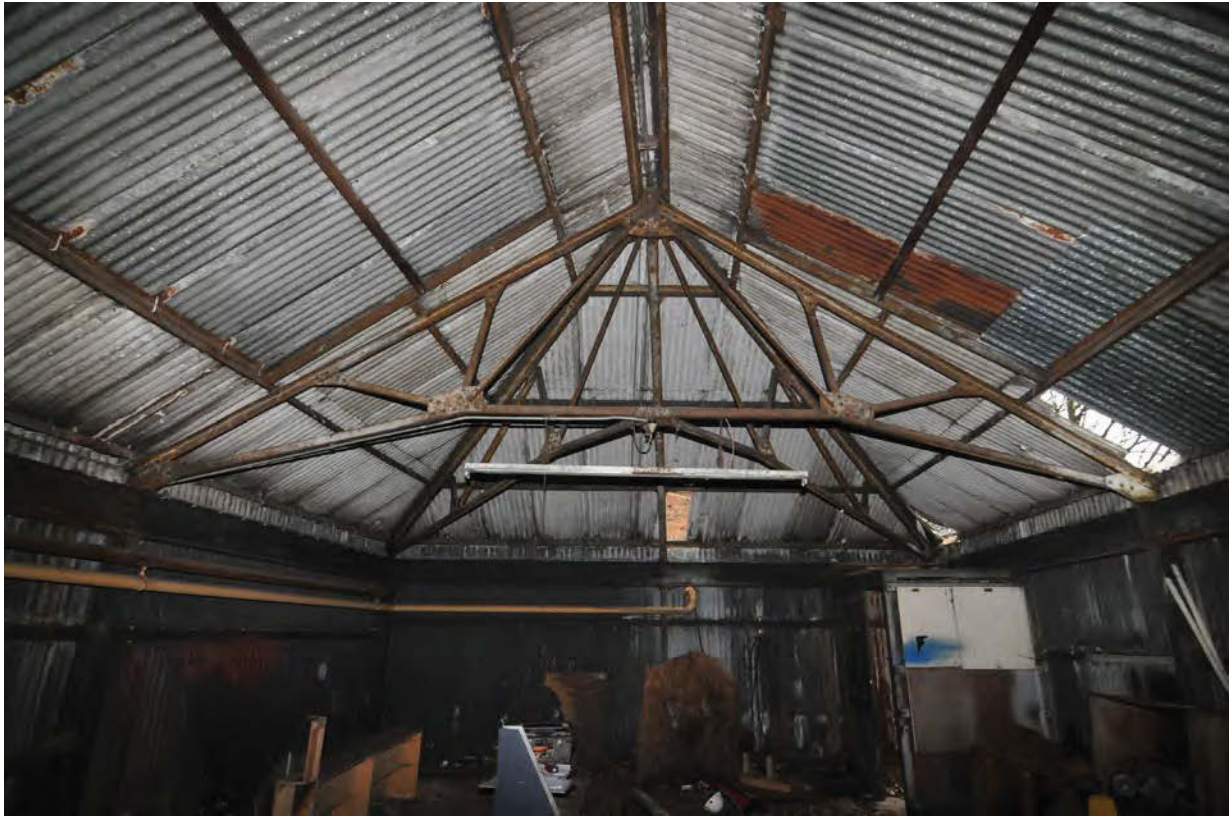
The corrugated asbestos roof is carried on two trusses constructed of angle iron. Both trusses are bolted directly to an upright I-beam column. Each truss has a pair of struts which are bolted to a plate on the underside of the rafter beam. The ridge piece comprises a pair of iron beams. In order to carry the hipped section of the roof, two composite rafters again using bolted angle-iron, are swept back at c.45 degrees with three struts that diminish in size towards the corners of the building.

Plate 7. Composite angle-iron truss detail

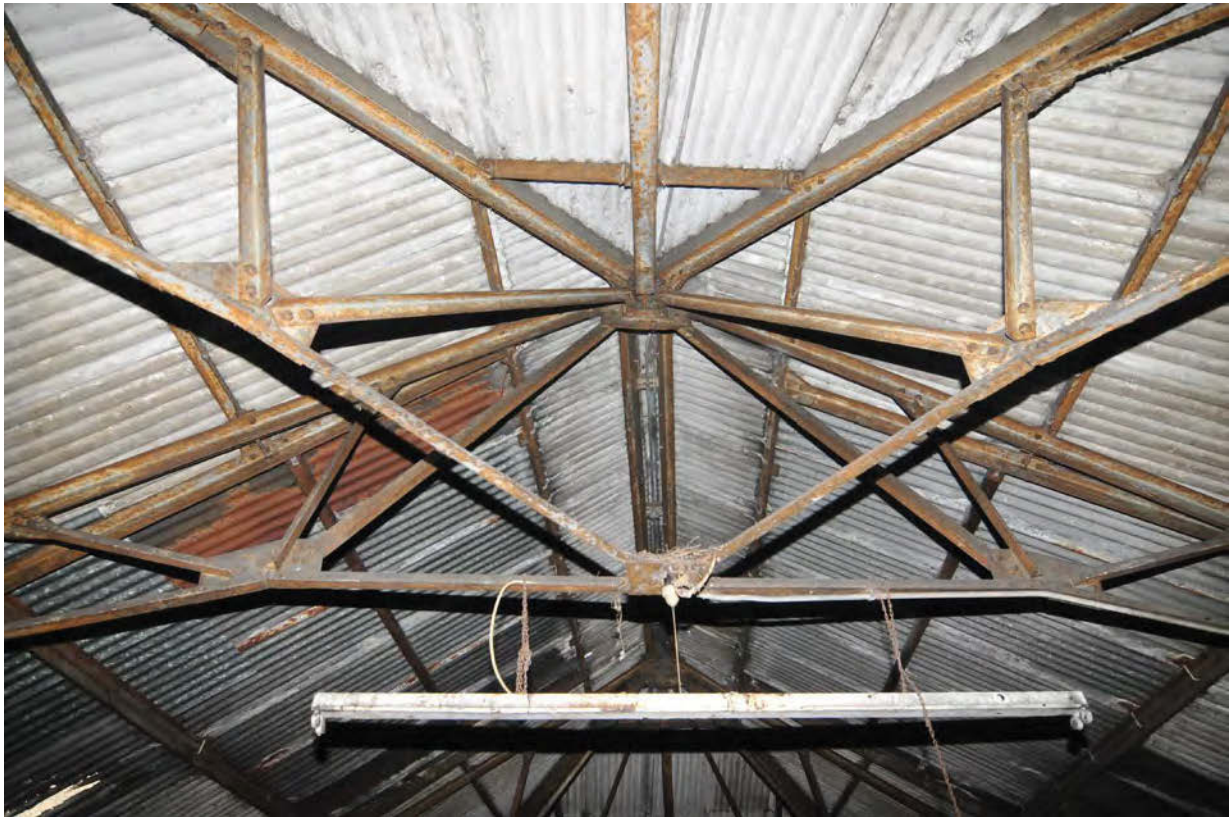
Plate 8. Hip truss projecting of the main pitched truss

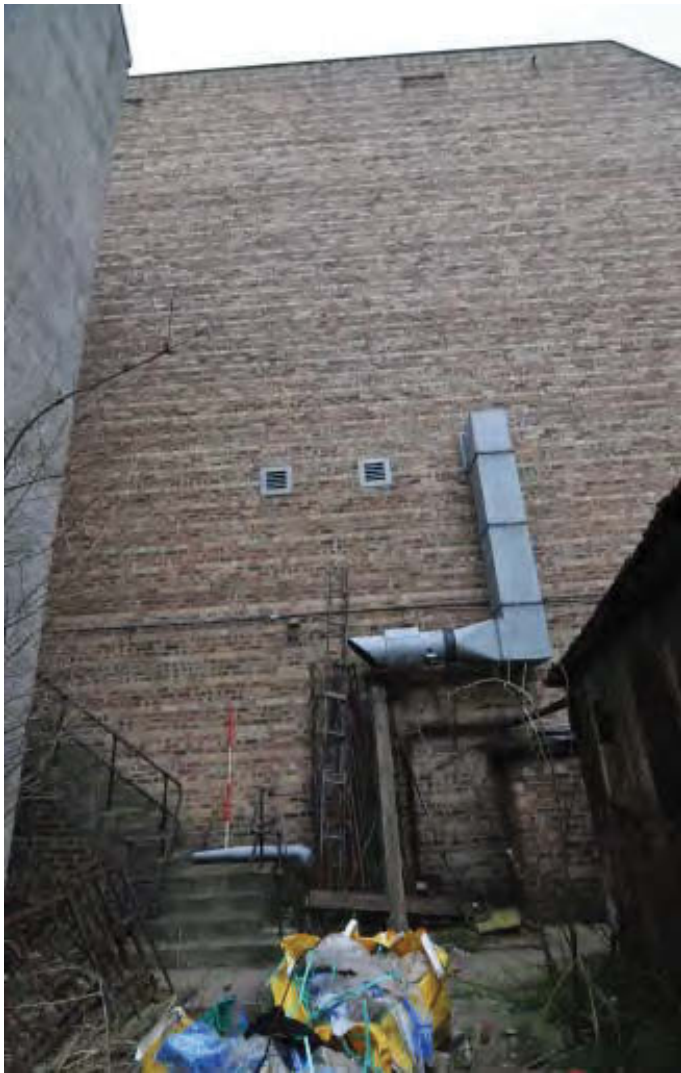
External west-facing elevation is 19m high and 24.75m wide and has a mansard-shaped roof configuration. The brickwork is uniform throughout and laid in English Cross bond (3:1). The brick measures 230mm x 110mm x 83mm (9" x 4" x 3"). The only notable feature related to fenestration is a large blocked rectangular opening at the south-west corner. The opening is blocked with later red brick which contrasts sharply with the surrounding 1930s cream-coloured brick. The opening is set about 1m above the ground level and has rounded surrounds.

Plate 9. Central part of west-facing elevation of Fly Tower

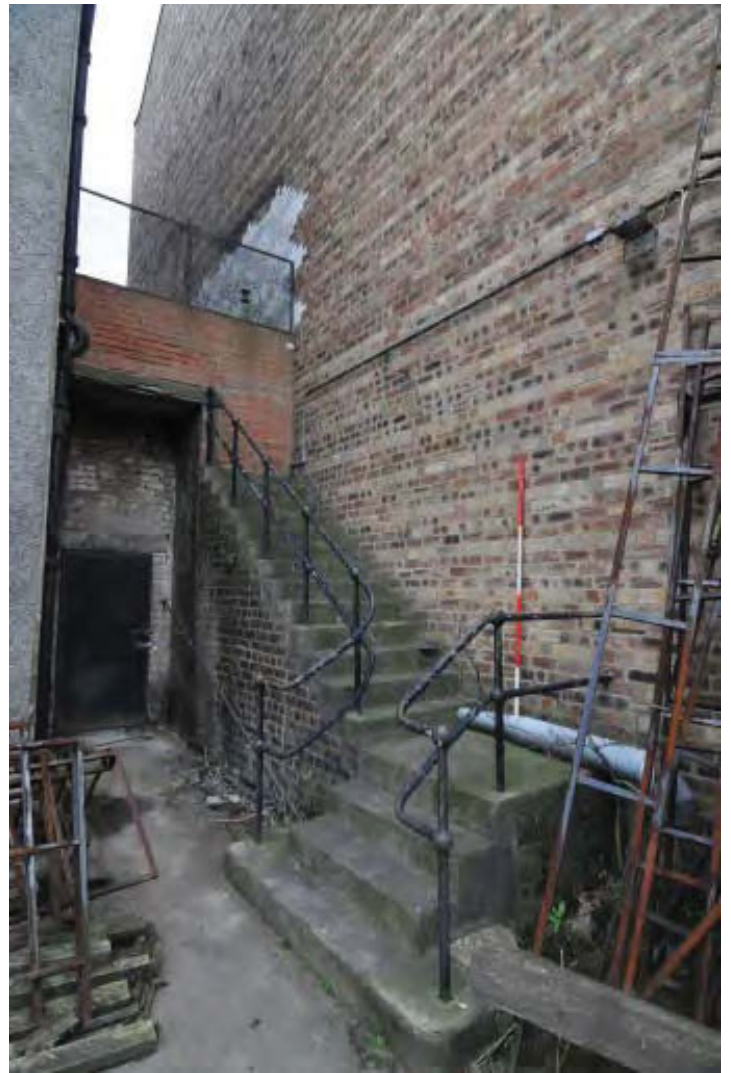
At the north end of the elevation there is a set of concrete steps with a steel handrail. The steps lead up to an opening that is now blocked. The CP mentions that the steps originally provided access from the tenement buildings to the rear stalls within the 1930s auditorium.

Plate 10. Detail of stairs, west-facing elevation of Fly Tower

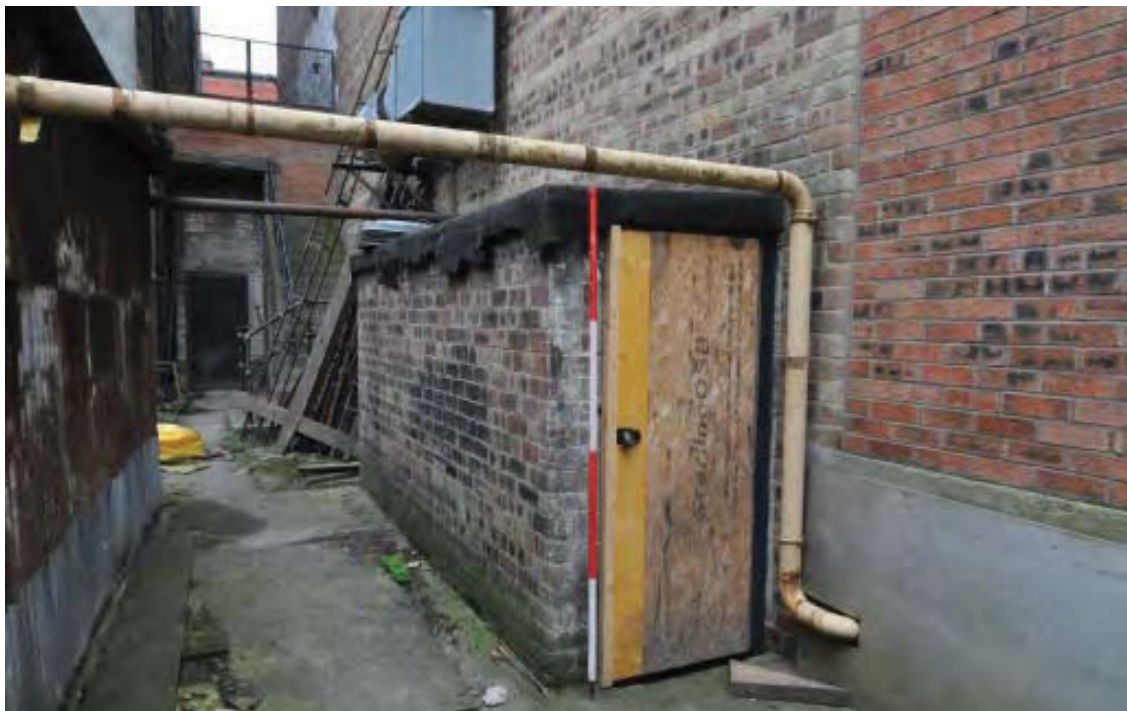
A small brick-built shed with a flat roof measuring 4m by 1m has been built against the base of the elevation. It appears to have been a small store.

Plate 11. Detail of shed, west-facing elevation of Fly Tower

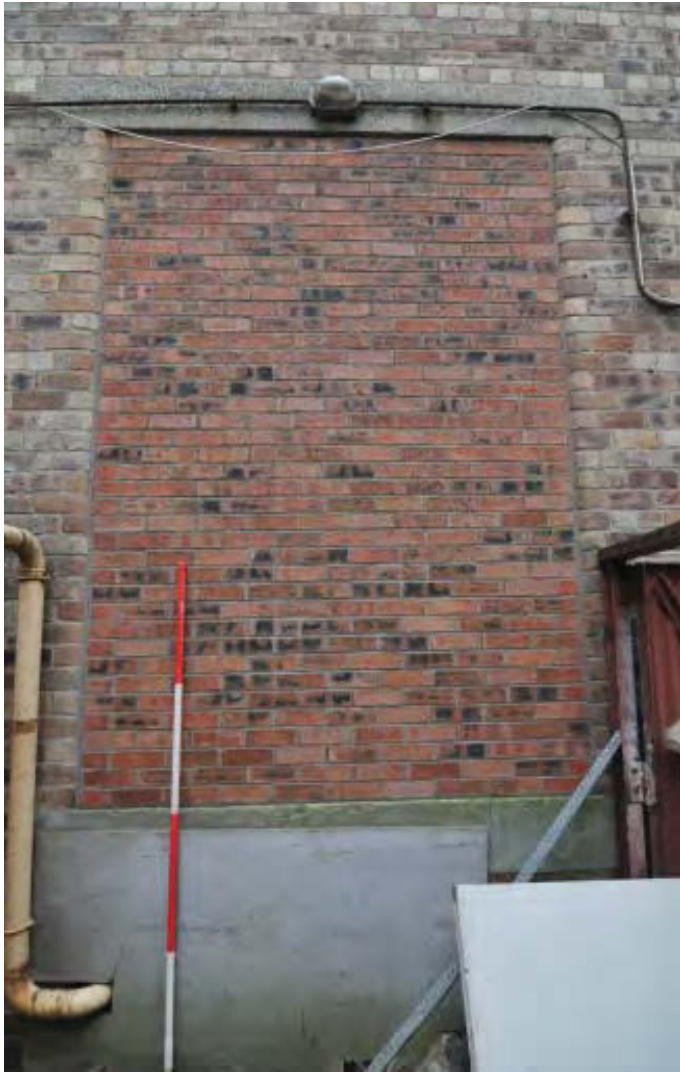
Plate 12. Blocked window, west-facing elevation of Fly Tower

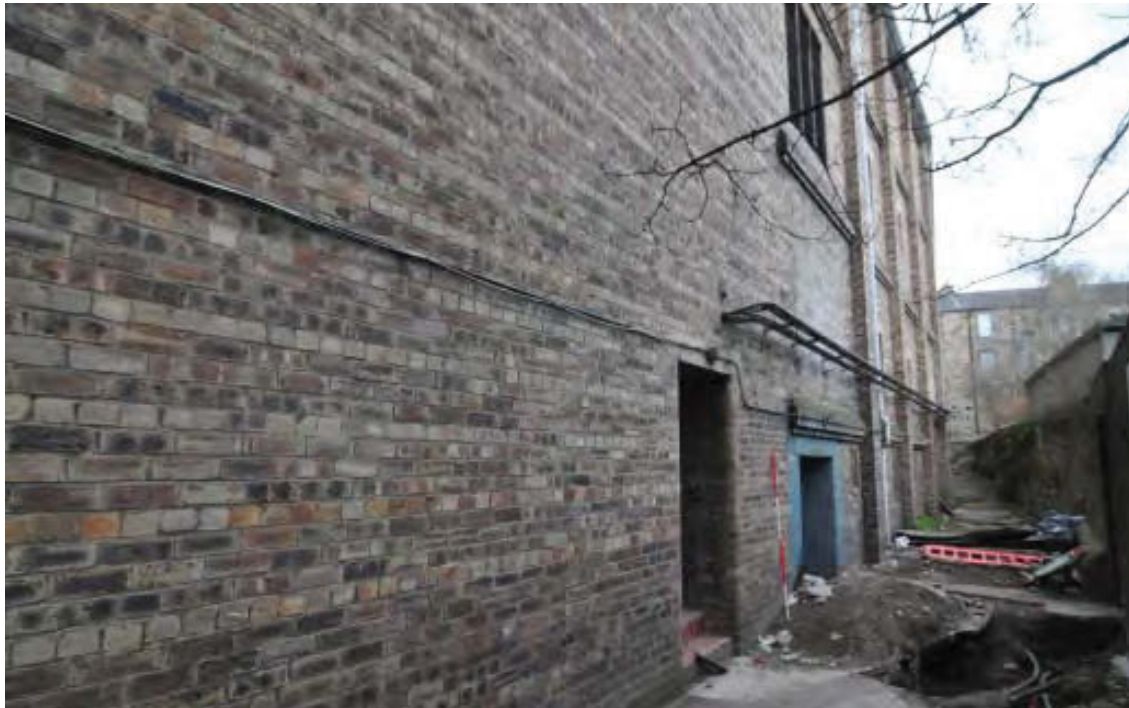
The south-facing elevation of the fly tower extends from the south-west corner to the main wall of the original cinema auditorium, which is architecturally distinct from the fly tower, being separated by a series of nine pilasters.

Plate 13. Oblique view of south-facing elevation of Fly Tower

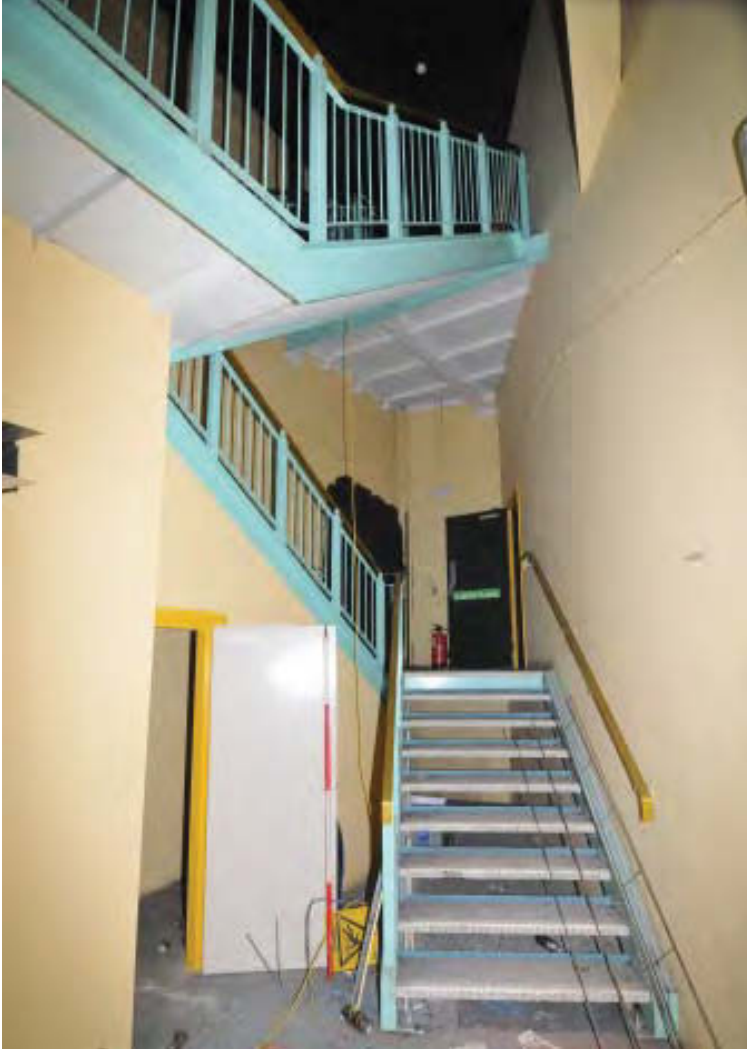
Plate 16. South stairwell

Cinema 5 is situated above the remains of Cinema 4 (Plate 15) and is accessed by two flights of stairs, the southern flight (Plate 16) being a fire exit. The main access stair (Plate 20) is on the north side of the cinema.

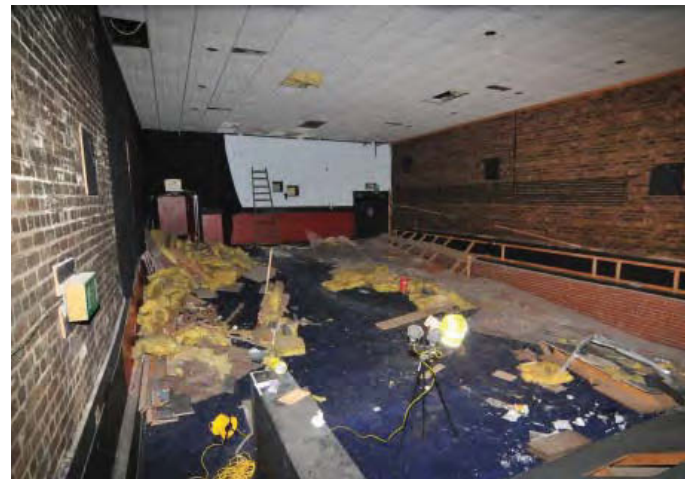
All that survives now is the shell of Cinema 5 (Plate 17) measuring 19.1m in length and 9.5m in width. The projection room survives at the northern end. At the south end a ramp leads up to a stage on which now stands three speakers, in front of which is the steel-framework for the cinema screen. Behind the stage is the black-painted wall of the fly tower. The cinema ceiling is clad with white panels.

The east-facing long wall of the cinema is clad with black cloth and wooden cladding to about dado height. The opposite wall has had its cladding completely removed exposing two contrasting phases of brickwork. The earlier 1930s brickwork is supported on a steel Bressumer beam. Below the beam the brick work is a recent addition (2013) which has infilled a large void between the floor and suspended ceiling of Cinema 4. The brickwork was installed to provide structural support and effectively divide the fly tower area from the main Odeon complex prior to a change of ownership.

Plate 17. Cinema 5

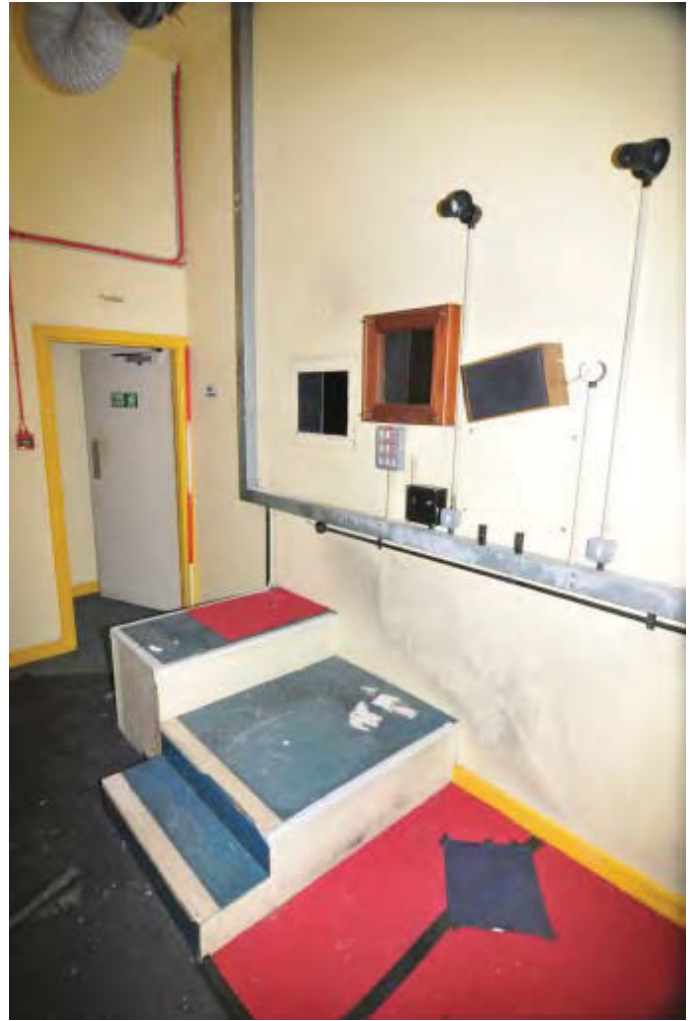
The projection room is situated at the north end of the cinema and is accessed by a doorway at its east side. The room measures 4.7m by 2.3m. No projection equipment survives. A small stepped dais that once held the projector occupies the west side of the room and the glass covered opening for the projector beam is still in situ. The rest of the walls are featureless with the exception of the east wall (west-facing) which contains an array of electrical switch gear associated with the projector equipment and lighting.

Plate 19. Interior of Cinema 5 projection room

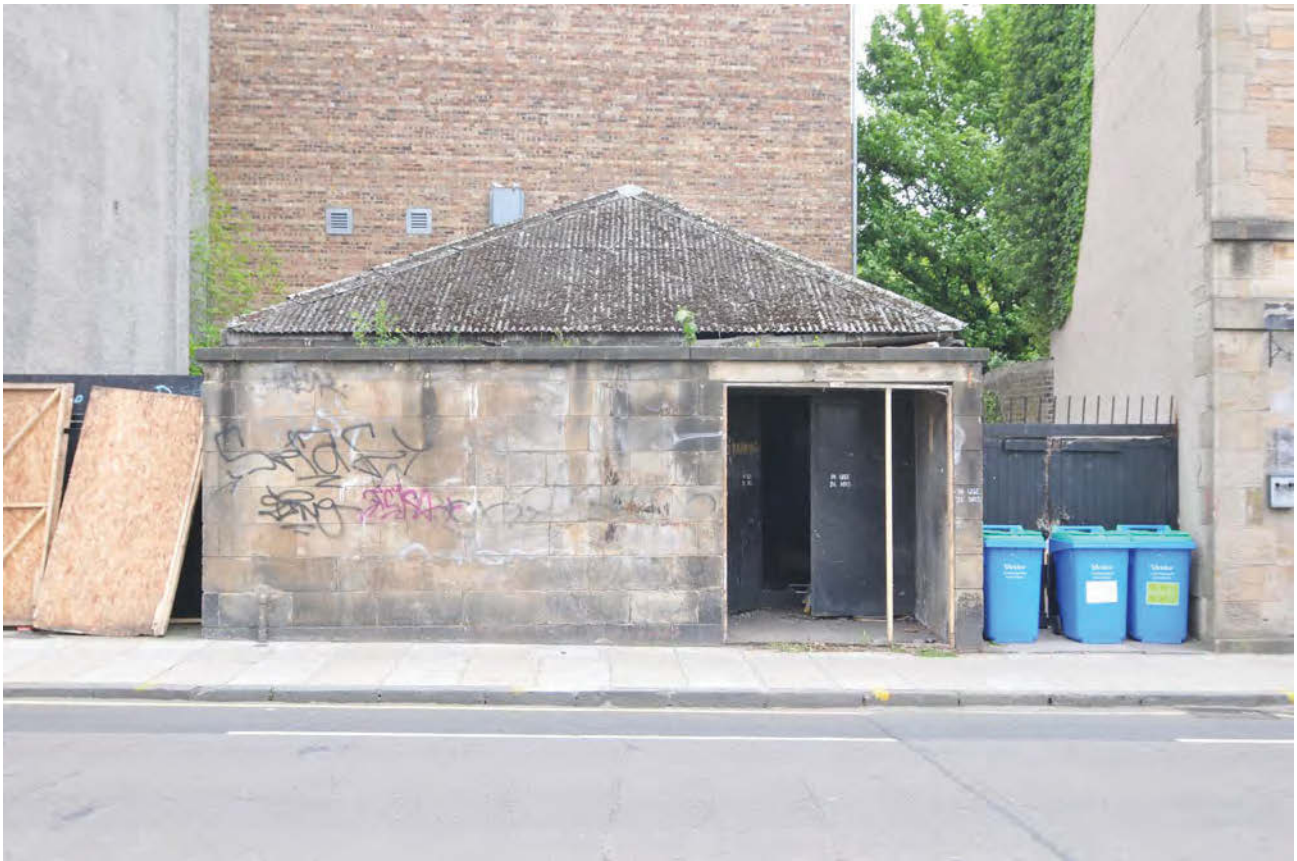
This elevation is 7m long and is 2.7m from the pavement to the cap stones at the wall head. The elevation is constructed of ashlar sandstone and framed with ashlar quoins. The sandstone blocks measure on average 0.64m by 0.34m. The eight quoins on each side of the elevation measure 0.45m x 0.30m (long) and 0.34m x 0.15m (short).

Plate 21. West-facing elevation of Queue Shelter
