Former Cookridge Hospital

Archaeological Evaluation

Report No. Y018/11

Former Cookridge Hospital
Leeds
West Yorkshire

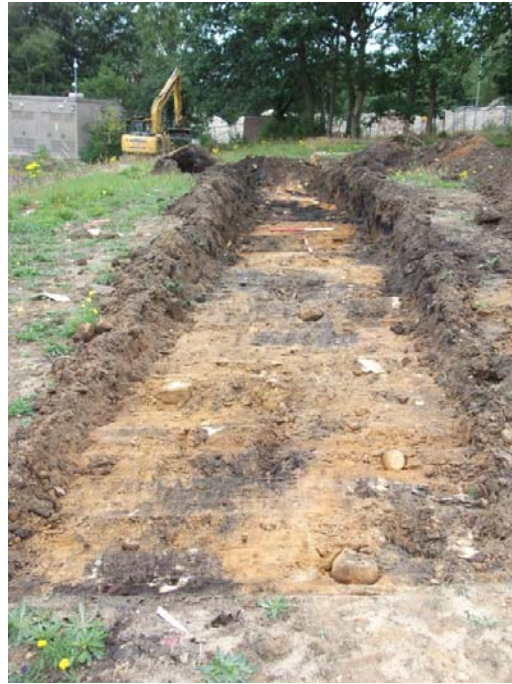
Plate 1: Trench 1 Looking West

Trench 1 was within the area of a demolished building. Loose, re-deposited topsoil, mixed with construction debris such as bricks, plastic coated wire and modern pottery was present. Beneath this was the natural geological layer, disturbed in places by drains, associated with the demolished building.

| Trench 1 | | |
|--|---|--|
| Trench 1 contained no archaeological remains, Plate 1(Photograph numbers 37 & 38) | | |

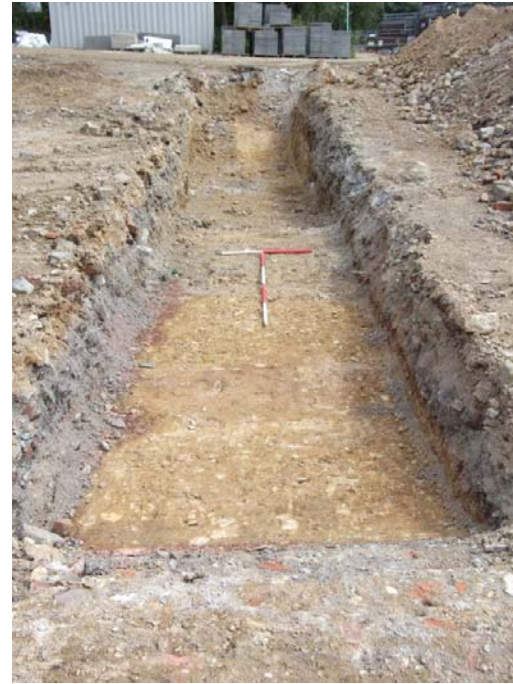
Plate 2: Trench 2 Looking Northwest

No topsoil was present in Trench 2, though there were three distinct layers of building rubble, and one of re-deposited natural visible before the natural geological layer was reached.

| Trench 2 | | |
|--|---|---|
| Trench 2 contained no archaeological remains Plate 2 (Photograph Numbers 61-62) | | |

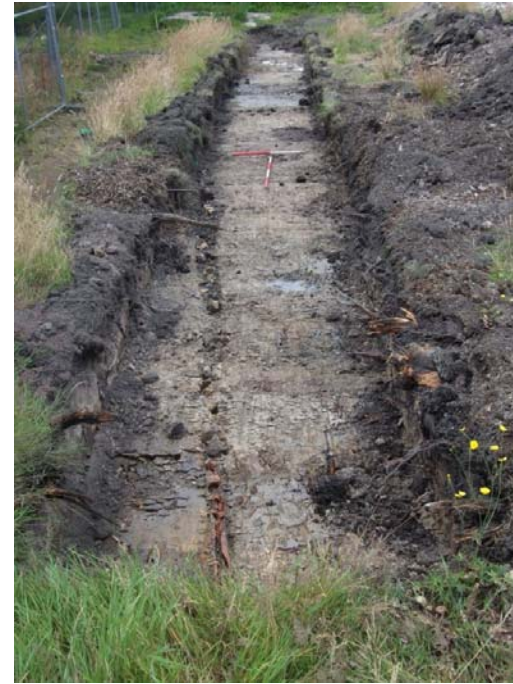
Plate 3: Trench 3 Looking Northwest

This trench was located in the southwest corner of the site. Topsoil was present to a depth of 0.4m and two modern land drains were visible running east-west cutting the natural deposits.

| Trench 3 | | |
|---|---|--|
| Trench 3 contained no archaeological remains and no finds were recovered, the trench contained two modern drains. Plate 3 (Photograph Numbers:57-58) | | |

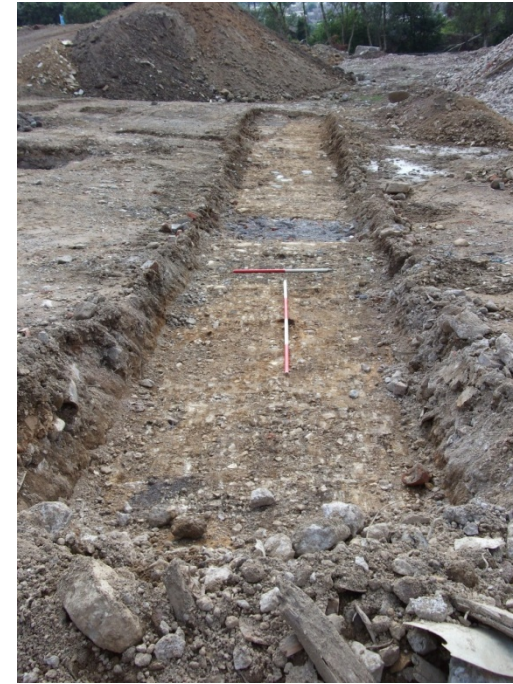
Plate 4: Trench 4 Looking Southwest

Excavation of this trench was almost immediately onto the natural geology, through a layer of building rubble. Two modern land drains and possible rubble foundations were cut into the natural.

| Trench 4 contained no archaeological remains | | |

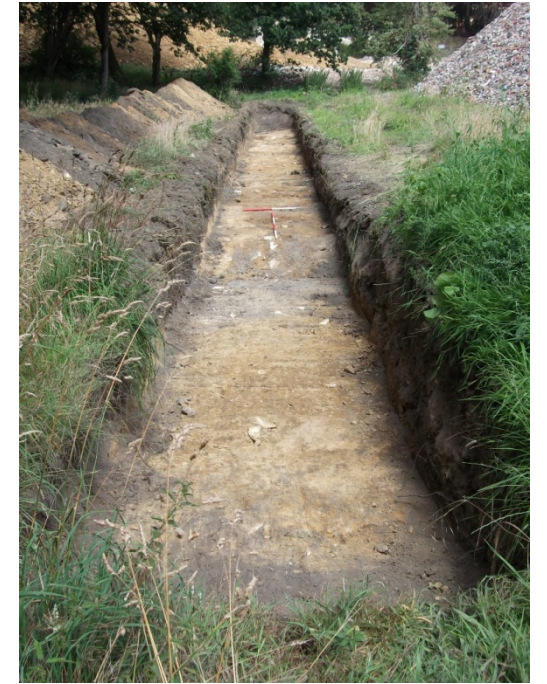
Plate 5: Trench 5 Looking Northwest

This trench was located in the southwest corner of the site. Topsoil was present to a depth of 0.55m, and a modern land drain was noted running east-west in the southern end of the trench.

| Trench 5 contained no archaeological remains | | |

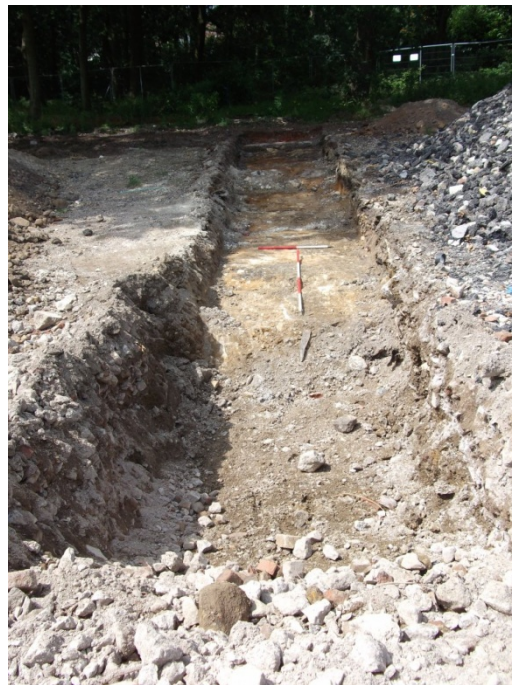
Plate 6: Trench 6 Looking Northwest

No topsoil was present in this trench. A layer of mixed modern construction debris overlaid the natural geological layer which was cut by four modern features probably removed services.

| Trench 6 contained no archaeological remains, only modern features | | |

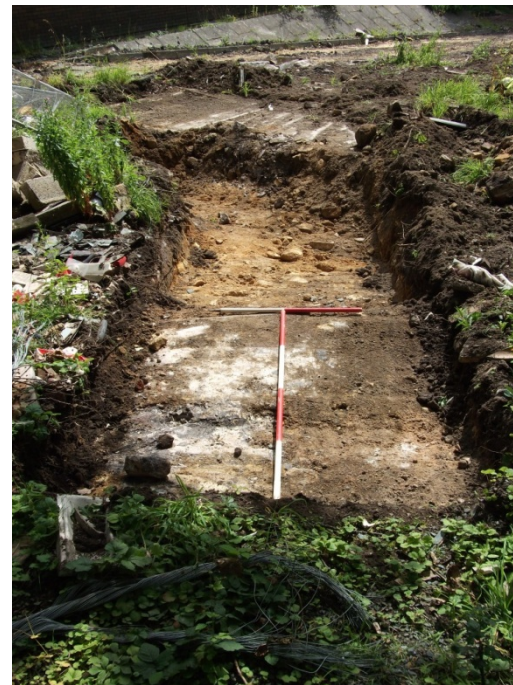
Plate 7: Trench 7 Looking South

Trench 7 was cut short to the south by the presence of a large concrete foundation. Modern construction debris was present at the north of the trench, underlying a thin layer of topsoil.

| Trench 7 | | |
|--|---|--|
| Trench 7 contained no archaeological remains | | |

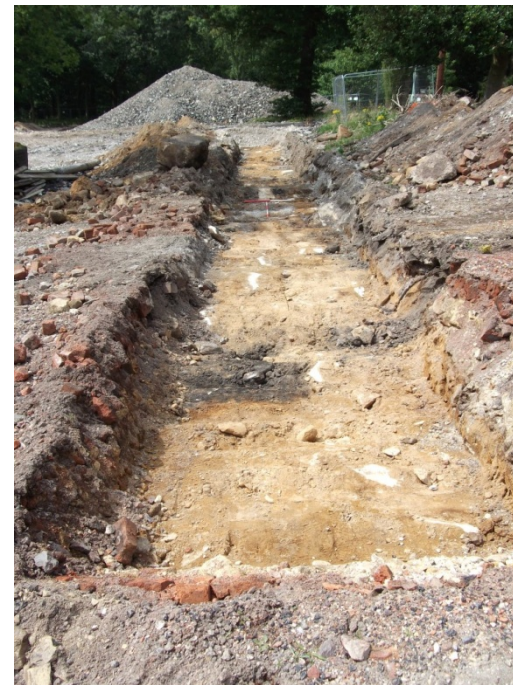
Plate 8: Trench 8 Looking Northwest

Trench 8 was located in the north of the site, no topsoil was present, only a thick layer of building rubble which included a distinct gravel layer possibly the foundation for a road, which overlay the natural geological layer.

| Trench 8 | | |
|--|---|--|
| Trench 8 contained no archaeological remains | | |

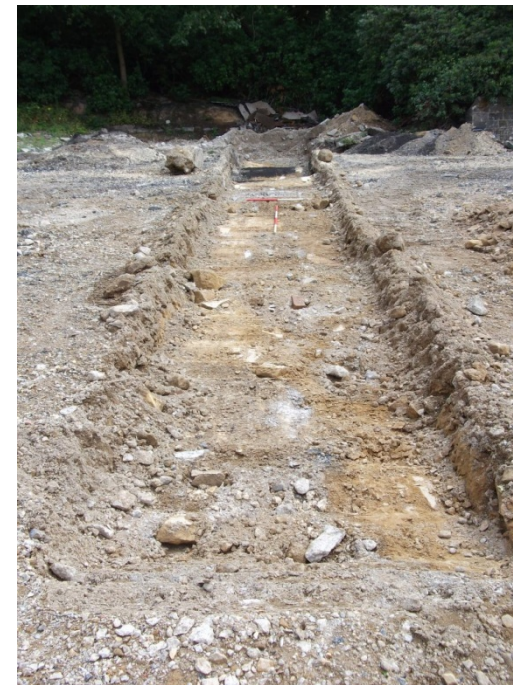
Plate 9: Trench 9 looking Southeast

Trench 9 was located from within the footprint of a modern demolished building to the road outside, and consisted of building rubble overlaying the natural geological layer. Building foundations (gravel for hard standing) and concrete blocks (kerbstones) were observed cutting the natural.

| Trench 9 | | |
|--|---|---|
| Trench 9 contained no archaeological remains, only evidence of modern building foundations | | |

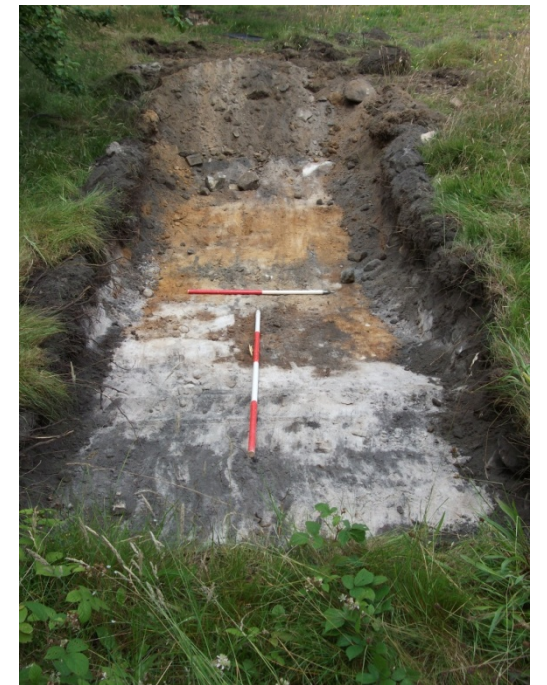
Plate 10: Trench 10 Looking Northwest

Trench 10 was located in the northeast of the site and was shortened due to the presence of an active gas main. It consisted of topsoil overlaying natural geology.

| Trench 10 | | |
|---|---|--|
| Trench 10 contained no archaeological remains | | |

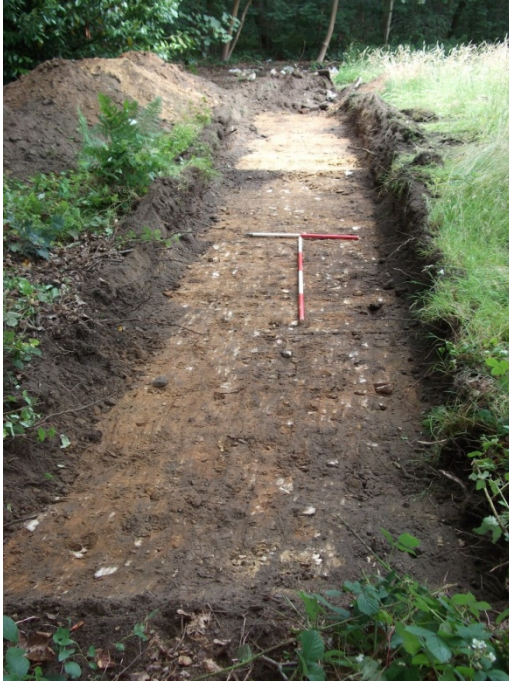
Plate 11: Trench 11 Looking Northeast

Trench 11 was located on the edge of woodland in the north-eastern part of the site. It consisted of topsoil overlaying the natural geological layer. No subsoil was present.

| Trench 10 | | |
|---|---|--|
| Trench 11 contained no archaeological remains | | |

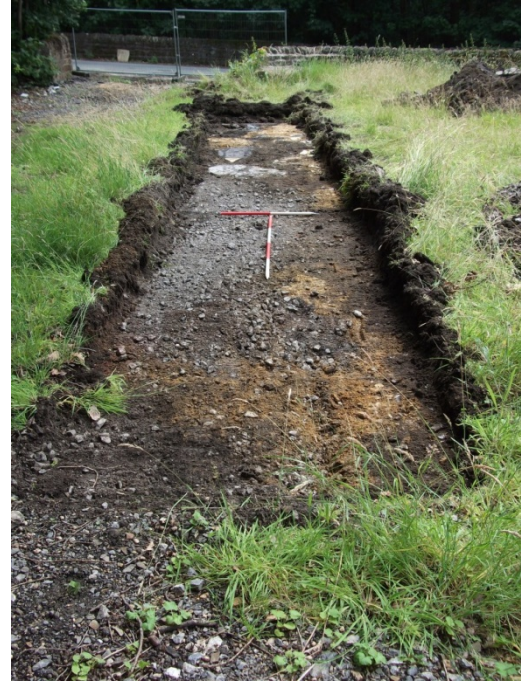
Plate 12: Trench 12 Looking Southeast

Trench 12 was located to the north of Trench 11 bordering woodland and the scheduled area. Within it a thin layer of topsoil was observed overlaying construction debris, including concrete blocks and gravel for hard standing cut into the natural geological layer.

| Trench 12 | | |
|---|---|---|
| Trench 12 contained no archaeological remains, only construction debris | | |

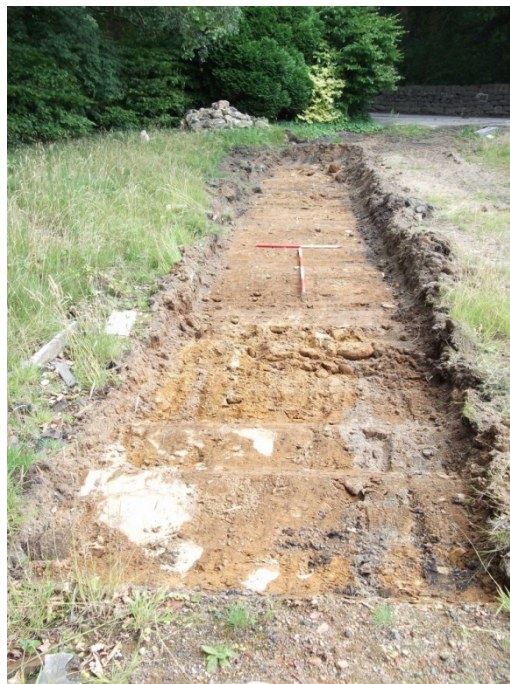
Plate 13: Trench 13 looking Northeast

Trench 13 contained a thin layer of topsoil mixed with building rubble; excavation almost immediately came on the natural geological layer. To the north of the trench, a thicker topsoil could be seen indicating that topsoil stripping had previously taken place in this area.

| Trench 13 | | |
|---|---|---|
| Trench 13 contained no archaeological remains | | |
