Development at Blackchapel Road Niddrie, Edinburgh

Archaeological Excavation

Data Structure Report

No. 3173.1

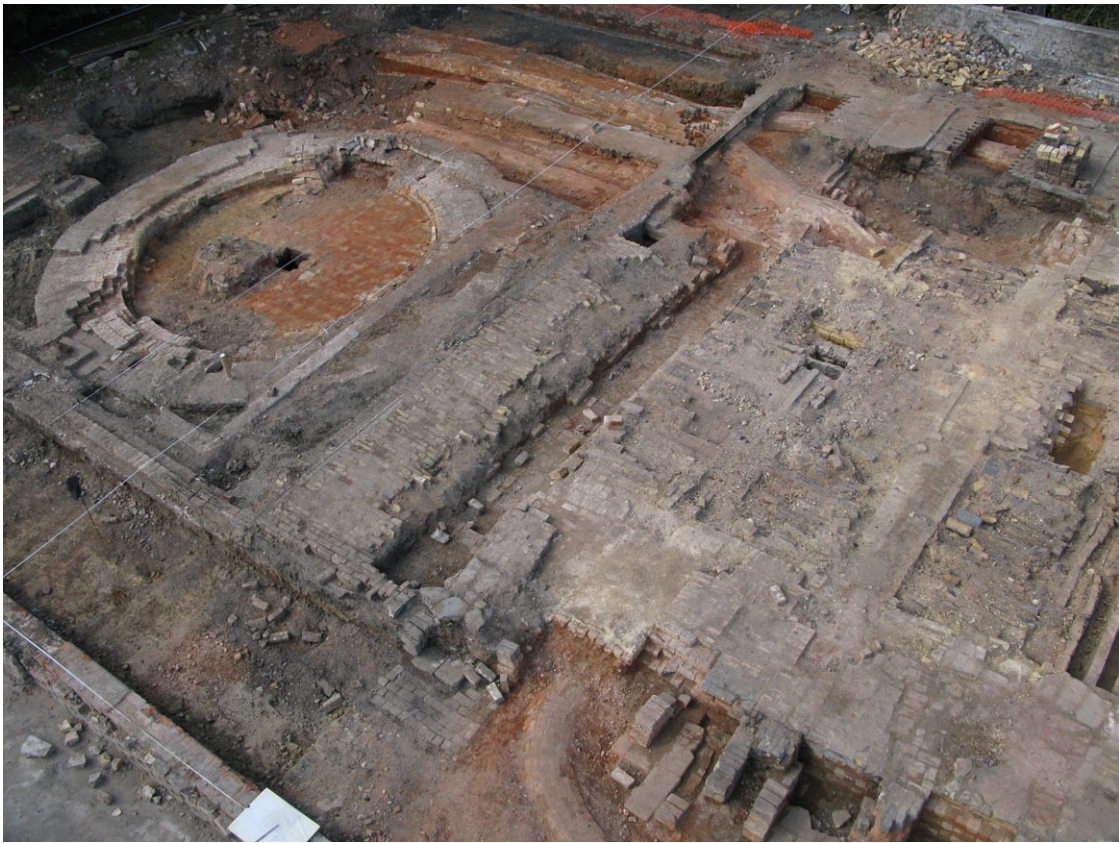
Fig. 7 - Overhead shot of western end of site

Building 3 (Fig. 7) had been built over the remains of Kiln 1 following its demolition. It measured c.16m north to south by 10m east to west and was constructed from frogged bricks stamped NIDDRIE. The brick walls sat on top of concrete foundations (036), which directly overlay natural. Concrete blocks containing the remains of cut-off I-pillars suggest that this building had a steel framework. The building had a concrete floor, which overlay the remains of Kiln 1 and parts of the flue system. A drainage system (037) for this building was present in the form of concrete-encased ceramic piping. Slight traces of surviving concrete and brickwork suggest that there may have been an annex to the west of this building.

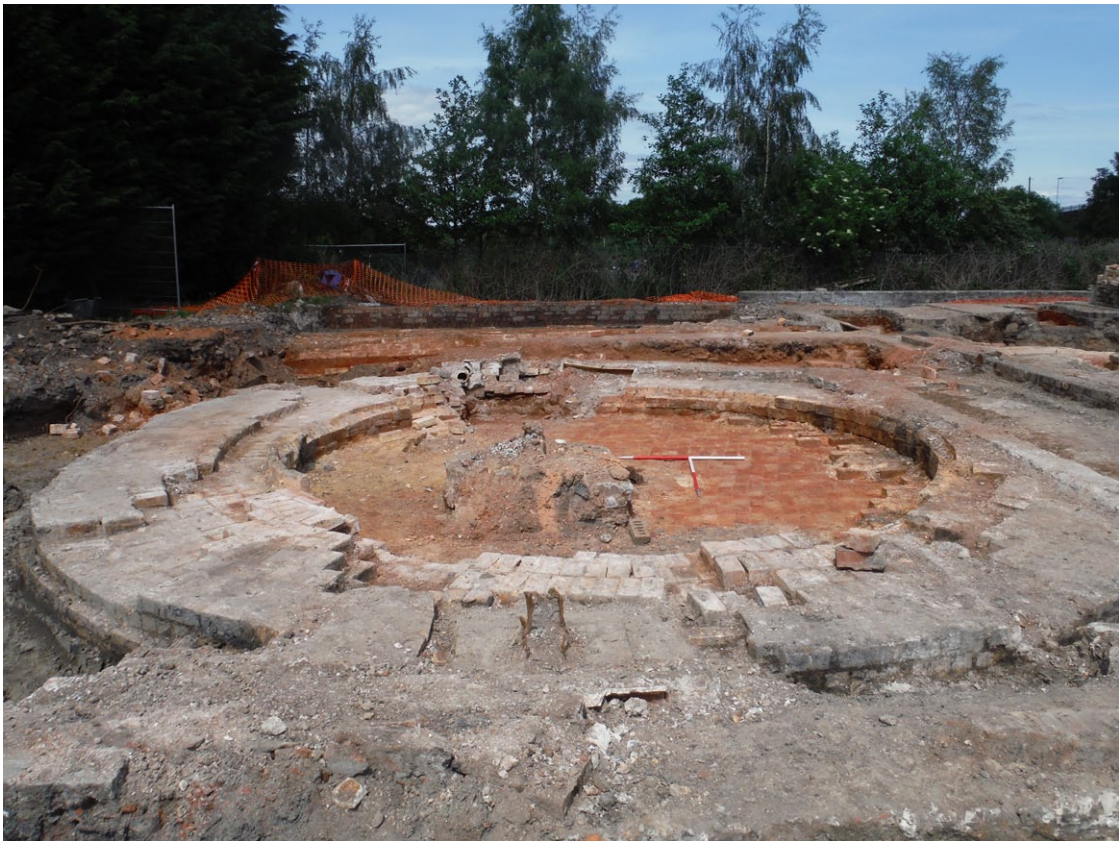
Fig. 10 - Kiln 1 from south

Kiln 1 (Fig. 10) was one of the features depicted on the 1908 Ordnance Survey map and represents one of the earliest elements of the fireclay works. It was circular in plan with an external diameter of 8.6m and an internal diameter of 5.3m. The wall (**003**) of this kiln was upstanding to a height of 0.3m externally and 0.45m internally, and was largely constructed from frogged bricks stamped MUIR ARMADALE. Internally, the kiln was lined with a single skin of unfrogged bricks stamped BOGHEAD. These were probably fire-bricks designed to withstand the high internal temperatures which would have been generated within the kiln. The upper courses of brick appeared to slope in slightly, possibly indicating that this may have been a beehive kiln with a domed roof.

The base (**004**) of this kiln consisted of a brick surface constructed from unfrogged bricks stamped BOGHEAD. These were of the same type as those lining the walls and are likely to have been of a highly heat resistant material. Rows of bricks were identified within the interior of the kiln sitting on top of the brick surface. These rows of bricks would probably have been used to support a floor surface at a level of perhaps 0.3m above the base of the kiln. This would have created a void beneath the floor to allow for the transfer of heat across the entire base of the kiln. A concrete

A square opening in the centre of the kiln base (**005**) dropped down vertically, giving access to an under-floor passage, which ran horizontally beneath the kiln in a north-west direction. The square opening measured 0.55m across internally, with its brick structure giving it an overall dimension of 1.05m across. Due to the quantity of demolition material within the void its overall depth was not recorded, but the depth to the base of the flue suggests that it would have been in the region of 1m.

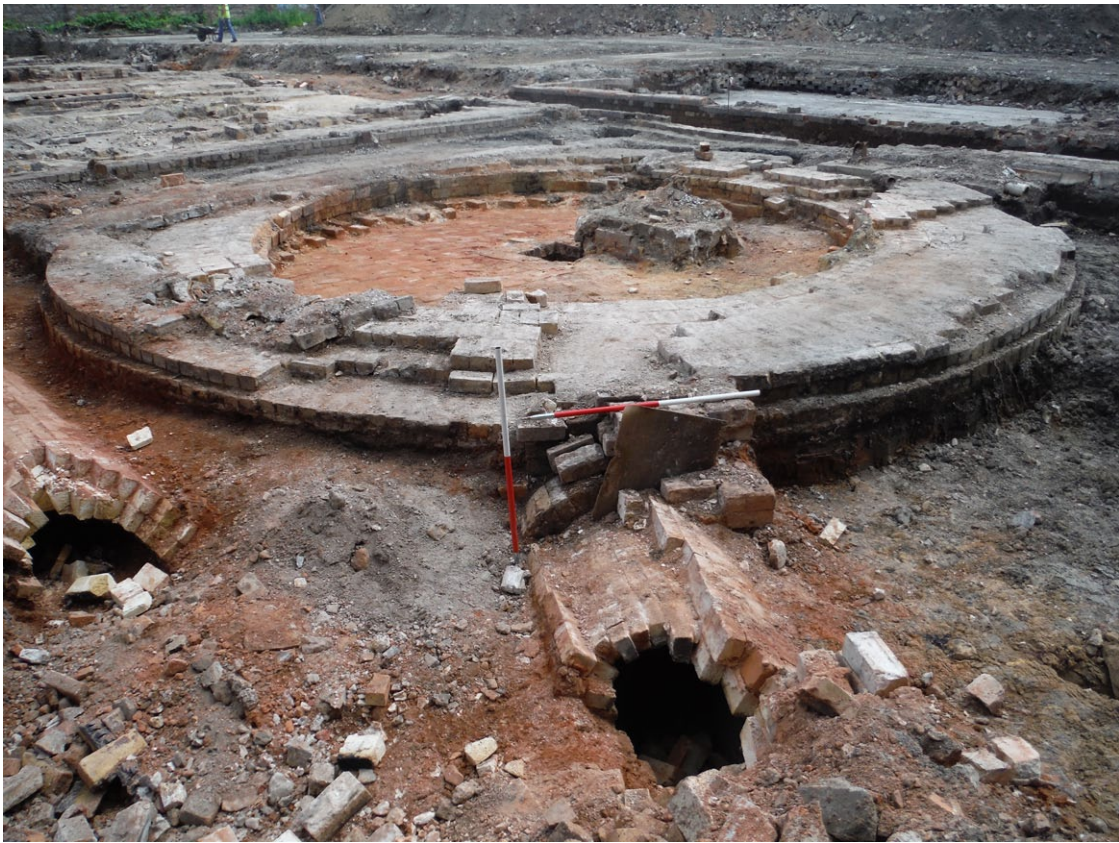
Fig. 11 - Kiln 1 showing flue 007

The under-floor passage ran out through a small extension (**006**) on the north-western side of the kiln into a brick-built flue (**007**) (Fig. 11). The extension was constructed from frogged bricks stamped ETNA, measured 1.1m wide, and protruded out from the wall of the main kiln structure by a distance of c.0.7m. A metal damper housed within this extension would have controlled the draw through the flue system and would have allowed the internal temperature within the kiln to be regulated. The flue itself was constructed from unfrogged and unstamped bricks and measured c.0.9m in width externally. A length measuring 1.5m was uncovered, with it extending into the trench section to the north-west. Where part of the flue system had caved in there was some evidence of internal blocking, presumably carried out after it had fallen out of use. Slight traces of a brick structure were identified sitting on top of the flue but it had been extensively damaged meaning that its original form and function could not be determined. It is assumed that this flue would have run to an external chimney located outwith the development area. A small structure depicted on the extreme western edge of the works on the 1908 and 1914 Ordnance Survey maps may indicate the location of this chimney.

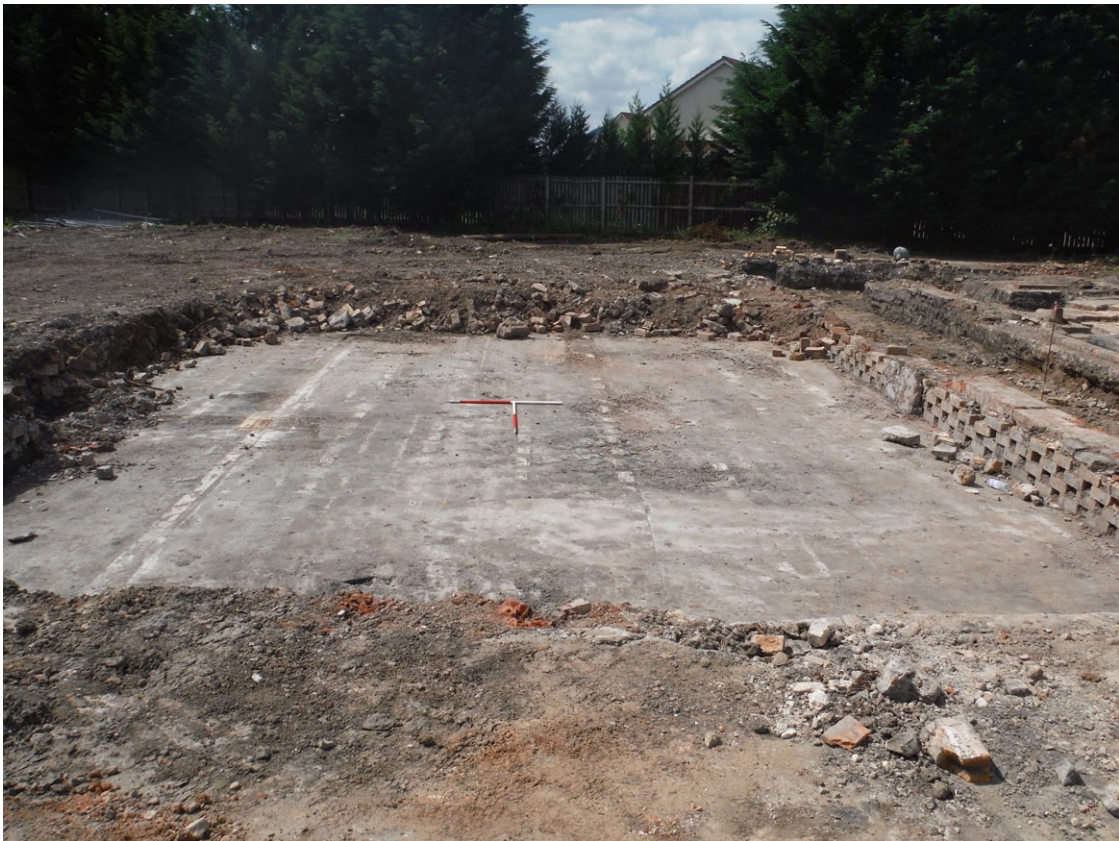
Fig. 12 - Building 1 from the east

Building 1 (Fig. 12) is also on the 1908 map edition and is depicted as a very large rectangular structure. An area of this building measuring 10.8m east-west by 8.2m north-south was excavated. It was constructed from unfrogged and unstamped bricks, with walls measuring 0.38m thick and upstanding to 0.55m (5 courses) in height. The walls (**008**) sat on concrete foundations, which were 0.1m thick and laid directly on the natural.

The interior of this building consisted of a concrete surface (**009**). The remains of lines of brick running east to west across this concrete surface indicate the position of sleeper walls (**010**), which would have been located to support a floor surface at a rather higher level. Upstanding segments of sleeper wall show that they were of honeycomb bond construction (Fig. 12) and that they were constructed from frogged NIDDRIE-stamped bricks. As the Niddrie brickworks did not open until c.1924, it is considered that these sleeper walls represent a more recent addition to the late 19th/early 20th century building. The date of the concrete surface is unclear, but it may be that it represents the original floor, with the floor level being subsequently raised at a later date. There were no clues as to the purpose of this building, but it may be that it was where the items of sanitary ware were being manufactured prior to firing in the adjacent kilns.

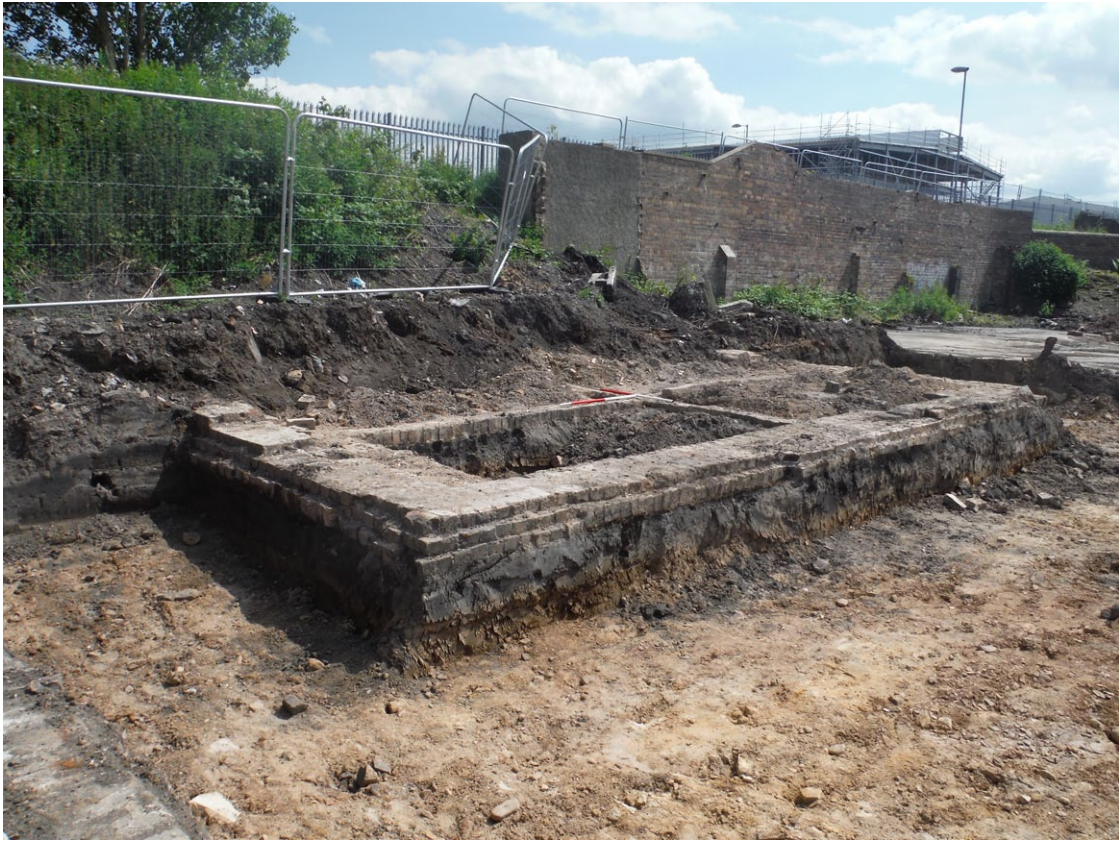
Fig. 13 - Building 2 from the north-west

Building 2 (Fig. 13) is depicted on the 1908 Ordnance Survey map edition as a square two-compartment structure with a small roofed annex at the north-east corner and an unroofed annex at the south-west corner. Due to the proximity of the steeply sloping bank along the eastern edge of the development area, this building was not fully exposed. The part that was exposed measured 9.4m NNE to SSW by >5m WNW to ESE, suggesting overall original dimensions of 9.4m by 9.4m. It was of brick construction and, like Building 1, the bricks were unfrogged and unstamped. The walls (**011**) were 0.6m thick (two brick lengths plus one brick width), survived up to a maximum height of 0.38m (four courses), were slightly stepped in from the base, and sat on made-ground c.0.2m above the level of the natural.

Internally, the building footprint was divided into four compartments by internal walls (**012**), one running NNE to SSW and the other running WNW to ESE. These walls measured c. 0.22m wide (one brick length or two brick widths). It is unclear if these walls represent internal divisions or if they were sleeper walls designed to support a floor surface at a higher level. As was the case with Building 1, there was no indication as to the purpose of this building, but its size may suggest something along the lines of site offices.

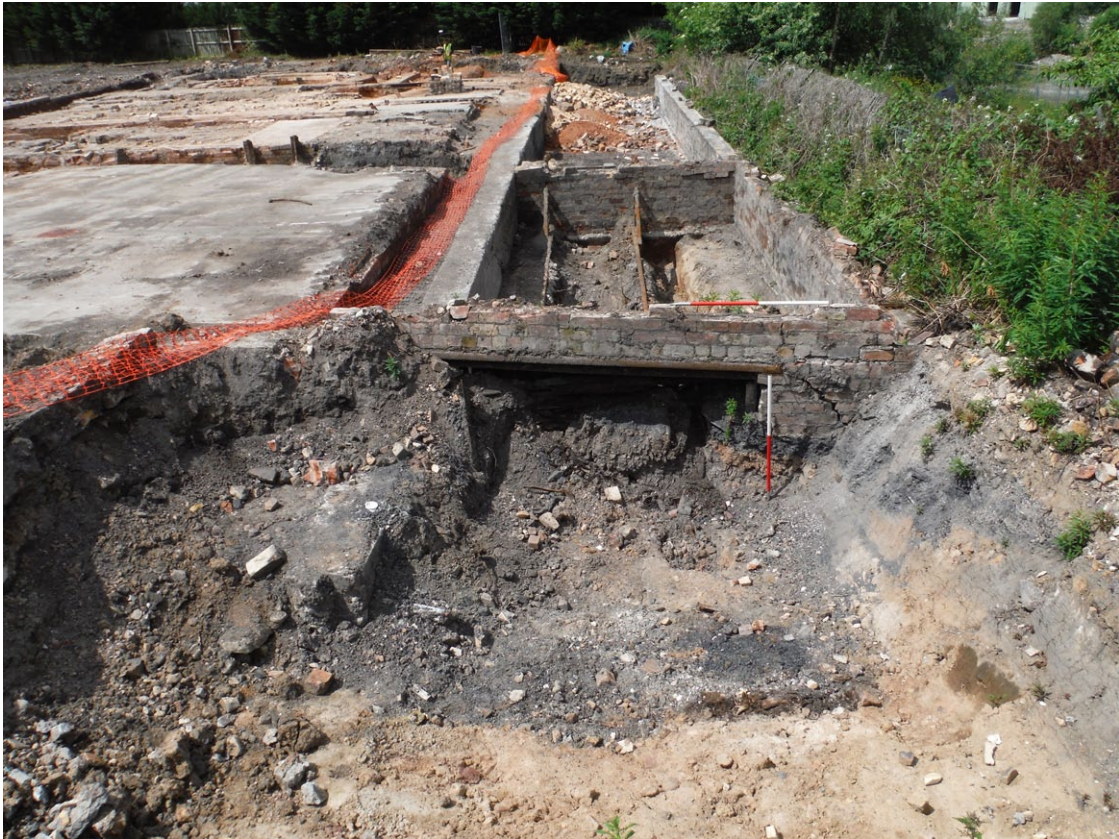
Fig. 14 - Railway Siding 1 from east

This railway siding (Fig. 14) is first depicted on the 1908 map, constituting the southernmost of a series of railway sidings associated with the Niddrie Junction (west). The Niddrie junction is depicted on the earlier Second Edition Ordnance Survey map (1895) with an extensive complex of railway sidings already established, so it would appear that this siding was constructed exclusively to provide railway access for the fireclay works. Overall, the remains associated with this siding measured c.31m east to west by 4.4m north to south.

The southern edge of the railway siding was formed by a concrete platform (**013**) running almost the full length of the part of the fireclay works located within the development area. The surface of this platform was c. 1m higher than the base of the siding. At its eastern end, the northern edge of the siding was defined by a brick-built wall (**014**) which was constructed from unfrogged and unstamped bricks and stood to a height of 1.2m above the base of the siding. This wall ran east to west for a distance of c.11m before turning through 90° to the south and running across the width of the siding to abut the concrete platform (**013**) (Fig. 15). Railway tracks were identified in situ at the base of this siding, but with the return wall creating an enclosure, there would have been no direct access from this end of the siding back to the mainline. Consequently, it is considered most likely that there was a railway-based crane within this location, which was only required to move a very short distance, perhaps slinging cargo over the embankment to an adjacent siding located to the north. Wooden shuttering at the eastern end of this part of the siding gave access to Building 4, which first appears on the 1934 Ordnance Survey map edition.

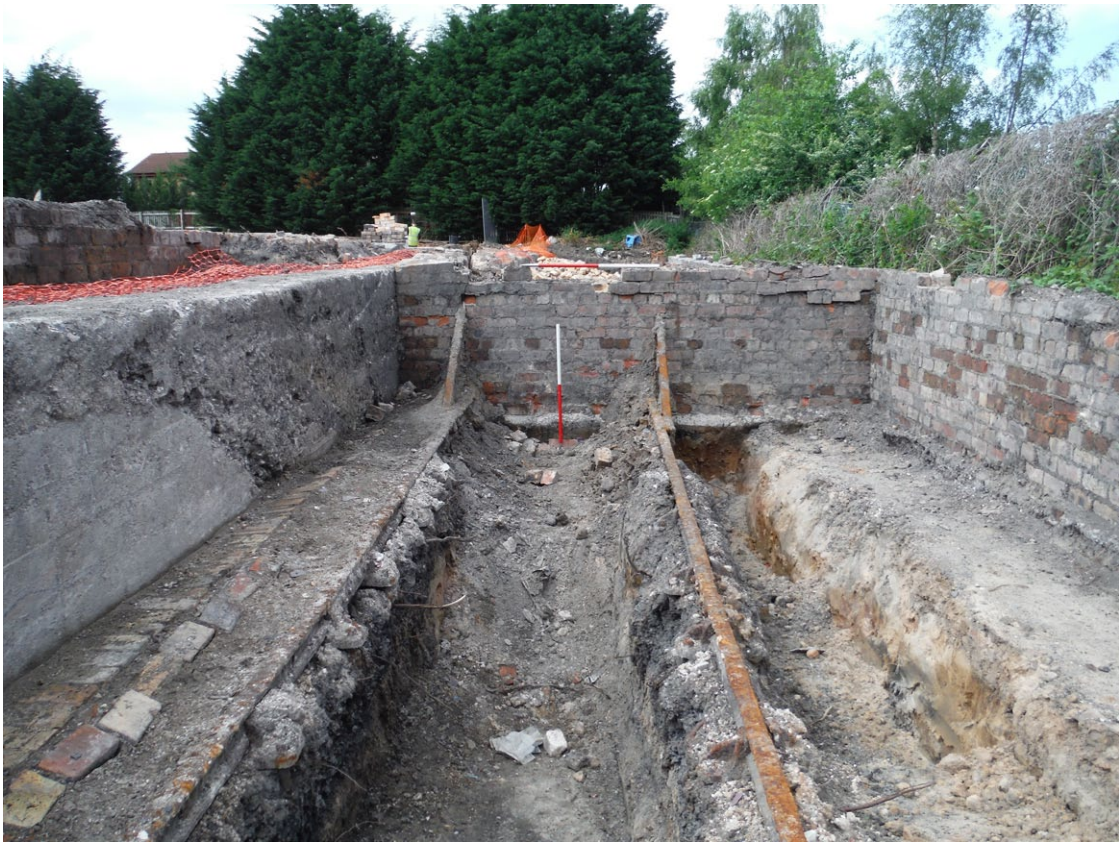
Fig. 15 - Railway Siding 1 showing wall 014

The northern edge of the western part of the railway siding was defined by another brick wall (**015**), which abutted wall **014**. This wall measured 20m in length, was constructed from unfrogged bricks stamped BONNYBRIDGE BRAND, and was

upstanding to a height of c.1.1m above the base of the siding. At its western end, this wall also turned through 90° to abut the concrete platform (013) and form an enclosure. As with the eastern compartment, this would have meant that there was no direct railway access from the mainline, again suggesting that it is most likely to have been the location of a railway-based crane.

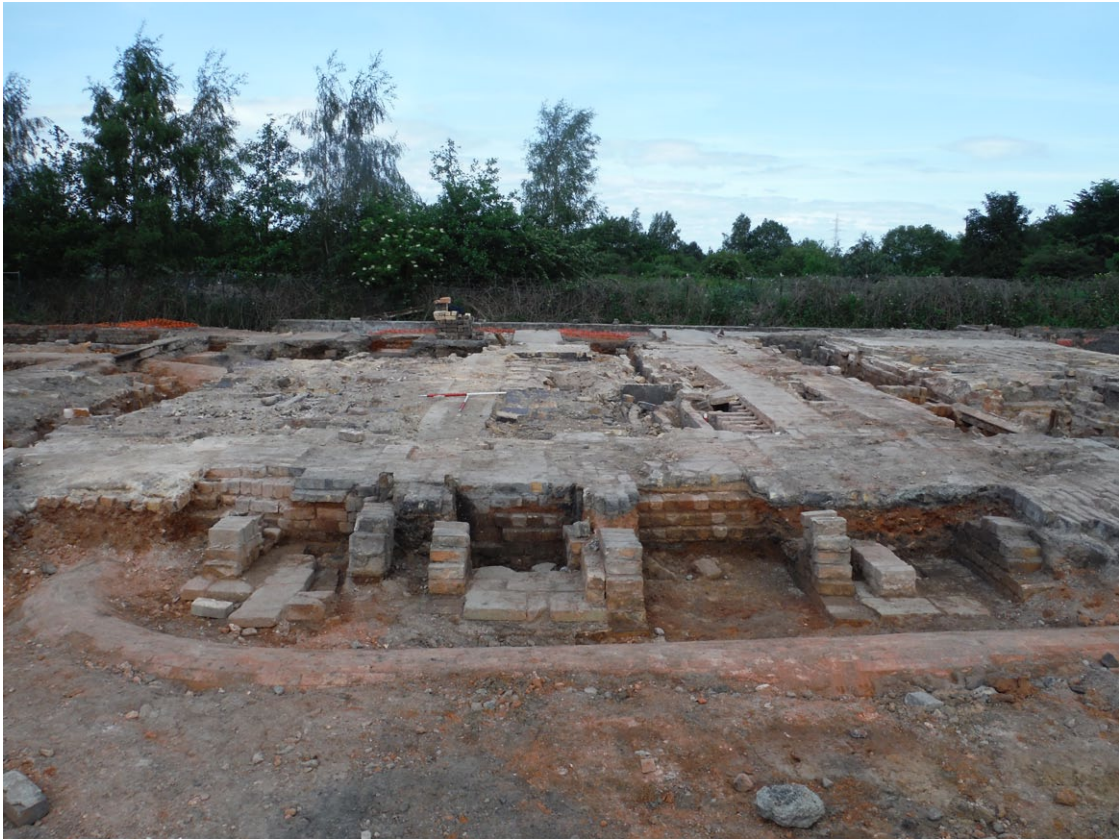
Fig. 16 - Kiln 2 from south

A building in the location of Kiln 2 is first depicted on the Ordnance Survey map edition of 1914, where it is shown as a rectangular structure, but with its north-east corner dog-legged. The excavated building (Fig. 16) was rectangular in plan, measured 12m by 9.2m, and was upstanding to roughly floor level. The wall footings (016) were constructed from frogged bricks stamped NIDDRIE, which were obtained from the nearby Niddrie Brickworks. This would probably imply that the kiln had been at least partially rebuilt from that shown on the 1914 map as the Niddrie Brickworks was not established until c.1924. The bricks sat on top of a 0.08m thick concrete foundation, which overlay the natural, and the walls were generally upstanding to a height of three courses. Four brick structures (017) at the southern end of the building are considered most likely to have been the bases for the furnaces that fired the kiln (Fig. 16). These brick structures protruded out from the main walls by a distance of c.1.4m and measured 1.25-1.5m wide. They were upstanding to a height of 0.6m, their bases were constructed from concrete slabs, and the bricks were generally unfrogged and unstamped, but with a few frogged bricks stamped WHITEHILL.

Internally, this kiln appeared to be divided into two compartments by a brick walkway (018) running up the centre of the building. The walkway measured 0.75m wide and was constructed from unfrogged bricks stamped BONNYBRIDGE BRAND. Further brick surfaces were present at both the northern and southern ends of the building, constructed from bricks stamped DOURIE. On either side of walkway there were two areas identified as the kiln floors (019 and 020). These areas were rectangular in plan measuring c.8m by 4m. Numerous voids were identified beneath the floor level (Fig. 17), which would presumably have provided a system of heat transferral across the whole of the kiln floor. These voids were c.0.3m deep and were formed from a network of low walls constructed using unfrogged bricks stamped BONNYBRIDGE BRAND. The low walls acted as supports for the slabs used to construct the kiln floor. A number of these brick walls showed evidence of vitrification indicating the level of heat used to fire the sanitary ware. At the centre of each of the kiln floors, there was a square hole (021 and 022) (Fig. 17) dropping down vertically into a flue system. These holes measured 0.5m across and were divided in two by precast slabs.

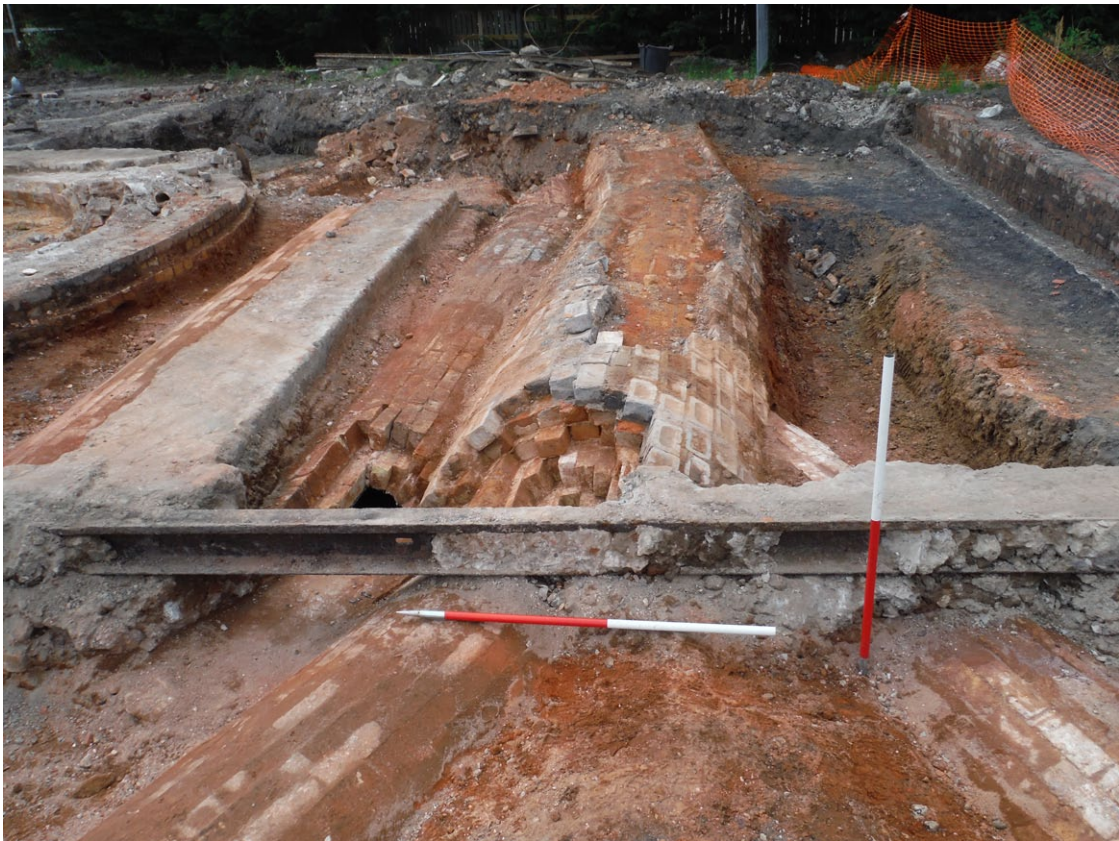
Fig. 19 - Phase 1 and 2 flue system

The draw for the kilns was provided by a series of brick-built flues attached to external chimneys. Three phases of flues (Fig. 19-20) were identified in relation to Kiln 2. The earliest phase consisted of a brick-built flue (**026**) running in a northern direction from the central vent-hole (**022**) in the eastern compartment before turning through 90° and heading in a westerly direction, terminating where it had been cut by a later flue (**028**). The exit into this flue had been bricked up after it fell out of use. A short length of flue (**027**) identified within the footprint of Building 3 is considered likely to be contemporary, and is thought to have run from the vent-hole (**021**) in the western compartment of Kiln 2 prior to being demolished and replaced with the phase 2 flue system. Both of these flues had internal measurements of 0.6m by 0.6m and external measurements of 1m by 1m. They had been constructed from a double skin of unfrogged bricks stamped BONNYBRIDGE 9R. The bricks forming the arched roof of the flues were slightly wedge shaped in profile. It is assumed that these flues would have run to the same chimney as that serving Kiln 1 on the western edge of the works.

The phase 2 flues (**028** and **029**) appear to have taken a rather more direct line away from the vent-holes (**021** and **022**) in the kiln bases, eliminating the need for the right angle turn present in flue (**026**). This would perhaps have provided a better draw and explain why the phase 1 flues were replaced. These flues utilized the same construction methods as the phase 1 flues and had the same 0.6m by 0.6m internal measurements. Both of the phase 2 flues were constructed with a double skin of unfrogged bricks stamped BONNYBRIDGE. However, within the footprint of Building 3, the flue running to the eastern kiln floor had been reinforced with a double skin of very light unfrogged and unstamped bricks and an outer skin of frogged bricks stamped either NIDDRIE or PRESTON GRANGE. These flues had been bricked up at the draw holes in the kiln floors after they had fallen out of use. It is assumed that the flues would have run to the same chimney as that serving the phase 1 flues, and represents a direct replacement for the earlier system.

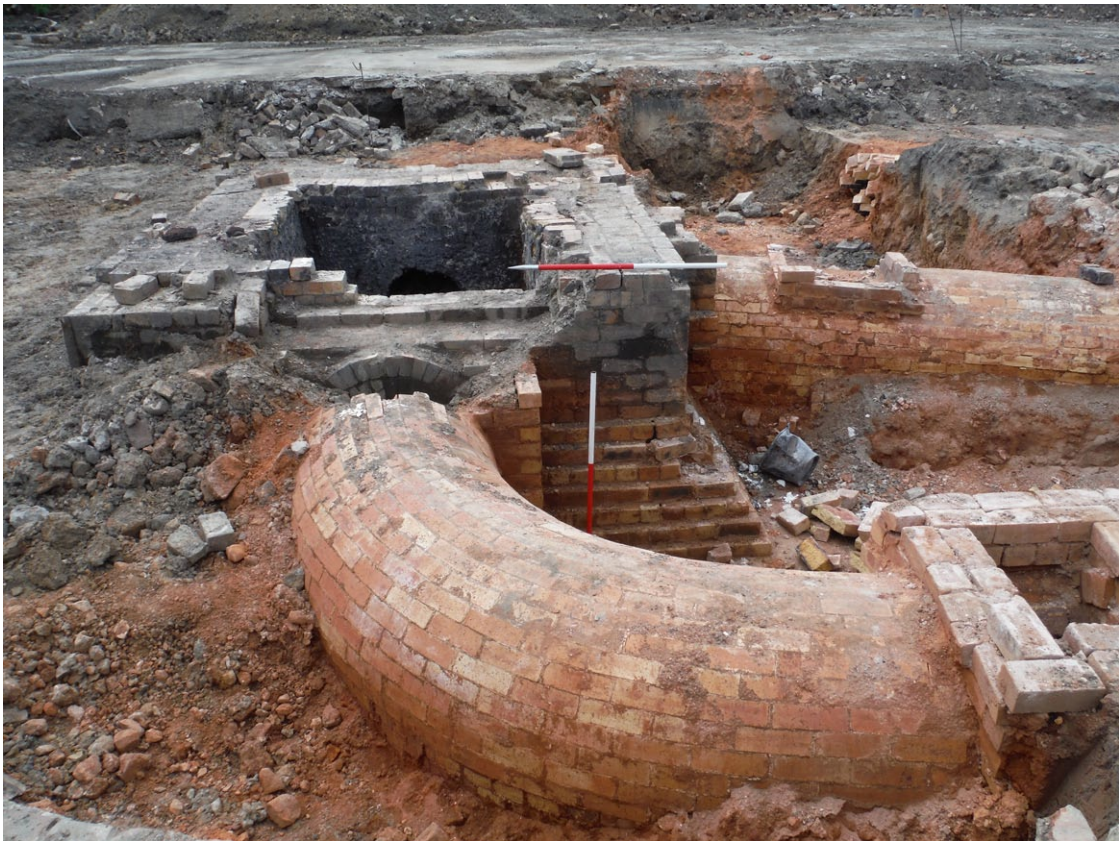
Fig. 20 - Phase 3 flue system

The phase 3 flues (**030**, **031** and **032**) represent an entirely new system for providing the draw for the kilns, exiting into a more recent chimney stack to the east (Fig. 20).

This chimney also served Kiln 3 and was probably contemporary with the later kiln representing a time when there was a considerable programme of expansion and upgrading within the works. In terms of construction, these flues were very similar to the earlier flues having the same 0.6m by 0.6m internal measurements. The flue (030) from the western kiln floor (019) in Kiln 1 was constructed from bricks stamped CALDER BRITISH MADE while the one (031) from the eastern kiln floor (020) was constructed from bricks stamped BONNYBRIDGE, and the one (032) from Kiln 3 was constructed from bricks stamped CALDER. All of these flues had a small brick built structure (033) located somewhere along their length where there was a small hatch giving access to the inside of the flue. These brick structures measured c.1m by 1.2m and were constructed from frogged bricks stamped NIDDRIE. The purpose of these structures is unknown, but they may have been inspection hatches, or they may have housed some kind of damping mechanism for controlling the draw through the flue.

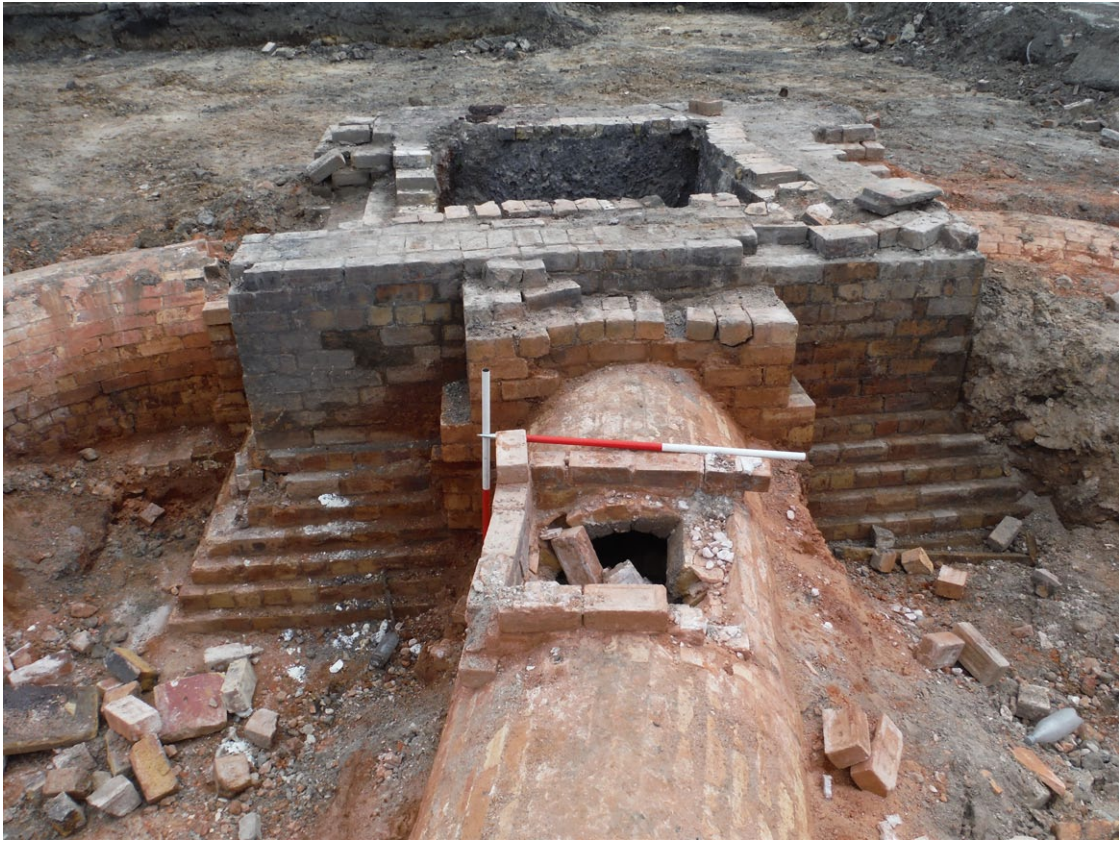
Fig. 21 - Chimney Base 1 from west

Chimney Base 1 (034) (Fig. 21) related to the final phase of flues in Kiln 2 and to the single phase flue in Kiln 3 (flues 030, 031 and 032). Internally it measured 1.8m by 1.8m while externally it measured 3.2m by 3.2m, stepping out to a maximum of 4.2m by 4.2m at the very base. It was upstanding to a maximum height of 1.5m from the concrete surface on which it was constructed and had a depth of 1.25m internally to floor level. Although largely constructed from frogged bricks stamped NIDDRIE, the interior had been lined with a single skin of unfrogged bricks stamped BONNYBRIDGE BRAND. This gave the walls an overall width of 0.7m.

Internally, the chimney base was divided by two lengths of diagonally placed wall (035) creating one compartment representing 50% of the floor area and two compartments each representing 25% of the floor area. Each of these three compartments related to a specific flue, with the larger compartment relating to the flue (030) exiting from the western kiln floor in Kiln 2. It is unclear as to why this compartment was double the size of the other two, but it may relate to the greater length of this flue, or indicate that a higher temperature was required in relation to this particular part of the kiln. These internal walls were constructed from unfrogged bricks stamped BONNYBRIDGE BRAND. Considerable evidence of vitrification was apparent throughout the interior of the chimney base indicating the high temperatures that it was subjected to.

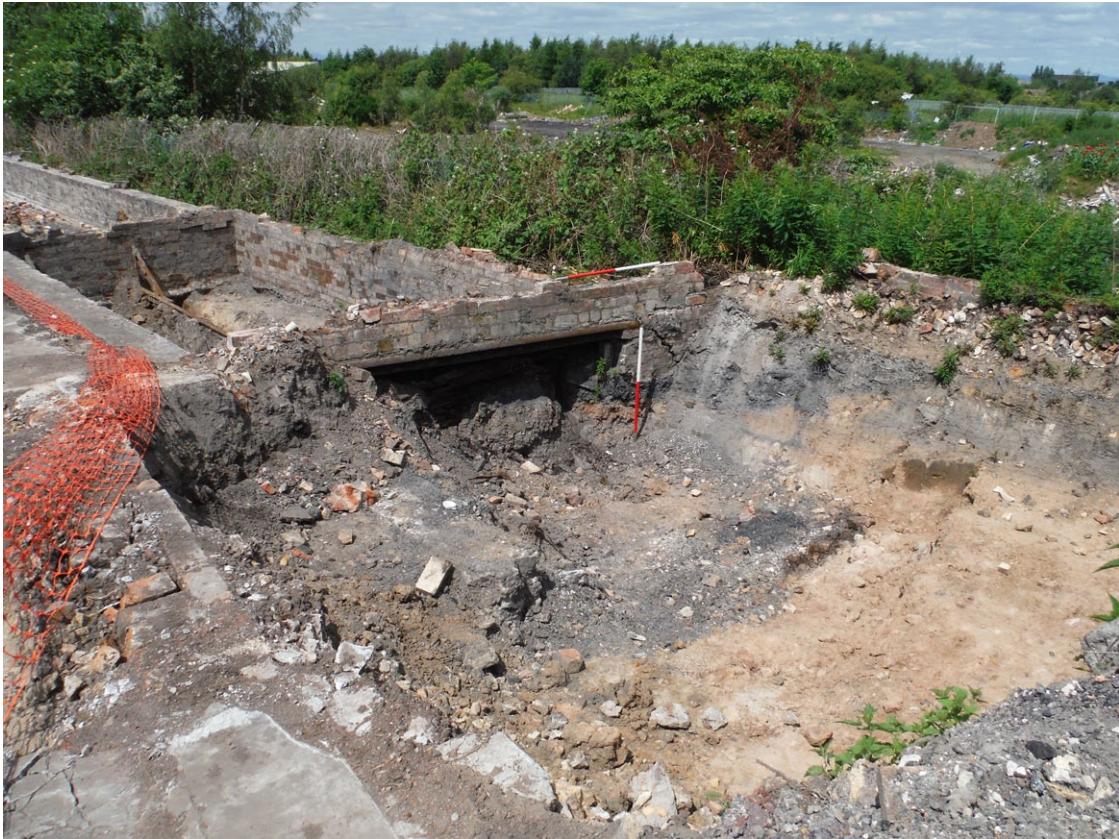
Fig. 22 - Building 4 from south-east

Building 4 (Fig. 22) is first depicted on the 1934 Ordnance Survey map at the eastern end of Railway Siding 1. The excavated remains measured c.7.5m north to south by 6m east to west. At its western end, the walls (**038**) of this building were upstanding to a height of c.2m above the base of the railway siding. These walls were constructed from frogged bricks stamped PRESTON GRANGE. An entranceway in this western wall gave access to the railway siding. This entranceway measured 2.7m wide by 1.4m high and was topped with an I-beam supporting several more courses of brick walling. The entranceway had been blocked with wooden shuttering.

The northern, southern and eastern walls (**039**) of this building were constructed on made ground at a level c.1.5m higher than the base of the western wall. Traces of concrete at the base of these walls suggest a floor level at about the same height as the metal beam spanning the top of the entranceway into the railway siding. The implication of this entranceway and raised floor is that the railway siding extended into the building, with the raised flooring perhaps serving as a loading platform.

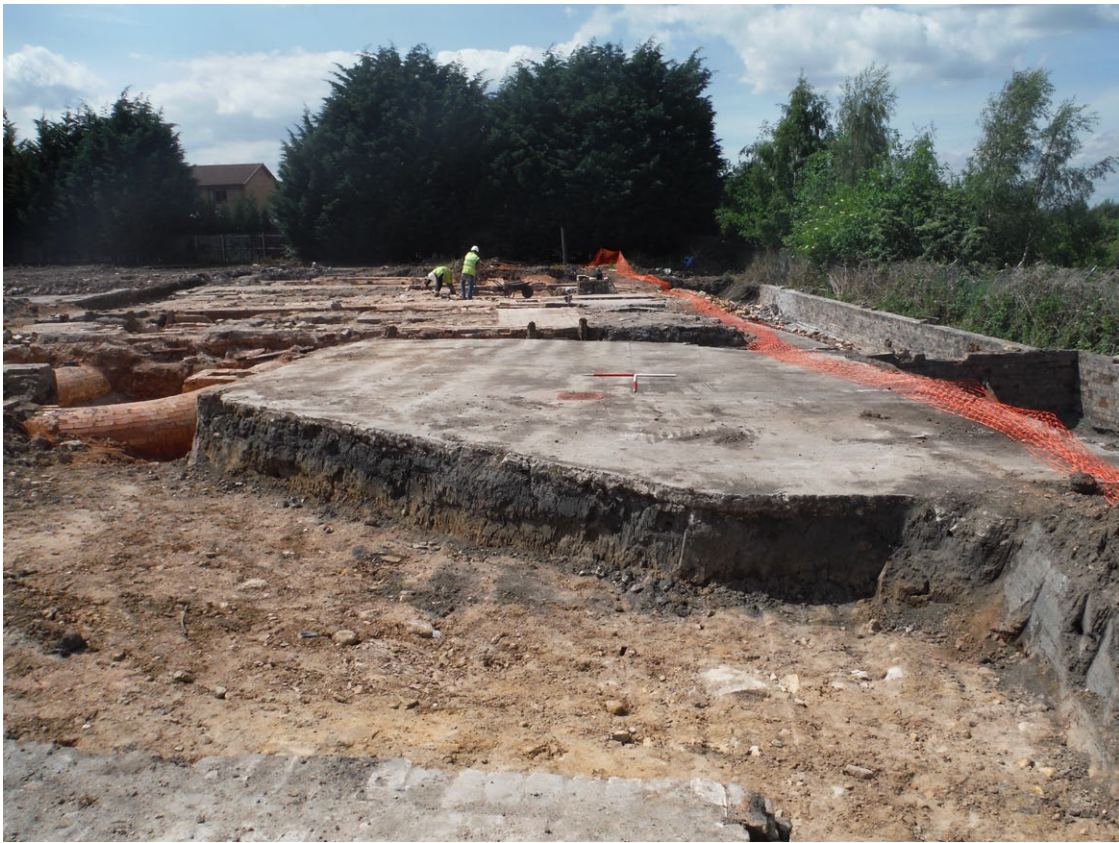
Fig. 23 - Platform 1 from east

Platform 1 (Fig. 23) was pentagonal in plan and consisted of a concrete surface (**040**) bordered by low brick walls (**041**). The brick walls were upstanding to a height of 0.32m (four courses) and were 0.23m wide (one brick length or two brick widths). The walls had been constructed from bricks which were unfrogged and unstamped. The bricks sat on top of concrete foundations which were c.0.1m thick and were laid on made ground at a height of c.0.2m above the natural. Breaks in the concrete surface indicate that the interior of the wall footings had been backfilled with rubble prior to the surface being laid. The age of this structure is uncertain; a line with a slight dogleg on the 1934 map indicates the line of the western side of this structure, but the brick used in its construction is the same as the earlier structures on the site.

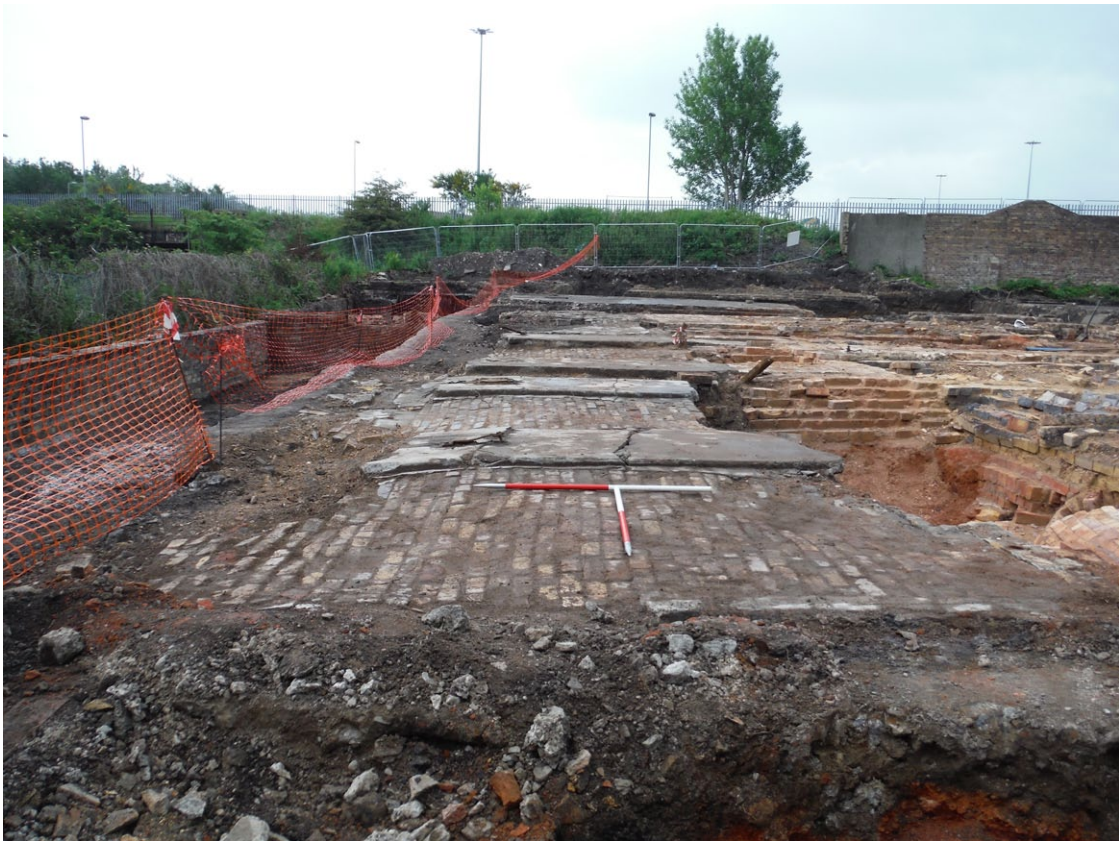
Fig. 24 - External Area 1 from west

External Area 1 (Fig. 24) was located between Kilns 2 and 3 and Railway Siding 1. It measured 17m east to west by 3m north to south and consisted of alternating areas of brick (**042**) and concrete surfacing (**043**). The brick surfaces were unfrogged and unstamped. Several metal fixings were present on the areas of concrete and there was a metal plate attached to a chain on one of the brick surfaces. These surfaces sat on top of 0.5m of made-ground.

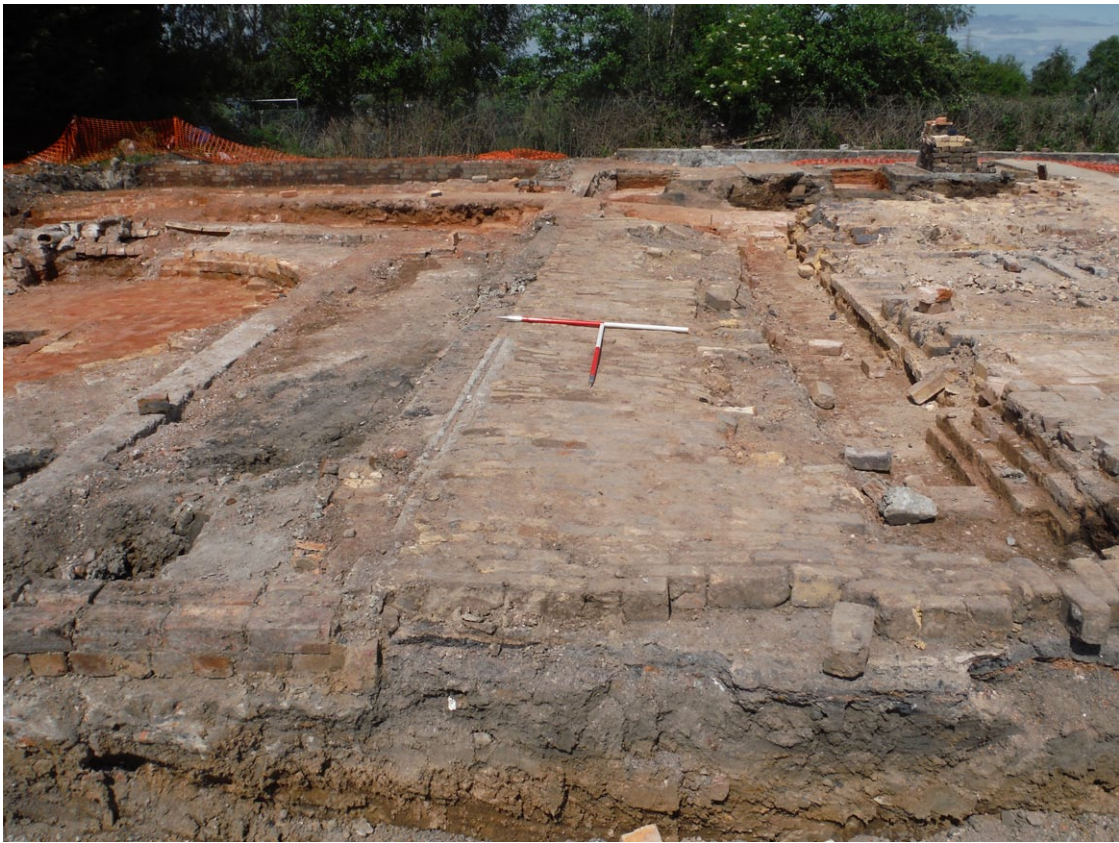
Fig. 25 - External Area 2 from south

External Area 2 (Fig. 25) was located between Building 3 and Kiln 2. It measured 14m north to south by 2.5m east to west. This area was partially brick surfaced (**044**) along its western edge with unfrogged bricks stamped BONNYBRIDGE BRAND. Towards the northern end of this surface there was a brick built inspection chamber containing some metal pipe-work. The chamber measured 0.7m north to south by 0.4m east to west and had a depth of >0.5m from the surface. A second brick surface (**045**) was located along the eastern edge of the area at a level c.0.3m below the aforementioned western one. Between these surfaces were larger concrete blocks

containing upright metal fixings. These metal fixings may have been for supports for some kind of walkway covering.

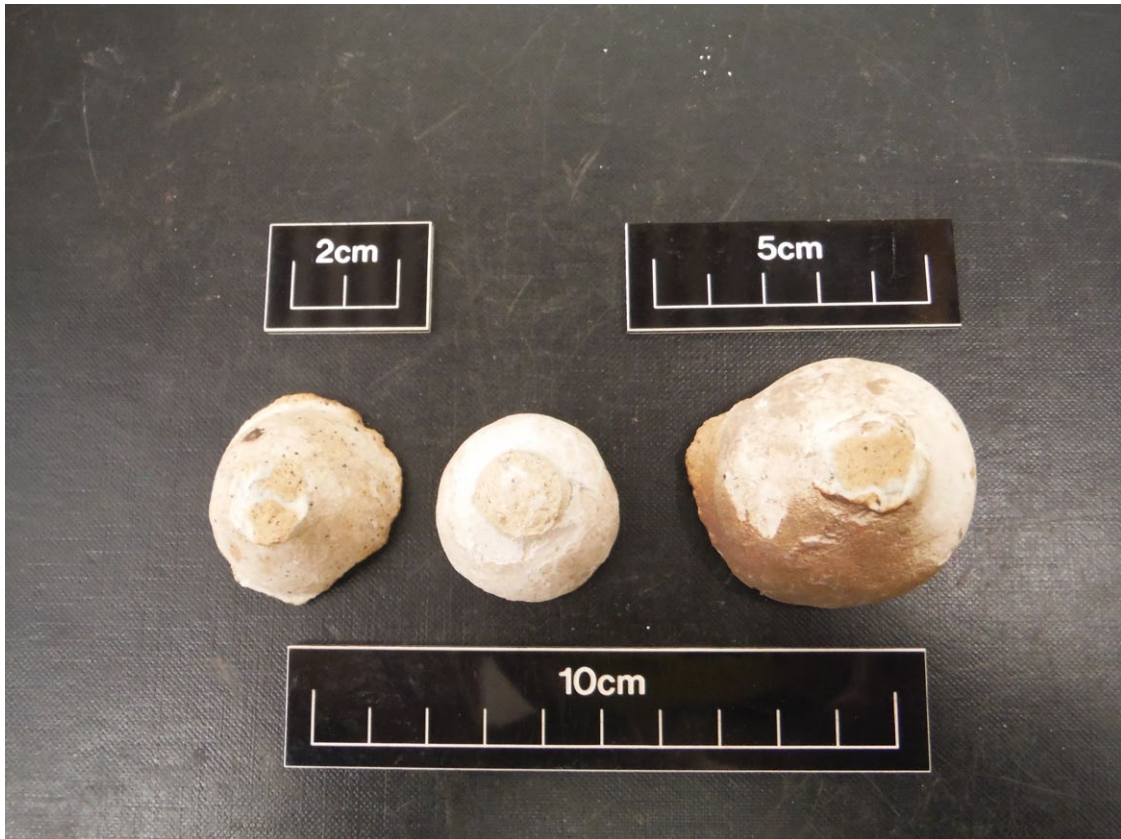
Fig. 26 - Kiln spurs from Kiln 2

A limited number of finds (Appendix 4) were recovered from the kiln floors (**019** and **020**) of Kiln 2. These consisted of three kiln spurs (Fig.26), a piece of kiln furniture consisting of a lozenge-shaped pedestal support (Fig.27) and a barley-twist ornamental edging piece (Fig.28) which may have been produced in the works. The kiln spurs would have served the purpose of keeping small items within the kiln supported and separated, while the pedestal support is likely to have been for a large concave item such as a urinal. The implication of the barley-twist ornamental edging piece is perhaps that other items were being manufactured in addition to the documented sanitary ware.
