**184 Woodhall House,
Woodhall Road,
Edinburgh**

**Monitored Strip
Report No. 3162**

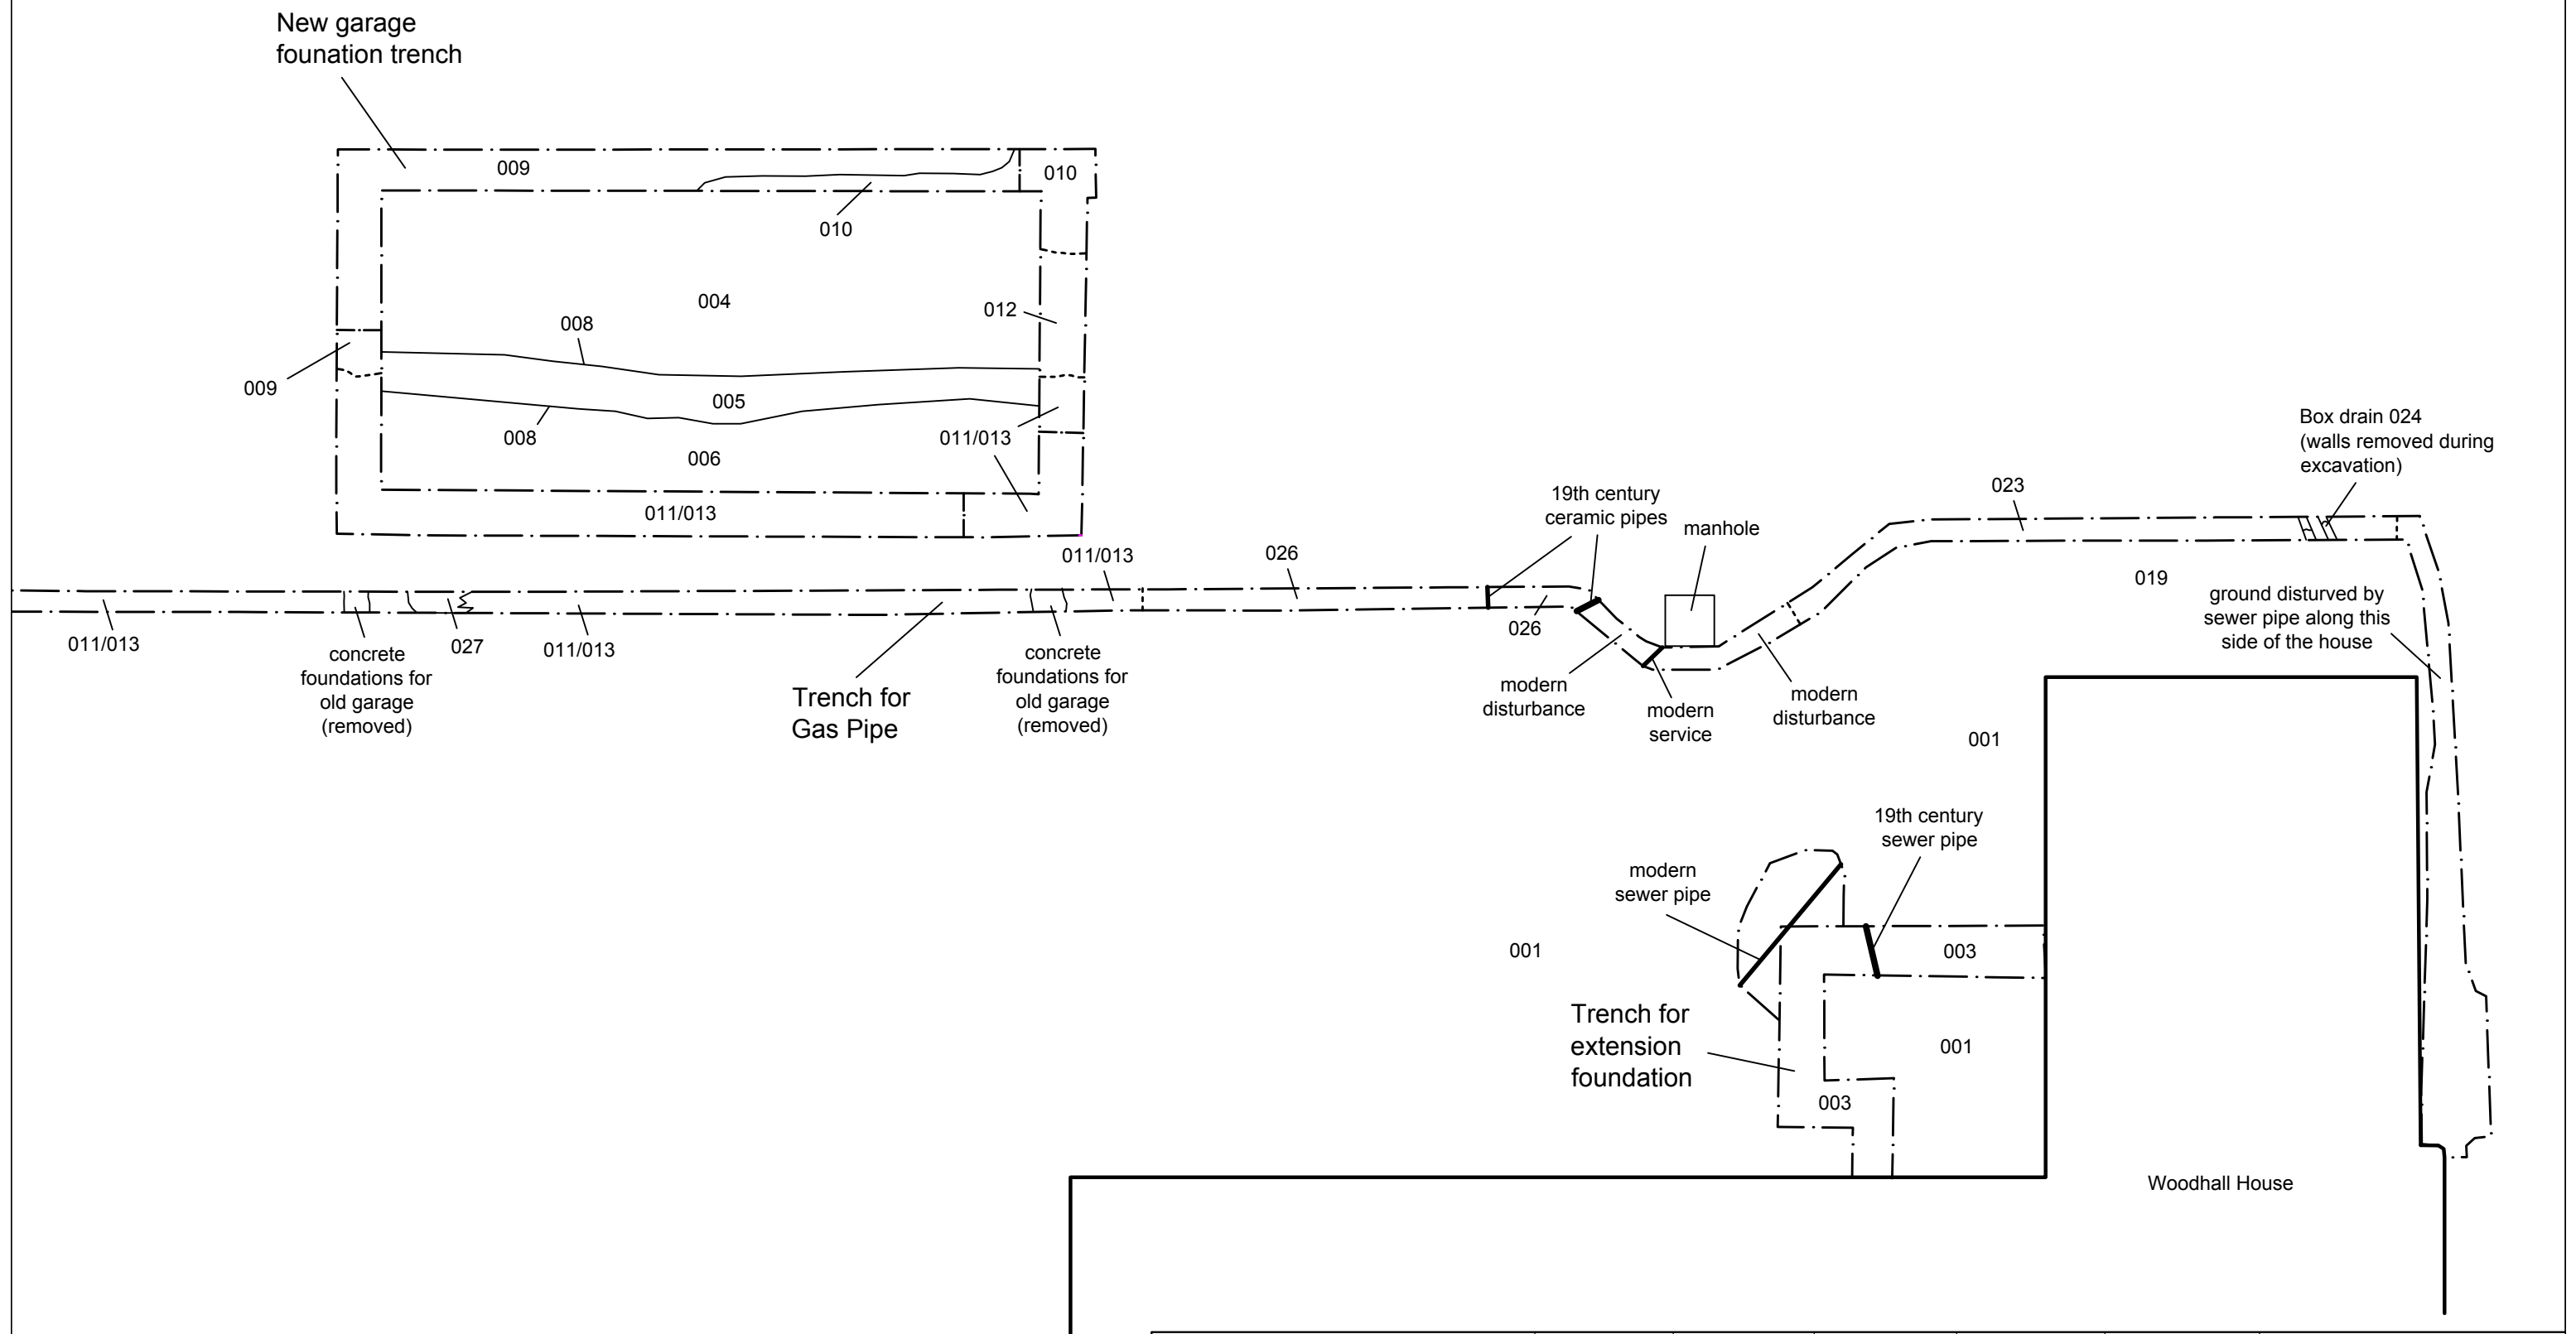
<div>CFA ARCHAEOLOGY LTD The Old Engine House Eskmills Park Musselburgh East Lothian, EH21 7PQ t: 0131 273 4380 f: 0131 273 4381 e: info@cfa-archaeology.co.uk w: www.cfa-archaeology.co.uk</div>	Fig. No: 1	Revision: A	Drawn by: TB	Checked: BG	Report No: 3162	Client: Mr and Mrs Martin Robertson
	Title: Deposits and features around Woodhall House and Garage			Project: 184 Woodhall House, Woodhall Road, Edinburgh Archaeological Monitored Strip		Scale at A3: 1:125

The ground breaking works for the new garage was monitored. Modern deposits were revealed including layers and drainage associated with a former garage (**004**, **005**, **006**, **007** and **008**). Excavation of the foundation trench for the north side of the new garage revealed modern levelling deposits (made ground) (**009** and **010**) to the full 0.90m depth of the trench, indicating that large quantities of modern material had been dumped to level out the natural downhill slope. The foundation trenches for the south side the garage revealed two earlier dumped layers (**011/013** and **012**) which contained domestic refuse (oyster shell, coal and charcoal) and lime mortar, possibly from early renovations of the hall. The lack of 20th century material in these levelling deposits formed to the rear of the house suggests a 19th century or earlier date.

Trenches for various services were excavated during the development. These included a gas pipeline around the back of woodhall house, as well as water and cable trenches for electric lighting further to the west. Deposits revealed along the East side of Woodhall house were found to have been heavily disturbed by an earlier waste water pipe. Further west however, made up ground (**023**) was revealed in the trench extending along towards a manhole where it was truncated by modern services. This mortar-rich deposit was similar to layers (**011/013**) in the garage trench and it was probably laid down during renovations to the house in early 19th century. A stone box drain (**024**) had been cut into this layer. Further to the west the gas pipe trench encountered dumped layer (**011/013**) again and two more modern levelling layers (**026**) and (**028**). A narrow water pipe trench was excavated from the garage towards the tennis courts. Deposits in this trench largely comprised disturbed topsoil (**032**) and made up ground (**017**) above natural gravels and bedrock (**000**). At the far western end of this trench the foundations for a wall (**031**) running at an angle to the trench

The monitored strip has shown that various deposits of made ground have been dumped to the North of Woodhall house over the last two centuries. This essentially extended the house grounds by levelling up an area which naturally would have sloped down to the water of Leith. As the natural geology was not encountered on this side of the house it appears that this slope was originally very steep. The lower dumped deposits that contained domestic refuse (oyster shell, coal and charcoal) and lime mortar appear to be levelling deposits created in the 19th century or earlier. It seems likely that they relate to renovations when the house was converted into a late Georgian mansion.

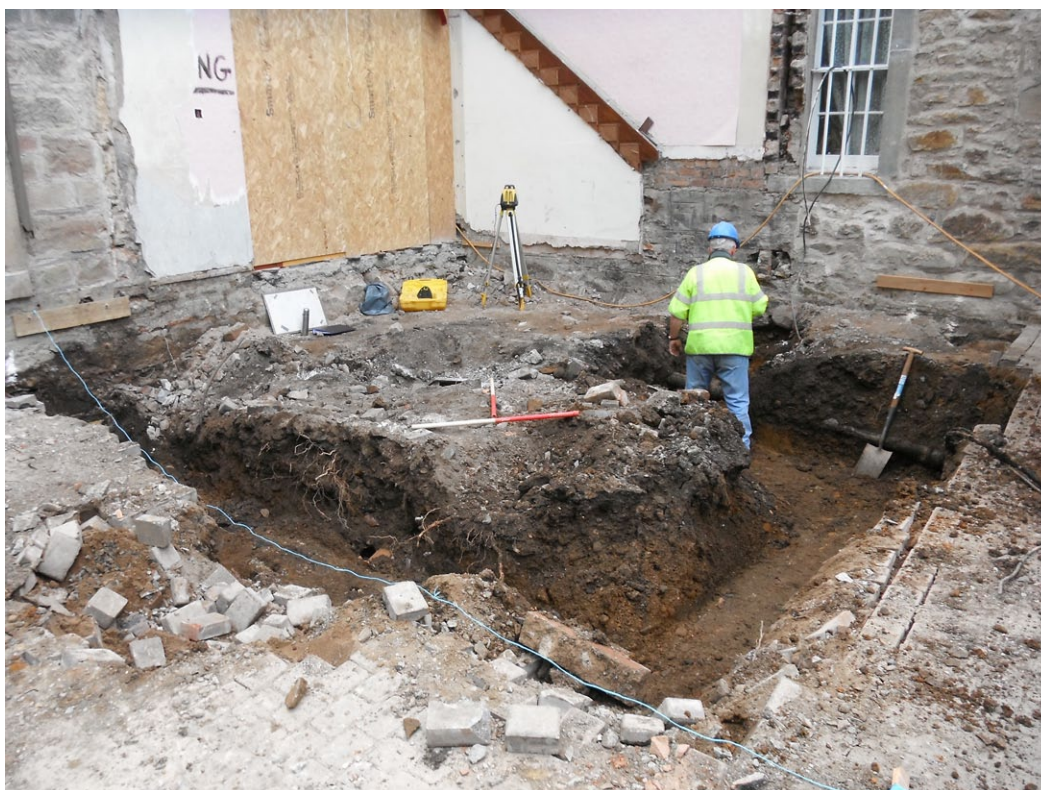
Fig. 3 - Shot of trench for extension foundations

The ground breaking works for a small extension to the rear of the main house was observed. A trench c.9.5m by 0.9m wide was excavated to a maximum depth of 0.75m. A brick surface (**001**), c. 0.05m thick overlay 0.1m thickness of type 1 (**002**), below which was made ground (**003**). Various modern and 19th century services were observed but no significant archaeological deposits or features were revealed.

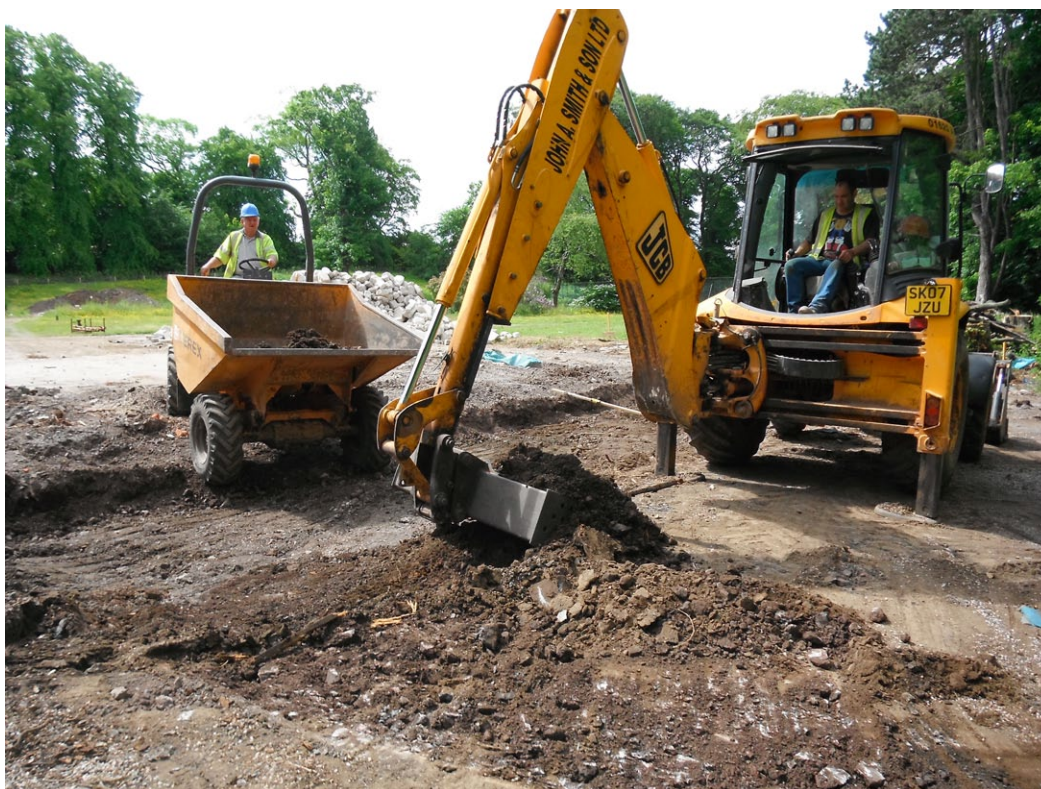
Fig. 4 - Shot showing stripping of topsoil for garage foundations

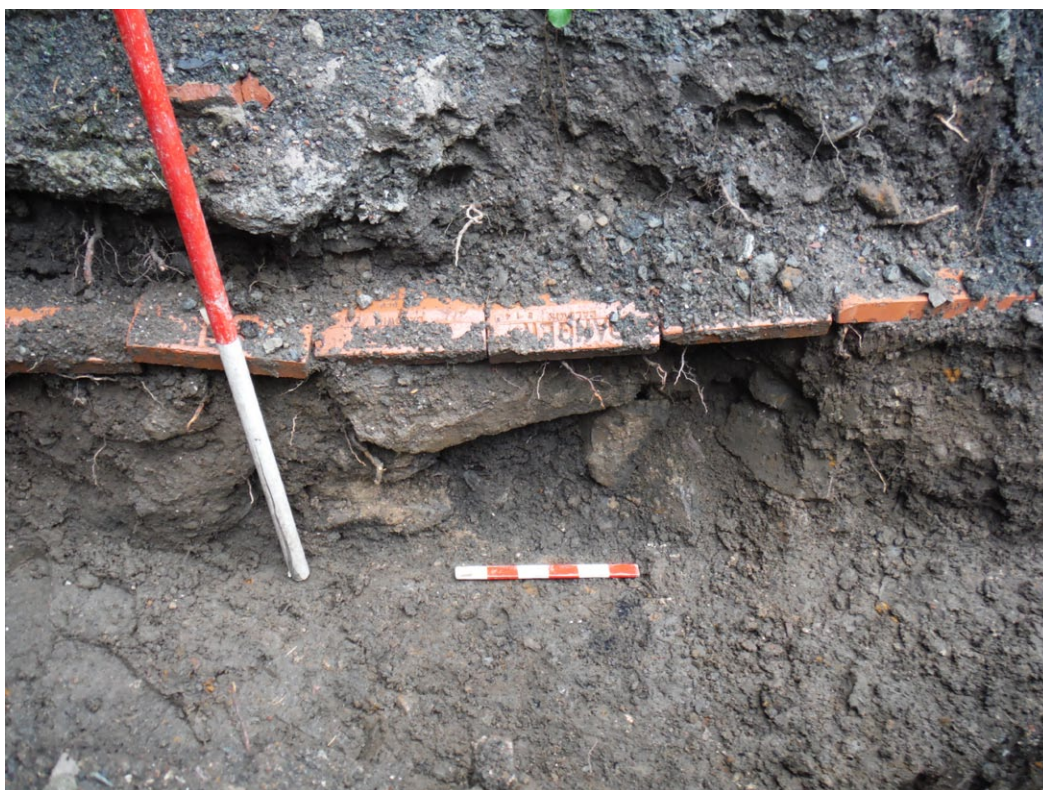
Fig. 5 - Photo of box drain 024 in gas Trench

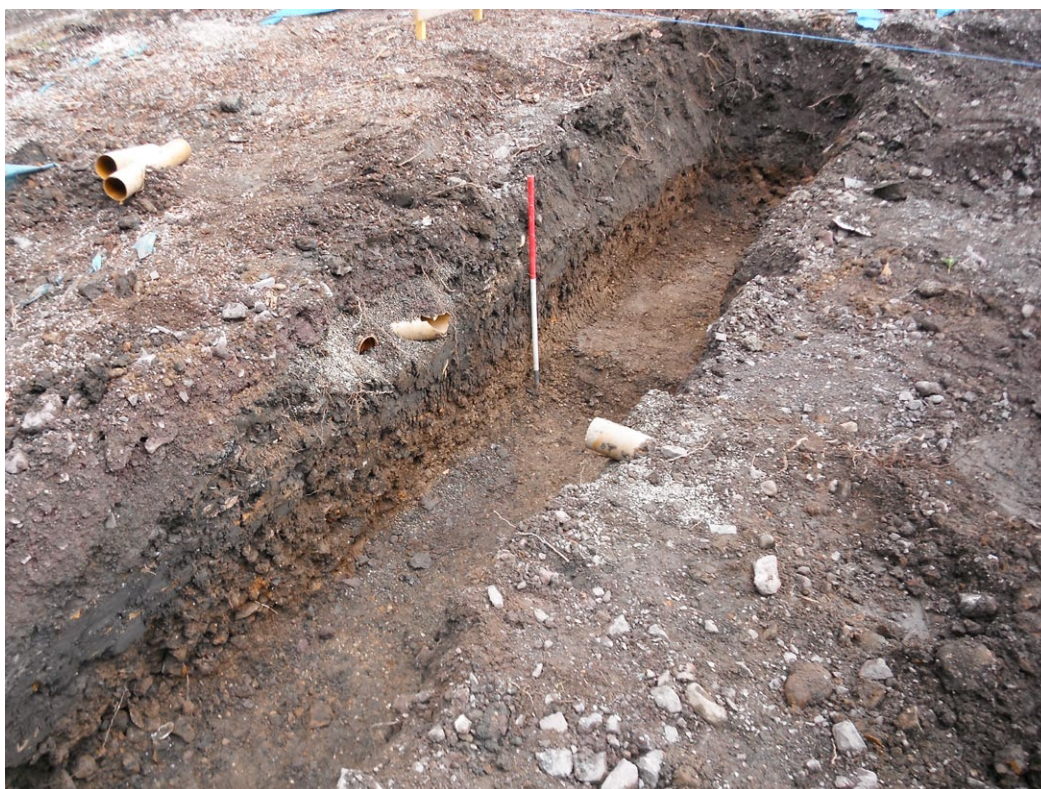
Fig. 6 - Photo showing mortar-rich deposit 013 in garage foundation trench

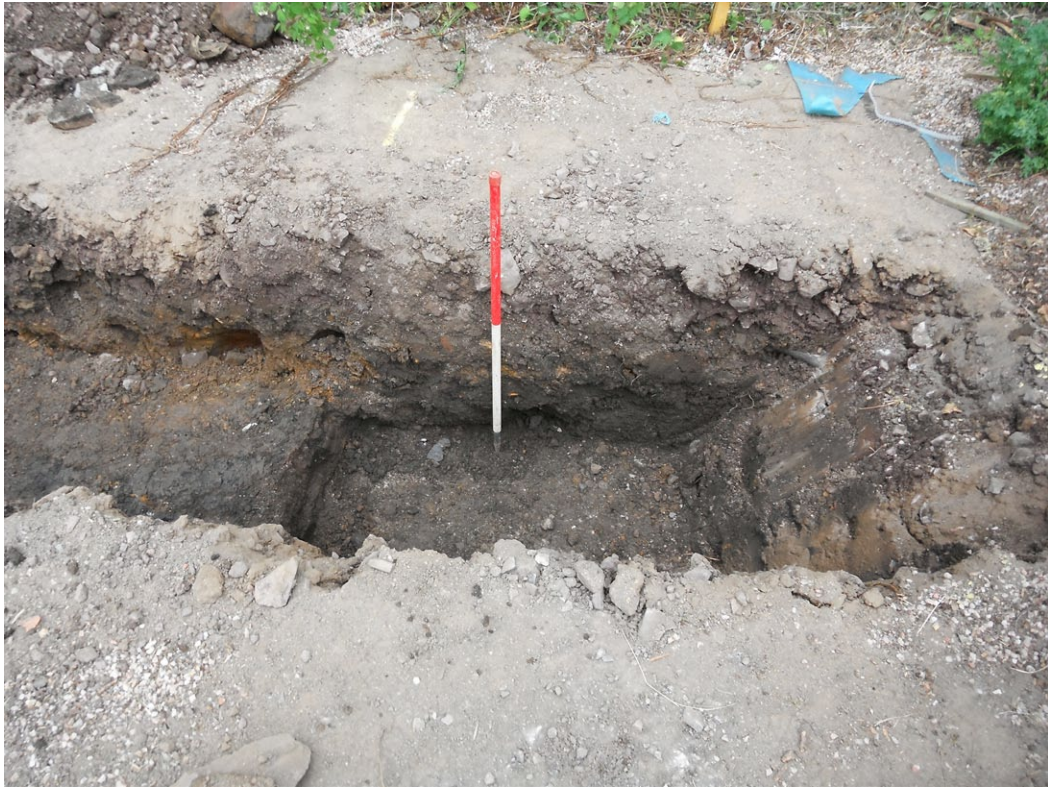
Fig. 7 - Photo showing dark made up ground 010 at the rear of the garage

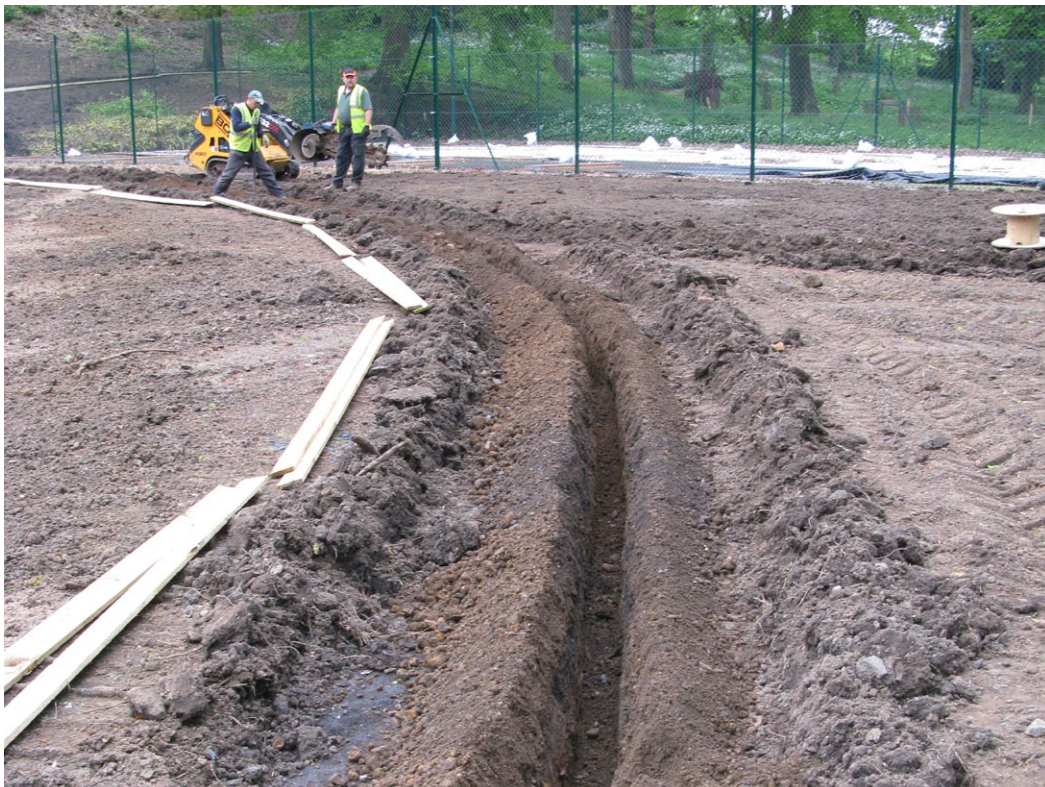
Fig. 8 - Excavating trenches for lighting

were found cut into the natural ground. Shallow trenches for cable lighting were also viewed but these revealed only disturbed topsoil (032).

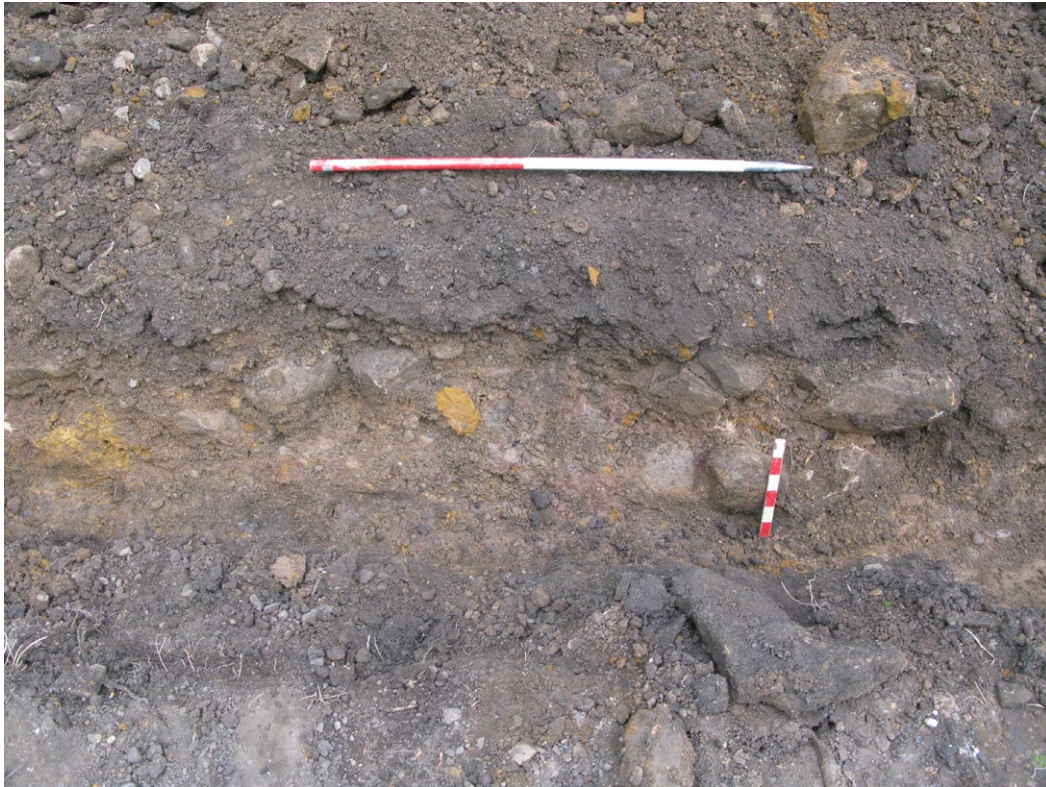
*Fig. 9 - Wall foundation **031** discovered in the water pipe trench*

The stone wall revealed in the water pipe trench east of the house may have been part of a garden boundary in this part of the grounds.
