**Land at Oswestry Water Works
Oswestry
Shropshire**

Archaeological Desk-Based Assessment

Report No. Y160/14

Author	Rebecca Hunt BA MA AIfA
Illustrator	Shelley Werner BA MPhil PhD
Editor	Martin Lightfoot BA MA MIfA
Commissioned by	United Utilities
Date issued	June 2014
Version	1.0
National Grid Ref.	SJ 27829 29267

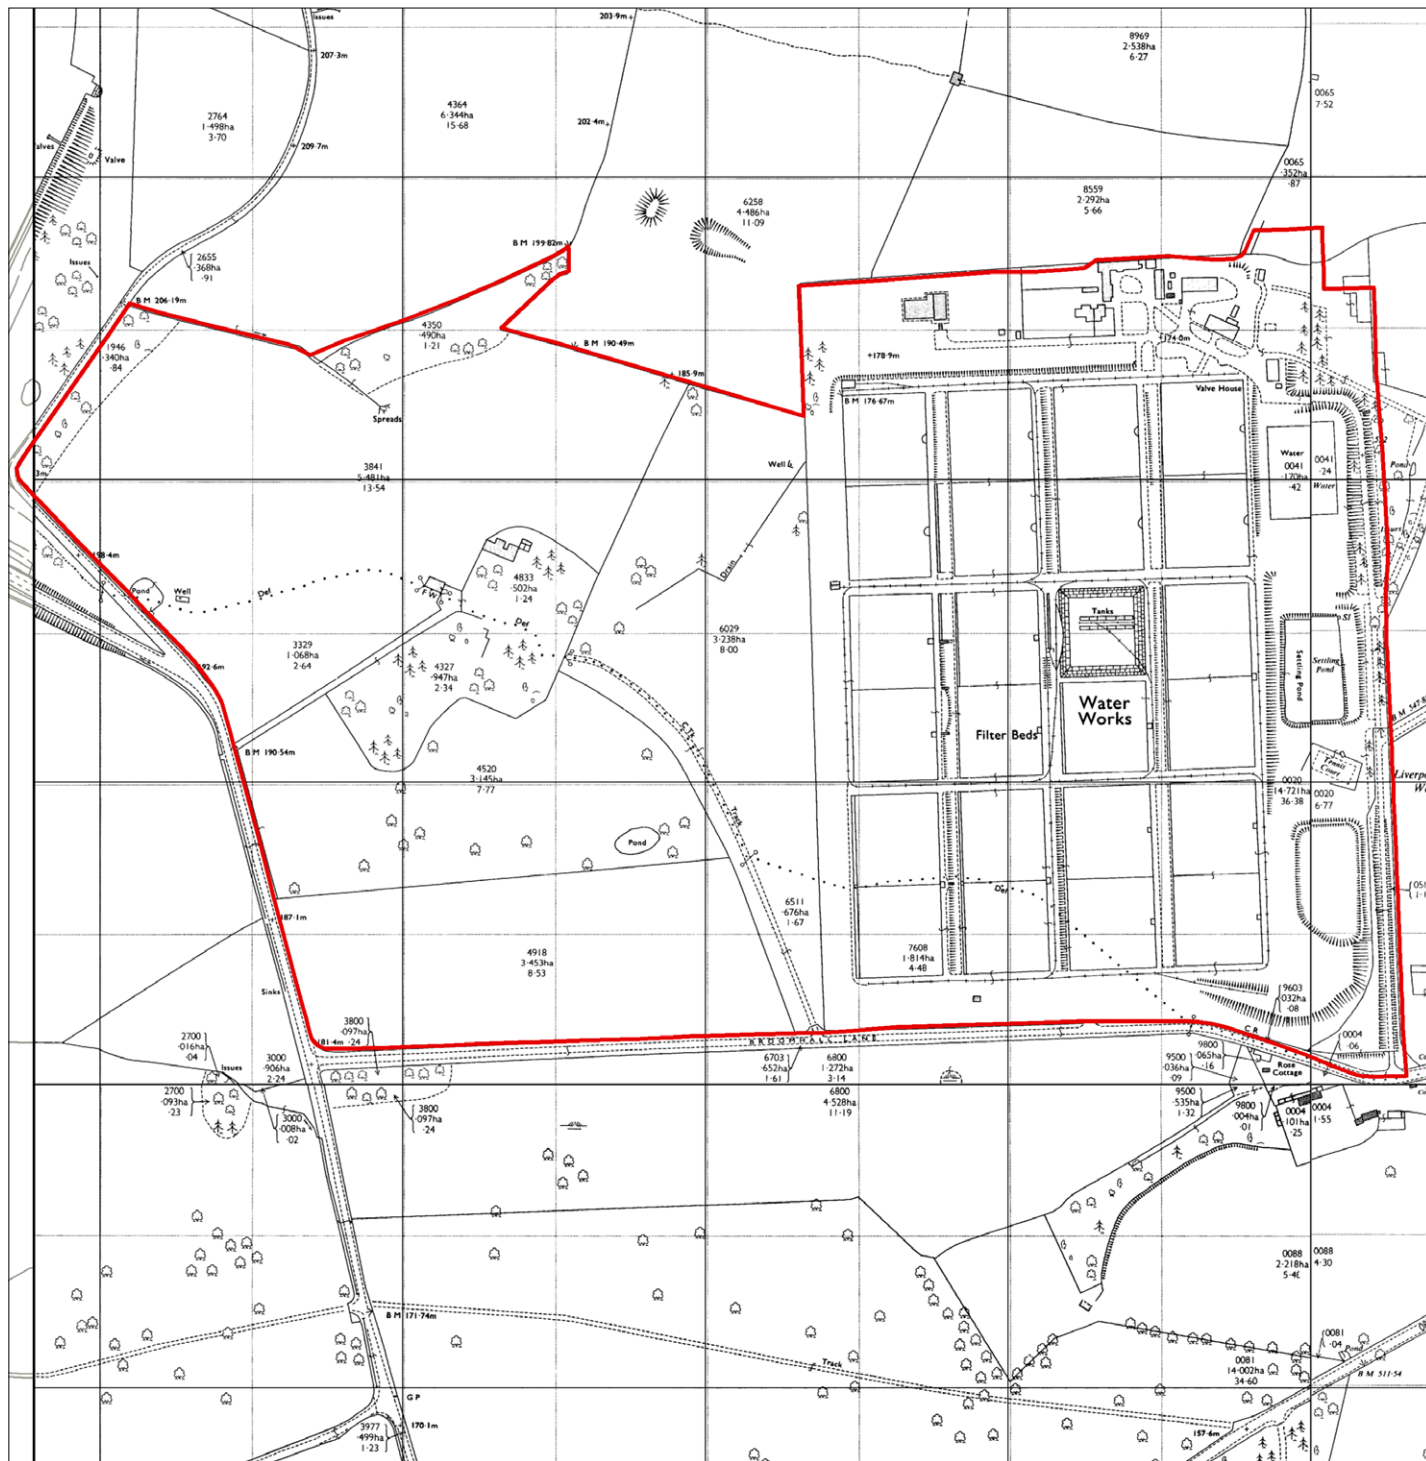
Fig. No: 4 Report: Y160/14 Drawn: SW CKD: ML Date: 17/06/14

Title:
**Ordnance Survey 1969, 1:2500
 Map**

1969 Ordnance Survey 1:2500 Shropshire Map (Figure 4)

The 1969 OS Map shows the south-east complex of buildings associated with the Llanforda-isaf are no longer in existence, with the exception of the north and west structure, with some minor possible walls still evident. However, the previously unmapped, tree-lined boundary to the south of the Llanforda-isaf has been recorded.

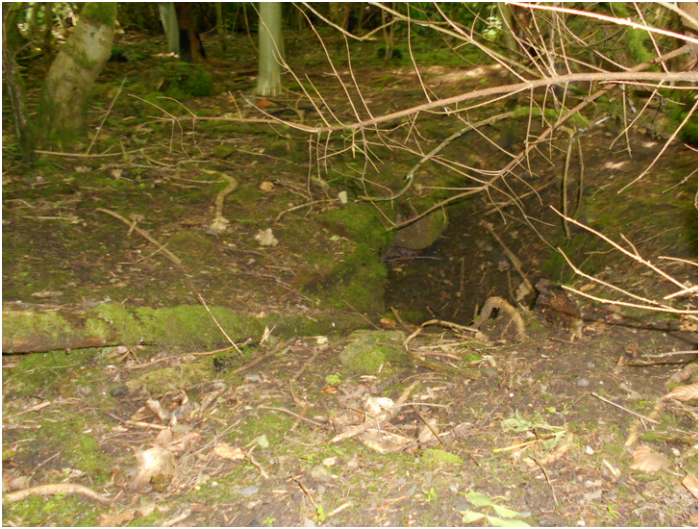
Plate 1: A man-made hollow within woodland at Llanforda-isaf farmstead

The remains of Llanforda-isaf farmstead were visible from the field to the west of the water works, (Fig. 2; 26505). The majority of the farmstead remains were within a dense woodland area which it was not possible to access. Though some upstanding structures visible on the 1969-1974 OS were still present (Fig. 3), along with some manmade hollows (Plate 1). The surviving structures within the woodland comprised a series of walls, and a revetment wall to the farmstead which survived to a height of 1.7m, with stone and brick steps providing access from the lower to higher ground (Plates 2 and 3). Other features were visible within the area of the farmstead, some of which may have represented modern disturbance.

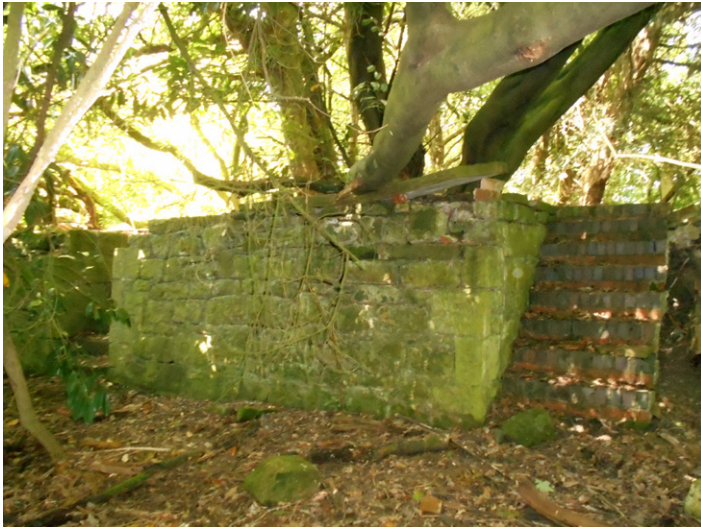
Plate 2: Revetment Wall and steps located within the woodland at Llanforda-isaf Farmstead

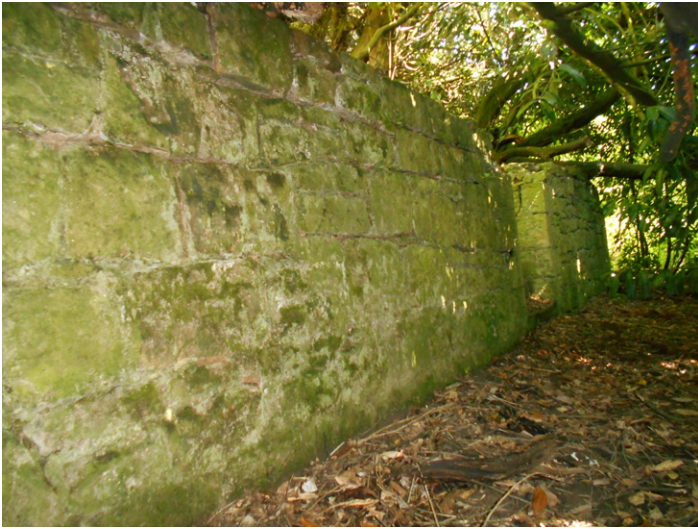
Plate 3: Revetment Wall and steps located within the woodland at Llanforda-isaf Farmstead

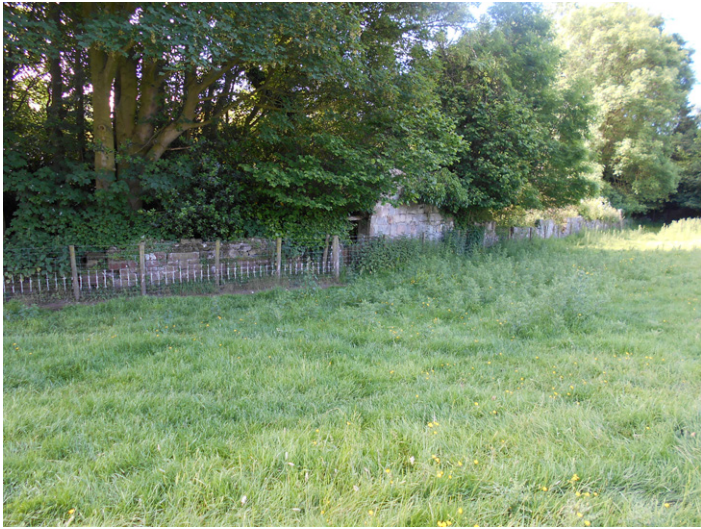
The building to the north of the Llanforda-isaf Farmstead (SJ 27454 29362) was only visible from the pasture field and full access was prevented by dense woodland (Plate 4). The remains consisted of an unroofed building, with its north-east facing elevation surviving to a height of 3.2m and width of 5.5m. It was constructed of squared, stone blocks in courses 0.3m high, with narrow filling courses forming a horizontal level for the next course up. The walls were 0.45m thick, with possible internal walls still

Plate 4: The remains of Llanforda-isaf Farmstead

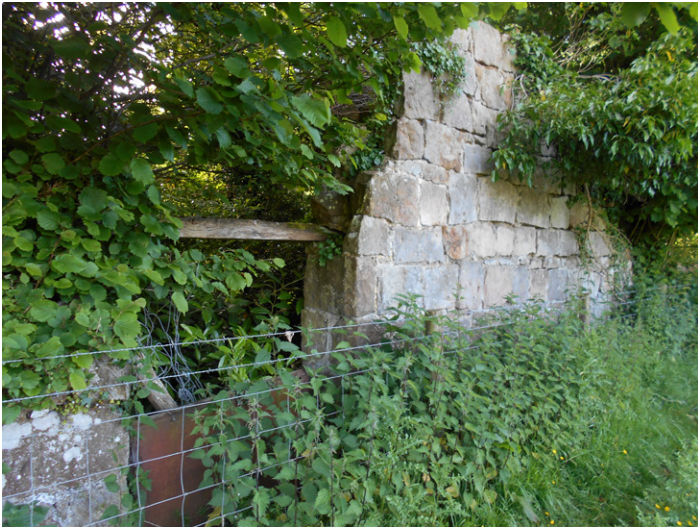
surviving. A doorway with a timber lintel was also present along this elevation (Plate 5). A building to the west survives and was being used as a cow shed.

Plate 5: The remains of Llanforda-isaf Farmstead

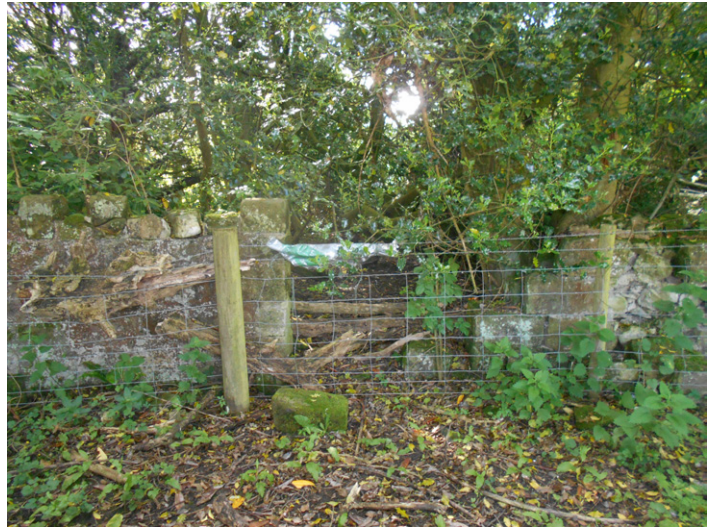
The boundary walls surround the farmstead and access path, now part of a public footpath survive to varying degrees of preservation. The north-west end survives the best to a height of 1.1m, and along the footpath, the remains of capping stones still survive (Plate 6). The walls do not survive the full length of the access path which is made up of pebbles and brick, overgrown with vegetation.

Plate 6: The remains of the south-east wall along the public footpath of Llanforda-isaf access track

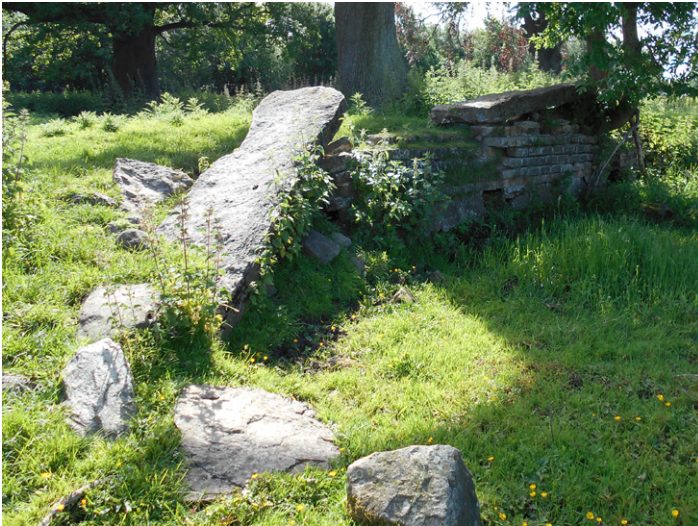
The pond to the south (Site 2) was much drier, but was still fed by a culvert from the west. It was dammed in the east by a stone wall (Plate 7), overlain with five brick courses in English bond. The brick part of the wall was 7.5m long north to south and 0.7m wide, capped with two large stone slabs, each 2.5m long, with holes carved into the western edge (Plate 8), possibly for railings. The slabs had been disturbed by vegetation, and the underlying stone courses extended north for another 2.5m. The visible depth of the wall was 1.3m, and it may have been a dam, revetment or a way of controlling water flow from the pond.

Plate 7: Stone structure at east of the southern pond (Site 2)

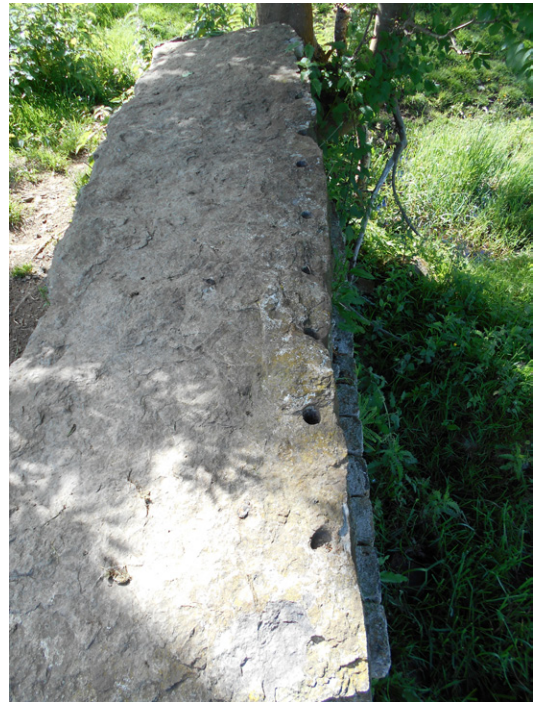
Plate 8: Capping stones
