**Old Military Road, Rest and Be Thankful  
Diversion Route:  
Cultural Heritage Assessment**

**Report No. 2115**

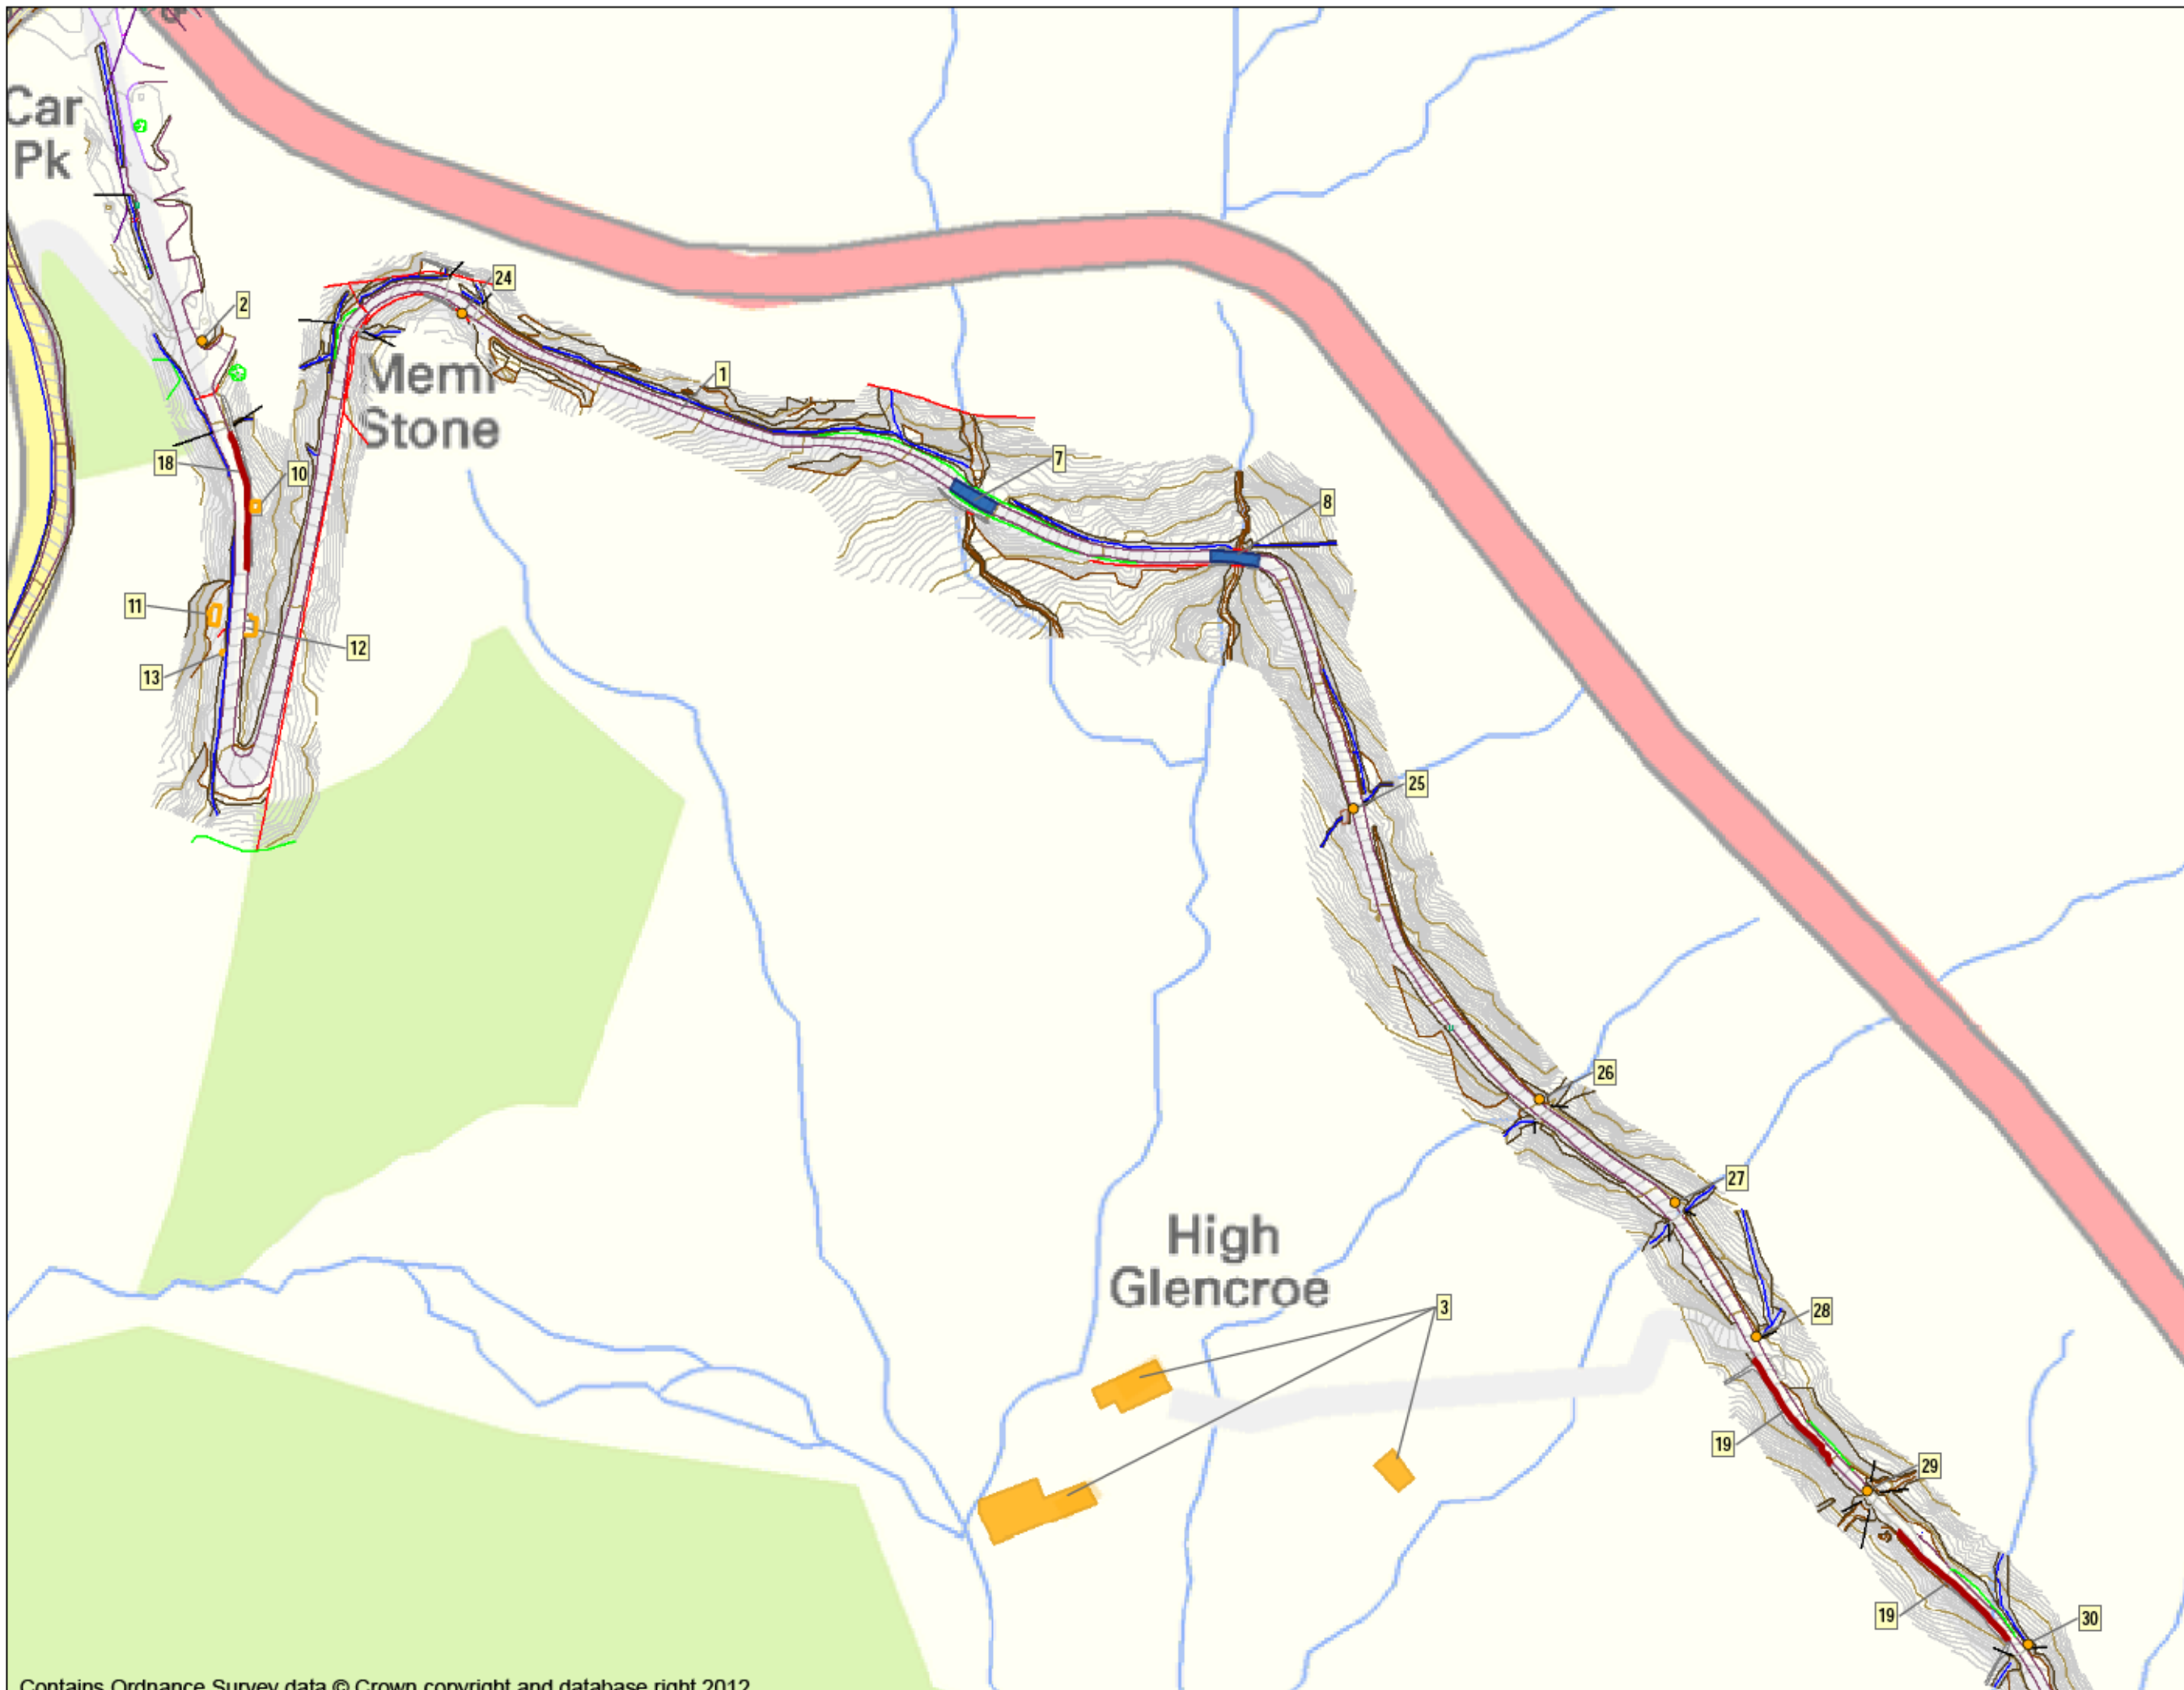
Fig. No	1	Revision	
---------	---	----------	--

This section details features of cultural heritage interest within the study area, all of which are depicted on Figure 1 and described in Appendix 1.
