## **Fernhill Service Reservoir to Dyce Drive Water Pipeline, Aberdeen**

### **Archaeological Watching Brief**

**Report No. 3177**

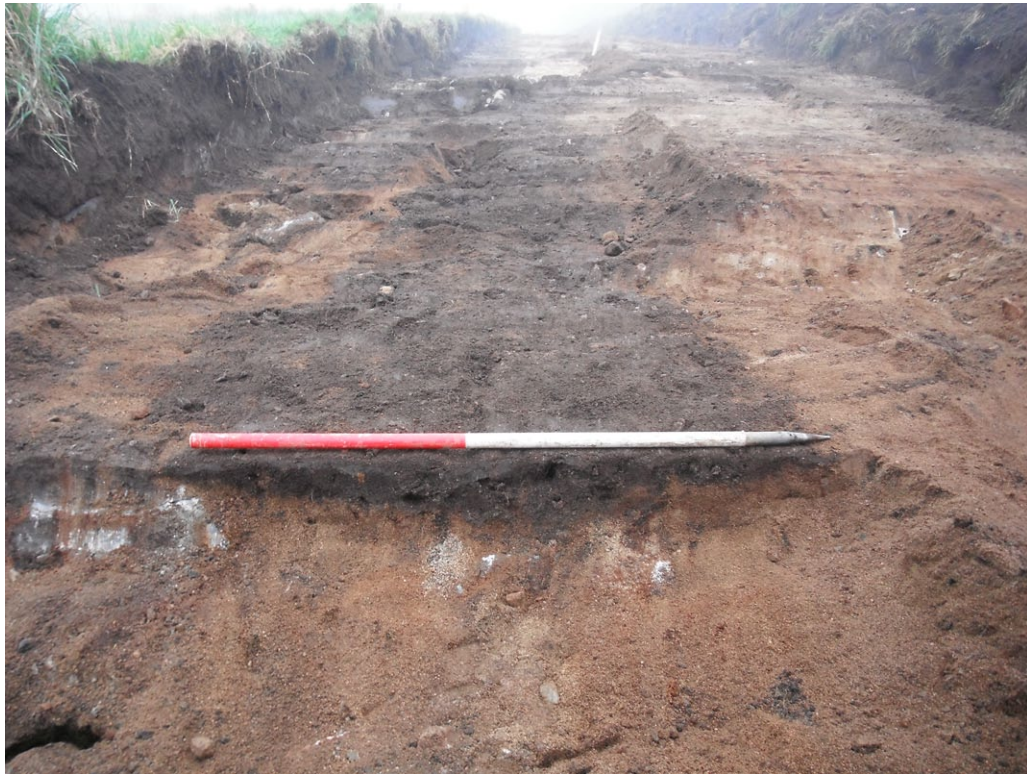
Two features were uncovered within this section. A north to south aligned linear feature [**012**] (Fig. 6) was interpreted to be an old hedge line due to the irregular edges of the cut and alignment with existing hedge lines also running in the same direction. A possible enclosure ditch cut [**014**] (Fig. 7) was uncovered in the same section, approximately 0.5m wide. The ditch ran north from the trench edge for approximately 4.5m before turning almost due west and running back into the trench edge. Due to the fill of the ditch (**015**) being the same as topsoil (**001**), the feature was interpreted to be relatively modern; potentially a backfilled drainage ditch. Vestigial traces of cultivation rig-and-furrow were also uncovered with a 5m wavelength and 1.5m wide furrows aligned north-west to south-east.

*Fig. 6 - Photograph of north facing section through linear ditch 012*

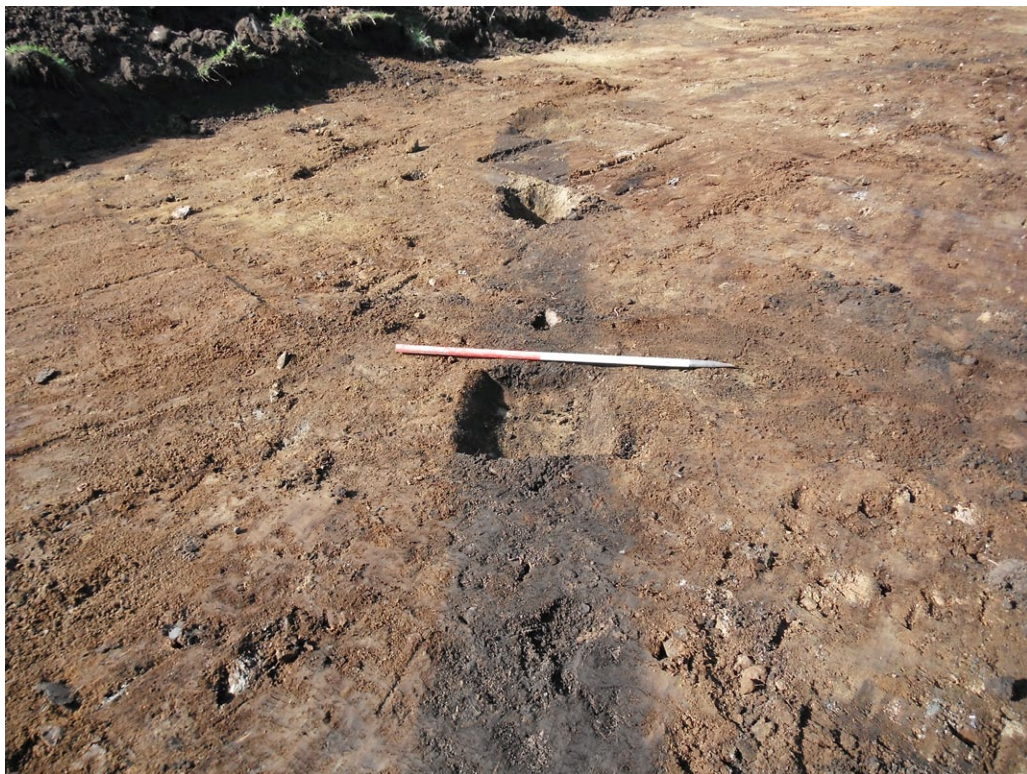
*Fig. 7 - Photograph of east-facing section through enclosure/drainage ditch 014*

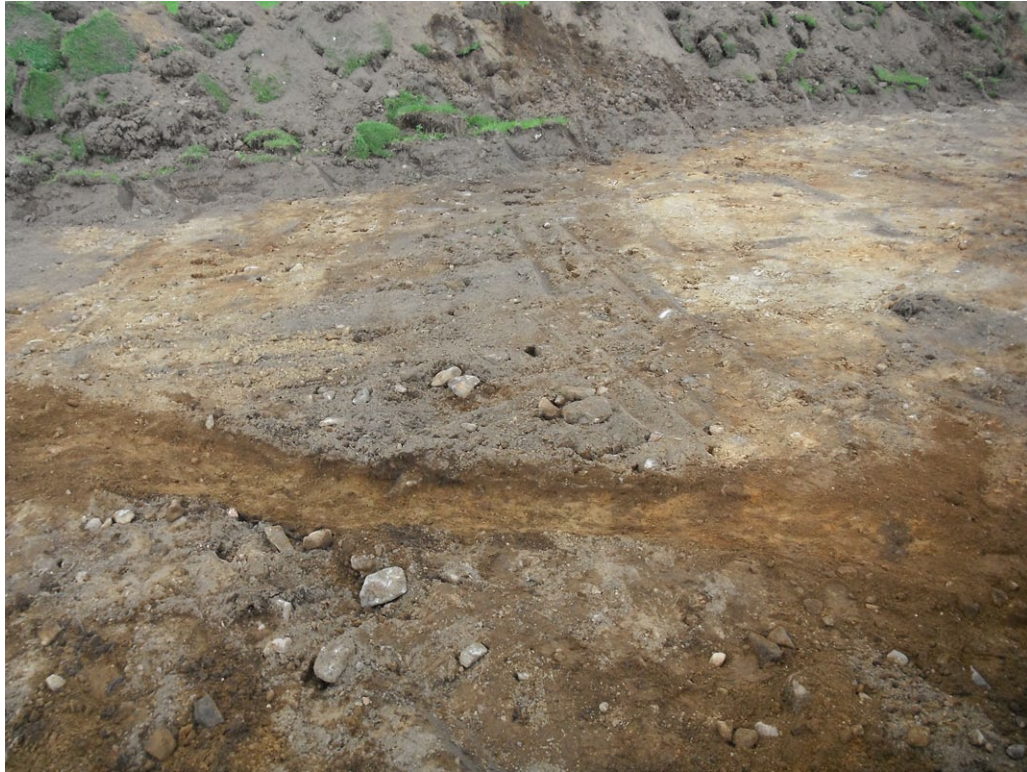
Further north, the next section of the route under archaeological supervision ran from Kepplehills Road (NGR: NJ 8845 0937) to a field boundary directly south of a cul-de-sac on Cloverfield Place (NGR: NJ 8837 0964) (Fig. 4). A single linear feature [**016**] (Fig. 8) with irregular base and sides, 2.2m wide and 0.18m deep, was uncovered in this section, with a north-west to south-east alignment. The feature was interpreted to be a field boundary or a hedge line due to the irregularly shaped sides, existing analogous features and fill (**017**) which was again the same as topsoil (**001**), within which one piece of Victorian pottery was recovered.

*Fig. 8 - Photograph of south-facing section through possible field boundary ditch 016*

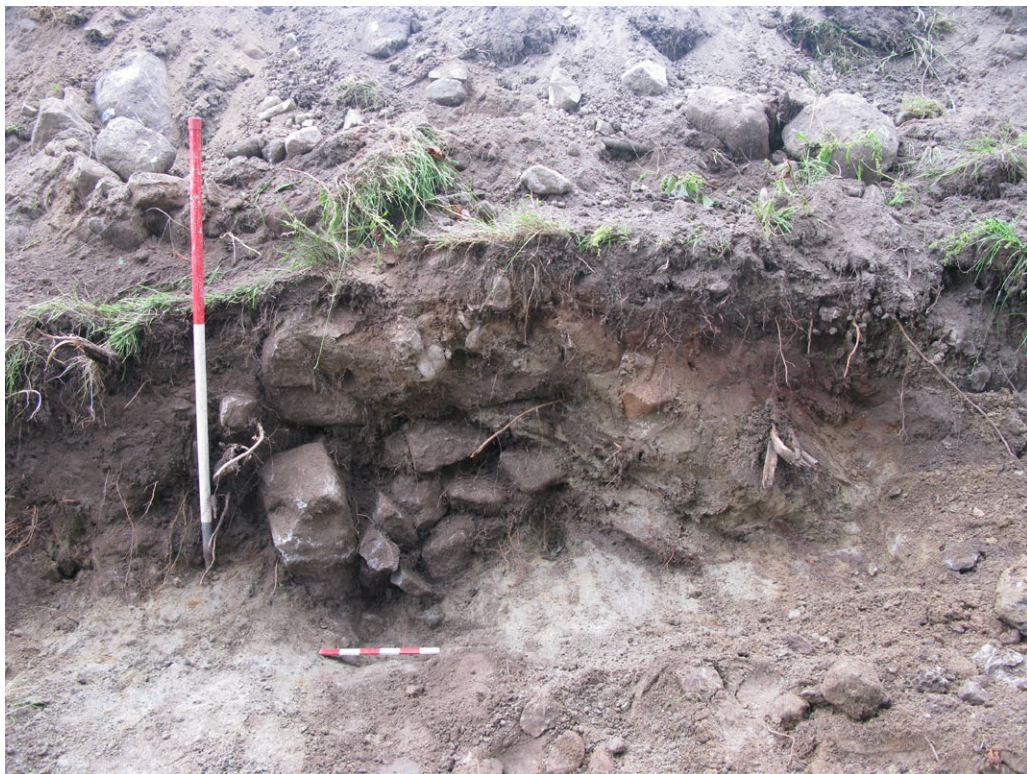
The sole archaeological feature to be uncovered in this section was a ha-ha wall/bank feature (Fig. 9). This feature consisted of a shallow foundation ditch cut **[011]** (Fig. 10) filled with an inner packing core of mid brown stony sand **(009)**, with large stones **(008)** on the outer face to solidify the construction. On top of this natural substrate was re-deposited **(010)** to form the uphill bank of the ha-ha wall. This is probably part of the plantation bank visible on the First Edition Ordnance Survey map of 1869.

*Fig. 9 - Photograph of SW facing section of ha-ha wall/bank 011*

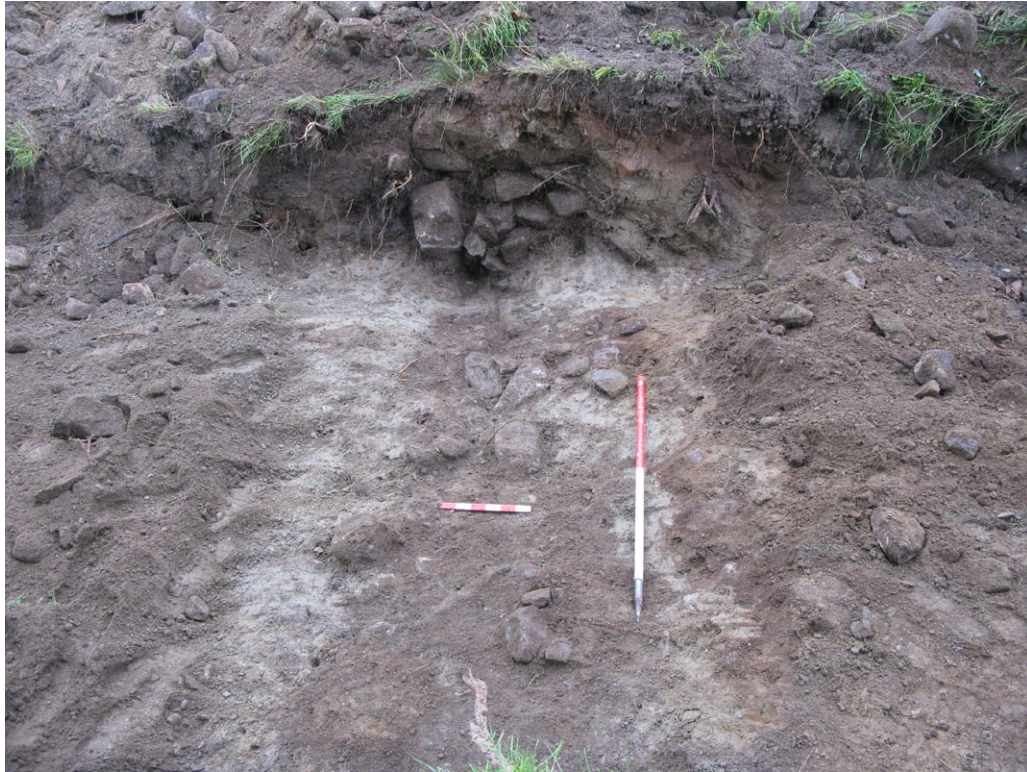
*Fig. 10 - Plan photograph of ha-ha wall/bank foundation cut 011*
