**Borders Railway Project
Garage to the rear of
19-21 Murderdean Road,
Newtongrange, Midlothian**

**Basic Historic Building Survey
Report No. 3201**

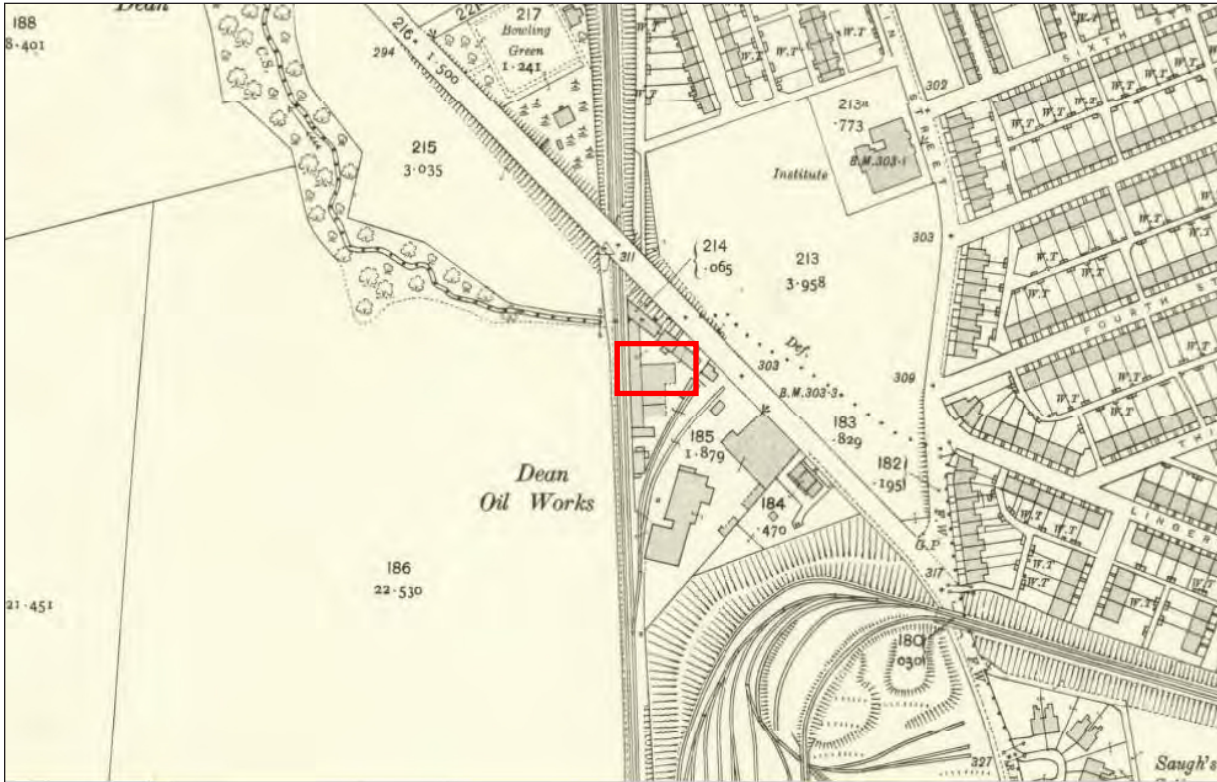
Fig. 2a - 1913 Ordnance Survey map

The 1913 Ordnance Survey map (Fig 2a) shows a collection of buildings on the east side of the railway line, one of which is linear with two buildings attached forming a crude t-arrangement.

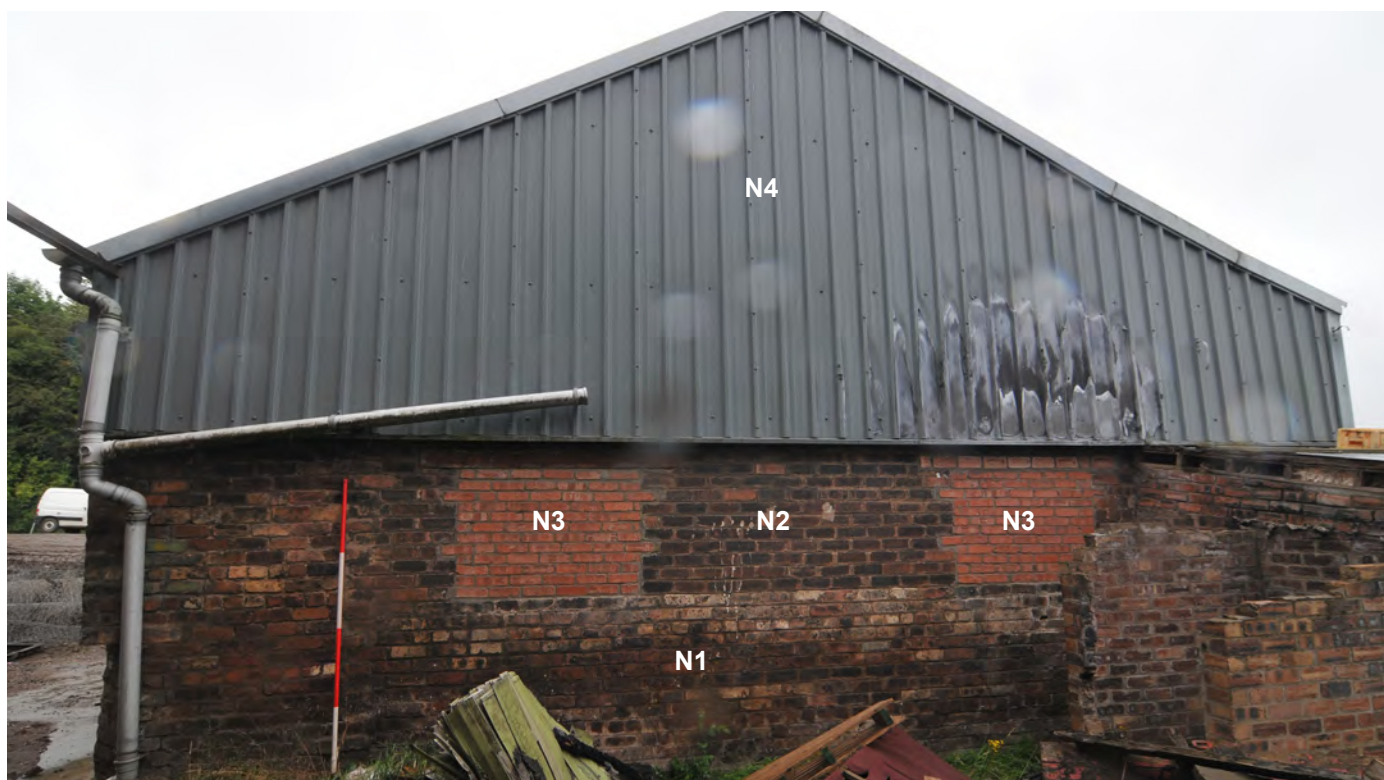
Fig, 4a - North-facing Elevation

Elevation	Feature No	Descriptive summary
North-facing (gable)	N1	Main brick build, English garden wall (EGW) bond (6:1).
	N2	Mid section of wall in stretcher bonded brick
	N3	Blocked windows either side of N2. Modern brick laid in stretcher bond.
	N4	Steel corrugated sheet cladding and ridge plate.
East-facing (side wall)	E1	Main build with dark red brick in stretcher bond, c. 1m wide. Distinct vertical joint between E1 and E2.
	E2	Wall insertion built of brick laid in EGW (5:1) infilling a large opening.
	E3	Modern steel roller shutter door with red-painted timber lintel.
	E4	Steel sheet roof with four plastic roof lights.
	E5	Brick-built lean-to laid in stretcher bond.
	E6	Double-leafed green-painted plank built door surmounted by a concrete lintel.
	E7	Single green-painted plank-built door surmounted by a concrete lintel.
	E8	Brick-built chimney stack with single terra-cotta chimney pot.
South-facing (gable)	E9	Square blocked opening on the right hand side of the roller shutter door (E3).

The north-facing gable has evidence of two blocked windows (N3) surrounded by contrasting courses of brickwork (N1 and N2). The blocking work appears to have occurred when the roof was clad with metal sheeting.

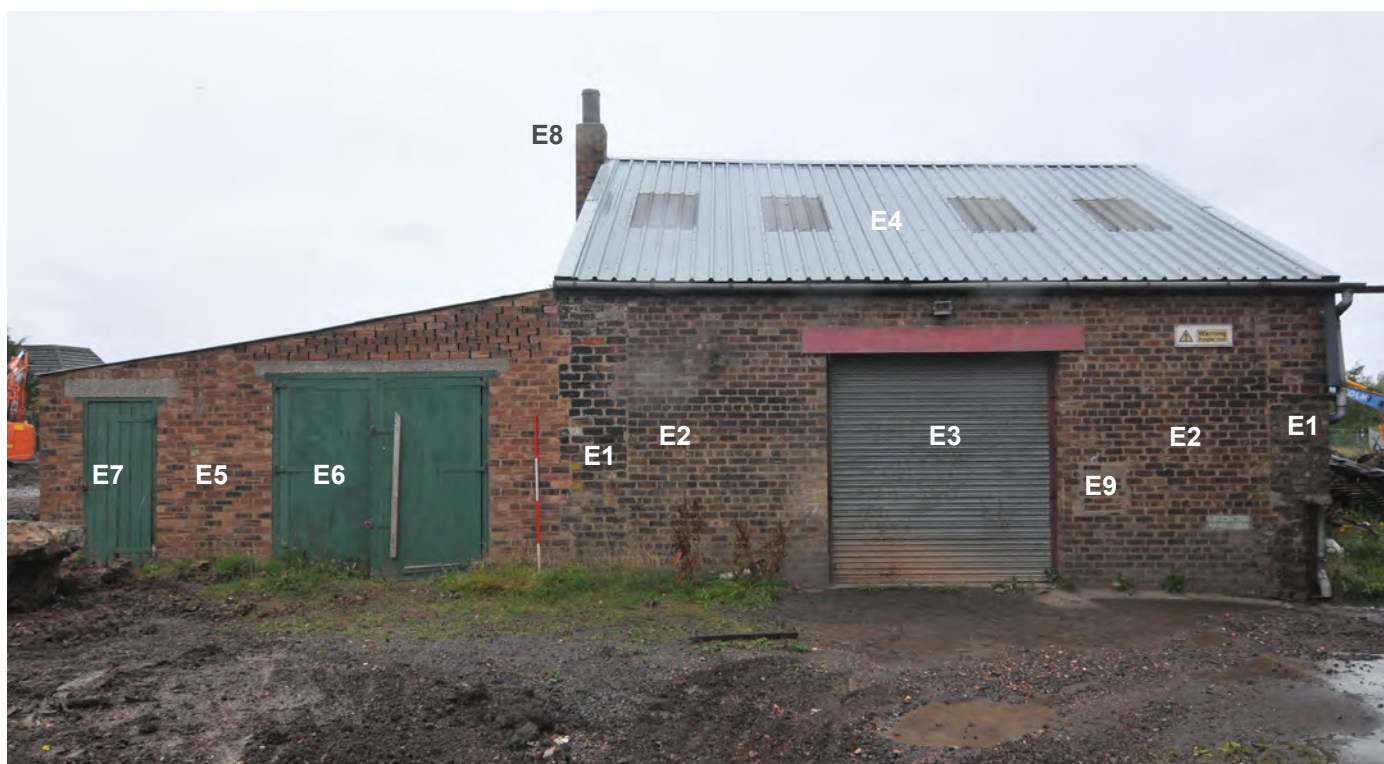
Fig, 4b - East-facing Elevation

The east-elevation has only one section of the original build surviving (**E1**); the rest is associated with the installation of the large bay-opening with a later roller shutter door (**E2** and **E3**) that blocked a larger opening. The later lean-to brickwork (**E5**) was keyed into the original (**E1**) brickwork.

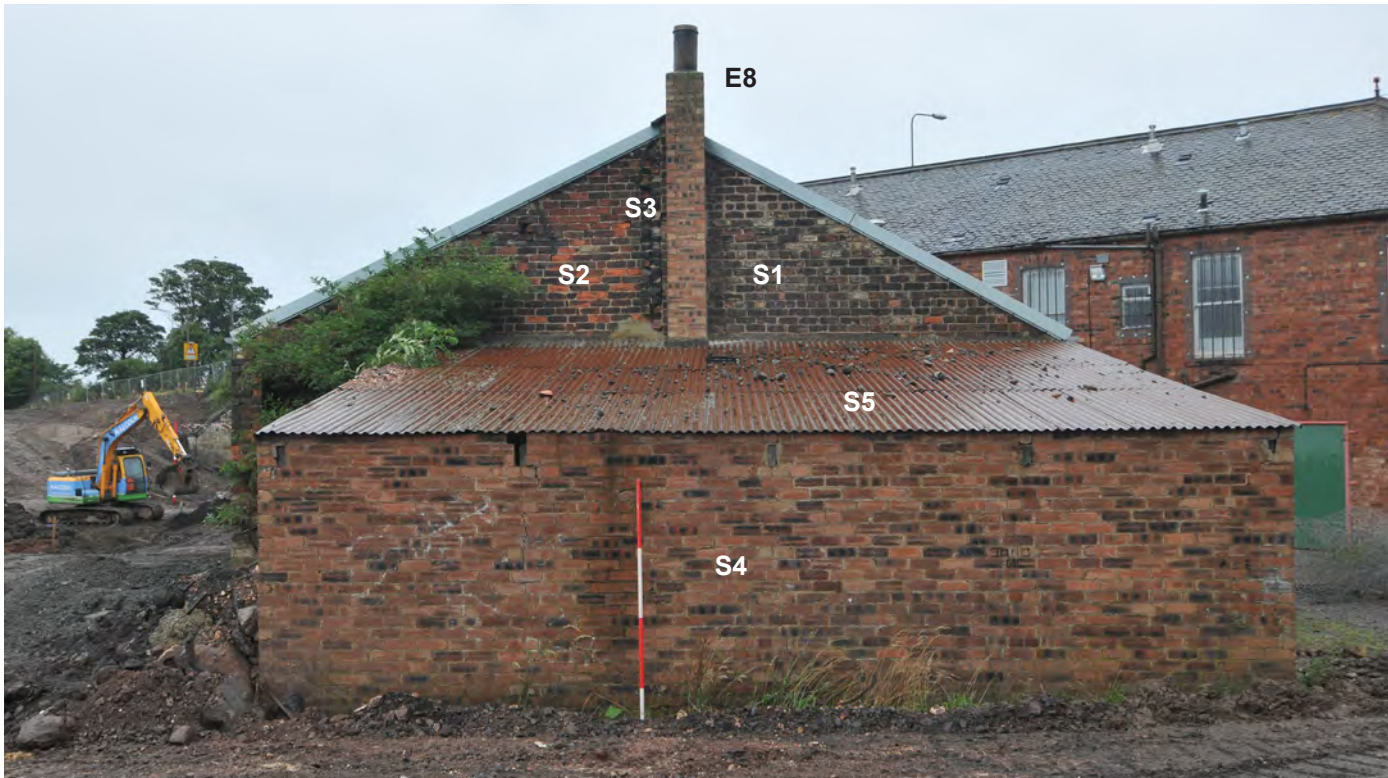
Fig, 4c - South-facing Elevation

S1	Gable wall (east side) built in EGW bond (5:1)
	S2	Gable wall (west side) built with variable courses of stretchers and headers.
	S3	Brick-built return wall stub projecting of the gable wall, two bricks wide.
	S4	Main build of the brick-built lean-to in stretcher bond.
West-facing (side wall)	S5	Red-painted corrugated iron roof.
	W1	Main brick-build laid in EGW bond (5:1).
	W2	Two blocked windows, blocked with stretcher bonded brickwork. Original timber lintels present.
	W3	Large section of blocking work incorporating two types of modern brick. Lower c.2m section is ribbed brick whilst upper is smooth.

The cartographic evidence shows that the garage was originally part of a much larger complex of industrial buildings. The return wall stub (**S3**) present on the south gable shows that the core block was part of a much larger building. This was demolished to leave a single rectangular block.

The south gable originally had three ground floor windows that were made redundant when a two-unit lean-to (**S4**) with a corrugated iron-roof was added. Contemporary with the lean-to was a chimney stack (**E8**) at the centre of the gable on the main core block.

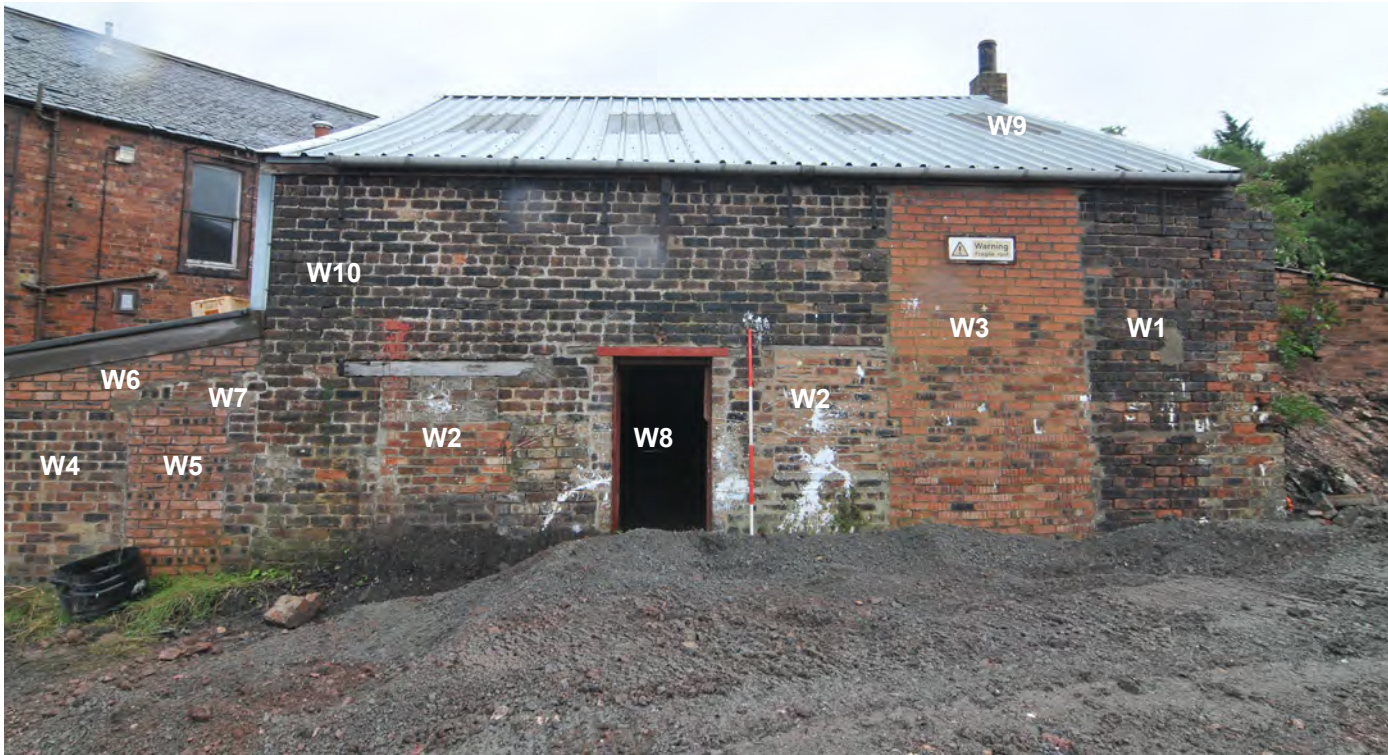
Fig, 4d - West-facing Elevation

Both sections of blocking work are laid in stretcher bond.
	W4	Main wall of small lean-to toilet block built with stretcher-bonded brick.
	W5	Blocked up doorway
	W6	Wall heightening using c.9 courses of the same brick used to block the doorway (W5)
	W7	Possible earlier roofline contemporary with the main build (W4).
	W8	Timber door frame and modern panelled door.
	W9	Steel clad roof with four roof lights (same as E4).

The windows (**W2**) and doorframe (**W8**) on the west elevation were later inserts. The toilet block on the north gable was also a later addition that appears to be represented by two phases, the first being a smaller structure that was enlarged by wall heightening (**W6**). A later door was blocked (**W5**). The large area of contrasting brickwork (**W3**) that extends up to eaves level may have been a large ground floor opening and mezzanine level window that were both blocked at the same time.

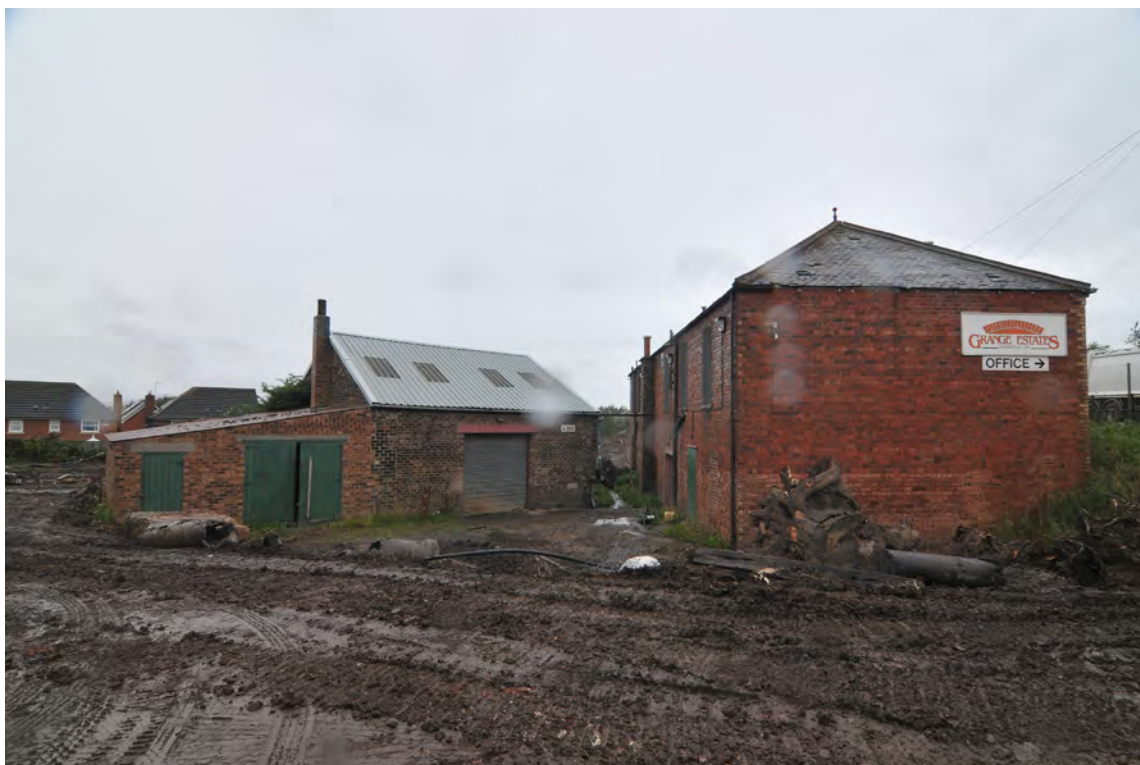
On the north-east side of the garage and fronting Murderdean Road is a row of C-Listed former manager's offices associated with the Dean Oil Works (Plate 1). The garage was a detached single storey brick-built structure with a large central bay opening on its south-facing elevation. A later brick-built lean-to had been added to its north and south-facing gable (Plates 1 & 2). The pitched roof was steel clad and incorporated four roof lights on each side.

Plate 1 - General view of the garage in relation to the former Dean Oil Works managers offices

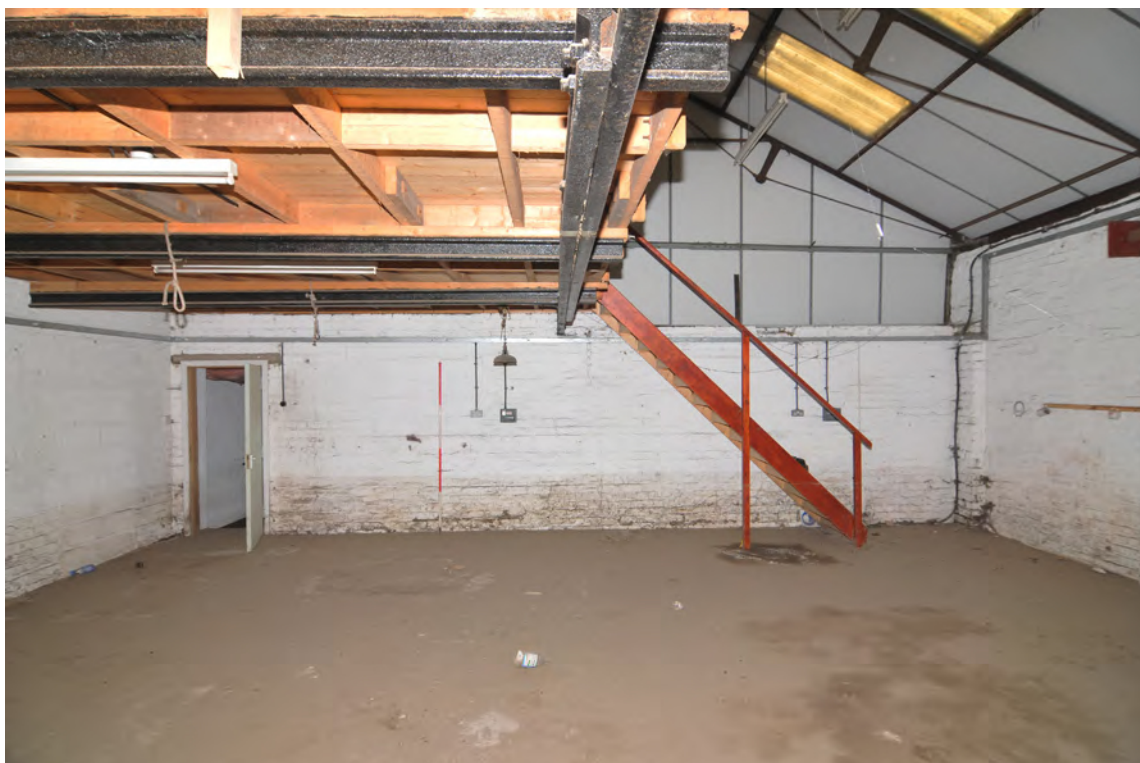
The interior south-facing elevation wall stood to a height of 2.10m and was whitewashed brick. The apex of the gable was clad with aluminium sheet panels set within a steel stud frame. A plain panelled door led off to a small toilet block in the north-west corner.

Plate 3 - Interior south-facing elevation showing the stairs to the mezzanine and railway lines that supported it

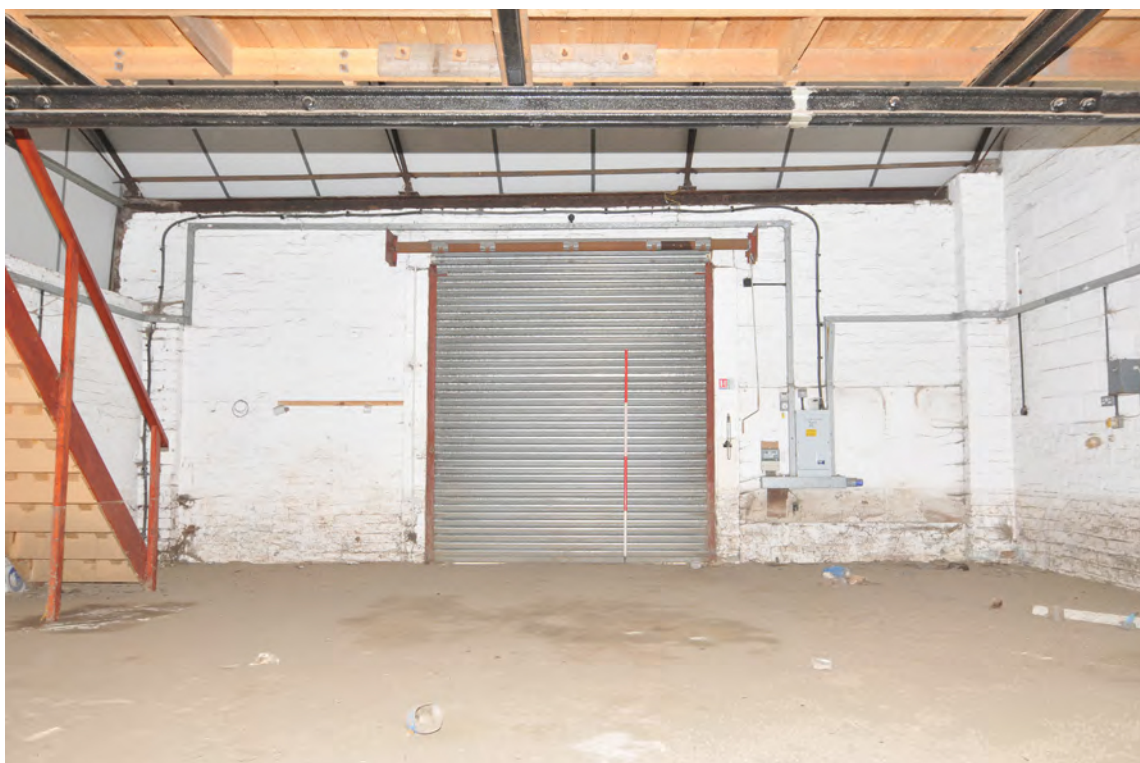
The interior west-facing side wall was whitewashed brick and contained the central roller-shutter door. A wrought-iron wall plate supporting the roof ran the length of the elevation. The walls flanking the doorway were buttressed.

Plate 4 - Interior west-facing elevation and the large roller doorway

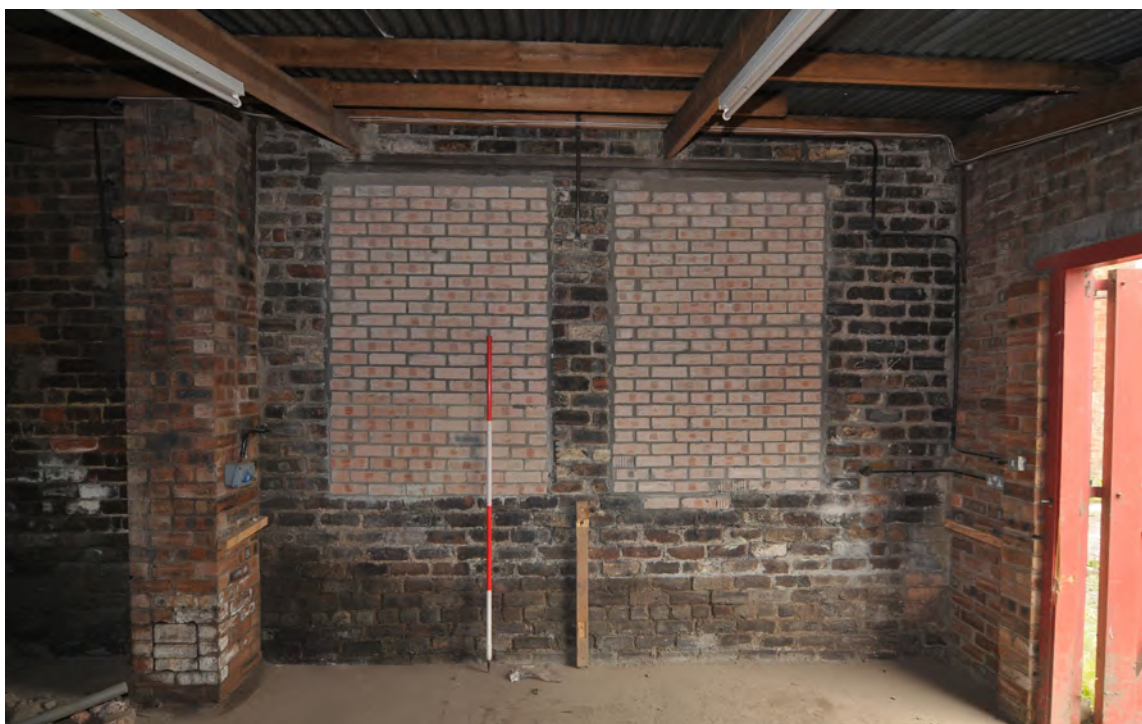
The walls within the interior of Unit 2 were uniform brick and featureless with the exception of the south-facing elevation which formed the lower gable of the main core block (Unit 1). Two bricked-up windows were visible (Plate 5). A third window on the west side of the wall was blocked by breeze blocks. A wall stub visible on the outside of the gable was visible down to ground level. A chimney abutting the main gable wall has a small blocked opening at its base suggesting that it once vented a small stove. The east-facing elevation had partially collapsed.

Plate 5 - Blocked windows on the gable seen within Unit 2

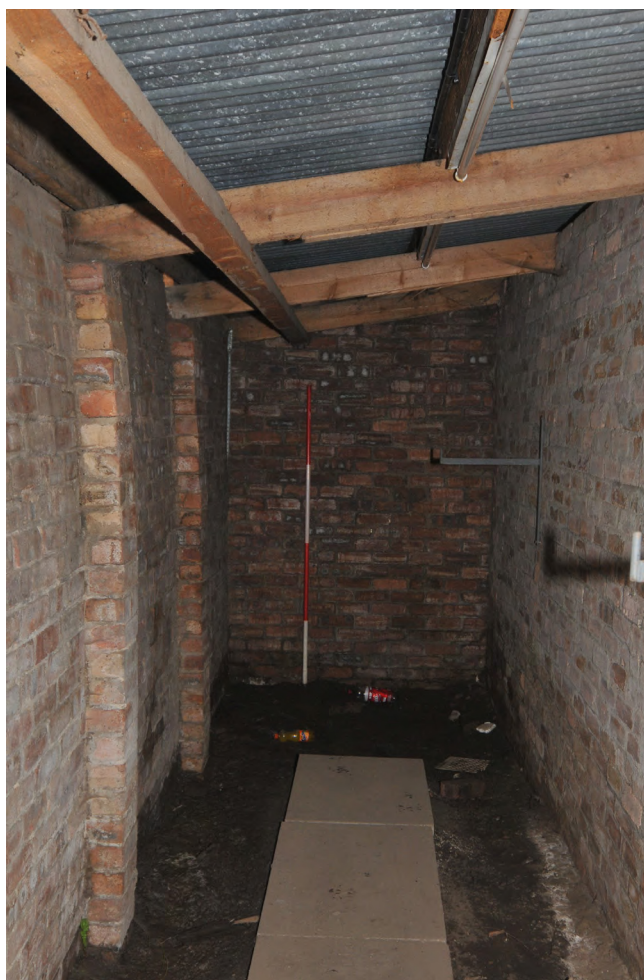
Unit 3 was a narrow room with brick-built buttressed walls (Plate 6). Access was via a door on the east-facing elevation. The unit had last been used as a store judging by the presence of shelving brackets on the north-facing wall.

Plate 6 - Interior view of Unit 3
