## **The Old Garage, Bowness on Solway, Cumbria Archaeological Evaluation**

**Data Structure Report  
No. 1969**

Author	Stuart Mitchell MA AIfA and Magnus Kirby MA FSA Scot AIfA
Illustrator	Tamlin Barton MA
Editor	Melanie Johnson MA PhD MIfA FSA Scot
Commissioned by	Mr Peter Anderson
Date issued	September 2014
Version	0
OASIS Reference	cfaarcha1-189353
Planning Application No	09/0617
Grid Ref	NY 22400 62735

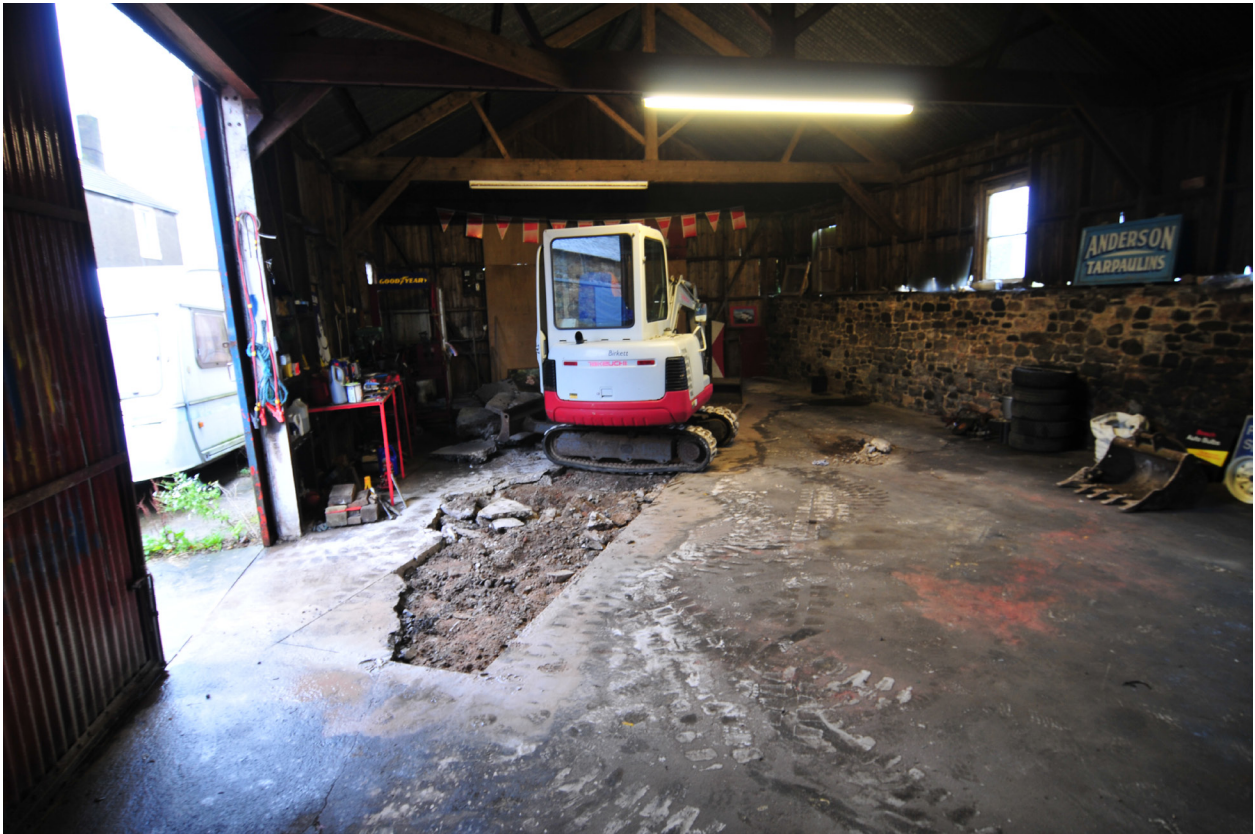
Fig. 2 - Interior of garage pre-excitation

The terms of the brief required the excavation of two trenches totalling 15<sup>2</sup>m. However, plans to extend the development into the adjoining field had to be shelved and consequently the investigation was limited to the garage site itself. As a result, a single trench measuring 9m by 1.3m (11.7m<sup>2</sup>) was excavated within the interior of the garage (Fig. 2).

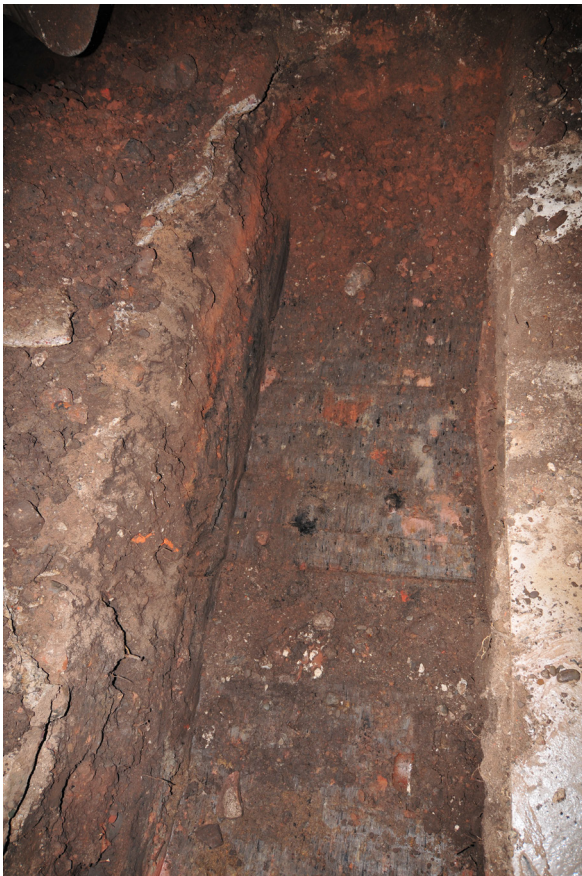
Fig. 3 - SE end of trench excavated to fullest extent

A single trench measuring 9m by 1.3m was excavated through the floor of the garage. A lack of space within the garage prevented excavation of the entire trench in a single excavation so approximately two-thirds of the trench, beginning at the SE end, was excavated (Fig. 3) then backfilled, following which approximately two-thirds starting

The SE end of the trench contained what was assumed to be a live waste water pipe at a depth of 0.7m, which prevented full excavation of the trench. Archaeological deposits were encountered at the NW end of the trench; however, their depth and the unstable nature of the trench sides prevented access for manual excavation. The deposits were carefully reduced down to natural using the machine. Due to space within the garage and the presence of the concrete floor it was not possible to extend the trench to pursue the deposits and realise their full extents.

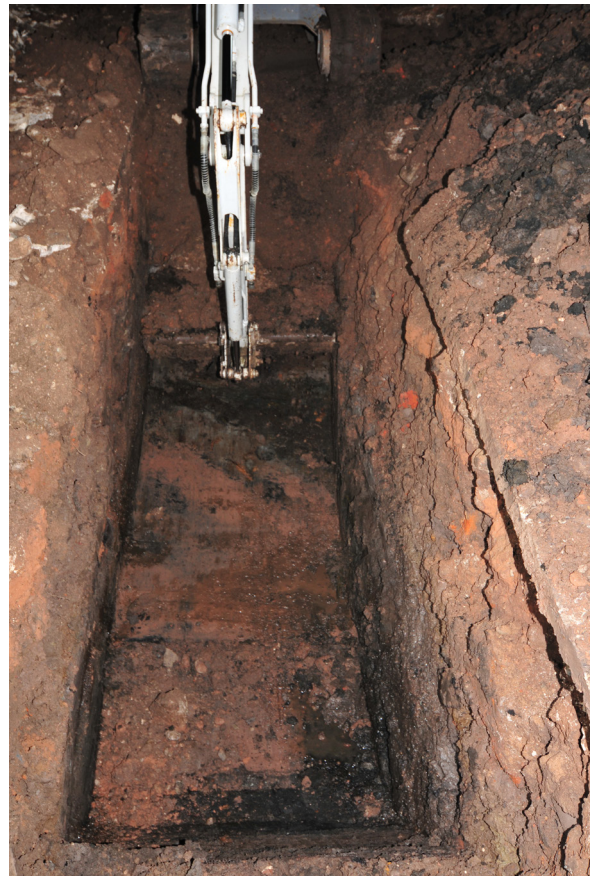
Fig. 4 - NW end of trench excavated to fullest extent

at the NW end was excavated (Fig. 4) then backfilled, ensuring a significant overlap to give an uninterrupted view of trench.
