**66 Buccleuch Street,
Edinburgh Odeon Cinema Fly Tower,
Historic Building Survey**

Report No 3225

Authors	Michael Cressey HND BA MSc PhD MifA FSA (Scot)
Illustrator	Graeme Carruthers MA MifA
Editor	Tim Neighbour BSc MifA
Commissioned by	Cruden Homes (East) Ltd
Date issued	November 2014
Version	0
Grid Ref	NT 2612 7279
Oasis Ref No	cfaarcha1-192615

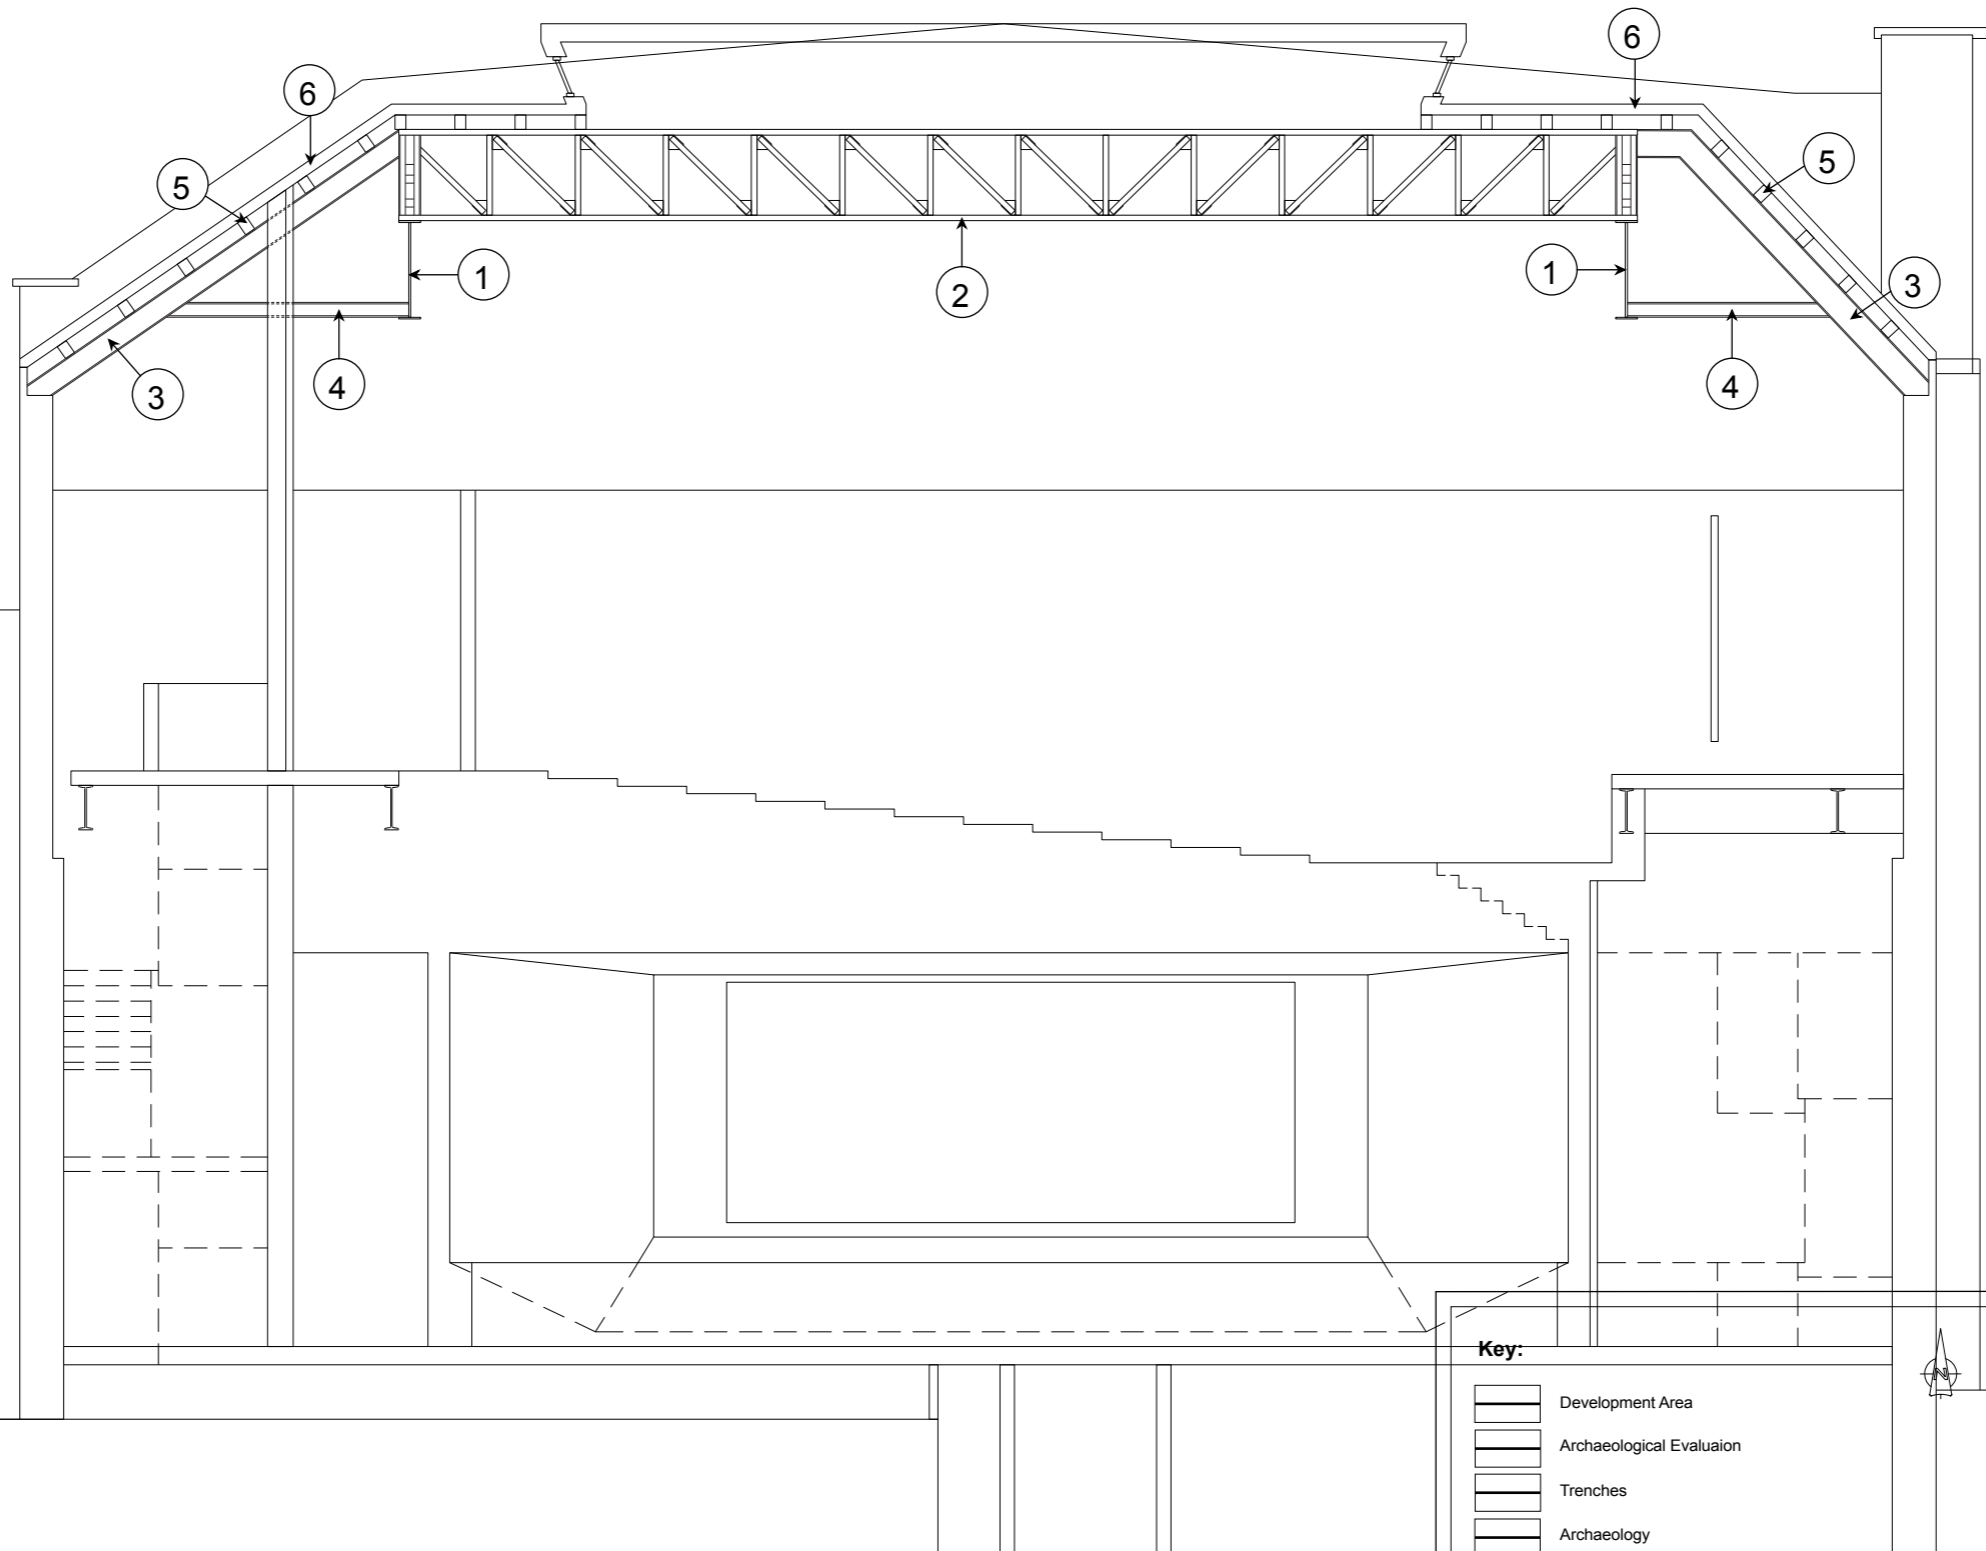
Fig. No: **2** Report No: **322A**

The fly tower roof had seven main structural components, as described in Table 1 and labelled on Fig 2.

Component No.	Description
1	Two main supporting Pratt trusses formed by two beams held together with riveted plates. A central post-arrangement is flanked by angled supports typical of Pratt trusses.
2	Two transverse Pratt trusses. Each comprises two I-beams held together with riveted plates forming a lattice construction.
3	Jack-trusses extending off the ends of the main transverse Pratt trusses.
4	I-beam brace supporting the Jack trusses
5	Timber purlins supported on angle cleats bolted on to the Jack-trusses
6	Timber sarking boards of the Mansard roof (removed)
7	Attic timber floor partially removed

Title:
Architects drawing of part of the roof with annotations

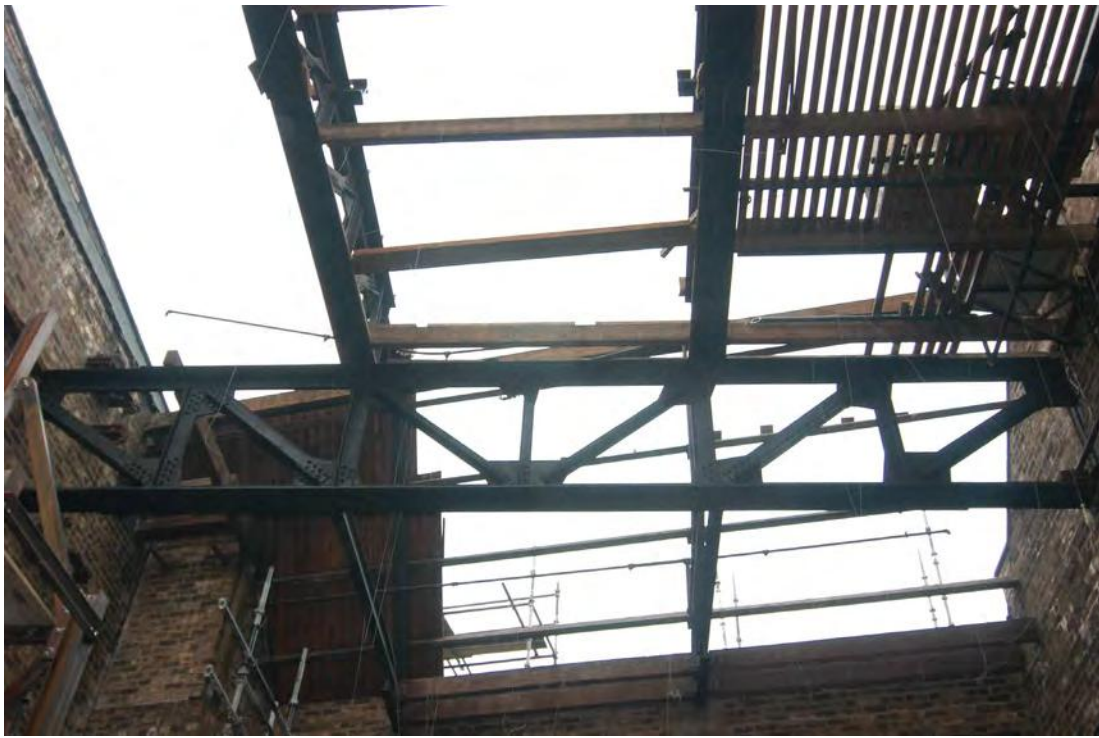
All the steelwork is presumed to be New British Standard Beams (NBSB) of the 1921 standards for this type of building (Gilbert 1930). The steelwork was designed so that the whole weight of the roof covering was carried on two main load-bearing supporting Pratt trusses situated on each side of the fly tower (Plate 1). These lateral beams (Plate 2) supported the timber attic floor. The attic housed an arrangement of sprinkler pipes and a water tank. The roof was designed with cross-braced jack-trusses (Plate 3-4) at the margins to form the low pitched Mansard slopes of the main roof. Two of the jack-trusses had numbers painted on them, which probably related to setting out when the roof was first fabricated (Peter Elliot, Heritage Engineer pers. comm.). The Mansard steelwork in turn supported the timber purlins onto which the roof sarking boards were nailed (Plate 5)

Plate 1: One of two main supporting Pratt trusses showing its rivet and lattice construction (004)

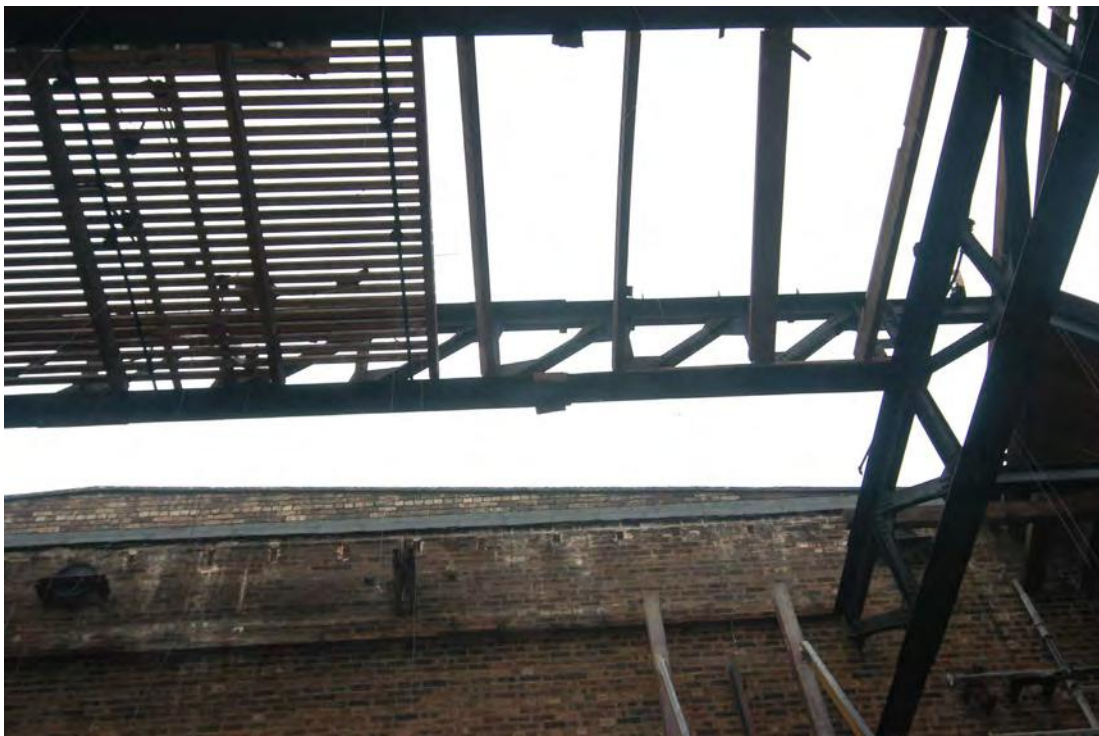
Plate 2: One of two lateral trusses carried on the main Pratt support beams (005)

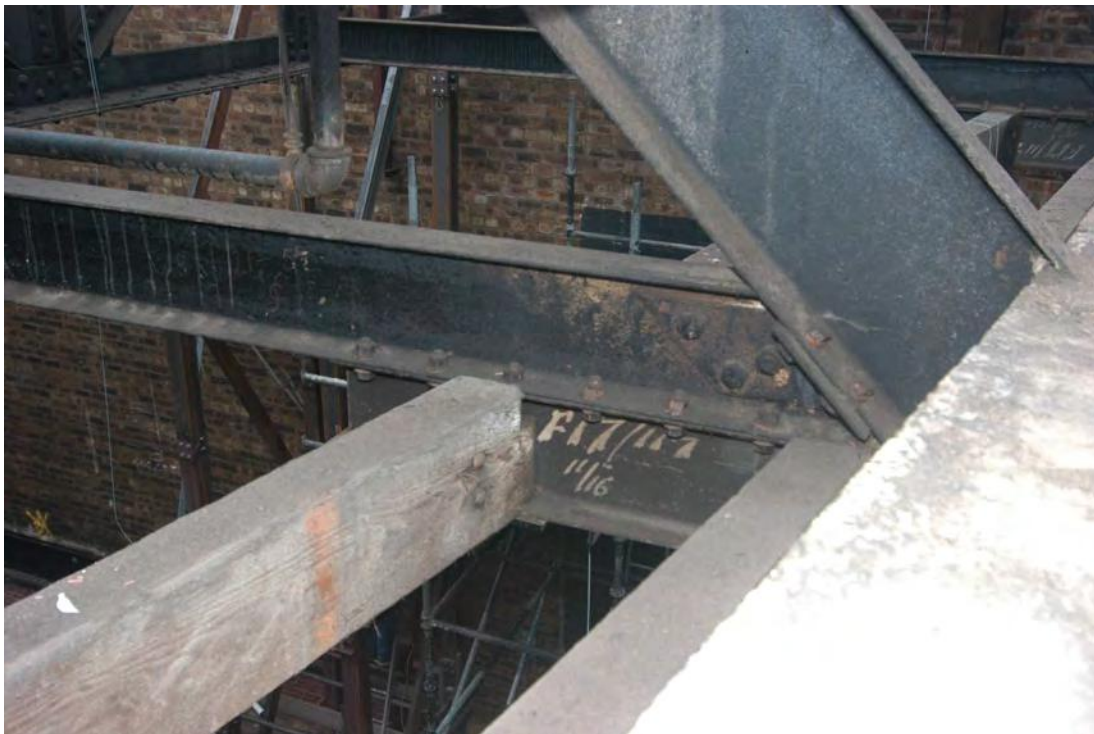
Plate 3: Cross-brace steelwork with setting out numbers and mansard jack beams (030)

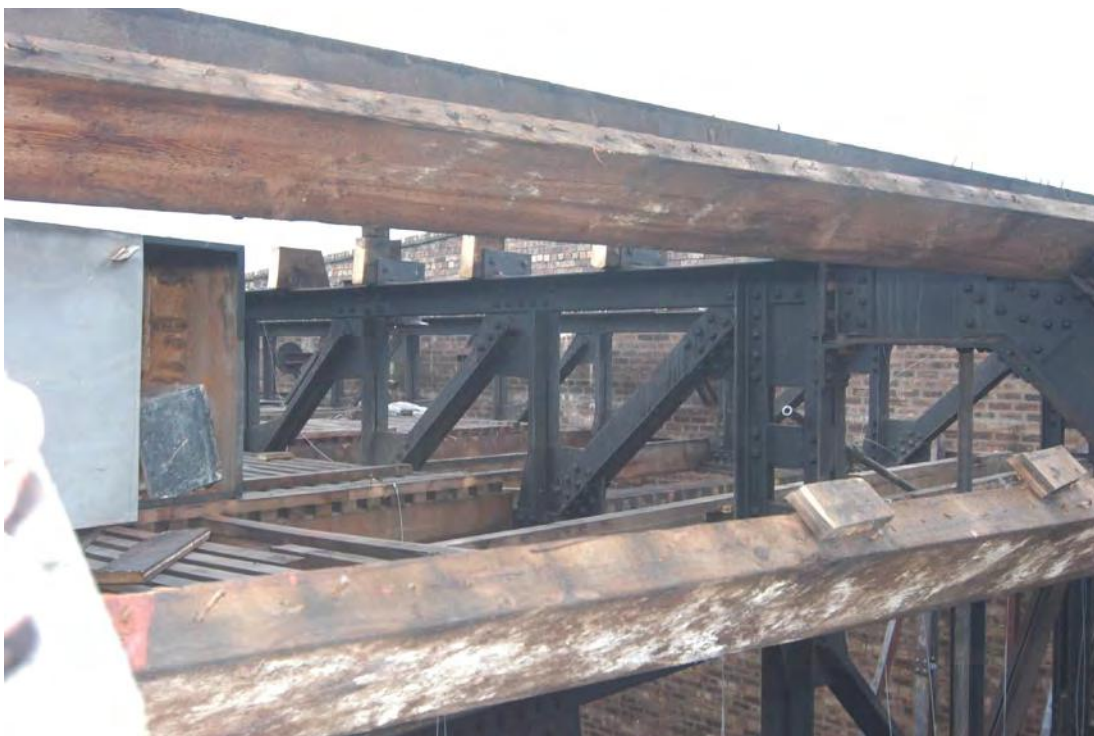
Plate 4: The transverse jack-trusses and part of the attic floor (032)

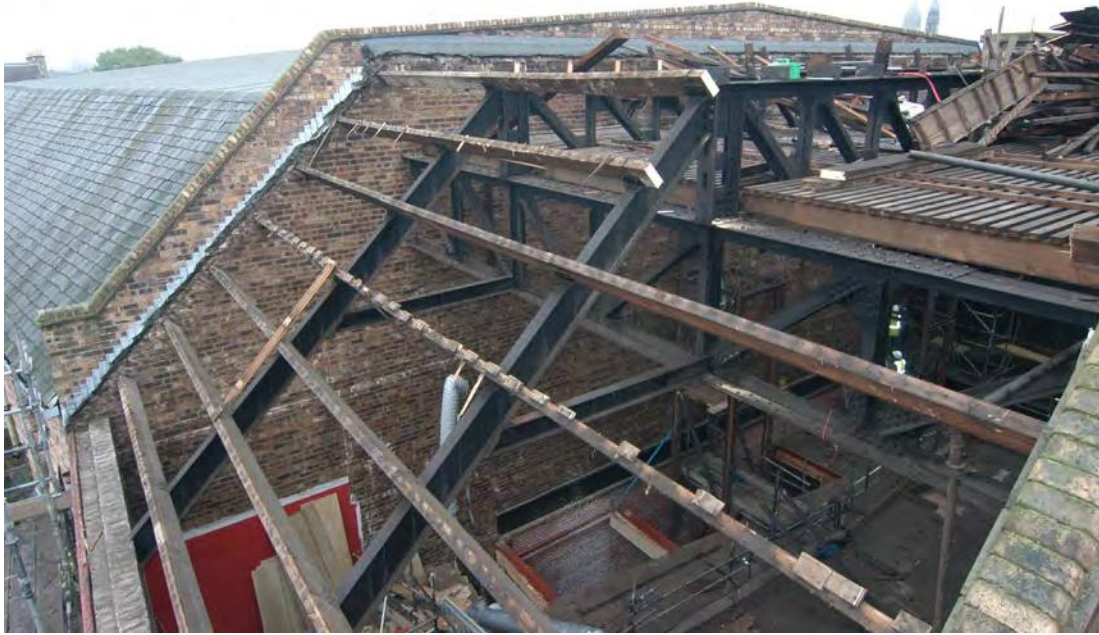
Plate 5: The mansard jack-trusses supporting the timber purlins, the attic floor can also be seen (035)

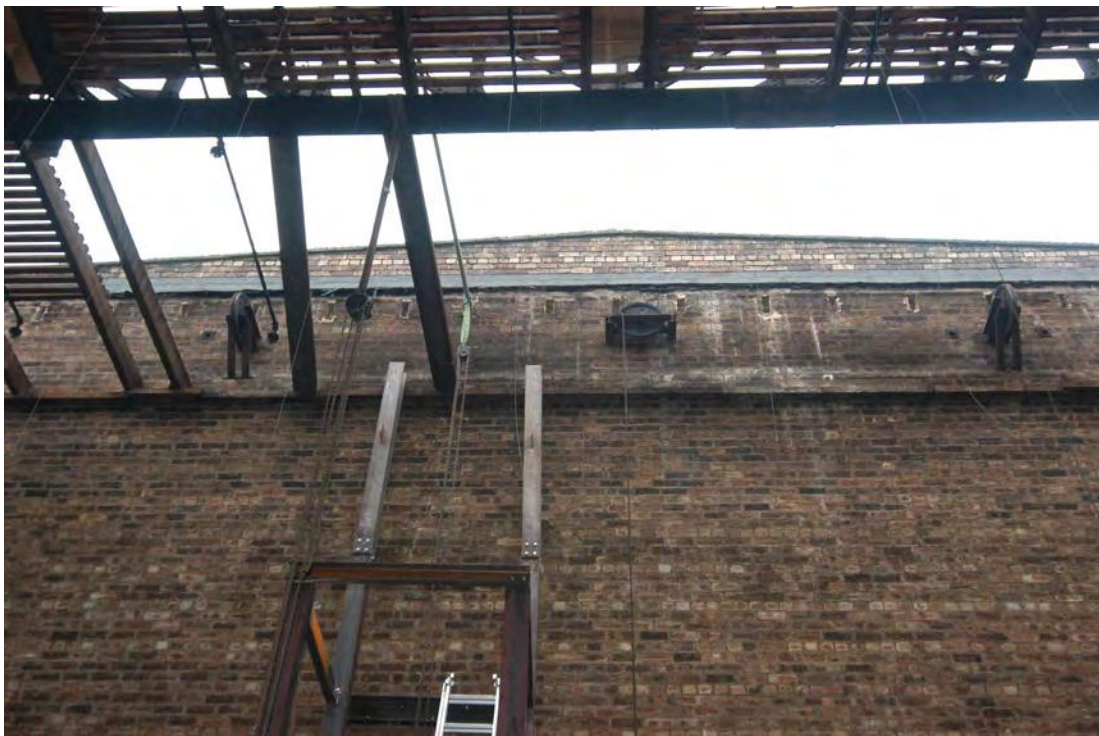
On the interior west-facing elevation three pulley wheels were present (Plate 6). These were installed to raise and lower the 1930s auditorium curtain.

Plate 6: Three pulley wheels that lifted the 1930s auditorium curtain (016)

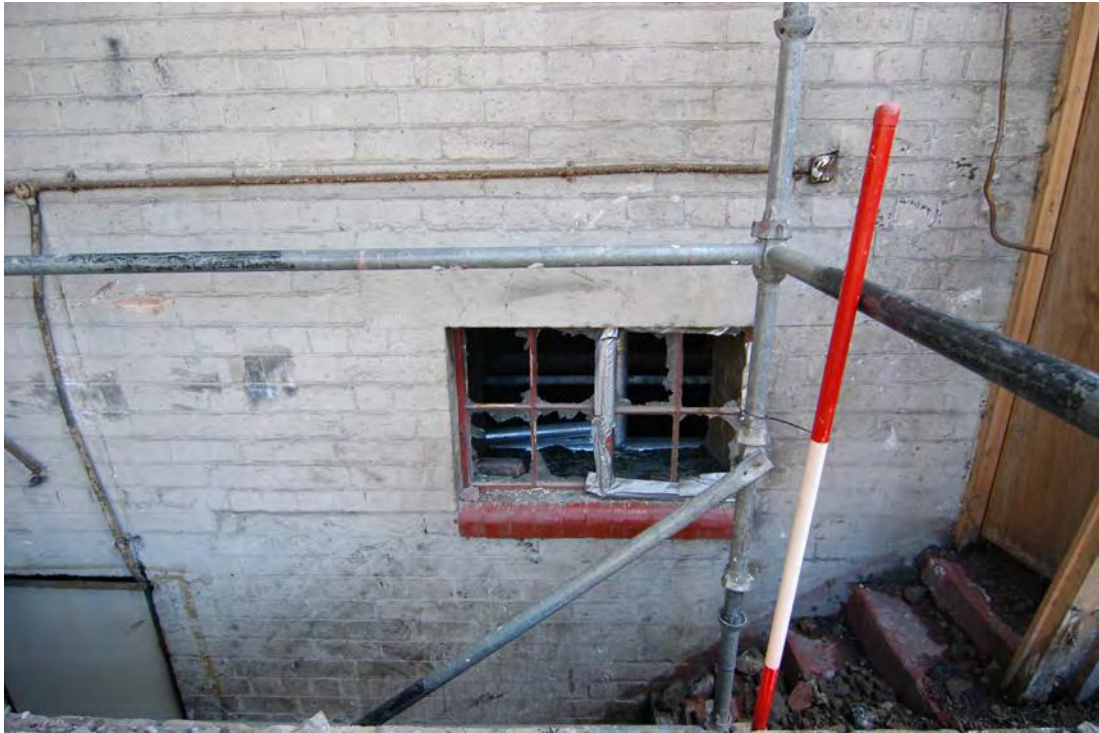
Towards the south end of the fly towers' external west-facing elevation was a flat-roofed brick-built shed that could not be accessed during the primary building survey. When removed this revealed a concrete stair leading to a boarded-up doorway. Two four-paned cast-iron windows had been built into the wall facing onto the stairs (Plate 7).

Plate 7: The external stairs and window (050)

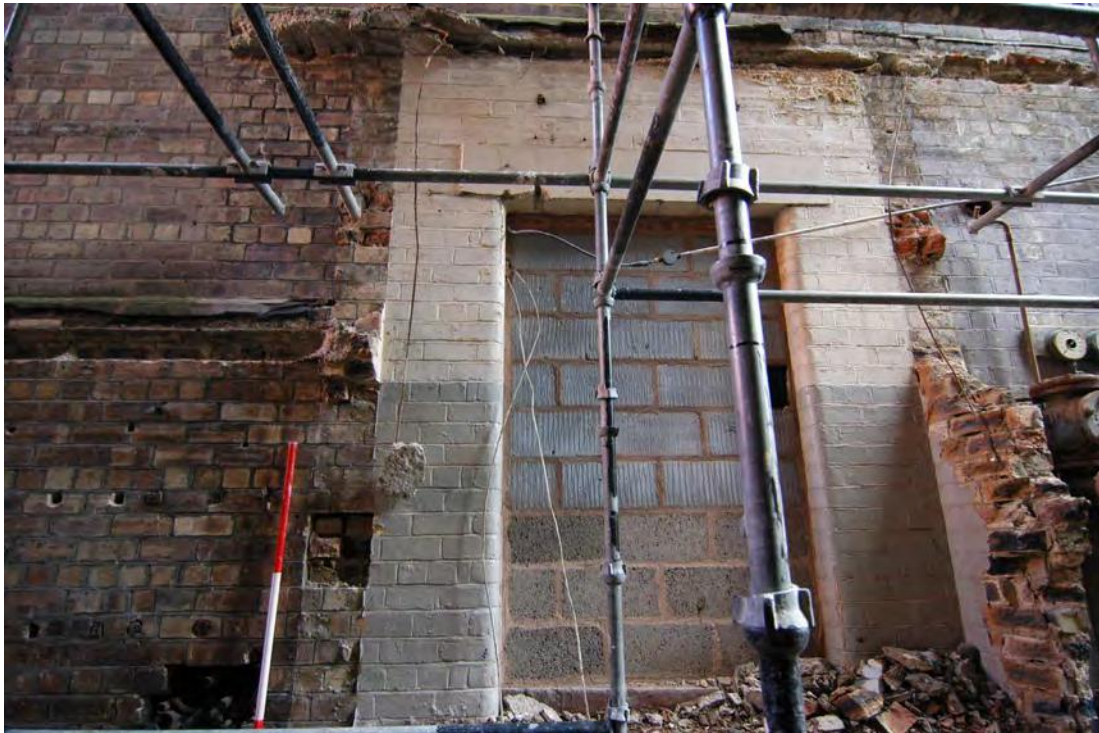
During the initial standing building survey a blocked-off concrete staircase was recorded at the north end of the west-facing elevation of the fly tower. Modern brickwork masked an original doorway into which the staircase led (Plate 8). This entrance was one of several entrances and possibly served as the main fire exit from the fly tower.

Plate 8: An external blocked entrance at the top of the demolished 1930 staircase (056)

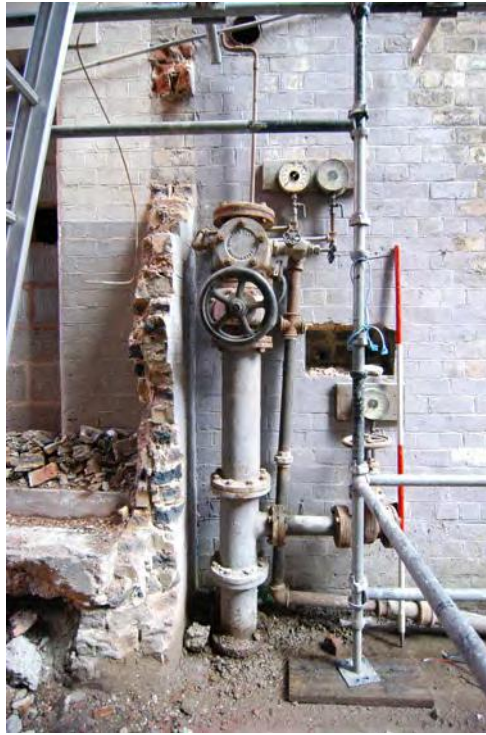
Towards the north end of the fly tower's external west-facing elevation was a concrete staircase with handrail. Demolition of the staircase revealed a mains water riser pipe valve wheel and three pressure gauges (Plates 9 and 10). The valve wheel allowed the theatre's sprinkler system to be regulated from the cities mains water supply. The apparatus was designed by Mather and Platt Engineers, Manchester.

Plate 9: External mains riser and sprinkler shut off valve (051)

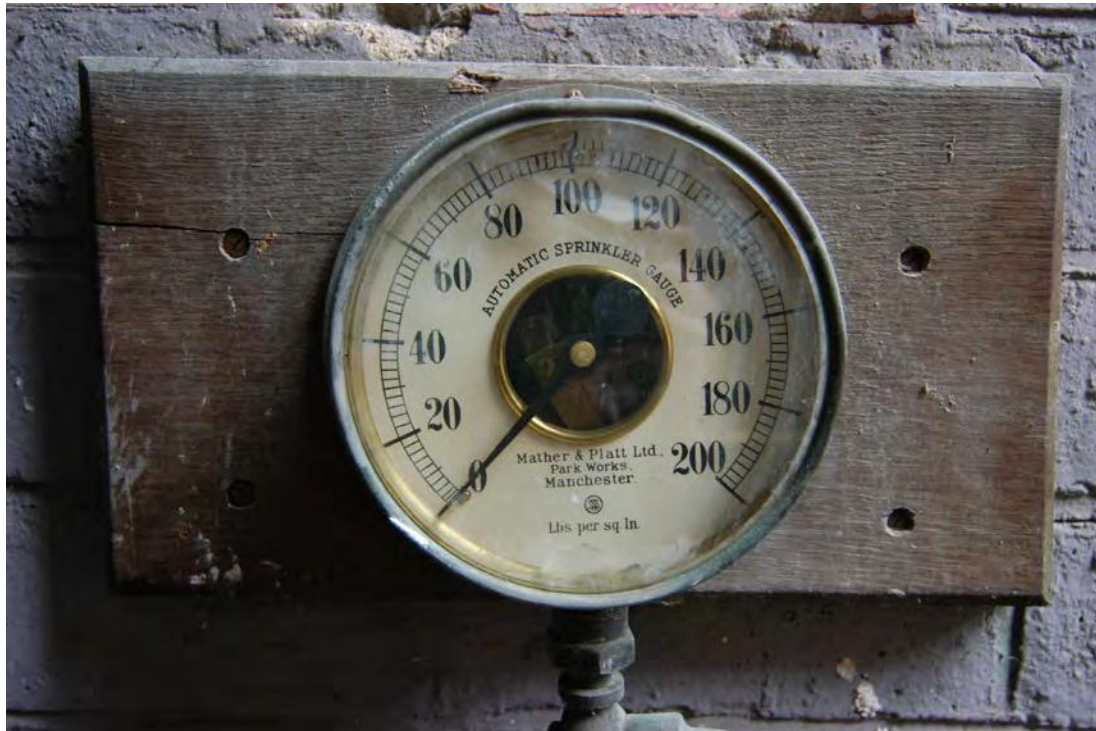
Plate 10: Detailed shot of one of the pressure gauges made by Mather and Platt, Manchester (053)
