**157 Duddingston Road West,
City of Edinburgh**

**Archaeological Watching Brief
Report No. 3109**

Author	Graeme Carruthers MA MifA
Illustrator	Graeme Carruthers MA MifA
Editor	Bruce Glendinning BSc PGDip MifA
Commissioned by	Thomas & Adamson <i>per</i> City of Edinburgh Council
Date issued	January 2014
Version	0
Planning Application No.	Ref 12/03480/FUL
Grid Ref	NT 2882 7177

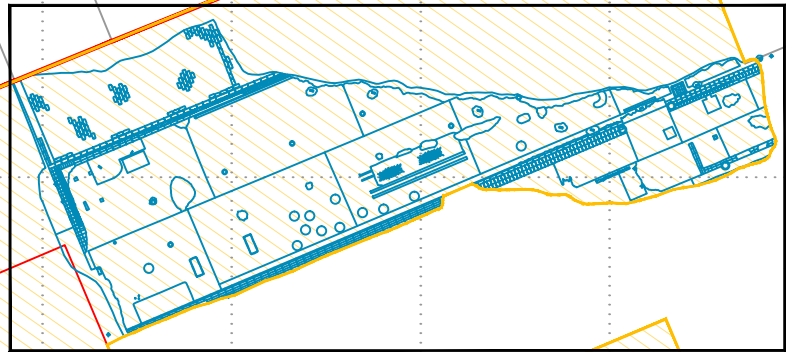
Fig. No: 1 Revision: A

Title:
Site location, area of Watching Brief and location of brewery floor

This report presents the results of an archaeological watching brief undertaken by CFA Archaeology Ltd (CFA) between November and December 2013 on land at 157 Duddingston Road West, City of Edinburgh (NGR: NT 2882 7177) (Fig. 1). The work was commissioned by Thomas & Adamson on behalf of City of Edinburgh Council.

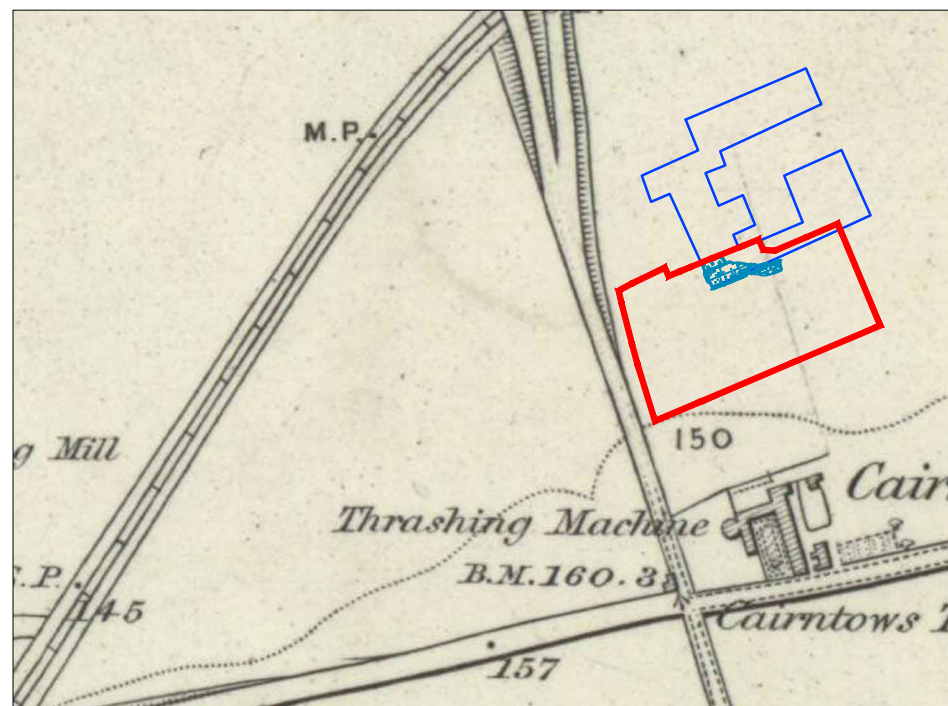
Fig. No: 2a-f	Revision: A	Checked: KH	Report No: 3109	Drawn by: GC
Title: Historical maps showing site development		Project: 157 Duddingston Road West, Archaeological Watching Brief		Client: City of Edinburgh Council

Fig.2a Extract from map by Ordnance Survey, 1852

Fig.2b Extract from map by Ordnance Survey, 1877

Fig.2c Extract from map by Ordnance Survey, 1895

Fig.2d Extract from map by Ordnance Survey, 1909

Fig.2e Extract from map by Ordnance Survey, 1919

Fig.2f Extract from map by Ordnance Survey, 1932

Cartographic evidence (Figs 2a-f) indicated that the site was undeveloped until the Castle Brewery was constructed between 1895 and 1909. However, the mapping indicated that only the southernmost part of the Brewery buildings extended on to the northern edge of the site.

The maps that were examined showed the identified buildings as first appearing on the Ordnance Survey map of 1909 (Fig. 2d). No depictions appear on the maps to assist in deriving what exact part of the Brewery process once took place within the surviving remains.

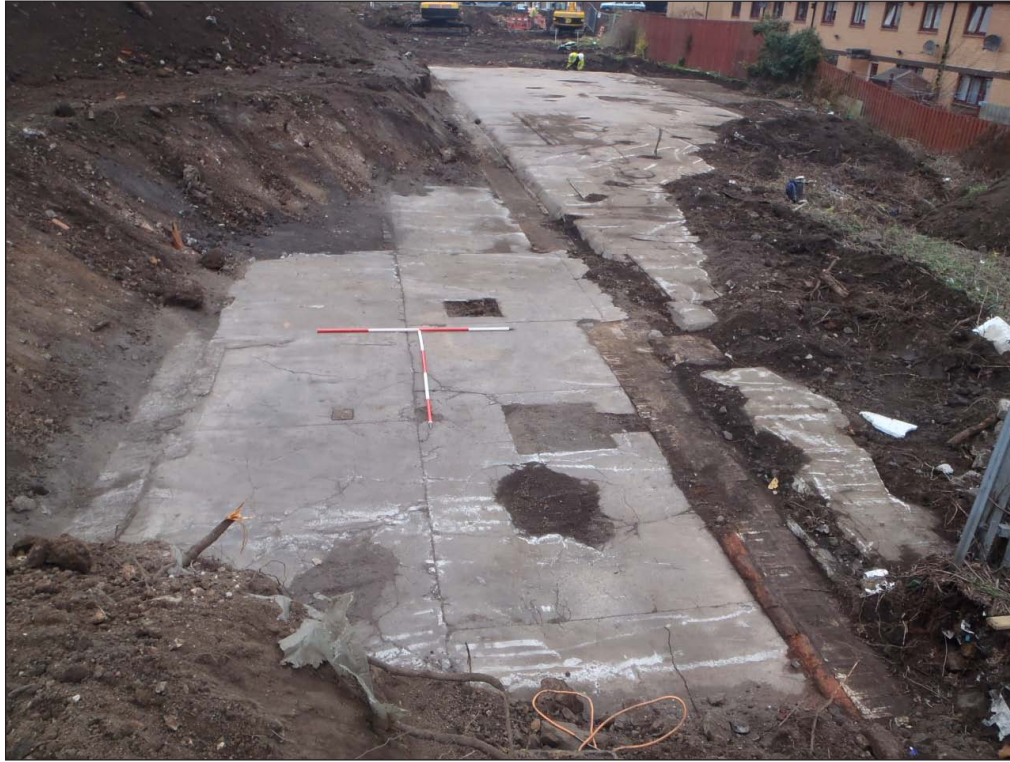
Fig. 4 – General view of building remains

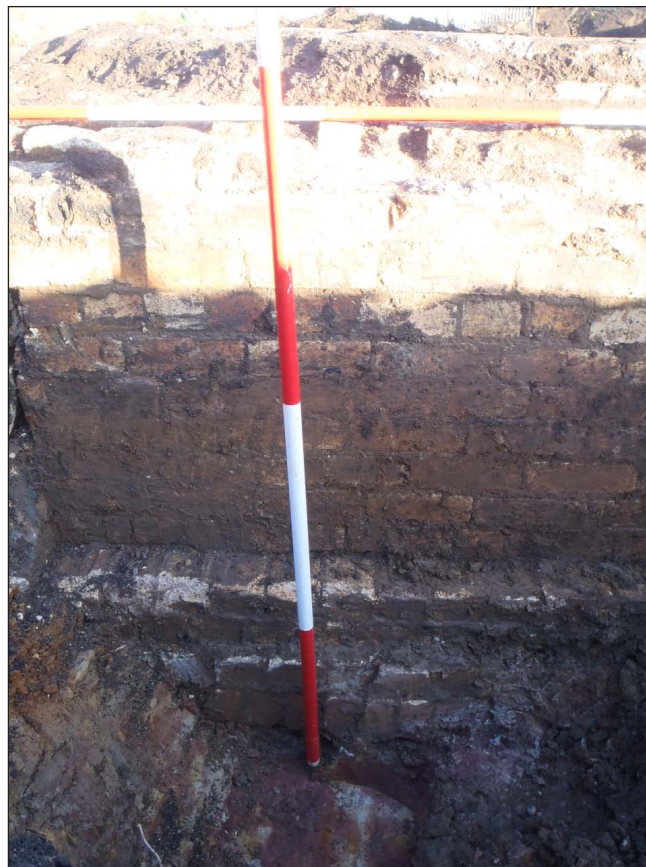
The walls were made from frogged bricks which were mostly stamped 'Whitehill'. A sondage was placed against the west facing elevation of wall **003**. This exposed the foundations and showed that the walls survived to a height of 1.3m. The construction of the walls was of English Garden Bond (5:1) (Fig.5).

Fig. 5 – West-facing elevation of wall 003 showing foundation footing

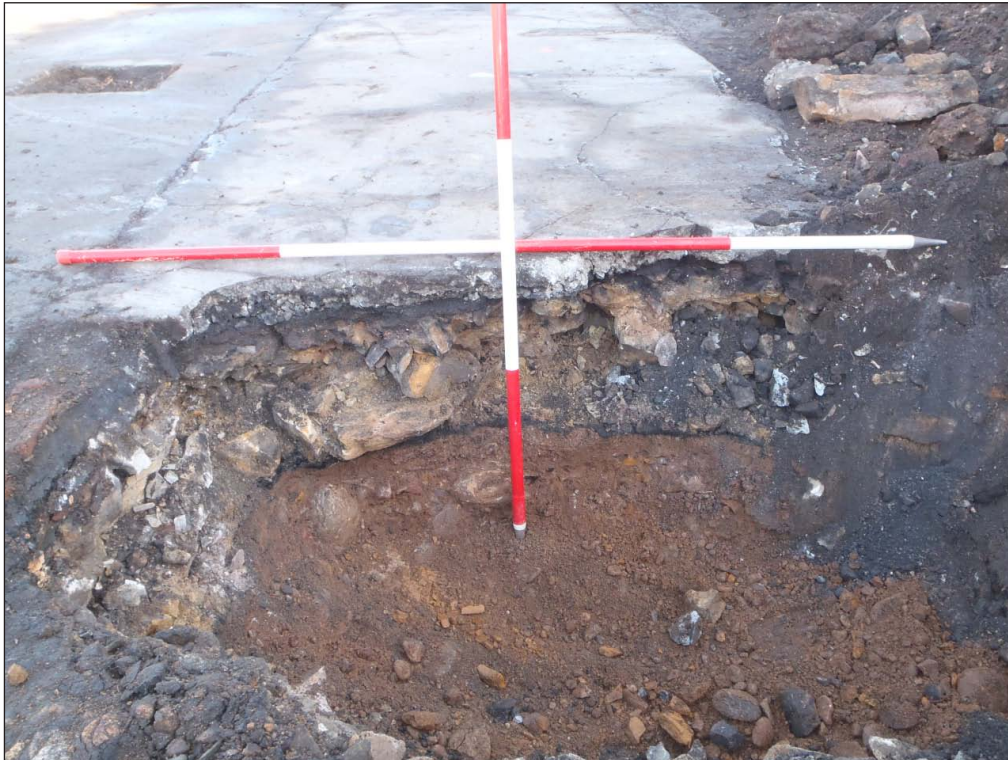
The concrete floors **001** and **012** were made from a 0.1m thick layer of cast in situ concrete sitting on levelling layers of black ash (**016**) and sandstone rubble (**015**) (Fig. 6). The casting marks were clearly visible in the concrete showing that the floor was been cast in a series of slabs rather than one continuous pour.

Fig. 6 – Section through floor 012 showing levelling layers beneath

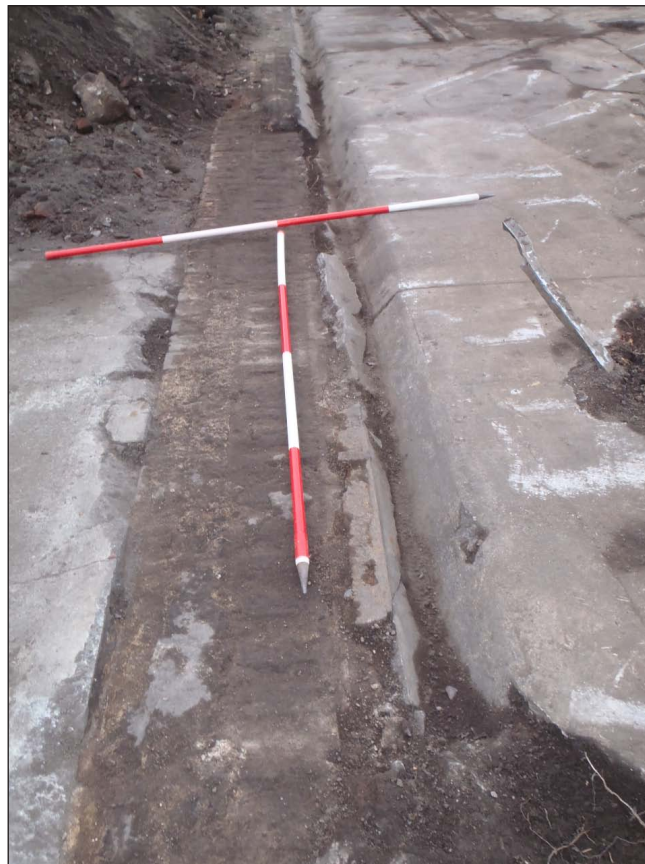
Along the northern side of the floor surface (**001**) a shallow drain (**019**) was cast in to the concrete and ran alongside wall (**004**). Another drain (**011**) (Fig. 7) was cast in to this surface and ran alongside the southern wall (**002**)

Fig. 7 – Drain feature 011 and wall 002

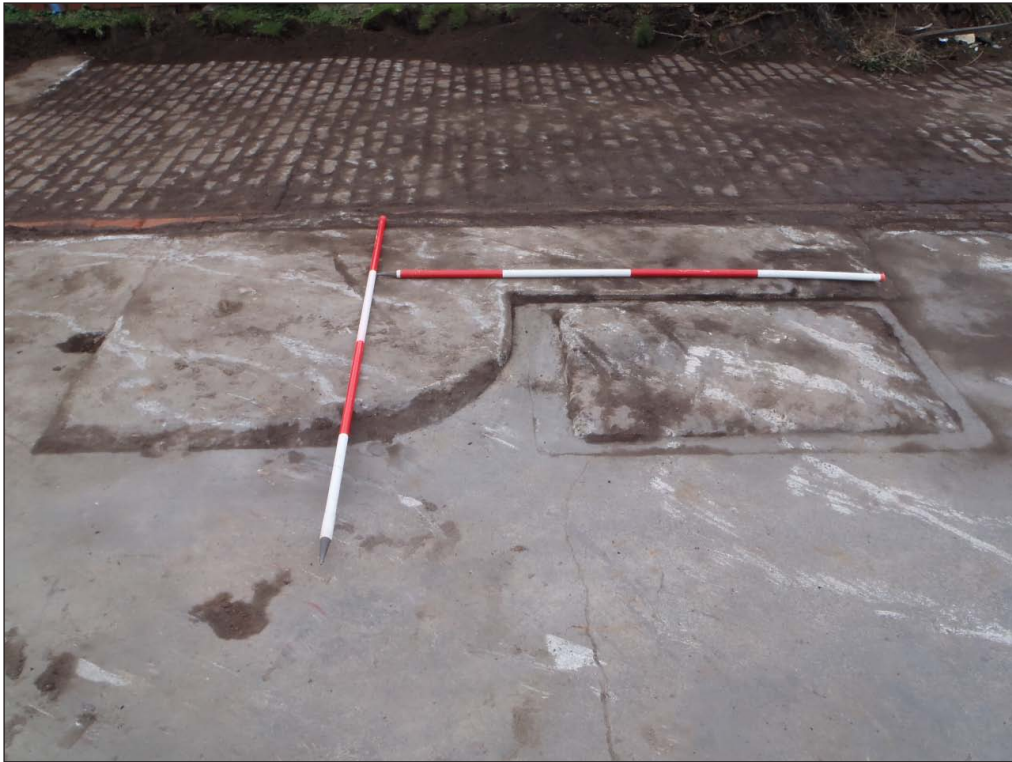
A number of other features were identified set onto the floor surface (**001**): A machine base (**020**) was located in the north eastern corner. The base was 0.05m high and the remains of two iron tie down bolts were present (Fig. 8). A possible machine base (**021**) was represented by two parallel concrete stubs both measuring 1m x 0.5m. The concrete had been chipped flush with the floor. A further possible machine base (Fig.10) was represented by two sets of iron rails (**007** & **008**) set in to the floor (**001**). Partially overlying these rails was a sub rectangular pad of concrete reinforced with lozenge shaped iron wire frame (Fig. 11). It is possible that the later reinforced concrete was a repair to the machine base or a modification to fit a different machine.

Fig. 8 – Machine bases in the north west corner of floor 001 and cobbled surface 005 to the rear

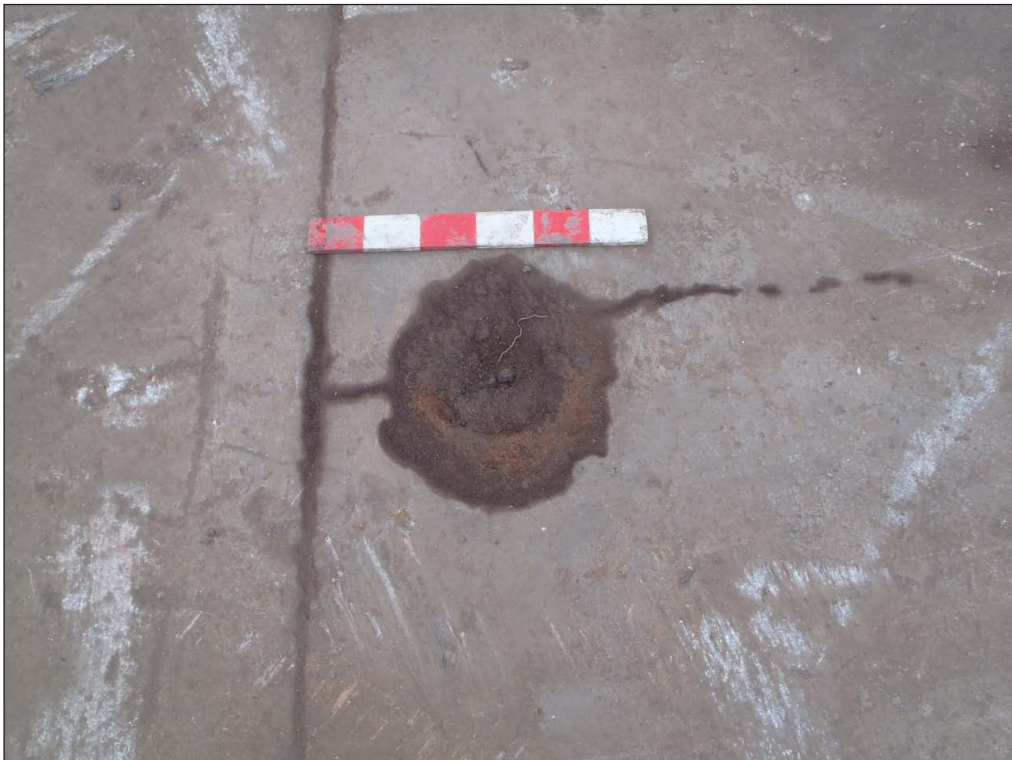
Two parallel rows of iron columns (Fig. 9), **006**, ran lengthwise down the middle of floor **001**. These columns were 0.16m in diameter. The surviving remains had been cut to 0.05m above the floor level with three of them having been dug out completely. These probably acted as internal supports for an upper floor or roof structure.

Fig. 9 – Example of column base 006

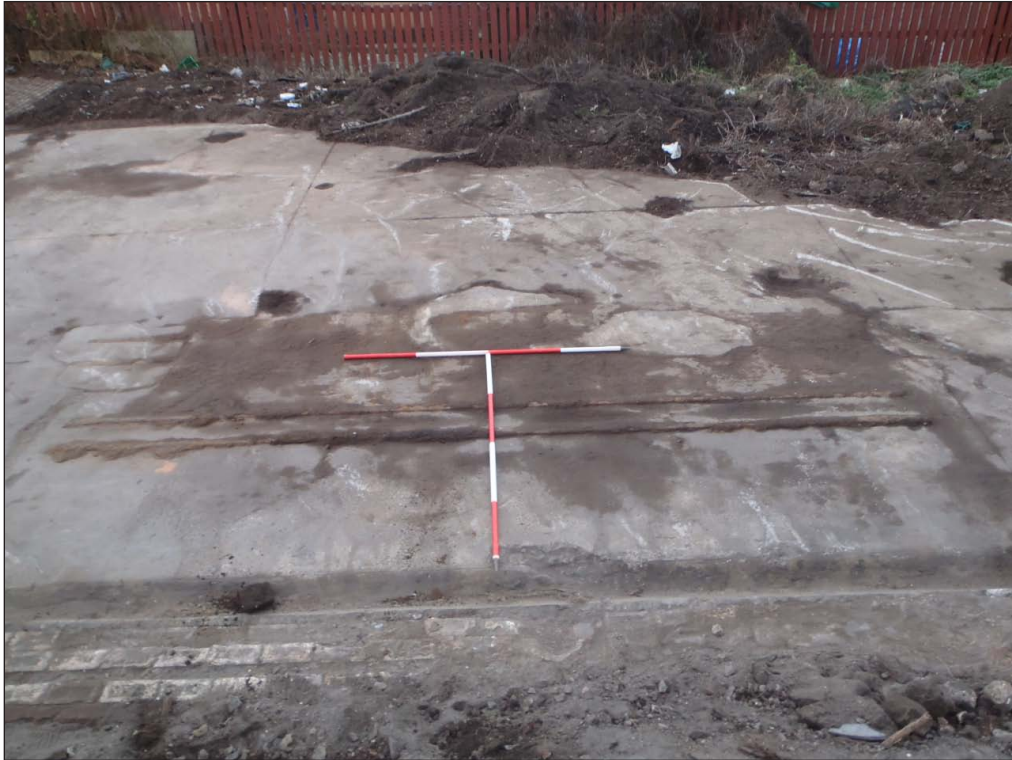
Fig. 10 – Iron rails 007, 008 and concrete area 009 with reinforcing mesh set into the concrete

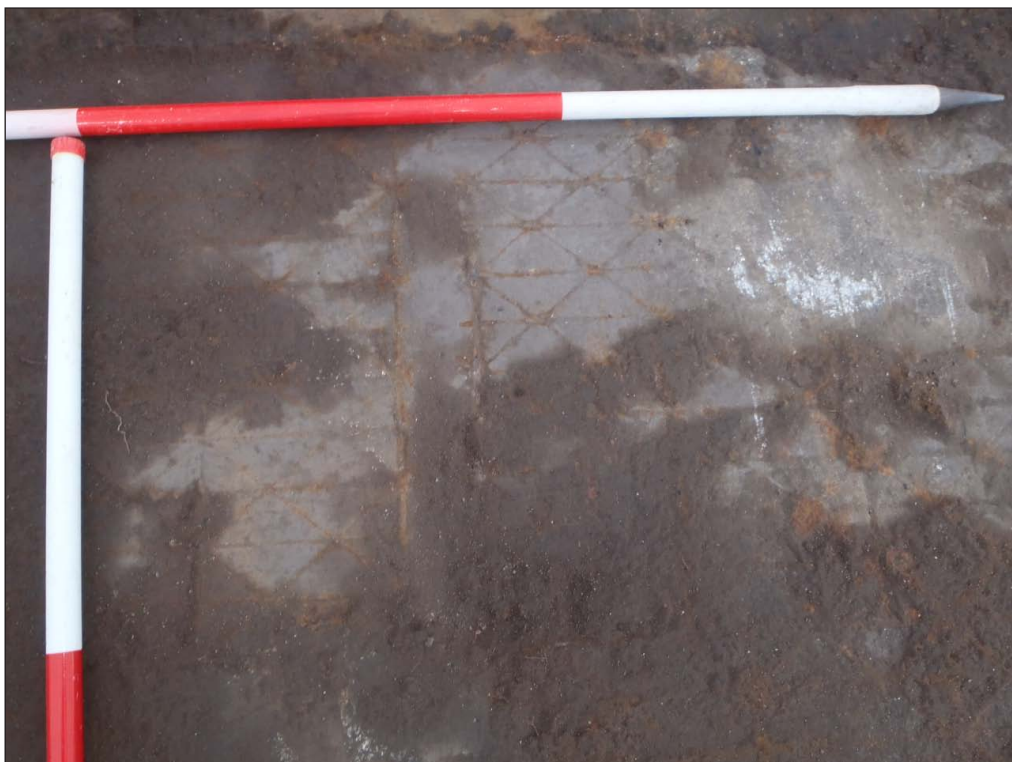
Fig. 11 – Detail of reinforcing mesh in concrete floor 009

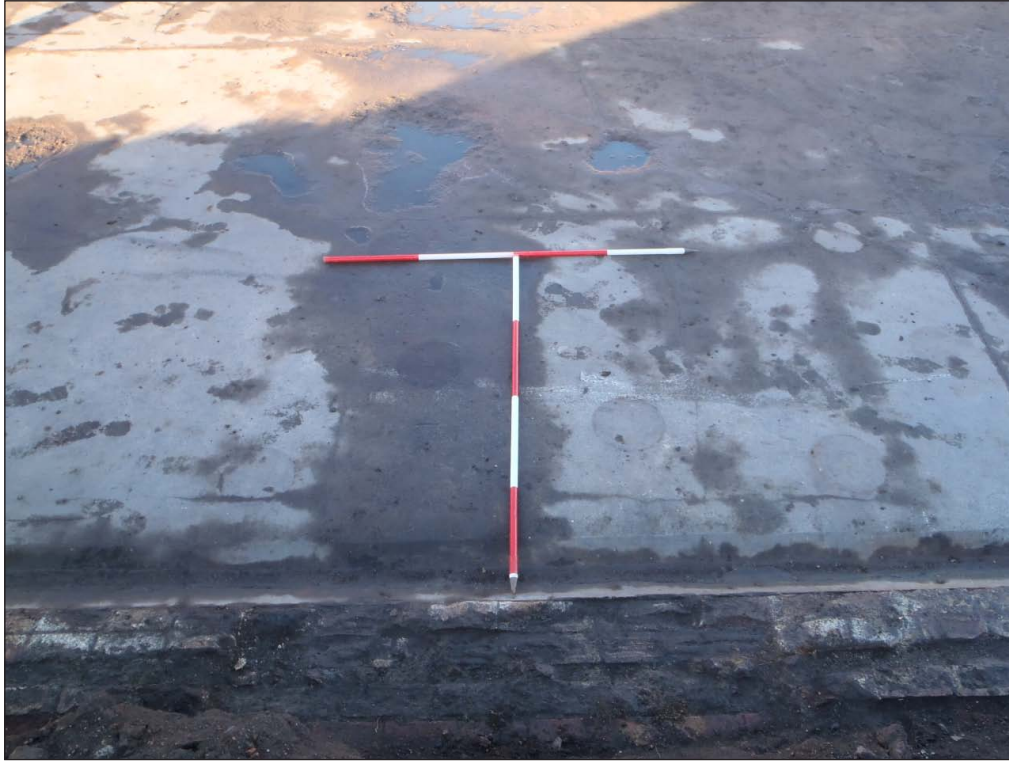
Intriguingly a dozen irregularly spaced concrete circular impressions (**010**) (Fig. 12) were identified set flush with the concrete floor and arranged near the southern wall **002**. These impressions were 0.3m in diameter and were found in one main group with one located further east and another located further west from the main grouping. It is possible that these are marks left behind when something was placed on the floor once it had been cast but not fully set, although what that might be is unknown

Fig. 12 – Circular features (010) on concrete surface

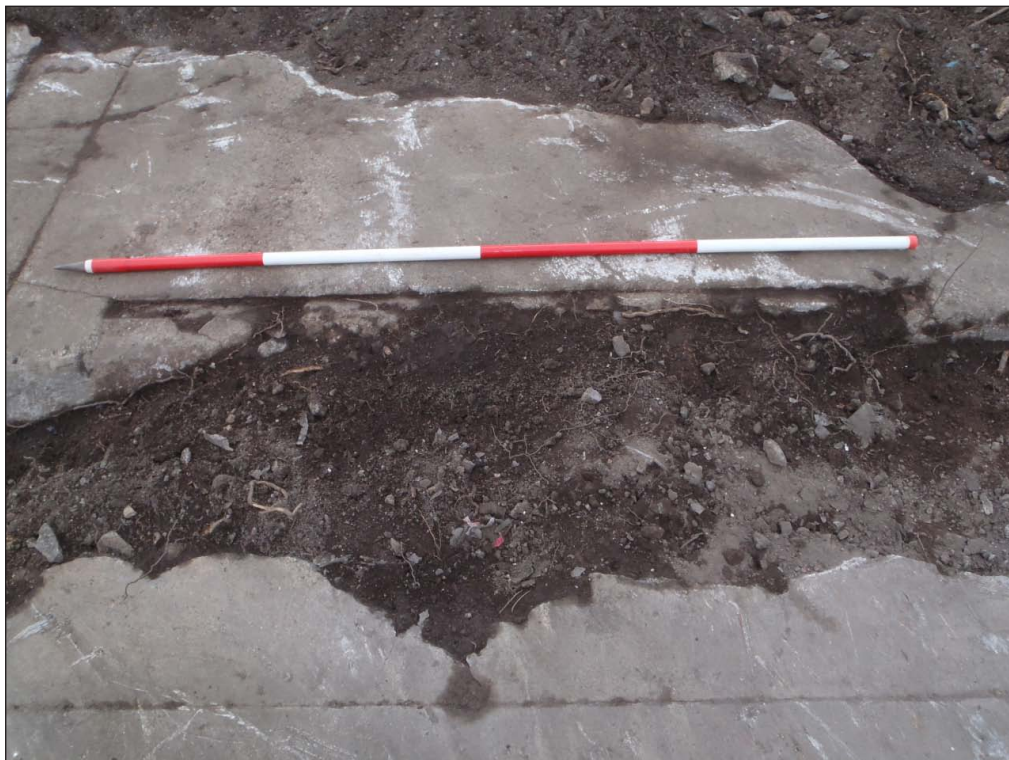
Fig. 13 – Detail of door rebate in floor 001

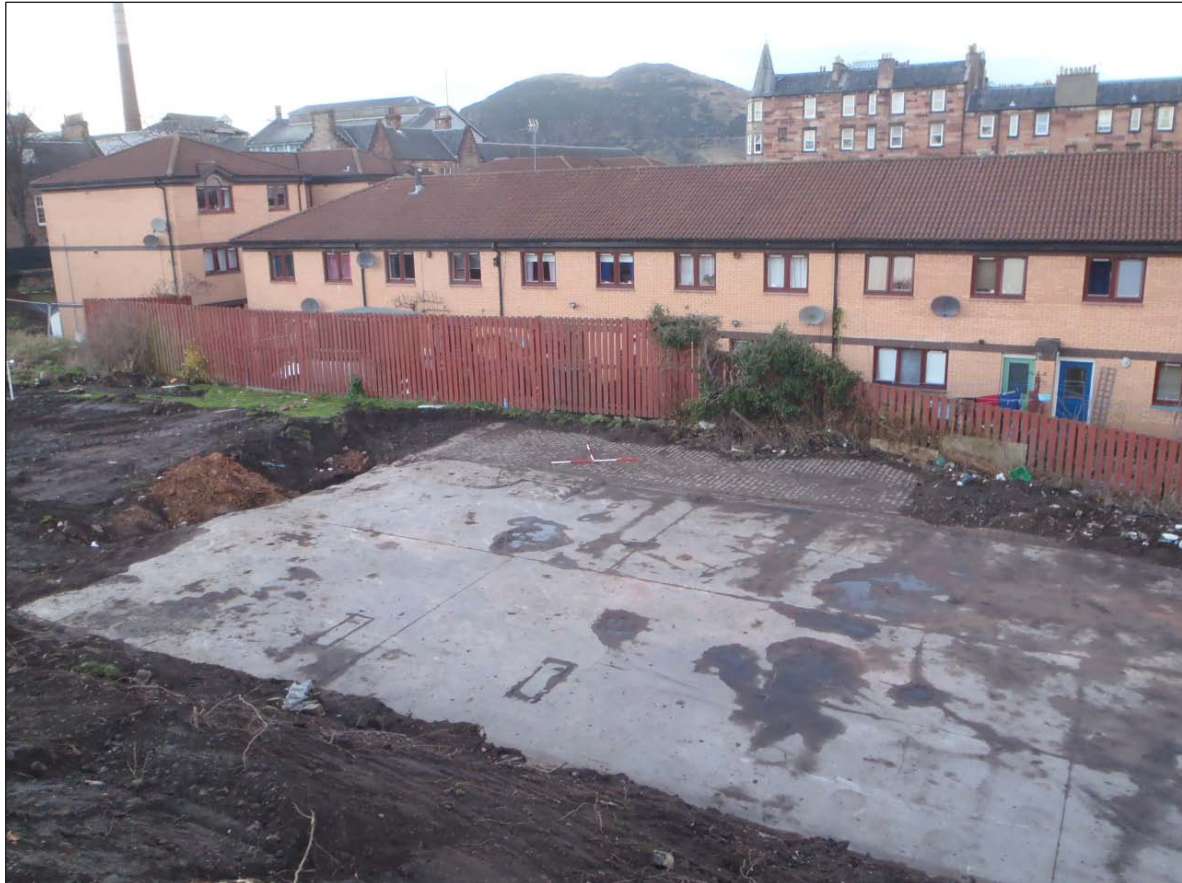
The remains of the buildings that survived had done so because they were not under the footprint of the recently demolished buildings and nor were they affected by adjacent developments. Any remains of the Brewery complex to the north of the site are now situated under a modern housing development. This modern development is approximately 1.5m lower than the level of the excavated remains of the Brewery (Fig. 14) implying that any further remains were removed during the excavations for that development.

Fig. 14 – View of western end of site showing the lower height of modern housing development

The full extent of the cobbled surface (**005**) (Fig 14) was not uncovered as it was truncated by modern disturbance to the north and east. However, it appears to have been a roadway that was external to the unit defined by walls **002**, **003**, **004** and surfaced with **001**.
