**Muir Dean Surface Mine
Annfield Extension
Inverkeithing
Fife**

Archaeological Evaluation

Report No. 2030

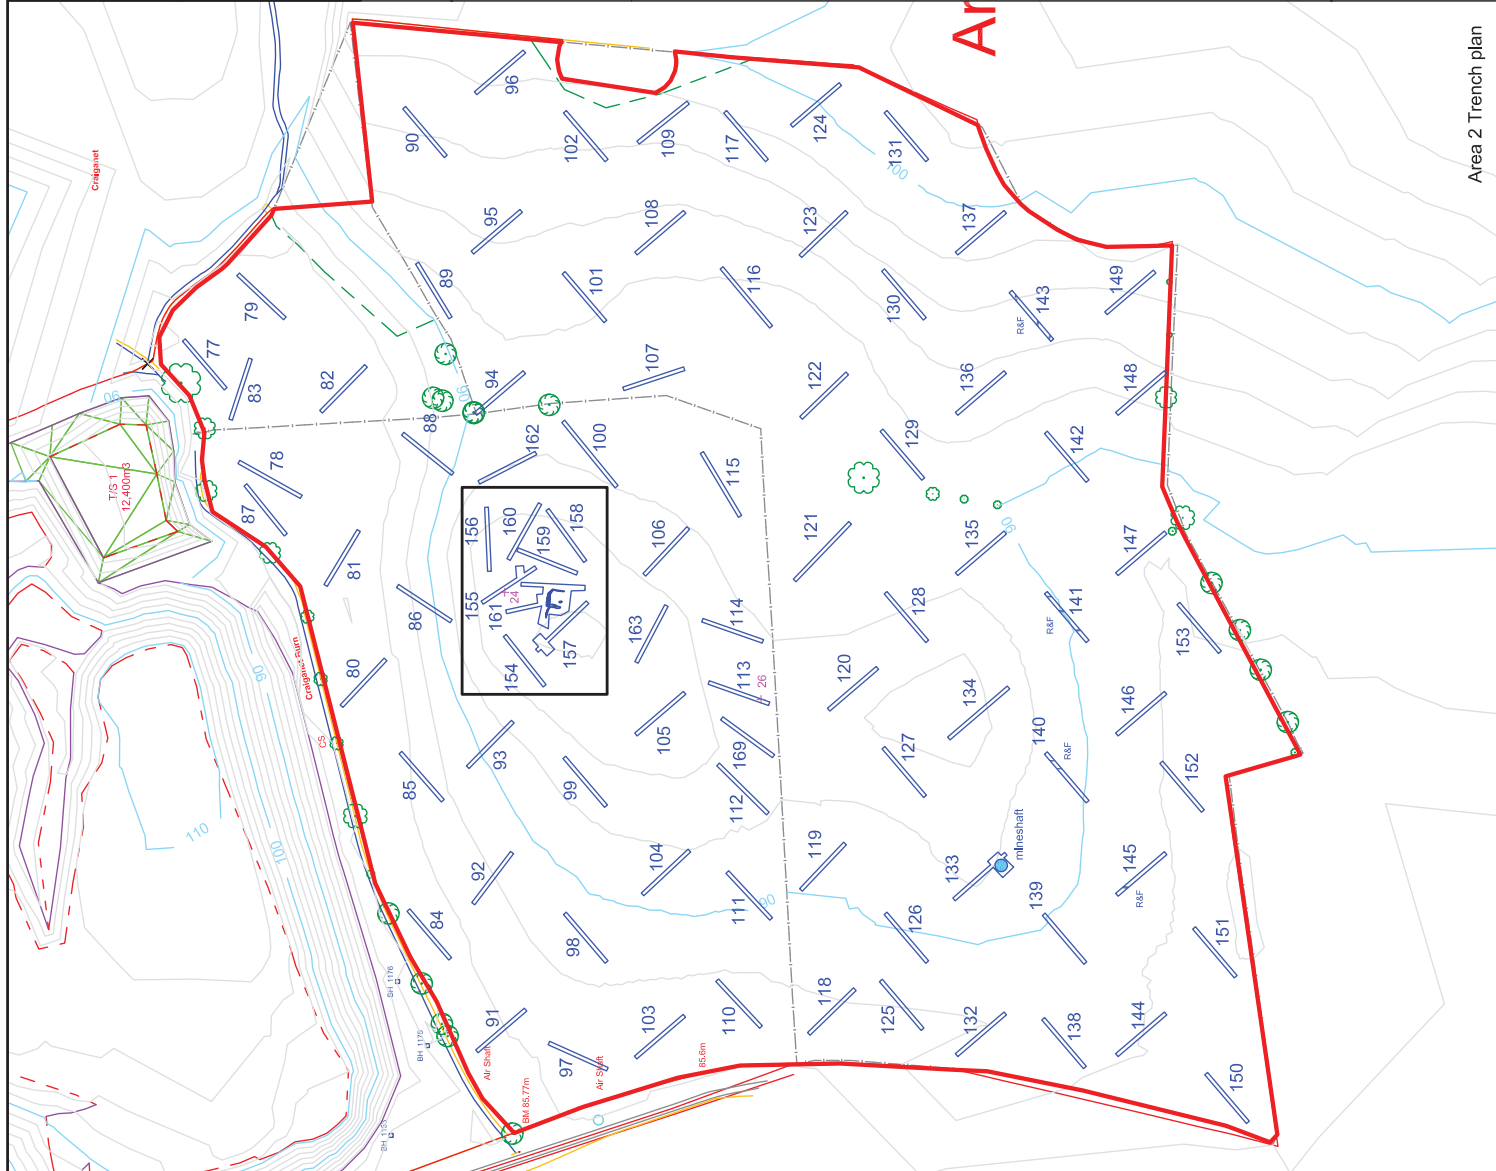
Title: Area 2 Trench plan showing Trench 161, possible foundation trenches associated with Damleys

Possible remains associated with Damleys farmstead were identified within Trench 161 (Fig. 2c). They consisted of three linear features (**038**, **040** and **044**), possibly representing the remains of three sides of a square or rectangular structure (Fig. 2c and Fig. 3). Linear **038** ran in a south to north direction for a distance of 8m before turning through 90° into linear **040**. Linear **040** then ran west to east for a further 8m, before turning southwards through two 45° bends into linear **044**, which continued southwards for a distance of 6.5m before terminating. A further linear (**042**) ran at c.90° to linear **038**, extending from close to the corner with **040** in an east to west direction for a distance of 6.5m, and a spread of demolition debris (**046**) measuring 1.6m north-west to south-east by 1m south-west to north-east was located c.2.2m to the east of the southern end of linear **038**.

Sections recorded across linear features **038**, **040**, **042** and **044** showed that they measured 1.6m in width by 0.2m in depth, 1.5m in width by 0.25m in depth, 0.33m in width by 0.2m in depth, and 0.3m in width by 0.05m in depth respectively. Linear **038** (Fig. 4) and **040** were very similar in nature with gently sloping sides and irregular bases, but **042** had steeply sloping sides and a concave base, and **044** had fairly

regular sloping sides and a flat base. The fill (**039**, **041**, **043** and **045** respectively) of these features consisted of loosely compacted soil and stone/demolition debris containing occasional sherds of 19th century pottery. Spread **046** was of a very similar nature to the fill of the other features.

It is considered possible that the linear features uncovered might represent the remains of foundation trenches associated with Damleys farmstead indicating a structure measuring 8m east to west by >8m north to south. However, no clear evidence of foundation stones was identified. It is also of note that linear **038** and **044** appear very wide for a foundation trench, although it is possible that these trenches were widened out during the demolition process for the purpose of the disposal of demolition debris.
