The Leith Programme Leith Walk, Phases 5 to 8

Archaeological Watching Brief

Report No. 3231

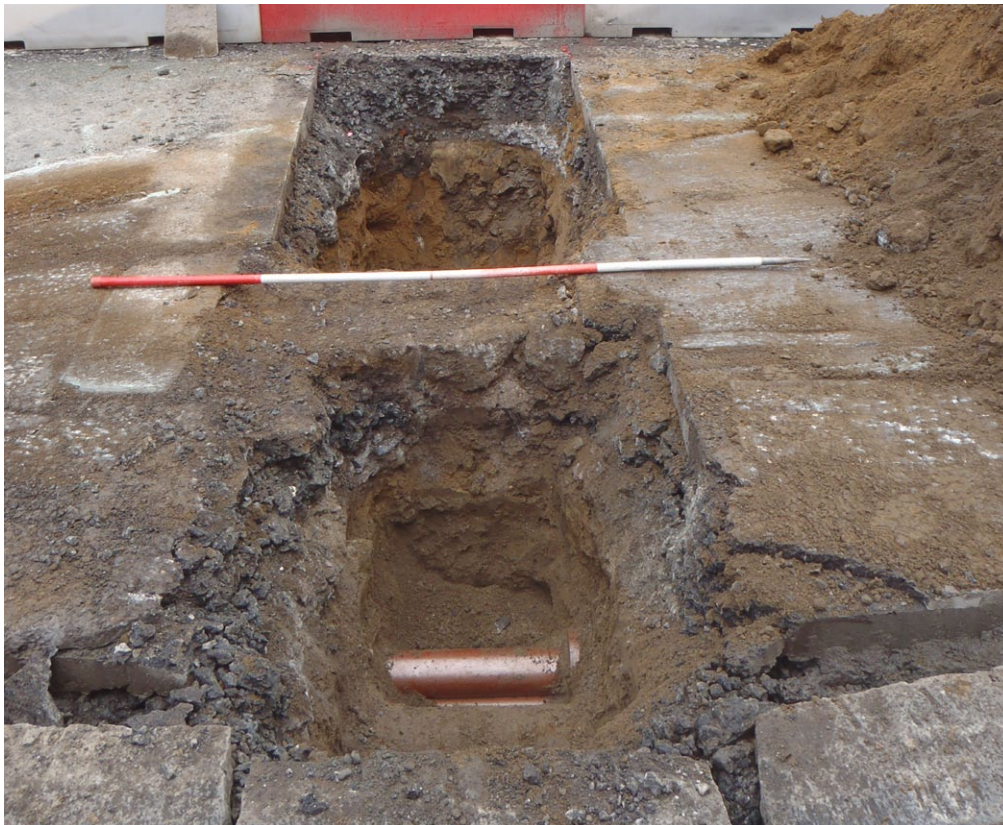
Fig. 8 Photograph of Trench 1, western side

On the eastern side of the trench gas and water service pipes were discovered so the targeted 1.5m depth could not be reached here. The western 5m of the trench also contained multiple ceramic and iron pipes containing services, with multiple cuts and fills for these visible below layer (002). This prevented the entire western section of the trench from being excavated to 1.5m.

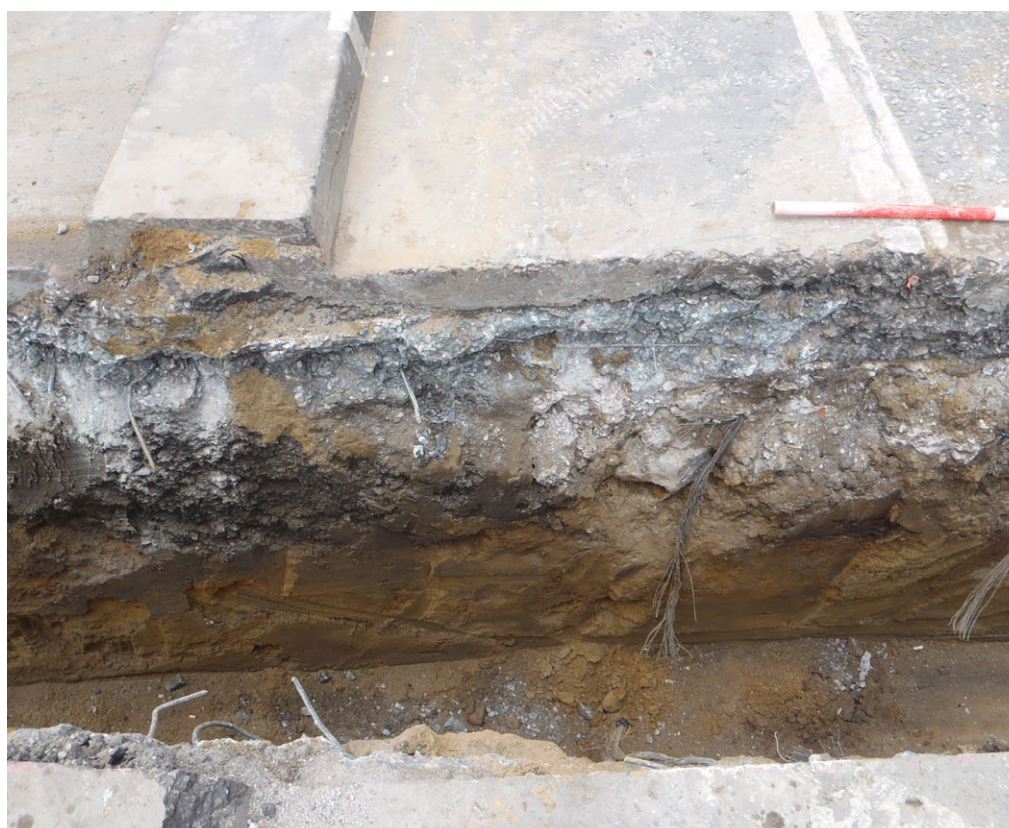
Fig. 9 Photograph of Trench 1, middle section

The road surface tarmac (001) at modern ground level directly overlaid a layer of type 1 (002) across the entire trench. Below this were further thin modern deposits and then underneath these were predominantly fine mid-brown sands which were consistent down to 1.5m depth. The sand deposit was extensively cut by modern services.

No archaeologically significant remains were discovered throughout the trench.

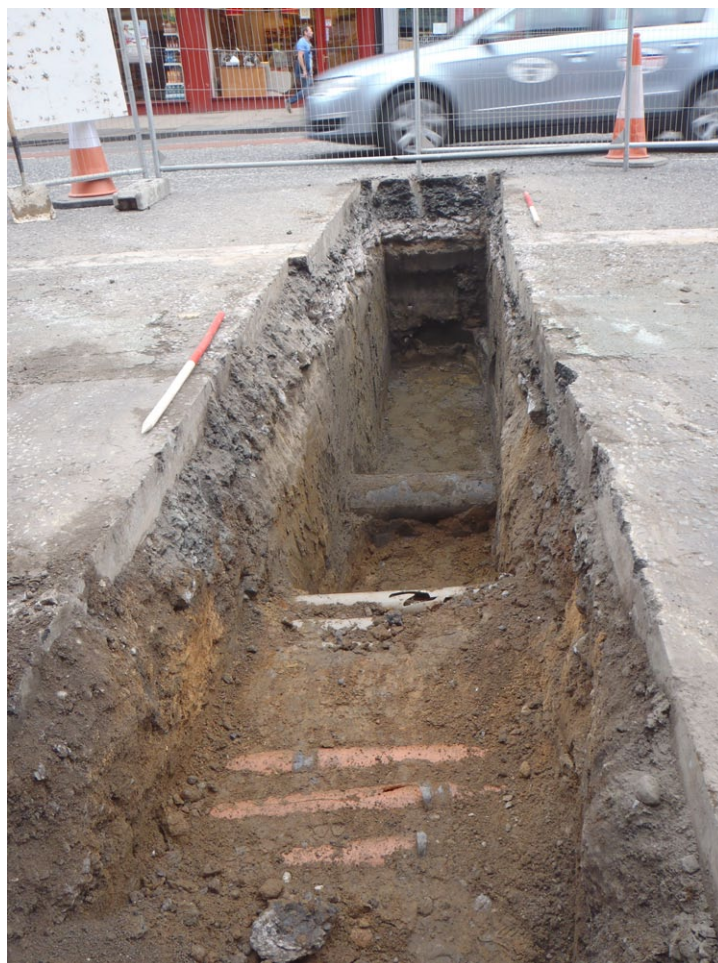
Fig. 11 Photograph of Trench 2, western side

The modern road surface of tarmac (001) and type 1 (002) overlaid a layer of cast concrete (027) which covered most of the trench apart from the eastern and western ends of the trench where a number of later service cuts were present.

Services prevented the excavation to full depth in the westernmost end of the trench and a service that ran parallel to the trench prevented the excavation to full depth along most of the eastern half of the trench.

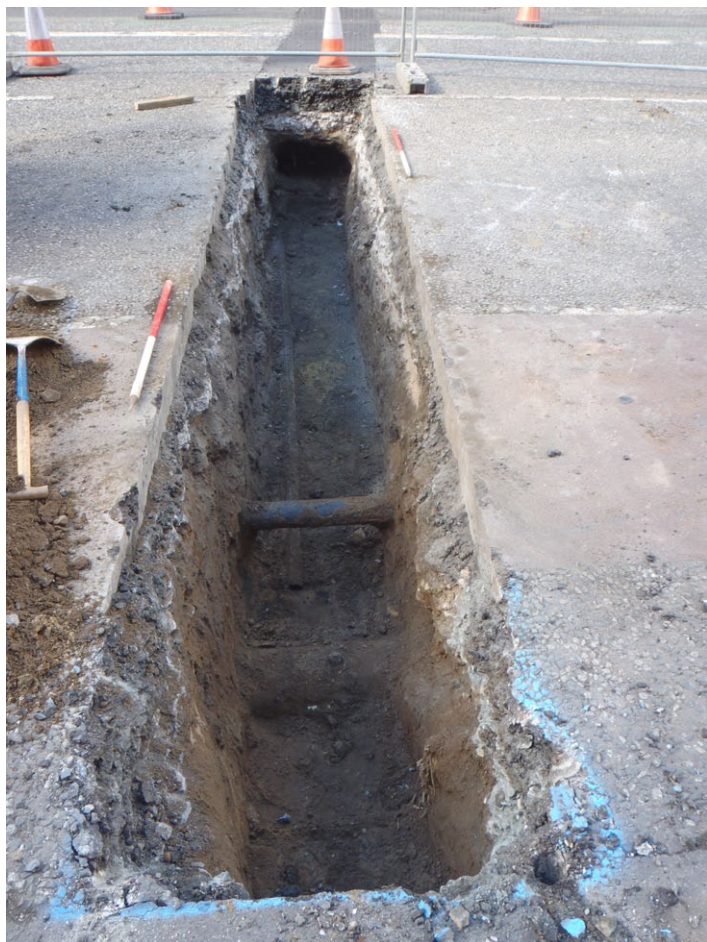
Fig. 12 Photograph of Trench 2, eastern side

Towards the eastern side of the trench a possible cut (046) sloping from east to west was identified. This contained a deposit of dark grey stiff clay (028) that overlay (042), a deposit of dark brown sandy clay. Only the eastern side of the cut was observed with any clarity as the western side of the trench was full of modern services and possible natural sand (029) was only identified at the very base of the trench so a clear base to the possible cut was not identified with any certainty. A cast iron service with no visible cut was contained within the deposit (028). This could indicate that the cut (046) was relatively recent with the pipe being laid at the same time the wider cut was made. The fills were clayey which was different to the surrounding soils which were sand rich so it seems likely that this cut was backfilled rapidly with imported material. Overall this suggests the cut was recent and not of archaeological significance such a large cut ditch that had silted up.

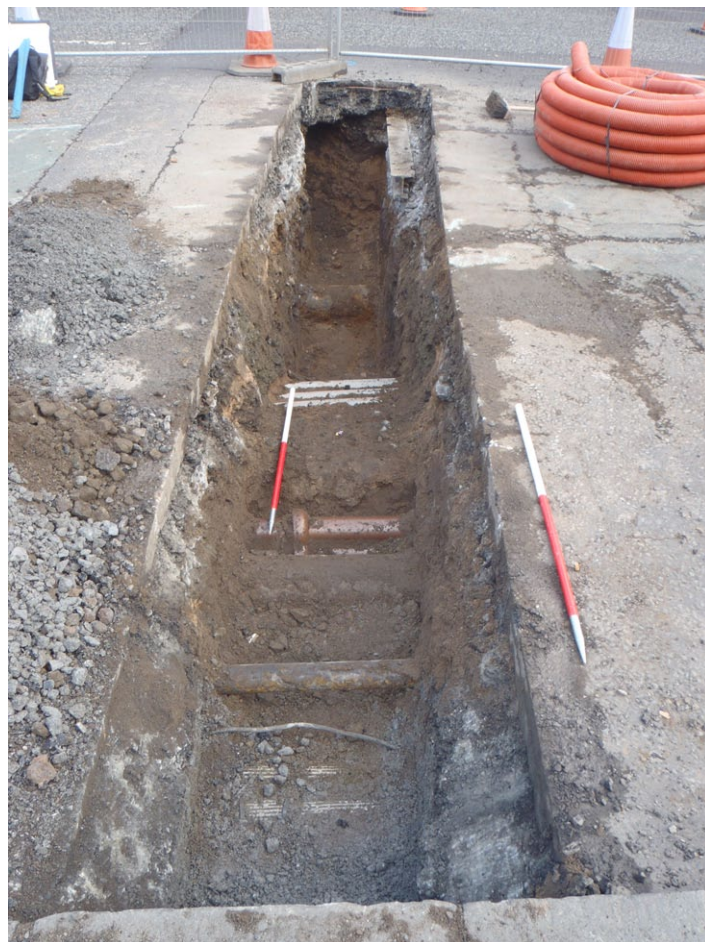
Fig. 13 Photograph of Trench 3, western side

The existing road tarmac (001) overlaid a layer of type 1 (002), which overlaid a concrete surface (048 & 070) although this was not present in the western 4.7m of the trench. Two iron beams / girders were set in to the northern side of the concrete surface.

In the westernmost end of the trench the 1.5 m depth could not be reached due to abundance of cast iron and ceramic modern service pipes at around 0.8m to 1.0m depth. The easternmost end of the trench was also significantly disturbed with modern services so the full depth of 1.5m could not be reached.

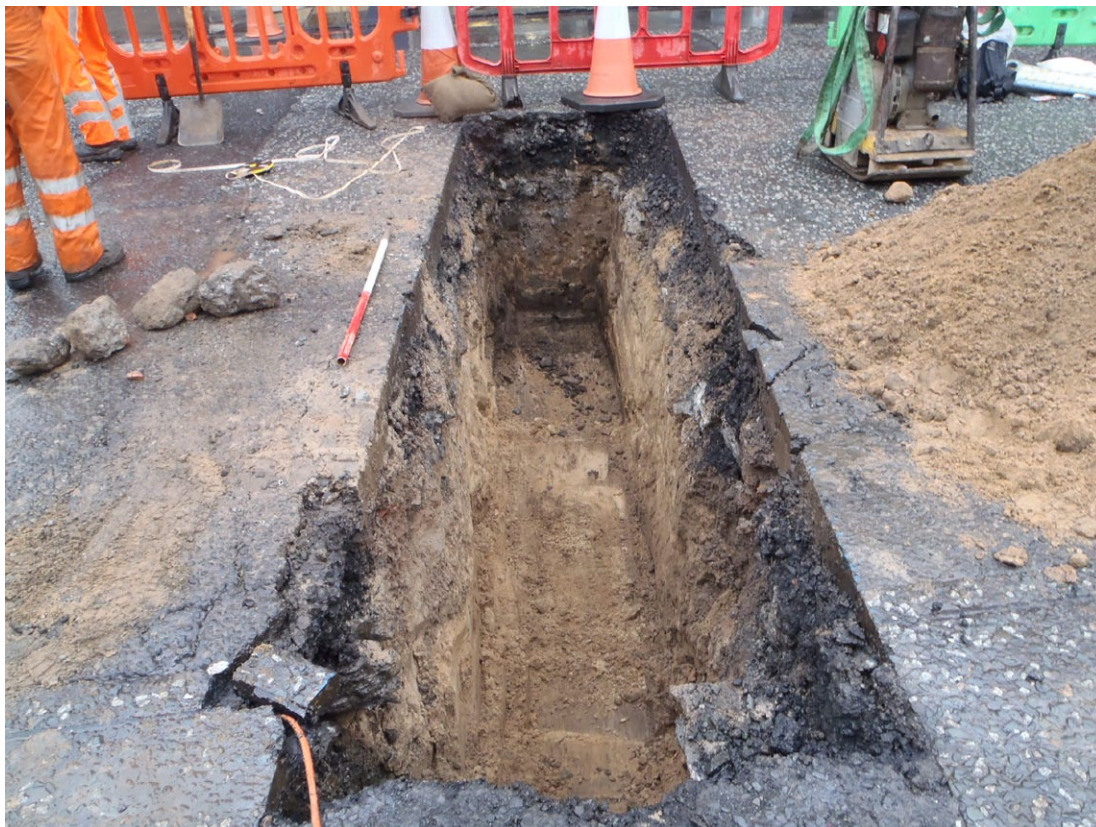
Fig. 14 Photograph of Trench 3, middle section

Between the clusters of services at both ends of the trench there were no services encountered and the trench was excavated to 1.5m through layers of yellow/mid-brown fine sands.

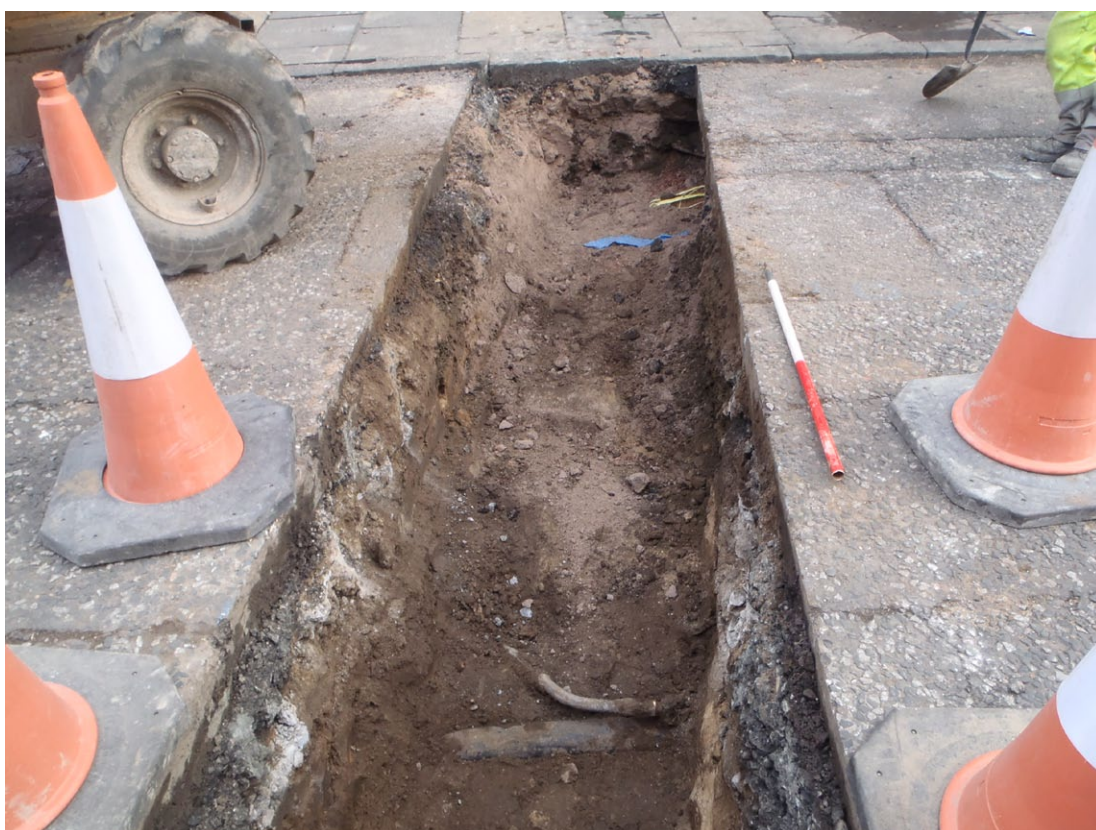
Fig. 15 Photograph of Trench 3, eastern side

No archaeologically significant remains were discovered throughout the trench.
