**Land Adjacent to Christ Church,  
Brooklands, Eccleston, St Helens**

**Archaeological Desk-Based Assessment**

**Report No. Y082/13**

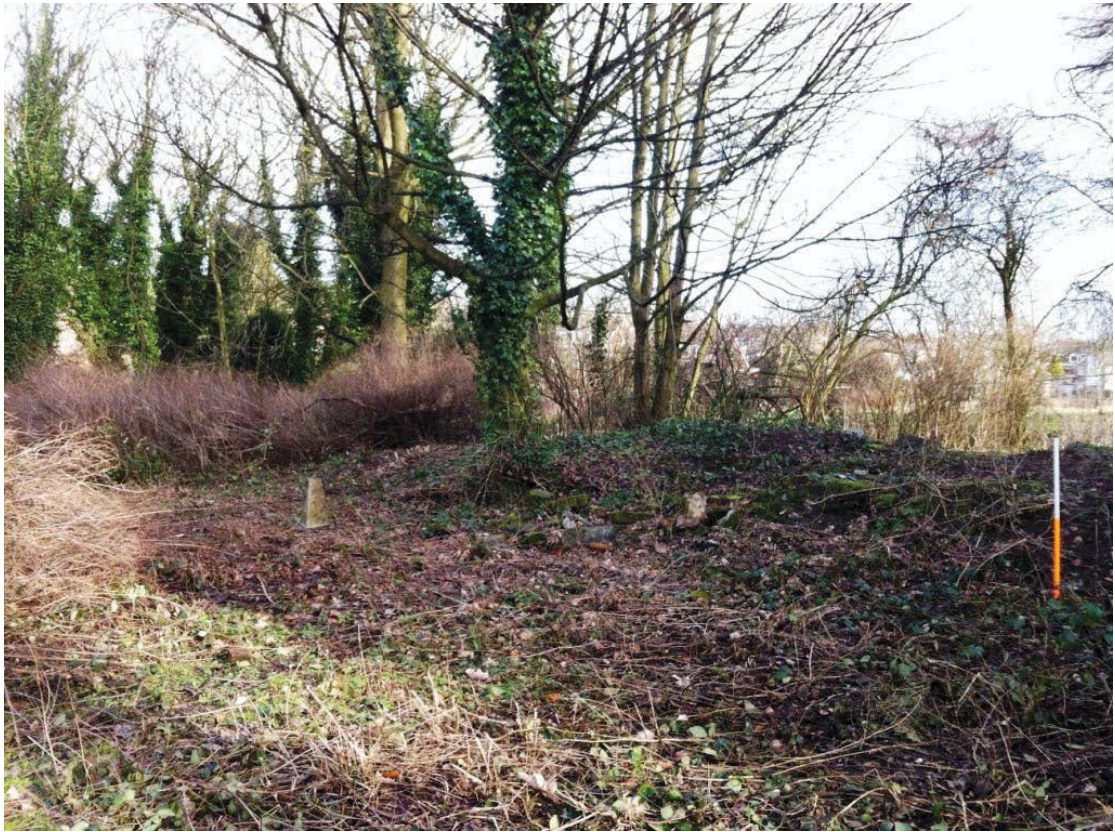
The west side of the mound (Plate 1), facing the road was formed by a collapsed wall made from in frogged and unmarked bricks and machine cut stone of various sizes.

Plate 1: View of the ‘enclosed mound’ looking north-east

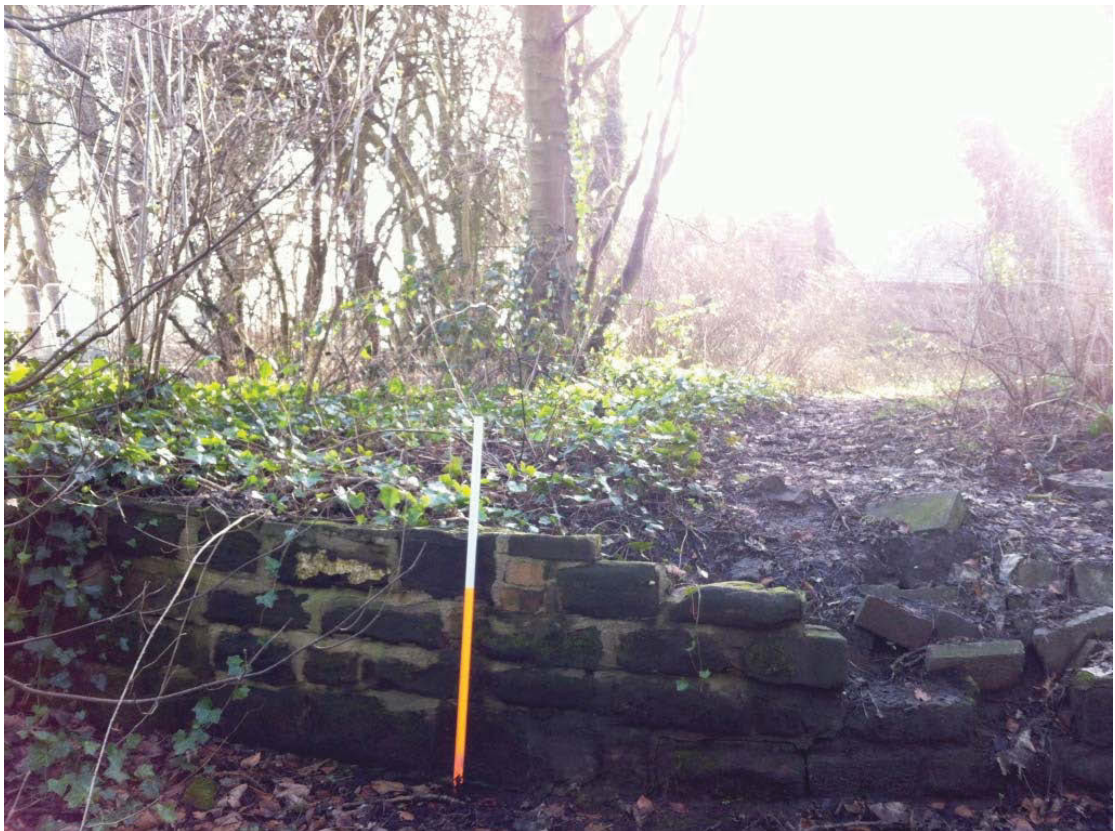
The north side the wall was well preserved, made of cut sandstone and seemed to have undergone recent repair with some brick patching bonded with concrete (Plate 2). The wall formed a revetment to the mound, which bowed out along this side, though whether this was due to the presence of root action from a tree sitting on top of the wall or was a deliberate feature is unclear. On the north-west side there has been an attempt to continue the revetting with concrete blocks/paving.

Plate 2: Curving revetment wall along the northern side of the ‘enclosed mound’

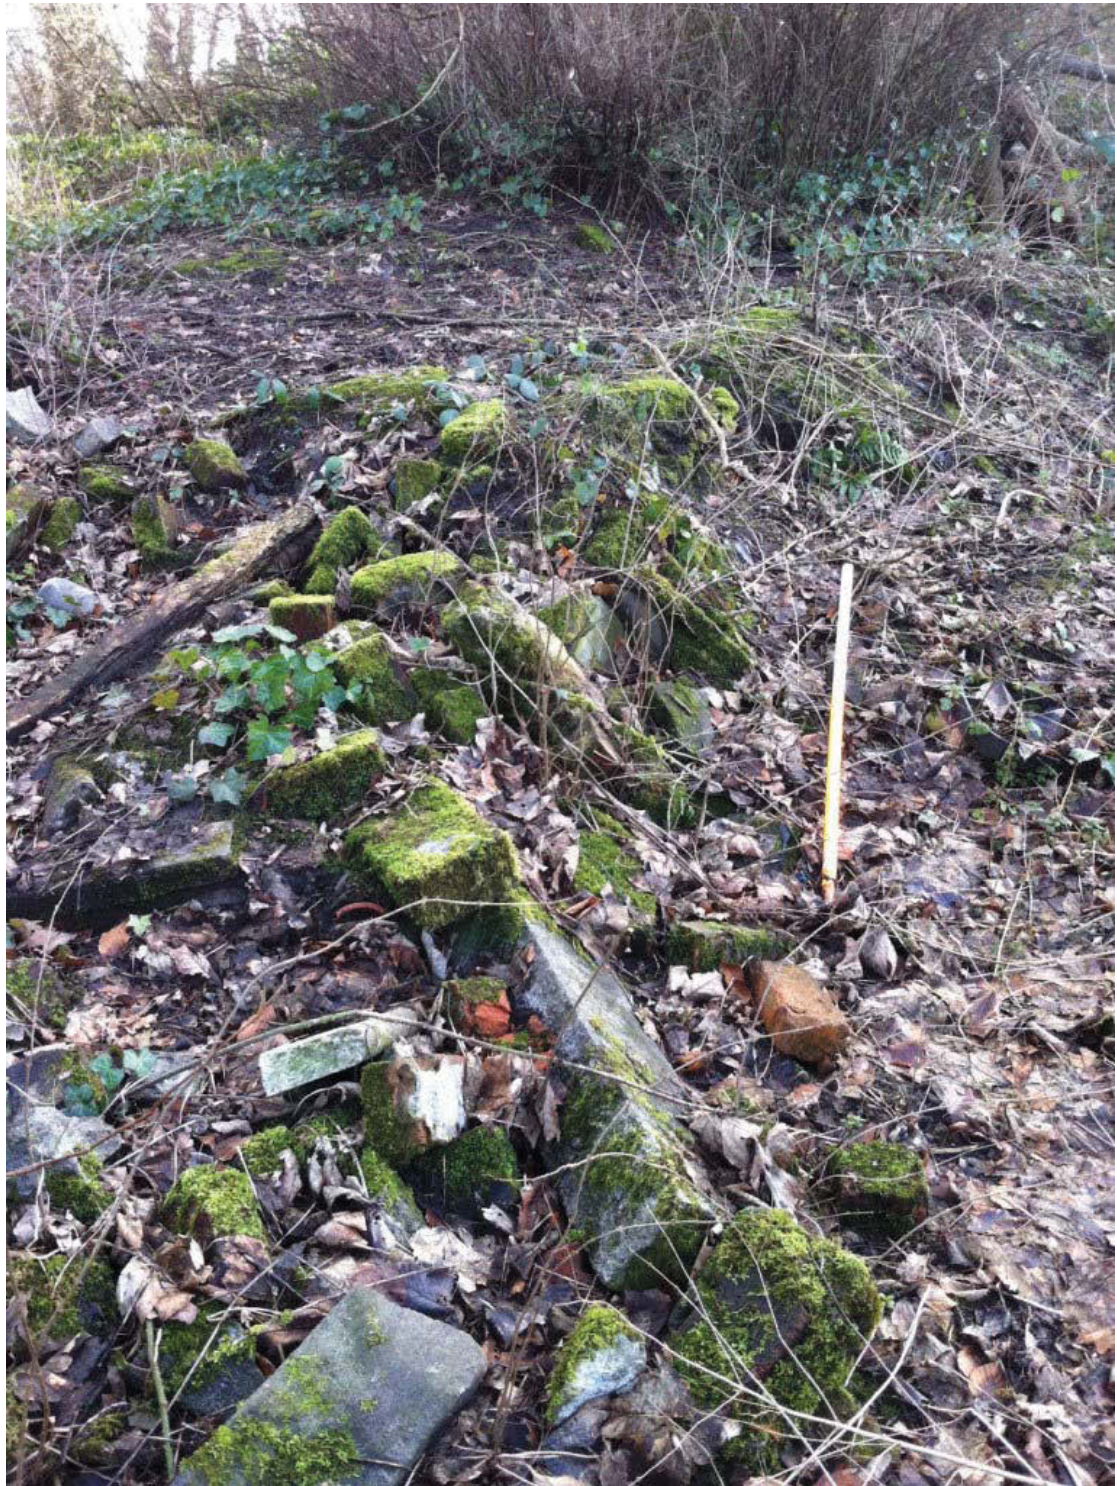
The mound itself was up to a metre higher than the surrounding ground and there were a number of large and mature trees, as well as some more recent sprouting. Large voids were present; tree boles caused by the removal or collapse of trees as well as animal burrows. Some irregular stone, and concrete debris was also observed scattered across the mound (Plate 3).

Plate 3: Collapsed and disturbed wall along the western side of the 'enclosed mound,  
looking north

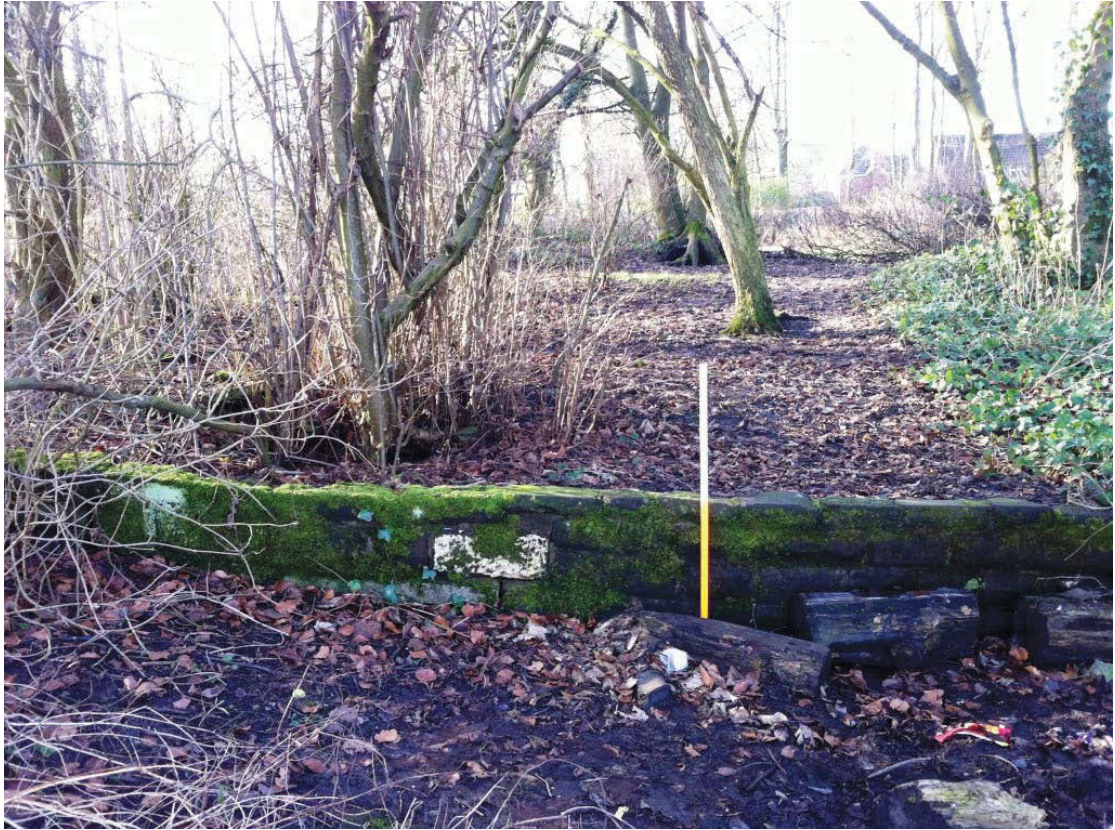
On the east side the wall forms a similar revetting and is well preserved along most of the length, though is buried in part (Plate 4). The sandstone here is similar to that of the church wall and indeed the church itself; with some of the wall constructed or patched up with the same stone curbing as used in the church graveyard.

Plate 4: Wall along the eastern side of the 'enclosed mound, looking west

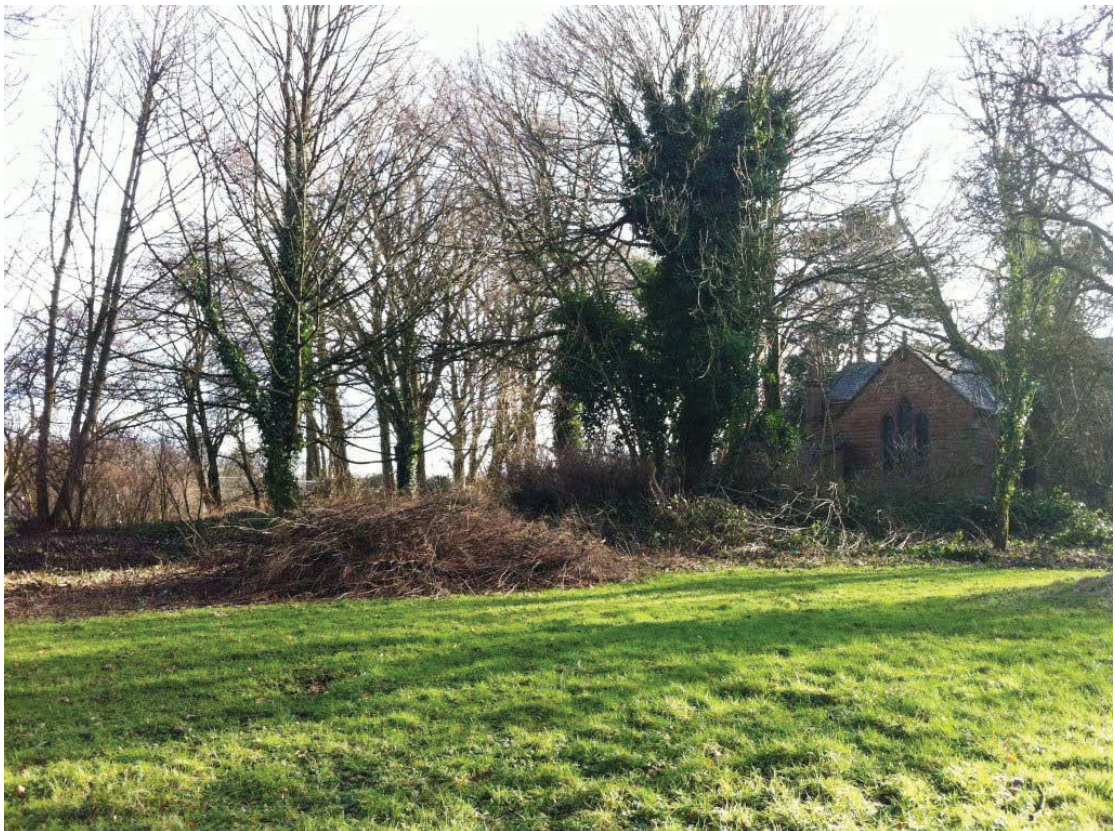
Plate 5: General shot of the setting of the 'enclosed mound' with Christ Church in the background

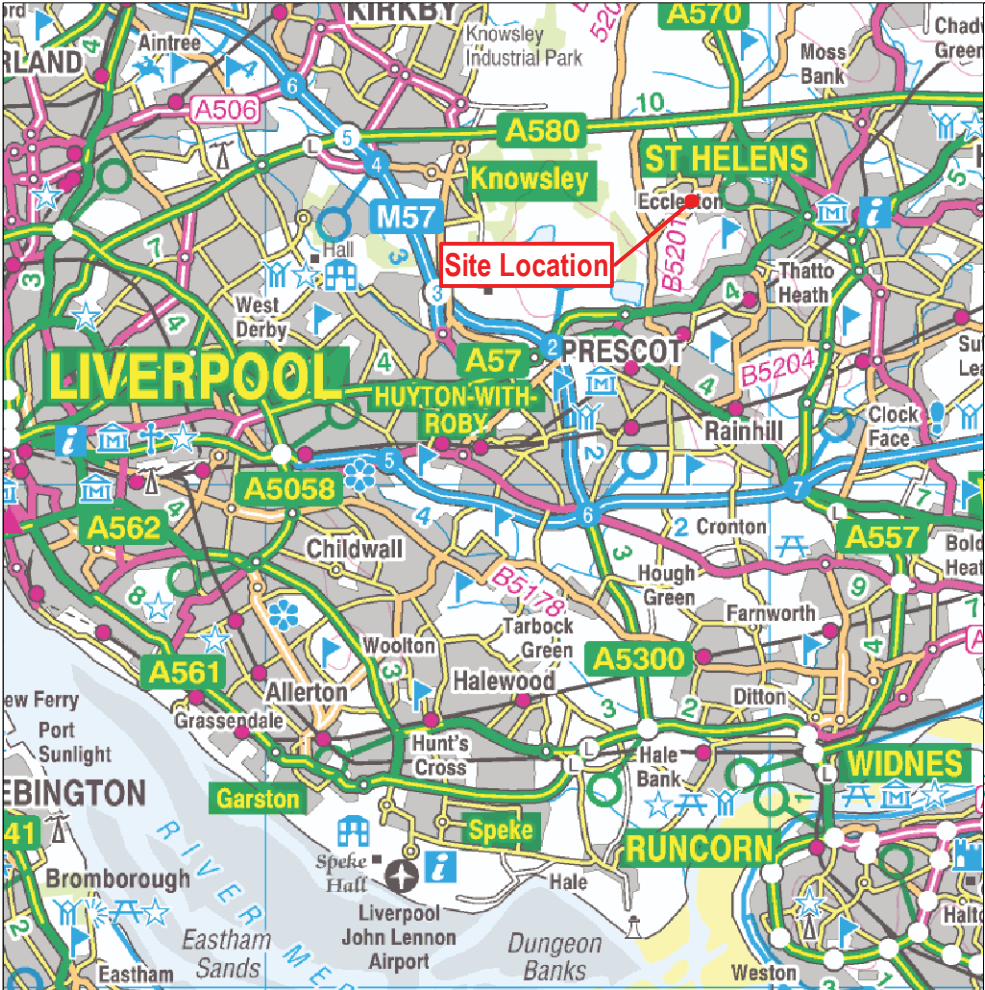
Fig. No	1	Revision
Title	Site location and area of archaeological impact	
Project	Brooklands Road, St Helens	
Scale at A3	1:250	
Client	United Utilities	
Drawn by:	SW	Report No: Y082/13
Checked by:	ML

The wall will also be affected by an underground pipe. In order to keep tree works to a minimum, the path of this pipe will follow the path of the access road. A section of the wall will need to be removed for construction requirements.

The site area comprises the working width for the construction of an access road connecting Church Lane with a new detention tank in a field to the north-west of Christ Church, Eccleston. The proposed road will pass east to west, through a wall and raised mound within a partially wooded, overgrown and grassed area to the north of the church (Fig. 1, NGR SJ 4846 9956).

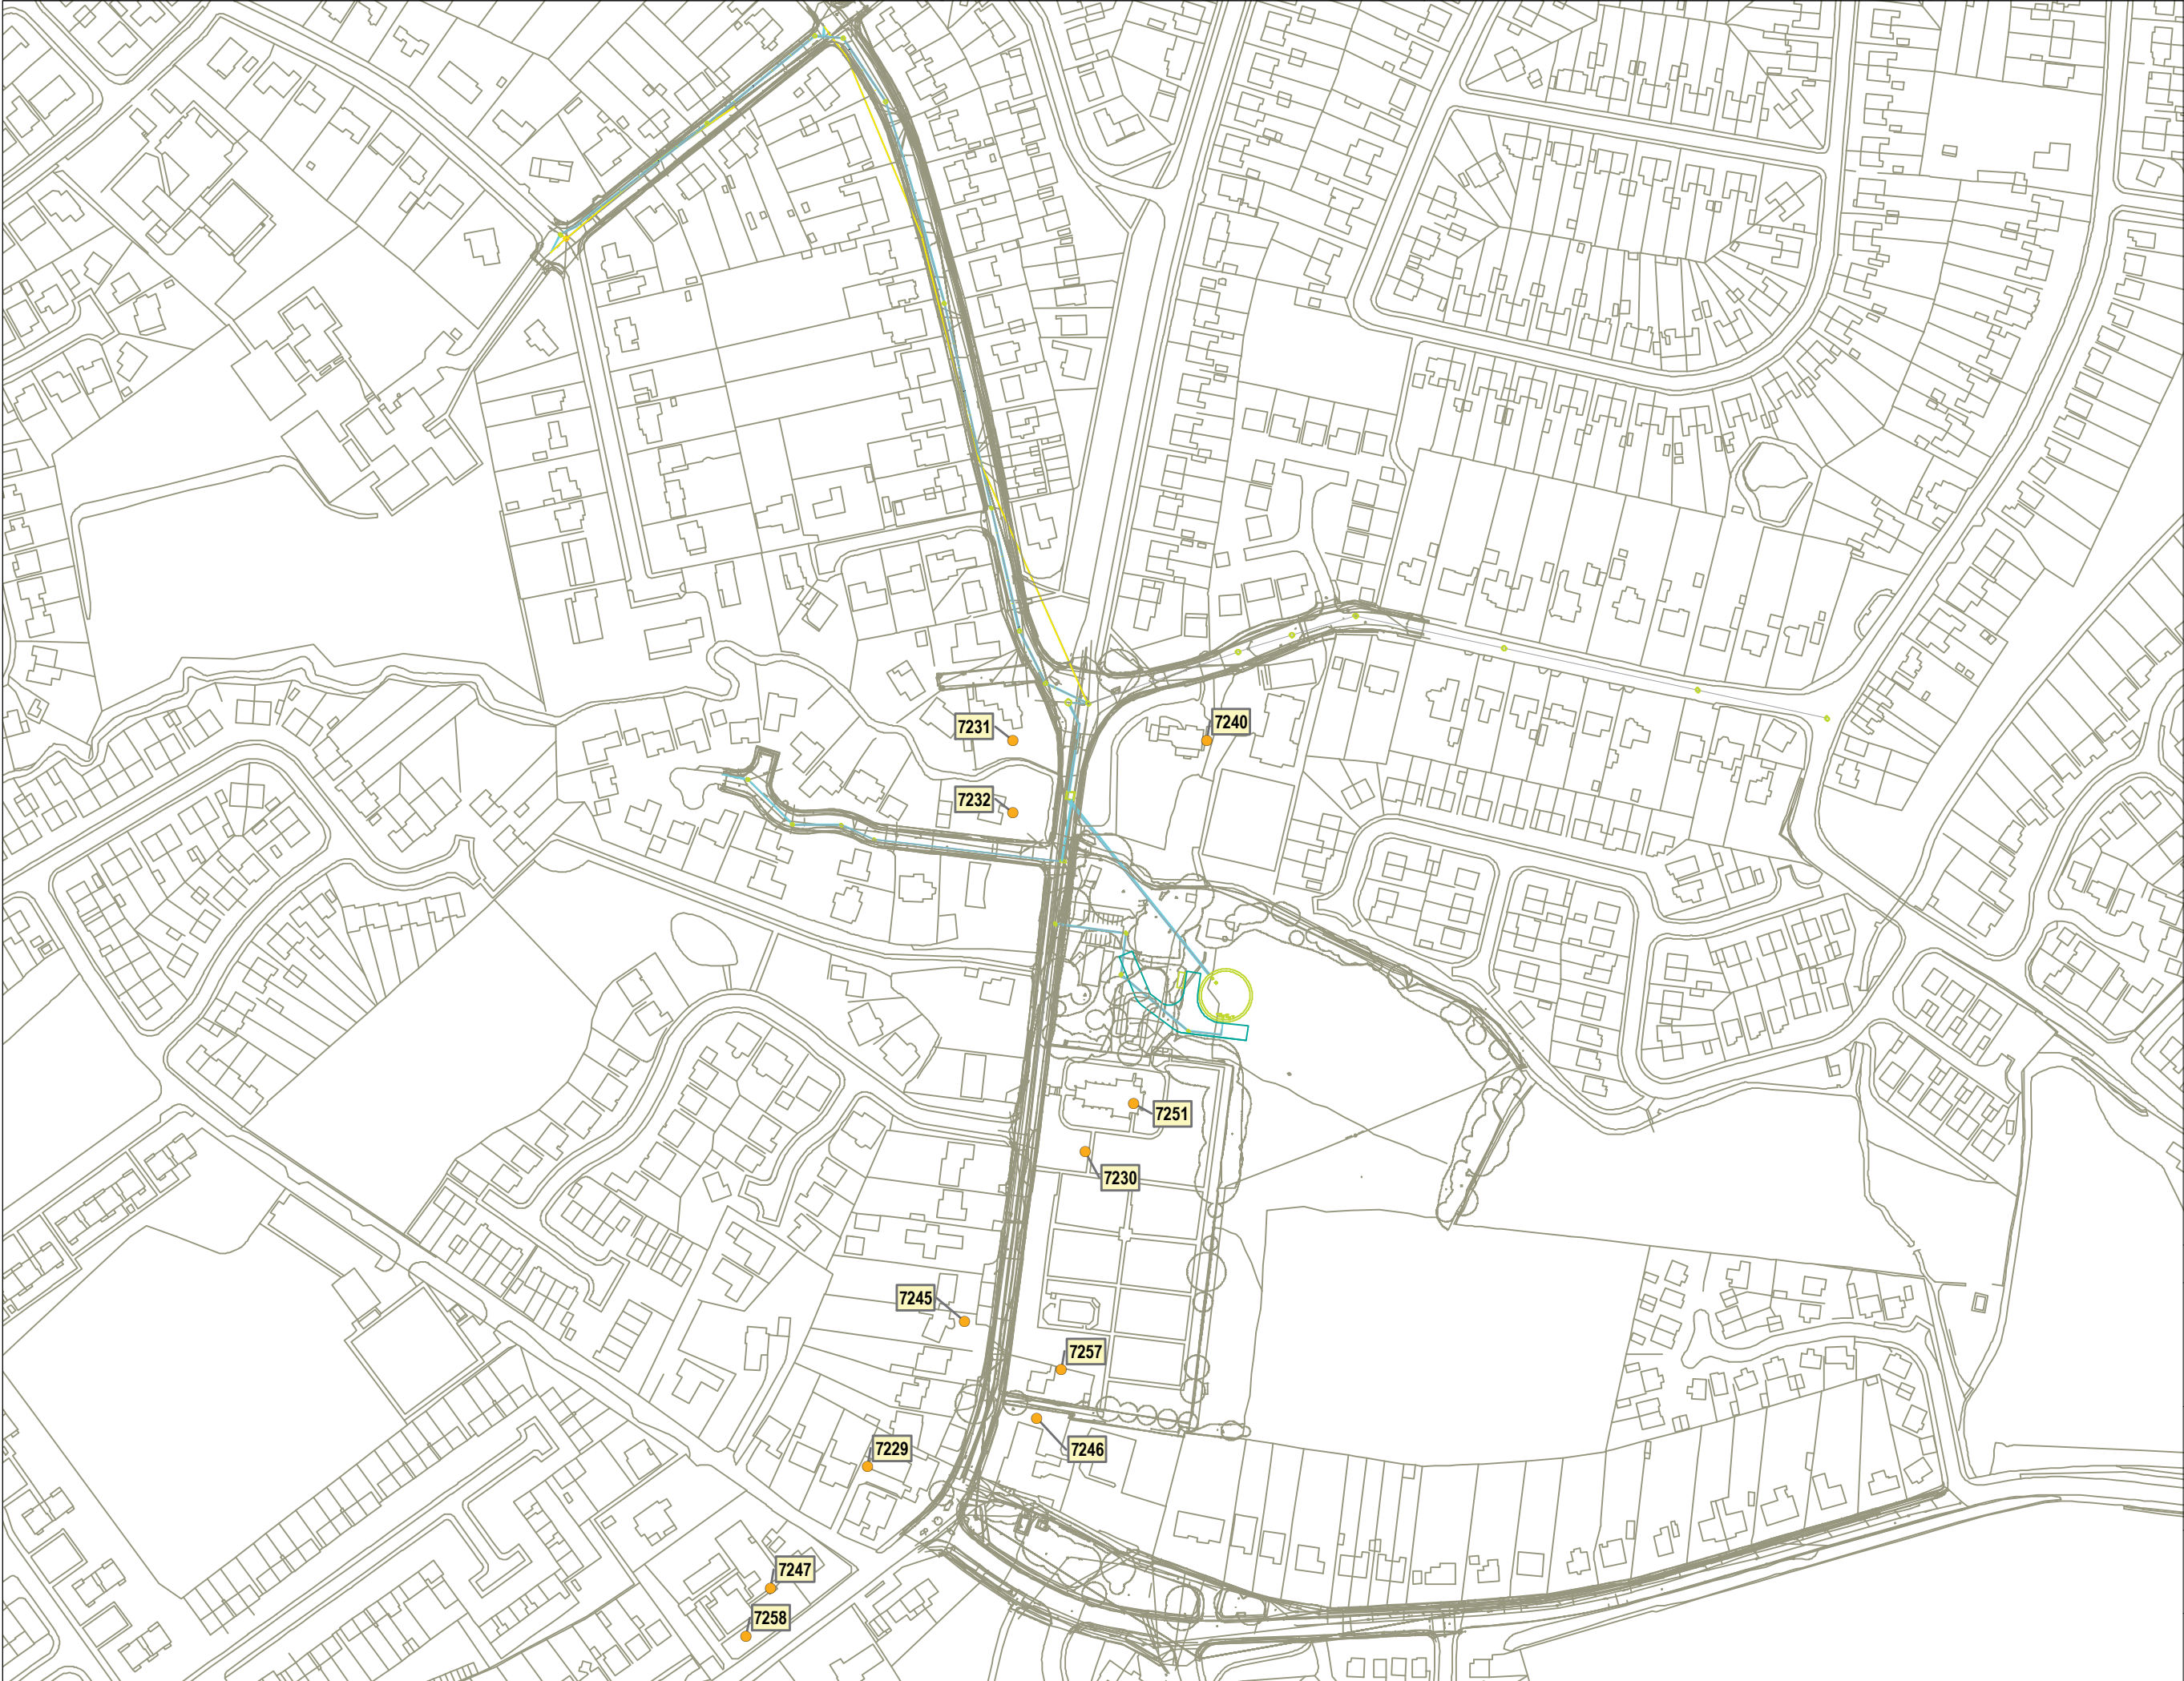
Fig. No	2	Revision
Title	HER events and sites within 100m	
Project	Brooklands Road, St Helens	
Scale at A3	1:2,500

The list of records of monuments and archaeological events recorded within the vicinity of the site appear as Appendix 1 and are plotted on Figure 2.

There is one findspot within 100m of the site, in the grounds of Christ Church. Although attributed to the Bronze Age, the object is described as an 'unidentified stone' (7230). The other entries in the HER are buildings or structures, the most notable being the bridge over Mill Brook (7232), the Vicarage (7240), a Blacksmiths Workshop, now a residence (7257) and a pinfold (7258).

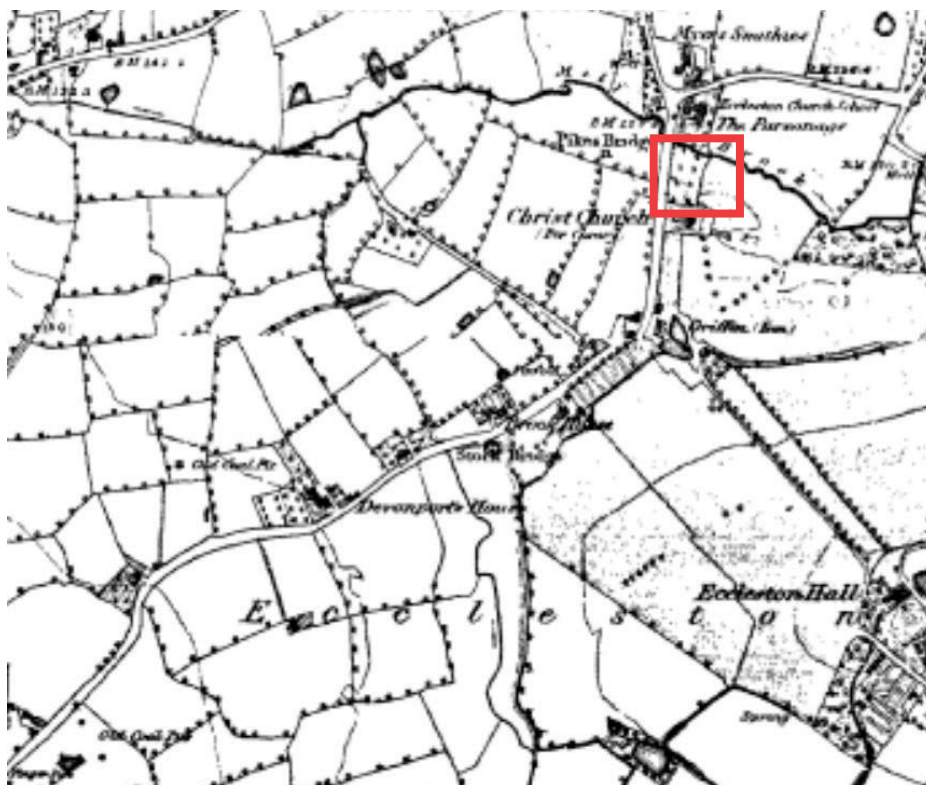
OS 1st Edition map, Lancashire, Sheet 107, 1850.

Christ Church is shown along with the field to the north, boundaries confirming to those of the present day (Fig. 3). Church Lane is shown as is Mill Brook and Pikes Bridge. There is nothing shown within the site area. The surrounding area shows agricultural land with small fields, presumably much of it is managed estate land.
