**Dunmaglass Windfarm,
near Errogie, Highland**

Archaeological Mitigation Works

Report No. 3224

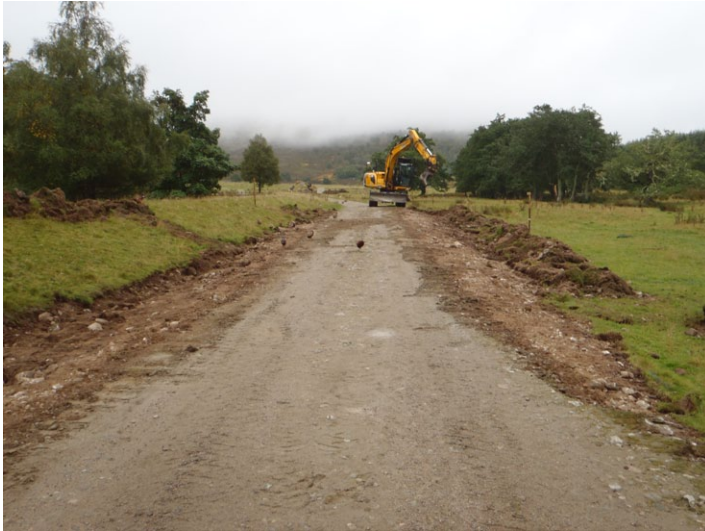
Fig. 5 - General shot of road works on haul road.

A watching brief was required during all ground breaking works for the new access track and during any new works or upgrades to the existing track, as well as a watching brief being required in areas of known archaeological sensitivity. These areas are marked on Fig. 1 and 2 and covered a section from the site entrance (at NH 60978 24355) for 5km to NH 59960 20738 (chainage CH5000), plus a section alongside the Allt Uisg an t-Sidhein burn between NH 60444 18753 and NH 60952 18153 (approx chainage CH7200 to CH8000). Much of the road construction was in the form of upgrading the existing Estate track by widening it to 8m (Fig. 5-6).

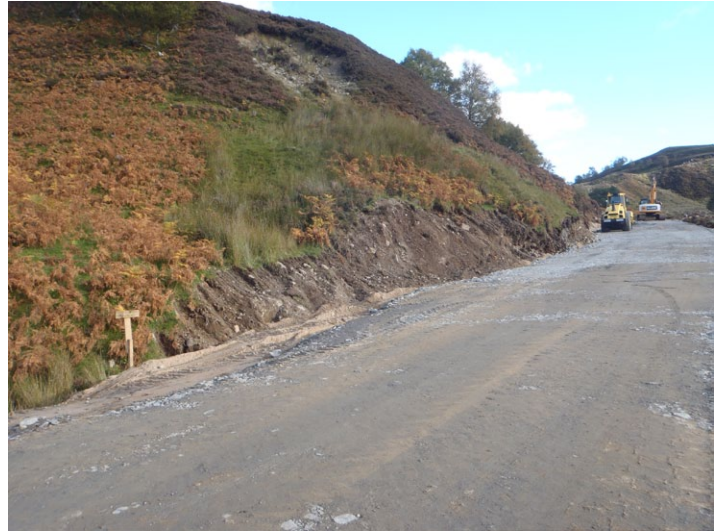
Fig. 6 - General shot of road works on haul road.

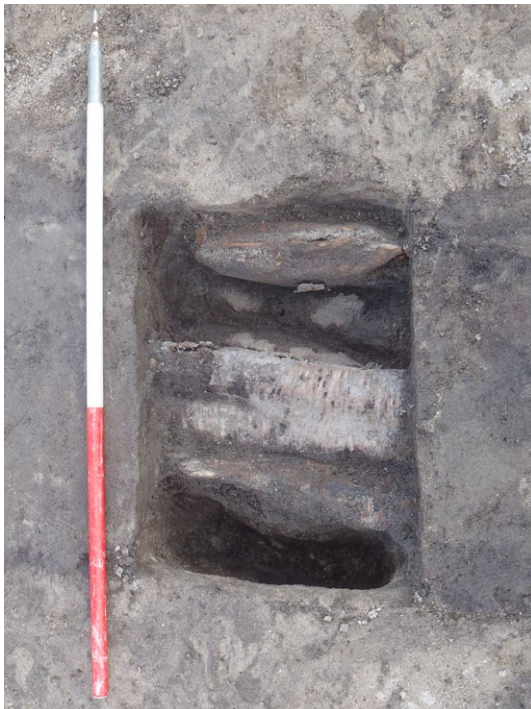
Features found during the watching brief include a birch tree field drain within a linear cut at NH 60703 24069 (Fig. 7), and a possible pit or tree throw at NH 60589 24148. The pit (**004**) measured 0.84m by 0.56m by 0.1m deep, filled with dark greyish-brown sandy silt (**005**).

Fig. 7 - Birch Tree field drain.

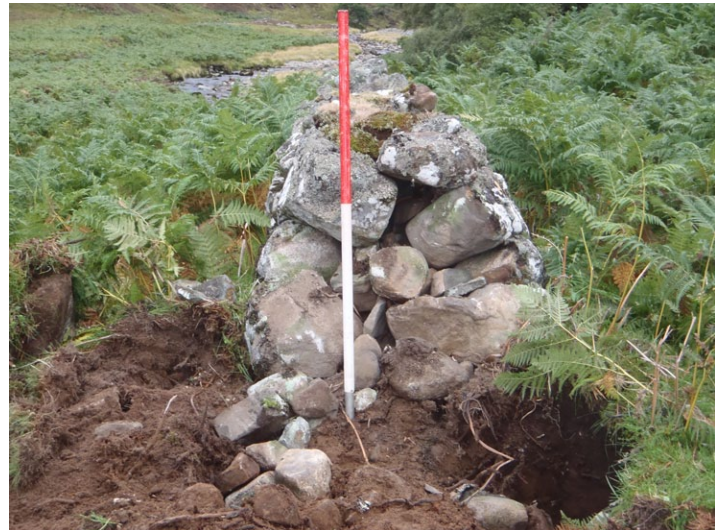
Wall A2, however, required to be partially removed prior to any works commencing, within the footprint of the substation (Fig. 2). Approximately 200m was removed by machine under archaeological and ecological supervision and was recorded. The wall varied in size between 0.6m and 0.9m in height and was between 1m-1.2m wide and was of stone and turf construction. Sections through the wall were recorded at four different locations (Fig. 8-10).

Fig. 8 - Profile shot of wall A2 at Substation site.

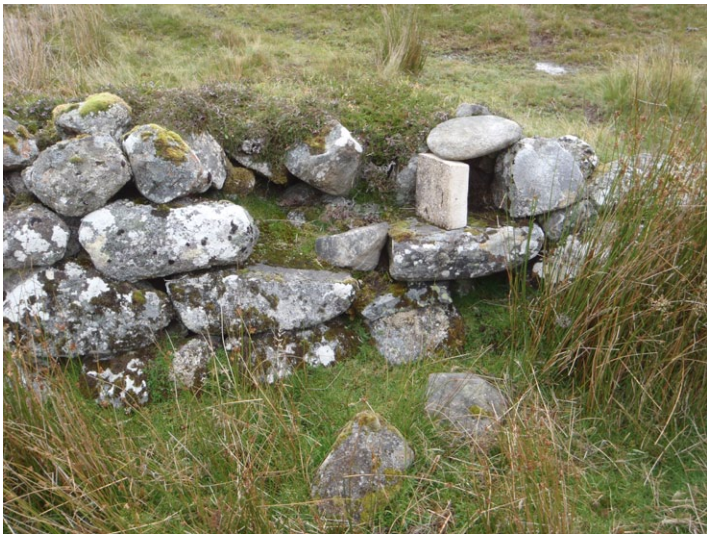
Fig. 9 - Detail of section of wall A2.

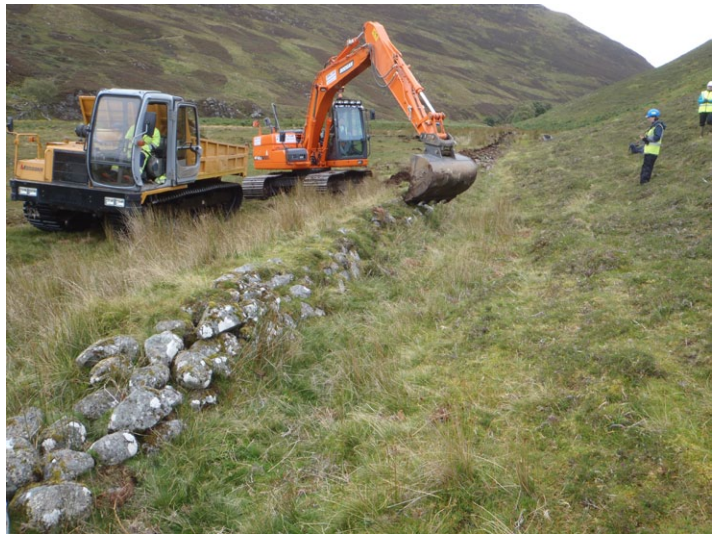
Fig. 10 - Removal of wall A2.

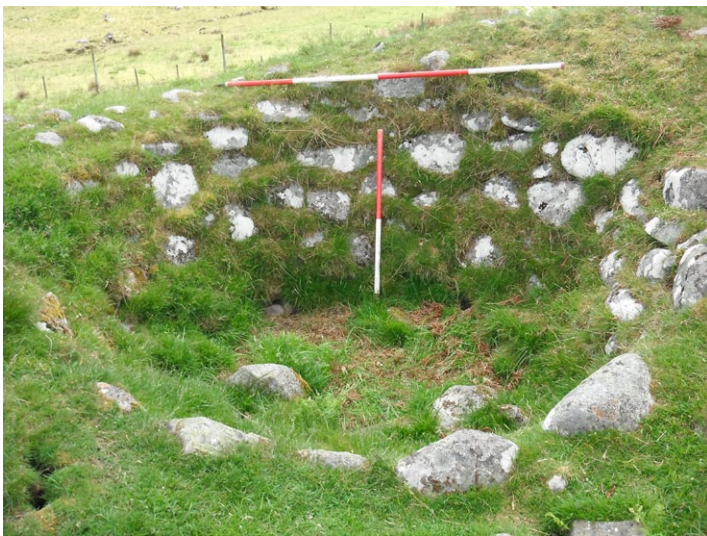
The township of Balnagaig (Site 28) is depicted on the 1st Edition Ordnance Survey map (1875) as an enclosure and a roofed building with attached enclosure. Field survey identified five buildings, one with an attached enclosure, a large rectangular enclosure and a corn-drying kiln within an area of improved pastureland set on a broad plateau. Several of the buildings are immediately adjacent to the existing Estate track.

A measured and photographic survey was undertaken of Site 28 to accurately map and record all of the visible earthworks, to enable assessment of the effect that the proposed access track to the substation would have on the surviving upstanding remains (Fig. 2, 11-14).

Fig. 11 - Shot of feature at Site 28 *Balnagaig*.

Following the survey, the proposed access track was re-routed to the south-west in order to preserve the site in situ. Site 28 was demarcated during construction works and a watching brief was maintained in its vicinity (see section 3.5).

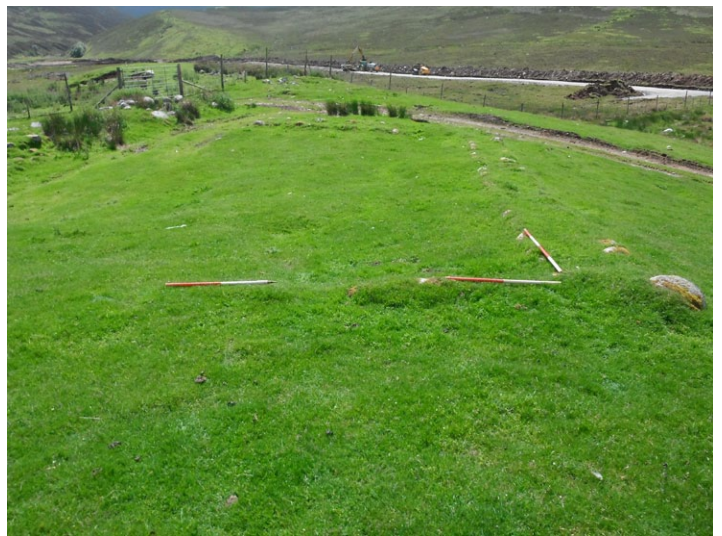
Fig. 12 - Shot of feature at Site 28 *Balnagaig*.

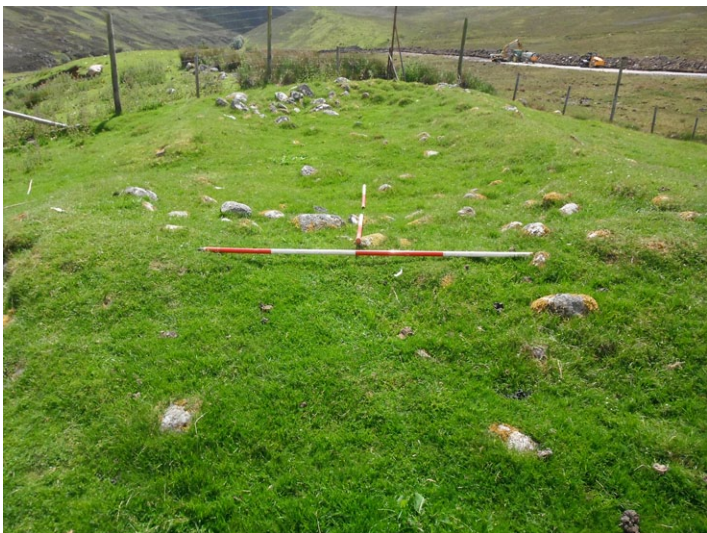
Fig. 13 - Shot of *Balnagaig*.

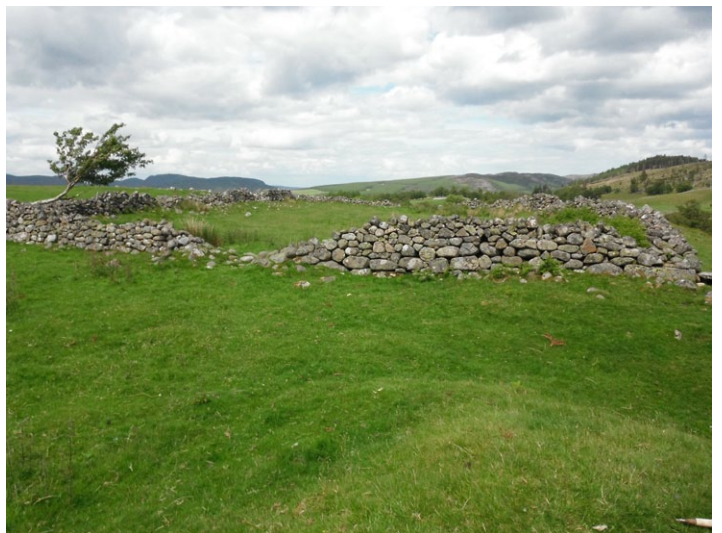
Fig. 14 - Shot of *Balnagaig*.

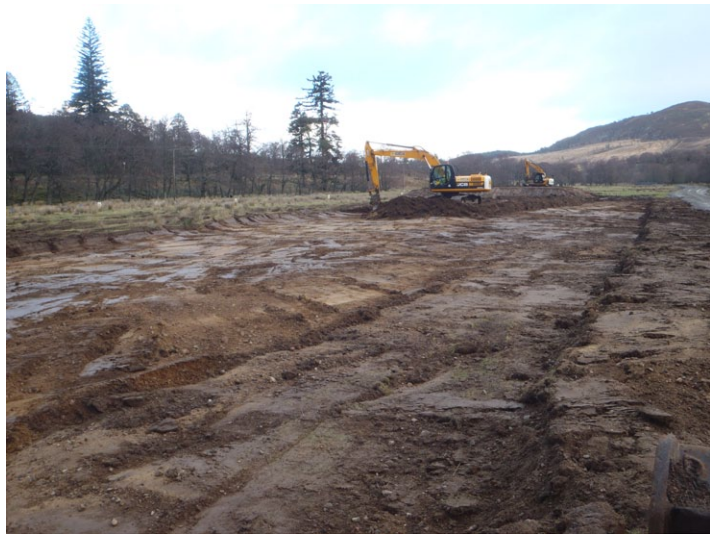
The watching brief did not uncover any archaeological features, deposits or artefacts. The topsoil was approx. 0.45m deep and overlay natural sand with large rounded boulders. The stripped area appeared to have been a natural flood plain for the nearby stream.

Fig. 15 - Compound 2.

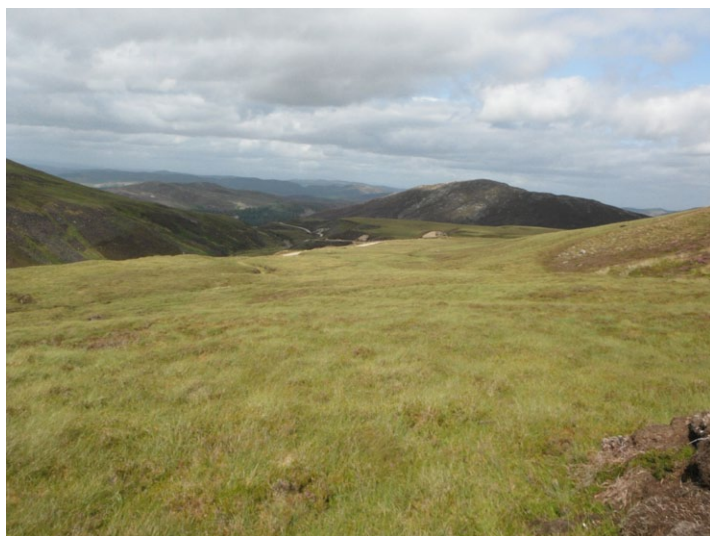
A walkover survey was conducted over a section of the proposed haul road route where the track diverted away from the pre-existing Estate track. This new road was to cross over new ground and a survey was conducted to establish if any archaeologically sensitive remains were present which would be affected by the works. The results showed that there were no archaeological remains along the proposed re-route: however, several modern Grouse Butts were present, Sites 001-012 (Brown 2013) (Fig. 3, 17).

Fig. 17 - Alternative Road Survey.

No mitigation was undertaken as the road was built as a floating road with no breaking of ground.

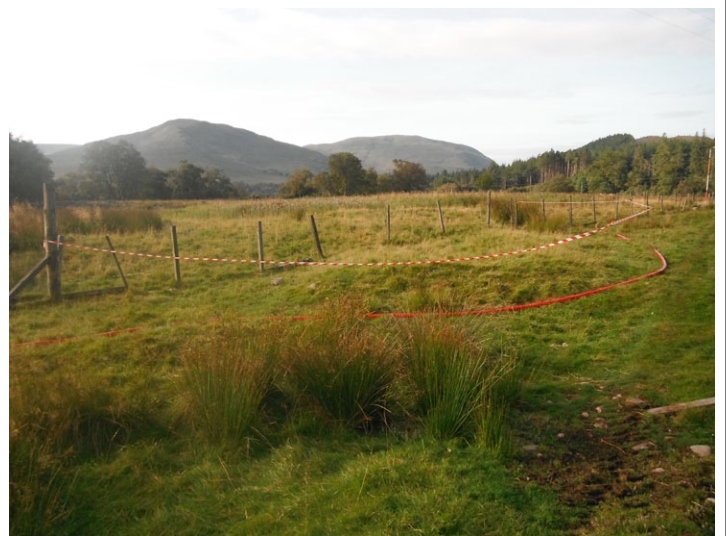
Fig. 18 - Demarcated structure on the cable trench route.

The cable trench route was to be buried underground from Achmalodan Cottage to the public road, passing through an area of post-medieval settlement remains (Sites 2-3). A walkover survey was conducted of the proposed cable route and a route through this area was agreed which micro-sited around upstanding remains, with sites demarcated for preservation in situ (Fig. 18). No upstanding remains were impacted upon. A watching brief was put in place and the ground works were monitored throughout (Fig. 4, 20). No archaeological features were uncovered.

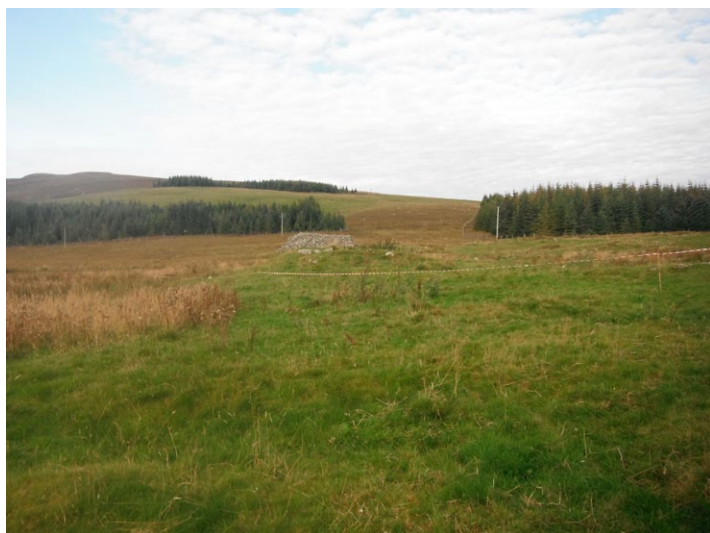
The route of the haul road followed the route of the current Estate road, taking it past settlement sites that appear on the First Edition Ordnance Survey (OS) map (1875) and which today are in ruins. These settlements are Crochy (Site 1), Drumnaclóich and Lagg (Sites 2 and 3), and Achnalodan (Site 4) (Fig. 2). These sites, whilst still visible on the ground, were not disturbed by the works as they were sited outside of the working area, thus they have been protected and preserved *in situ* (Fig. 19).

Fig. 19 - Demarcated site at Crochy.

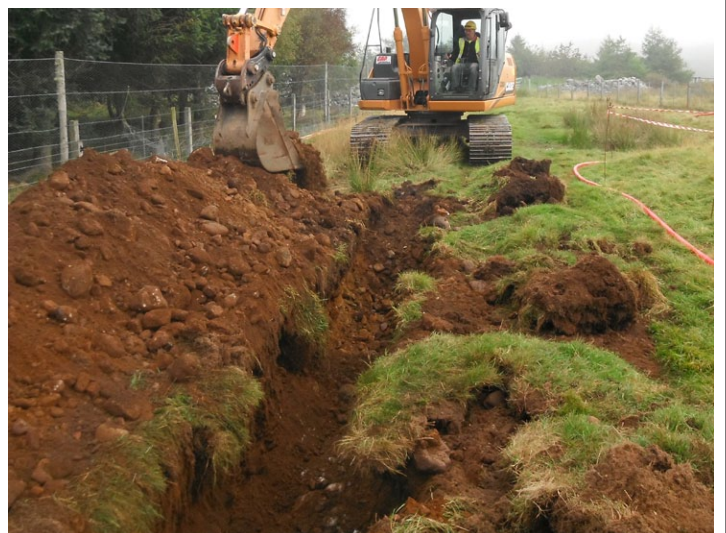
Fig. 20 - Cable trench alongside demarcated feature in Fig 18.
